Re: Safety-Kleen Systems Inc.
Facility ID: FLD982133159
Leon County

**Florida Department of
Environmental Protection
Hazardous Waste Inspection Report**

Inspection Date: 07/19/2019

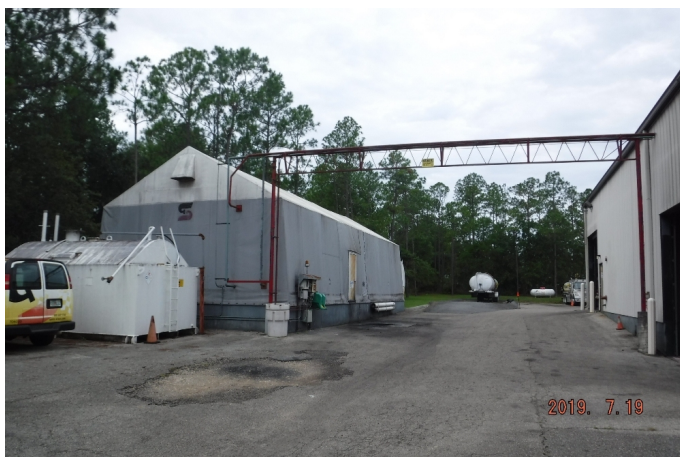
Entrance/Tank Storage

D. Tank Storage. This covered and enclosed tank storage area contains a 150-degree solvent, used oil tank, and permitted hazardous waste storage tank. Outside this area are a 150-degree solvent tank and used antifreeze tank. Tank 2, the permitted hazardous waste storage tank, was labeled as an Out of Service AST on the previous facility permit but the warehouse manager said it is still in use. Located in Appendix C of the previous permit, the last tank inspection report for this tank, dated July 15, 2014, deemed it satisfactory for use until the next inspection. Please ensure the tank is inspected in accordance with the schedule and procedures in the permit application (Part II Subpart B.2(7)). All tanks and the load/unload pipe manifold areas appeared to be in good condition. The hazardous waste solvent tank contents are transported by Safety Kleen Systems, Inc. (TX00050930) to destination facility Safety Kleen Systems, Inc. (SCD077995488) as waste combustible liquids (D001, D018, D039, & D040) approximately once a month.

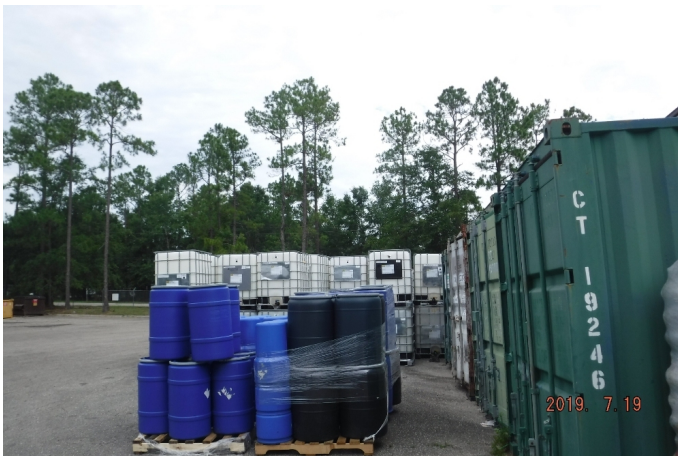
External Storage

E. External Storage. The outside storage/lay down area, driveways, vehicle parking lot, solid waste dumpsters, and the perimeter fence/lawn areas were inspected with no violations noted. Dry storage containers appeared to be in good condition. Signs are attached to the perimeter fencing and in good condition.

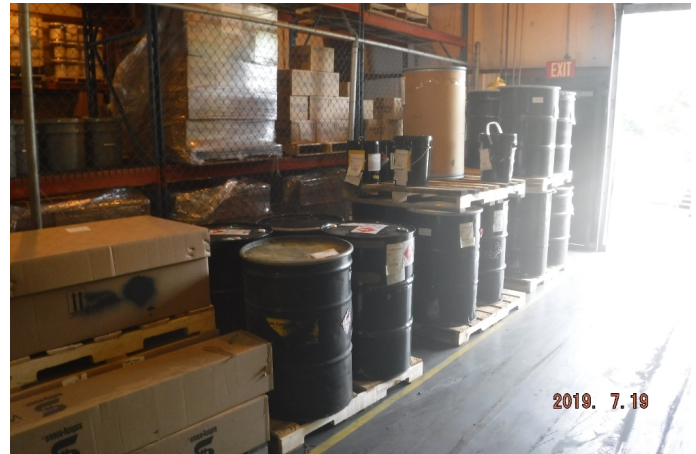
B. 10 Day Transfer Station Area. This Area contained 43 drums and six smaller drums/buckets of mixed hazardous and nonhazardous drums as well as boxes of waste lamps awaiting shipment. All drums were labeled, dated within the 10-day transfer date. Documentation for containers was checked and found to be in order. The safety equipment locker was fully equipped and in order. A SAA has been established in this area for expired used oil vacuum samples. This SAA was labeled and in good condition.

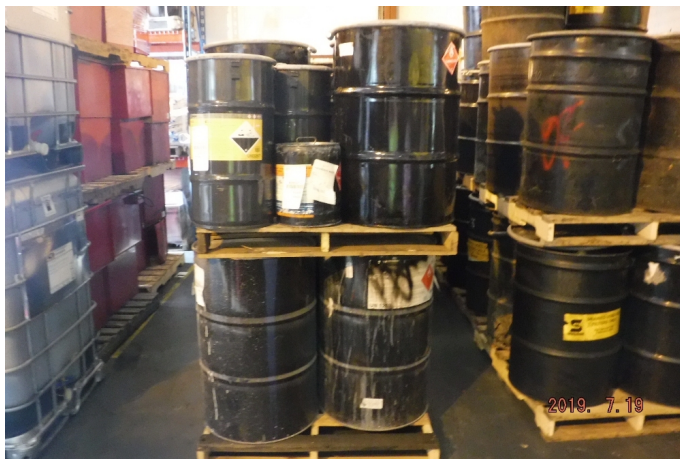
TSD Storage

C. Storage Area. This area is labeled on the site map as FRS 10-day Transfer Waste/Permitted Container Storage Area and cannot accumulate more than 6,912 gallons of hazardous waste in containers according to Part II Subpart B.1(2) of the permit. This area contained 31 drums of hazardous waste and three smaller hazardous waste drums awaiting shipment. The two rows of palatalized, labeled, and dated drums were not contained within the adjacent lined 10-Day Transfer Area and floor markings were not apparent. The latest date noted was 6/27/19, which is outside of the 10 day time restriction as the inspection was conducted 7/19/19, but well within the 90-day accumulation requirement for LQG's in 40 CFR 262.17(a). The facility needs to clarify this area on the upcoming permit renewal and provide an updated map of all storage areas at the facility. This area also stores components of solvent parts washers for distribution or repair.

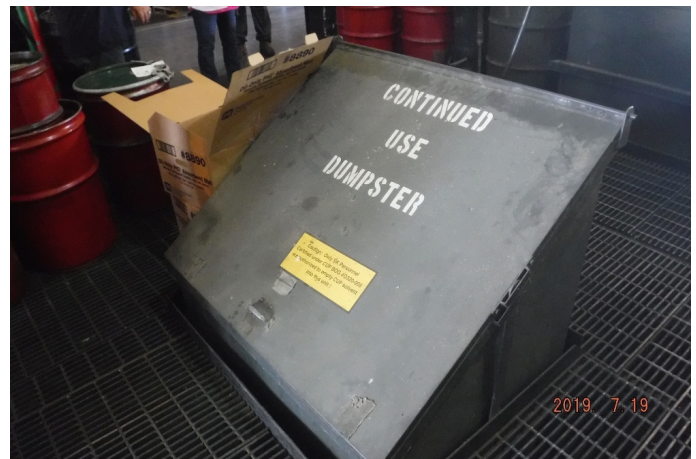
Continued Use Program Dumpster

A. Return/Fill Shelter: No loading/unloading activity was underway at the time of inspection. Both drain dumpster lids were closed. One Satellite Accumulation Area (SAA) contained a closed, labeled 55-gallon drum for hazardous waste solids/sludge from the dumpster/drum washing unit. The Continued Use Dumpster is located in this area for the Continued Use Program (CUP).
