Re: Safety-Kleen Systems, Inc.
EPA/DEP ID: FLD 980 847 214
Clay County – Hazardous Waste

**Florida Department of
Environmental Protection
Hazardous Waste Inspection Report**

Facility Name: Safety-Kleen Systems Inc
On-Site Inspection Start Date: 08/20/2019 **On-Site Inspection End Date:** 08/20/2019
ME ID#: 2319 **EPA ID#:** FLD980847214
Facility Street Address: 161 Industrial Loop S , Orange Park , Florida 32073-6259
Contact Mailing Address: 161 Industrial Loop S, Orange Park, Florida 32073-6259
County Name: Clay **Contact Phone:** (561) 523-4719

Inspection Date: 08/20/2019

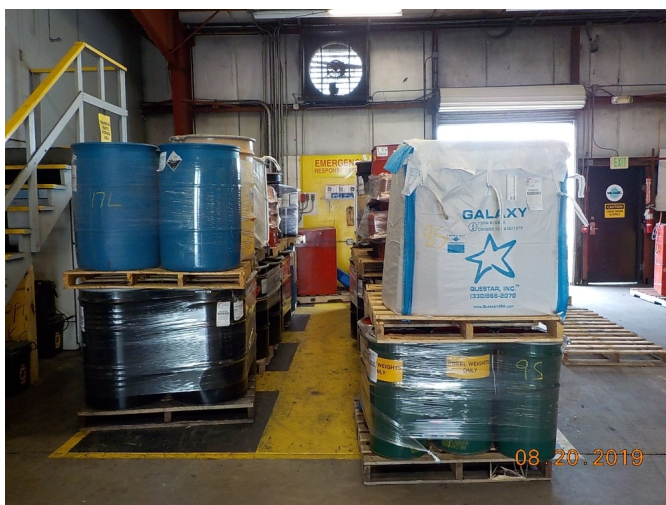
Photo 1 - Warehouse 10-Day Transfer Area

The Warehouse 10-Day Transfer Area is located inside the warehouse adjacent to the Container Storage Area and is one of two 10-Day Transfer Areas at the facility (Photo 1). This area had appropriate safety equipment, decontamination equipment and spill kits. At the time of the inspection, this area contained 18 pallets of hazardous waste and non-hazardous waste containers. All hazardous waste containers were closed, dated, labeled and had been in the Transfer Area for less than 10 days.

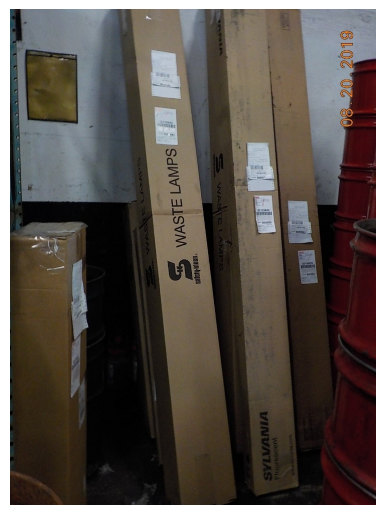
Photo 2 - UW in Container Storage Area

The Container Storage Area, located across from the 10-Day Transfer Area, is a permitted hazardous waste storage area with a maximum capacity of 2,553 gallons of hazardous waste allowed. This area had appropriate safety equipment, decontamination equipment and spill kits. At the time of the inspection, no hazardous waste was stored in this area. The Container Storage Area is also used to accumulate universal wastes. At the time of the inspection, there were four boxes of universal waste lamps in this area (Photo 2). The boxes were properly closed, dated, properly labeled, and had been stored less than 180-days.

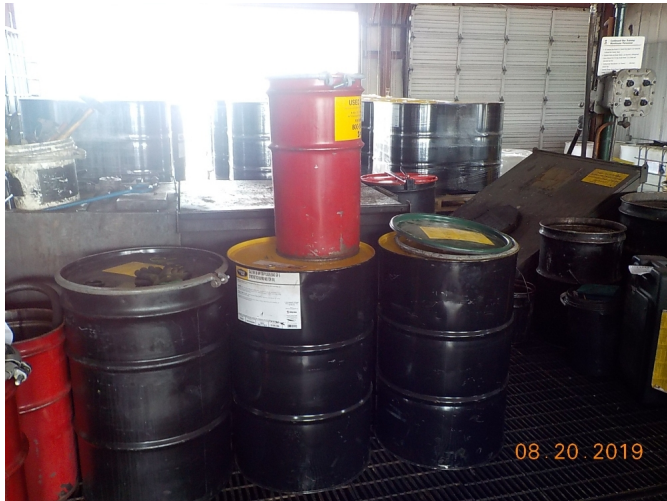
Photo 3 - Receiving Dock 10-Day Transfer Area

All hazardous waste, universal waste and waste solvent arrives through the Receiving Dock. This area is the second designated 10-Day Transfer Area at the facility (Photo 3). This area had appropriate safety equipment, decontamination equipment and spill kits. At the time of the inspection, this area contained five pallets of hazardous waste and non-hazardous waste containers. All hazardous waste containers were closed, dated, labeled and had been in the Transfer Area for less than 10 days.

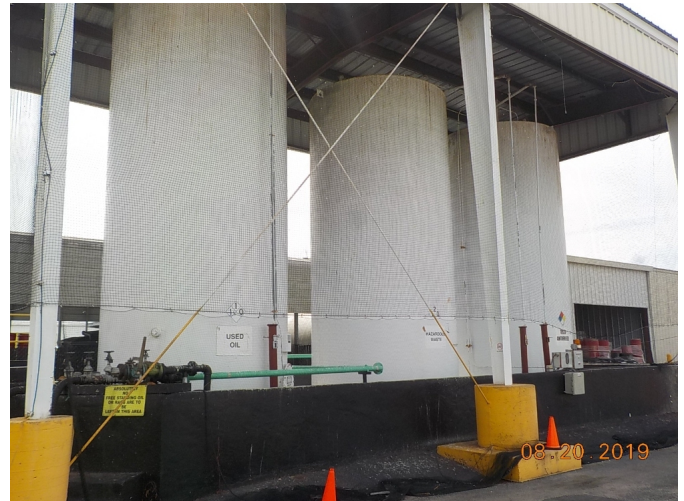
Photo 4 - Tank Farm

The Tank Farm contains three aboveground storage tanks as follows: one permitted 15,000-gallon hazardous waste storage tank, one 15,000-gallon used antifreeze tank and one empty 15,000-gallon tank labeled for used oil (Photo 4). The hazardous waste tank is used to store D001/D018/D039/D040 spent parts washer solvent/mineral spirits and was labeled "Hazardous Waste." The tank system, including associated ancillary equipment and secondary containment, appeared to be in good condition.
