Re: Univar Solutions USA, Inc.
Facility ID Number FLD020985727
Hillsborough County

**Florida Department of
Environmental Protection
Hazardous Waste Inspection Report**

Facility Name: Univar Solutions USA Inc
On-Site Inspection Start Date: 06/24/2020 **On-Site Inspection End Date:** 06/24/2020
ME ID#: 52299 **EPA ID#:** FLD020985727
Facility Street Address: 6049 Old 41A Hwy, Tampa, Florida 33619-8786
Contact Mailing Address: 6049 Old 41A Hwy, Tampa, Florida 33619
County Name: Hillsborough **Contact Phone:** (813) 336-0771

Inspection Date: 06/24/2020

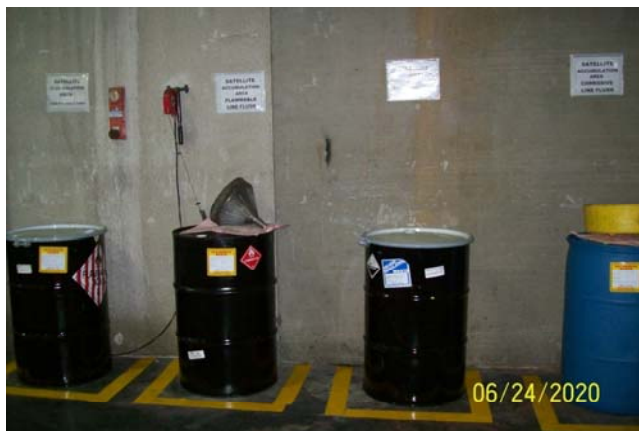
SAA at the Warehouse Chemical Packaging Area

A fill station for loading drums and IBCs is located inside the warehouse and next to the tank farm where. There are three separate designated satellite accumulation areas (SAAs) for hazardous waste generated from container loading operations; each SAA contains a single drum. The flammable line flush SAA contains a metal 55-gallon drum; the corrosive line flush SAA contains a polypropylene 55-gallon drum; and spill cleanup materials and used protective gear SAA contains a metal 55-gallon drum. All three SAA drums contained a hazardous waste label and label with an indication of the hazard (flammable, corrosive and flammable solid, respectively). A fourth non-RCRA regulated corrosive solids (empty sample bottles) SAA contains a metal 55-gallon drum. Emergency equipment and a contact call list was located in the area. Equipment included a telephone, eye washes, safety showers, fire extinguishers and the manual pull for the fire alarm. When satellite accumulation drums are full, they are replaced with a properly labeled empty drum and the full drum is moved to the facility's 90-day central accumulation area.

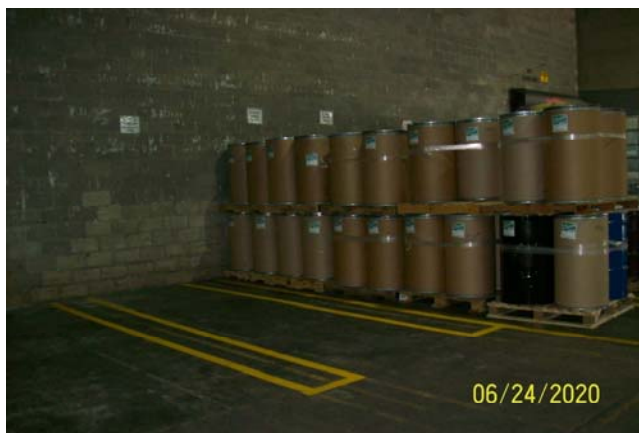
90-day CAA

The 90-day central accumulation area is located adjacent to the 10-day transfer facility area. The areas are designated by aisles painted on the warehouse floor, and each aisle is five pallets long. Spilled or damaged in the other product handling areas are immediately packaged, labeled, dated and placed in the 90-day area. At the time of this inspection, there was no waste being stored area.

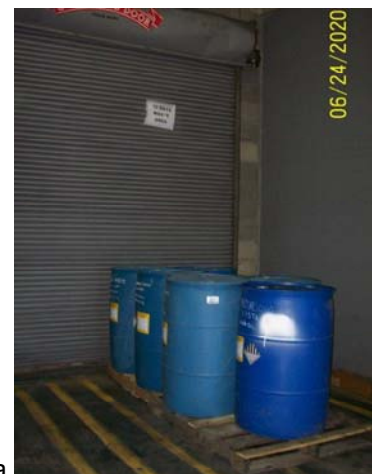
10-day Transfer Area

The transfer facility consists of six aisles, and therefore has a total capacity of the equivalent of 240 55-gallon drums. Waste is accepted in cubic yard containers, drums and smaller packages. Univar does not transport

hazardous waste in bulk. Univar does not open or repackage any waste, unless a container is found to be leaking or damaged. Overpack containers were available. All waste is transported using either a hazardous waste or non-hazardous waste manifest that lists the waste profile/waste approval number issued by the designated facility. Because of this, the District has not required the facility to open and screen used oil shipments for halogen content. The waste profile and approval meet the 40 CFR 279.44(d) recordkeeping requirement. Univar handles only a limited amount of material designated as used oil. At the time of the inspection, six 55-gallon polypropylene drums and one 35-gallon polypropylene drum were located in this area.

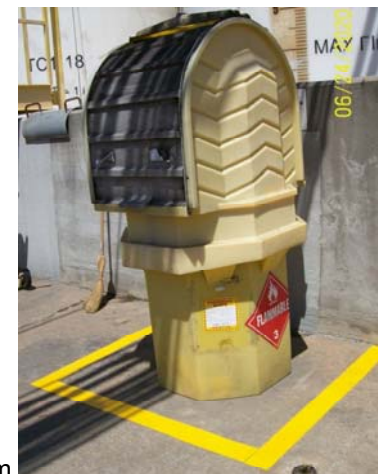
SAA at the Tank Farm

The storage tank farm is located adjacent to the main building. A fill station for loading drums and IBCs is also located adjacent to the tank farm. The flammable line flush SAA contains a metal 55-gallon drum is located next to the fill station. SAA drum contained a hazardous waste label and label with an indication of the hazard (flammable) as does the drum containment unit.
