**Florida Department of
Environmental Protection
Hazardous Waste Inspection Report**

Facility Name: Safety-Kleen Systems Inc
On-Site Inspection Start Date: 06/25/2020 **On-Site Inspection End Date:** 06/25/2020
ME ID#: 11672 **EPA ID#:** FLD984171694
Facility Street Address: 8755 NW 95th St, Medley, Florida 33178-1462
Contact Mailing Address: 5610 Alpha Dr, Boynton Beach, Florida 33426-1462
County Name: Miami-Dade **Contact Phone:** (561) 523-4719

Inspection Date: 06/25/2020

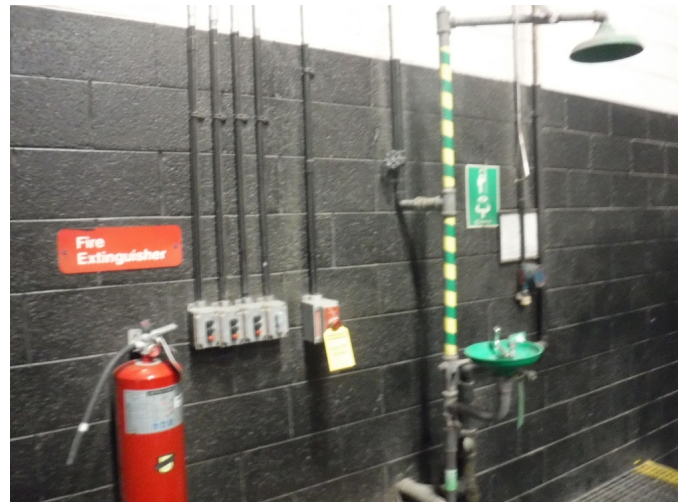
Preparedness and prevention measures

The following preparedness and prevention measures were observed throughout the facility: spill kits, eye wash/shower areas, fire extinguishers, internal communication system, and fire prevention methods.

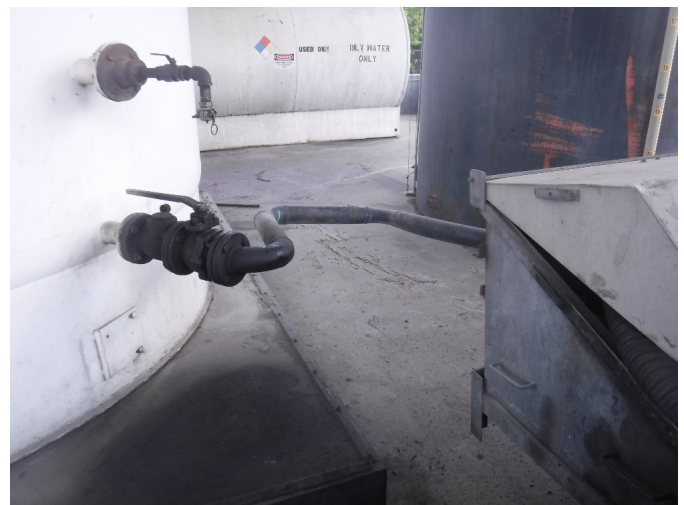
Secondary containment

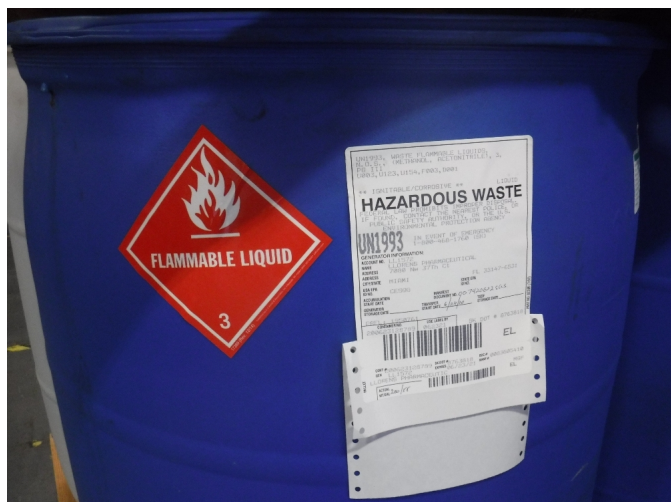
All drums were properly labeled and closed

All drums were observed to be closed, properly labeled, placed over the secondary containment, and in-compliance with the 10-day storage limit.
