**Florida Department of  
Environmental Protection  
Hazardous Waste Inspection Report**

**Facility Name:** Clean Harbors Florida LLC  
**On-Site Inspection Start Date:** 08/05/2020 **On-Site Inspection End Date:** 08/05/2020  
**ME ID#:** 50782 **EPA ID#:** FLD980729610  
**Facility Street Address:** 7001 Kilo Ave, Bartow, Florida 33830-6672  
**Contact Mailing Address:** 7001 Kilo Ave, Bartow, Florida 33830-6672  
**County Name:** Polk **Contact Phone:** (863) 519-6331

Routine Inspection for TSD Facility Facility

## Clean Harbors Florida LLC Inspection Report

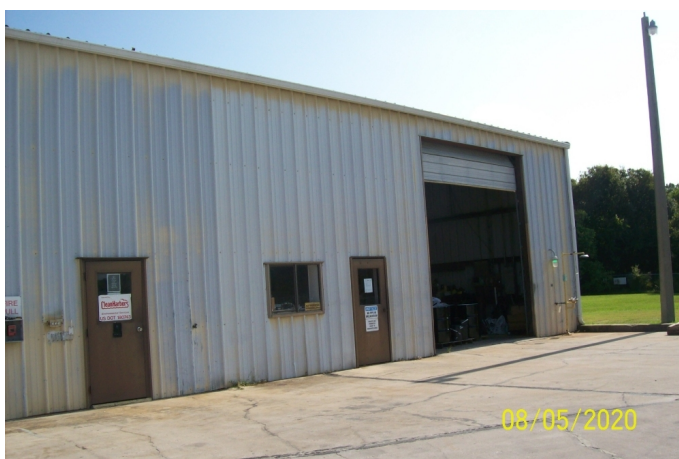
Field Services end of the Maintenance Building

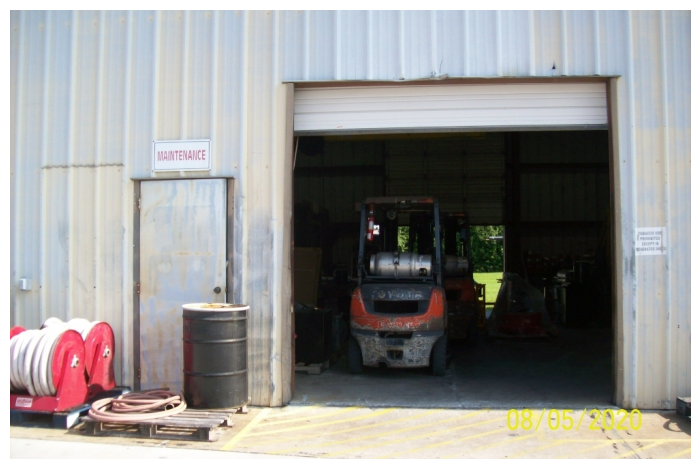
Maintenance Shop in the Maintenance Building

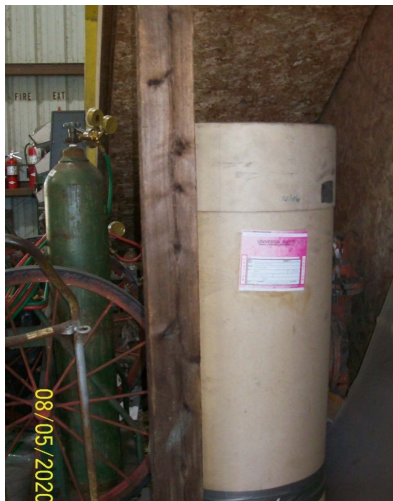
The Maintenance Building, which houses both the Field Services and Facility Maintenance, is located on the north side of the facility. No wastes are stored in the Field Services section of the building, just products. A closed container for shop rags and a container for 4-foot spent fluorescent bulbs were located in Facility Maintenance. The container was closed and properly labeled. The start date of October 15, 2019; please note that universal waste lamps cannot be stored on site for more than 365 days.

Spent Lamp container in the Maintenance Shop

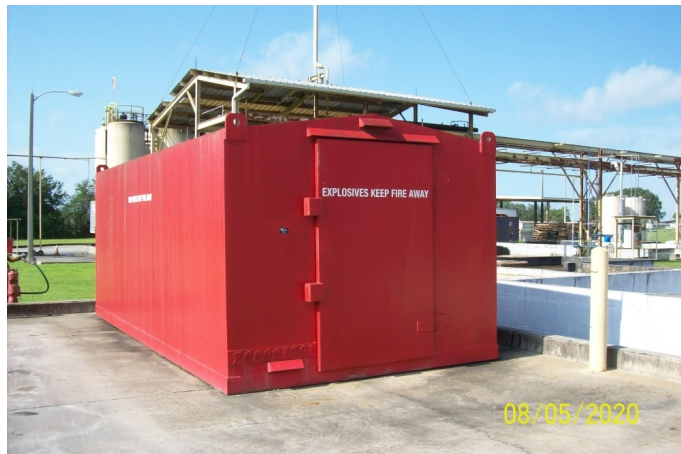
Consumer fireworks collected from retail locations may be stored in a low explosives magazine that now occupies a previously authorized roll off storage location, south of the North Container Storage Building. This unit was empty at the time of the inspection and appears to be well maintained.

Low Explosive Magazine

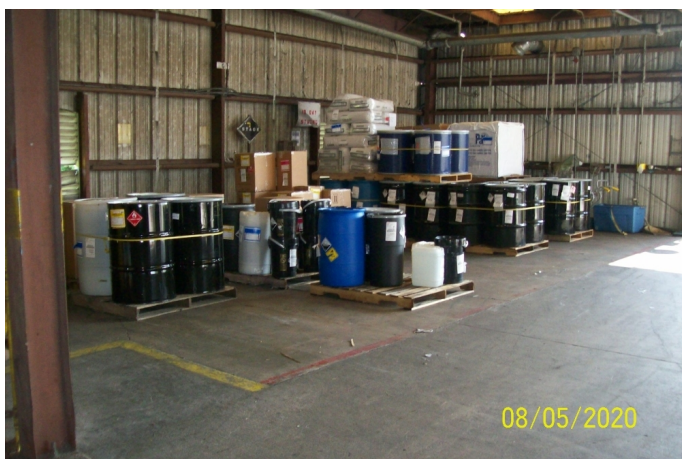
Containers of transfer waste were stored in designated areas, and none were found to have been held more

than 10 days during the course of transfer. In order to prepare for off-site container shipments, a pick list is selected depending on the designated facility, and the container bar codes are checked against the pick list when the container is staged for loading. Transfer waste and outgoing loads are staged in accordance with USDOT compatibility criteria prior to loading into semi-trailers.

10-day Staging Area in the North Container Storage Building

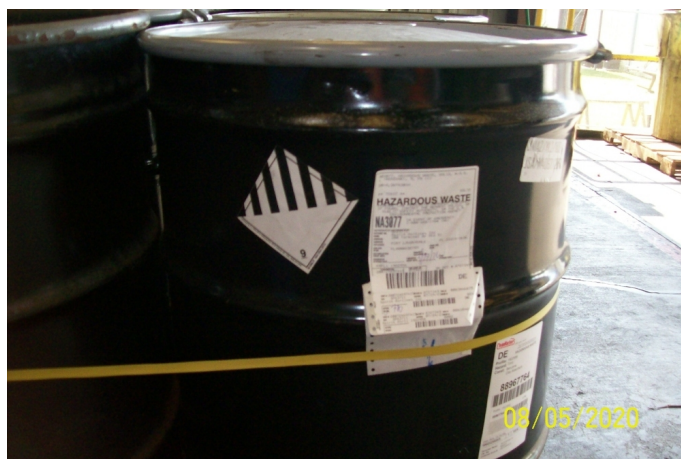
The North Container Storage Building was within permitted capacity. Containers were managed in rows of pallets in accordance with the permit. Containers were closed, contained hazardous waste labels and generally in good condition. Most of the containers had separate labels with an indication of the hazard of the contents in accordance with the requirements in 40 CFR 262.17 (a)(5)(B). However, for a number of containers, the additional label was a DOT Class 9 Labels. According to guidance provided by the EPA in recent meetings, DOT Class 9 Labels are not acceptable to meet this requirement as this label only indicates that the container contains "miscellaneous dangerous goods," and not an indication of the hazard of the waste. Upon closer inspection of the hazardous waste labels, an indication of the hazard was noted. However, the size of the writing on these labels makes identification of the hazard impossible without a close inspection of the label.

Container with DOT Class 9 label - North Container Building

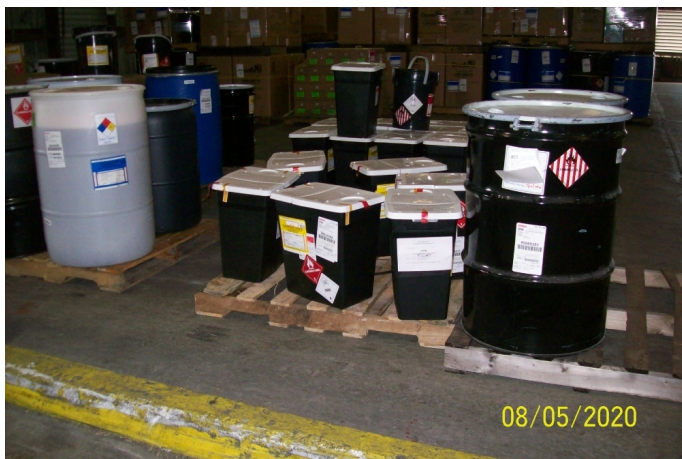
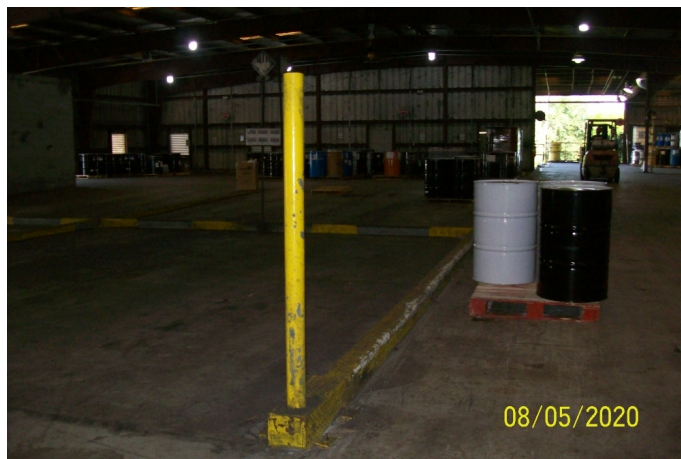
Hazardous Waste containers in storage - North Container Building

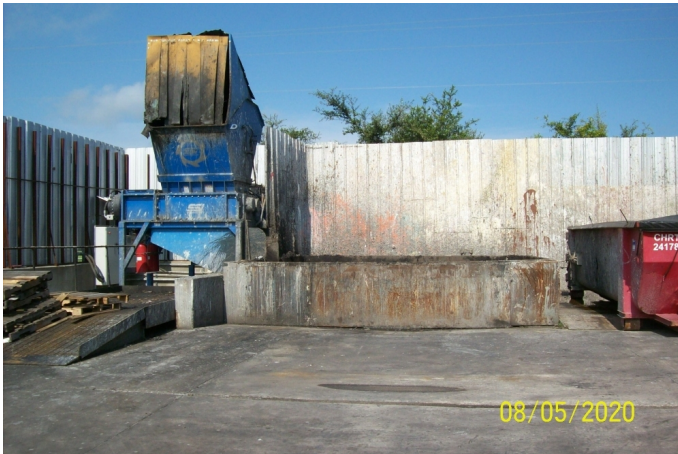
The facility permit authorizes operation of a solid waste shredder and solidification tub; this equipment is located on the west side of the facility. The Department conducted a Solid Waste Program inspection of this unit on July 10, 2020. A copy of the inspection can be found under the Solid Waste ID #WACS 101281.

Solid Waste Shredder and Mix Tub Solidification Area

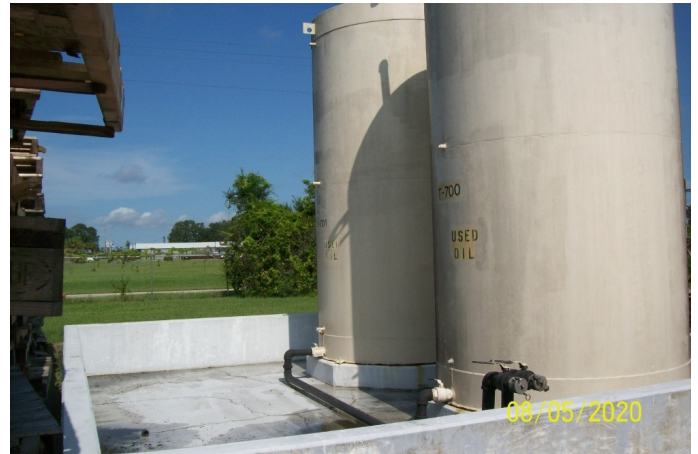
Two 5,800-gallon used oil aboveground storage tanks are located on the western side of the facility, south of the Boiler Building. This process is no longer being conducted at the facility and the tanks are empty with the exception of residual sludge in the bottom of the tanks. These tanks are registered with the Storage Tank Program under Facility ID # 9602192 and are designated at Tank 700 and Tank 701. The tanks were most recently inspected by the Department of Health in Polk County Storage Tanks Program on July 29, 2020.

Used Oil Tank Farm

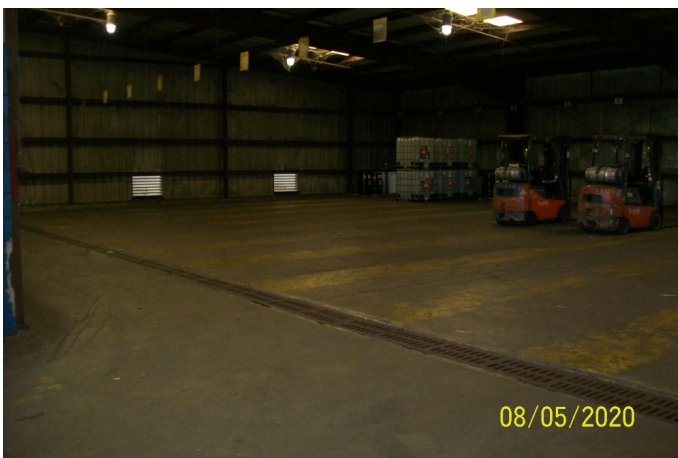
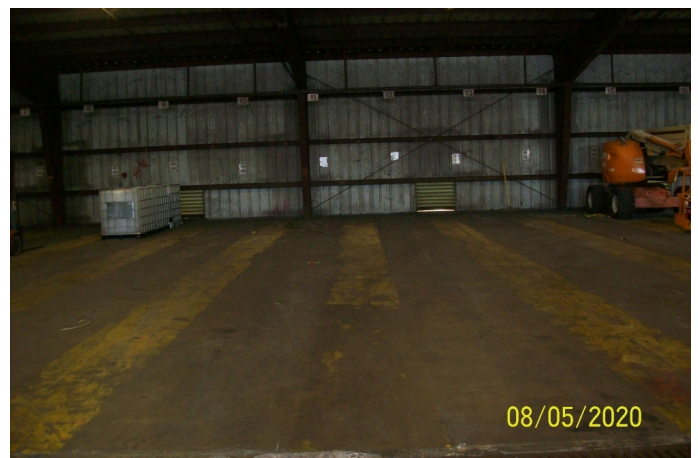
The South Storage Building was not actively being used for waste storage at the time of the inspection. A few containers of materials for beneficial reuse were in storage in this building. No wastes other than the satellite accumulation drum located next to the Fuel Blending Tanks.

South Container Building

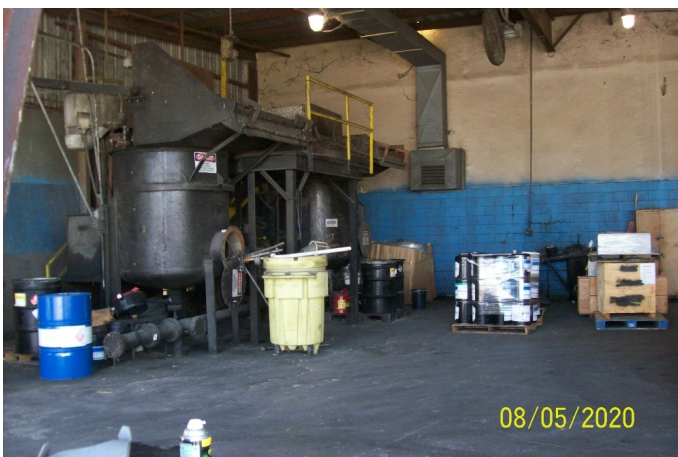
The fuel blending tanks, T-112 and T-114, are located inside the South Container Storage Building. This process is no longer being conducted at the facility. Two satellite accumulation drums are currently located next to the Fuel Blending Tanks is still present. Per Mr. Bosek, these drums will be removed in the near future.

Fuel Blending Tanks

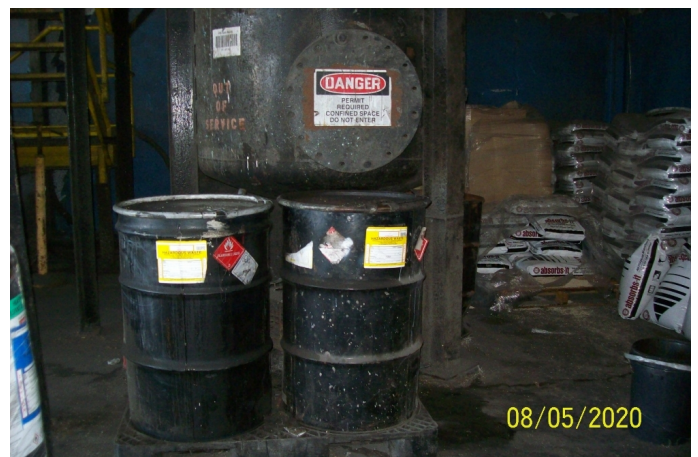
Satellite containers in the Fuel Blending Tanks area

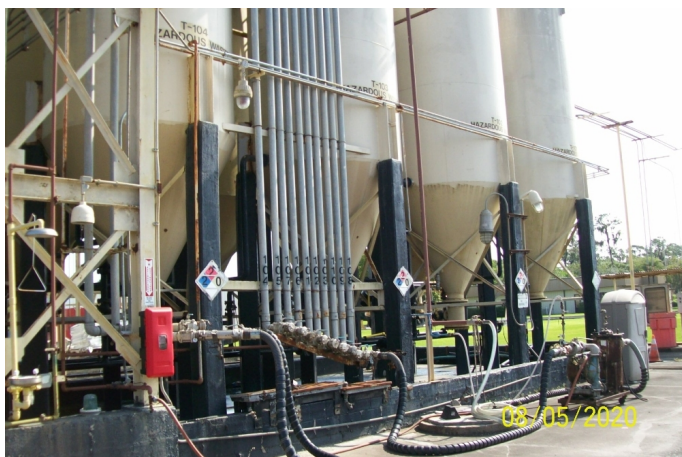
The tank farm, located north of the South Container Storage Building, contains ten hazardous waste aboveground storage tanks, designated at T-101 through T-110. Each of these tanks are 6,000-gallons in size. The hazardous waste storage tanks have a cone bottom and are not agitated. The entire content is transferred to a bulk tanker for transport either to a disposal facility or to the CSX Transflo intermodal transfer facility where rail cars are loaded. The tank shell thickness was most recently tested in March of 2020 by ultrasound, and inspection records were available.

The facility's tank system was in compliance with Subpart J requirements. Valves and flanges were tagged as required by 40 CFR 264 Subparts AA and BB. Inspections and emissions monitoring are being conducted in accordance with the permit, and records are maintained.

One of these tanks is out of service due to corrosion detected in a shell thickness check (T-101). The remaining tanks contained between 1,358 and 3,799 gallons of hazardous waste (mostly sludges in the cones at the base of the tanks).

Hazardous Waste Tank Farm

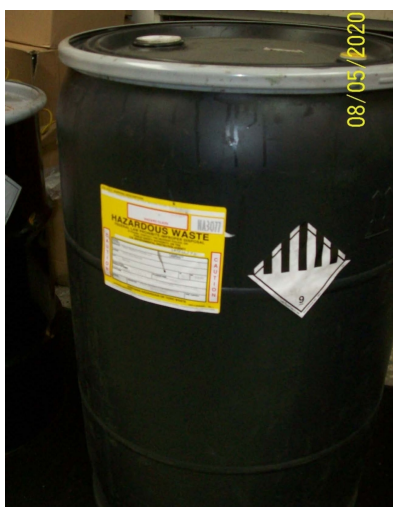
code as the container and are transferred to the facility's lab which is located in the Operations Office and Laboratory Building. After the analyses are complete, and it is determined that there is no need to retain a sample, they are discarded into one of three containers in the satellite accumulation area: a 30-gallon metal drum for waste flammable liquids; a 55-gallon polypropylene drum for waste solid debris; and a 30-gallon-polypropylene drum for waste mixed PCB, flammable, corrosives or toxic liquids. Please note that, in accordance with 40 CFR 262.15(a), which was approved under the generator improvements rule, no more than 55-gallons of non-acute hazardous waste can be stored in a satellite accumulation area. As the total hazardous waste present in these drums was estimated to be less than 55-gallons in total at the time of the inspection, this provision was not in violations. However, the facility needs to evaluate this satellite accumulation area to ensure that they are able to comply with this provision. The containers were closed, contained hazardous waste labels and in good condition. While most of two of the containers were labeled with an indication of the as to the hazard of the contents per 40 CFR 262.17 (a)(5)(B), the waste solid debris was labeled with DOT Class 9 Label which does not meet the requirements of 40 CFR 262.17 (a)(5)(B). Upon closer inspection of the hazardous waste label, an indication of the hazard was noted. However, the size of the writing on these labels makes identification of the hazard impossible without a close inspection of the label.

Waste solid debris - Laboratory

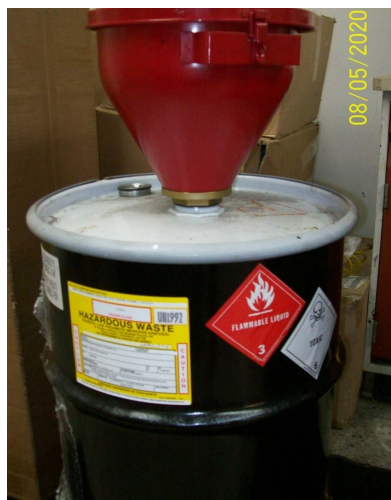
Waste flammable liquids - Laboratory

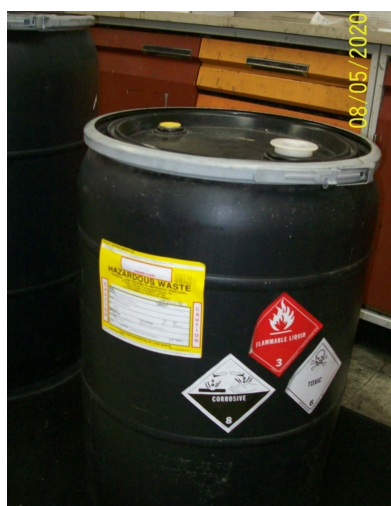
Waste mixed PCB - Laboratory
