Re: Safety-Kleen Systems Inc.
Facility ID #FLD984171694
Miami-Dade County

**Florida Department of
Environmental Protection
Hazardous Waste Inspection Report**

Facility Name: Safety-Kleen Systems Inc
On-Site Inspection Start Date: 06/25/2020 **On-Site Inspection End Date:** 06/25/2020
ME ID#: 11672 **EPA ID#:** FLD984171694
Facility Street Address: 8755 NW 95th St, Medley, Florida 33178-1462
Contact Mailing Address: 5610 Alpha Dr, Boynton Beach, Florida 33426-1462
County Name: Miami-Dade **Contact Phone:** (561) 523-4719

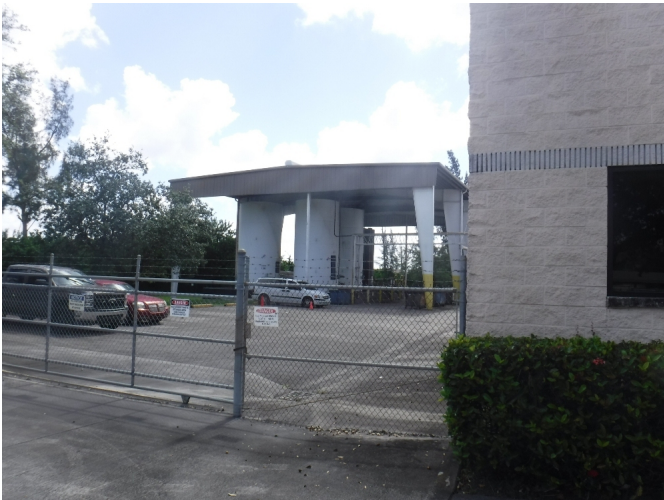
Front of facility

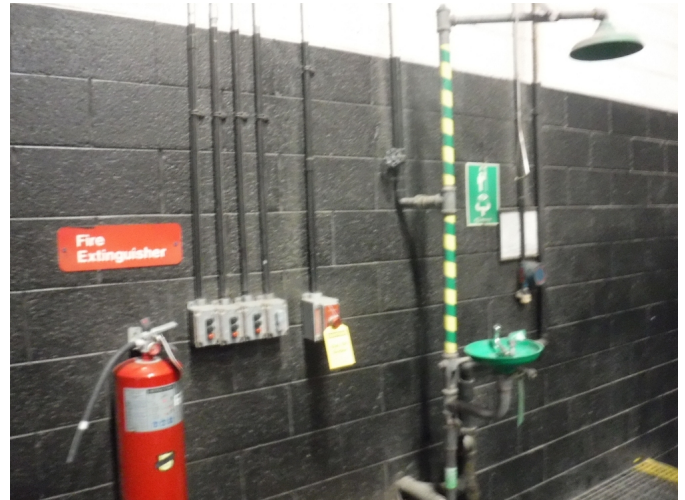
The following preparedness and prevention measures were observed throughout the facility: spill kits, eye wash/shower areas, fire extinguishers, internal communication system, and fire prevention methods.

Preparedness and prevention measures

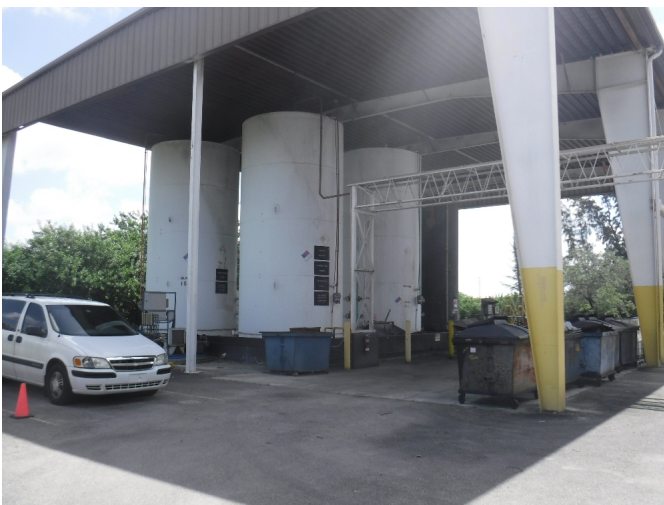
The storage tanks are housed under a covered concrete bunker equipped with a sump and high-level alarm. SK utilizes one 20,000-gallon storage tank for the management of waste solvent under their permit as well as one 15,000-gallon tank and one 20,000-gallon tank for used oil. Oily water is stored in the 10,000-gallon tank in this area and one 20,000-gallon tank holds bulk solvent product. All tanks were observed to be closed, in good condition, and properly labeled. The tank area was equipped with secondary containment, fire extinguishers, and a sprinkler system. Outside the south side of the tank storage building is the tanker truck spill containment area. This is where tanker trucks are loaded/unloaded, or tanker-to-tanker transfer occurs. This area is also equipped with a sump. Facility representatives indicated that each tanker is equipped with a TIF and ChlorDetect dextsil kits, and each load is screened for halogens at the pick-up location.

Storage tank area

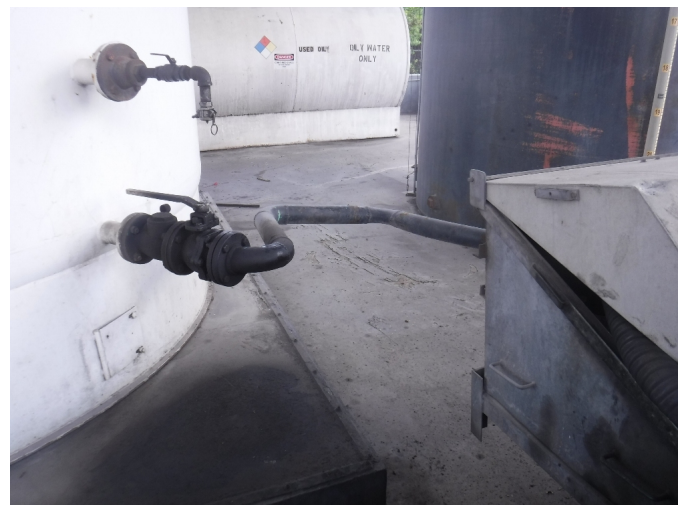
Secondary containment

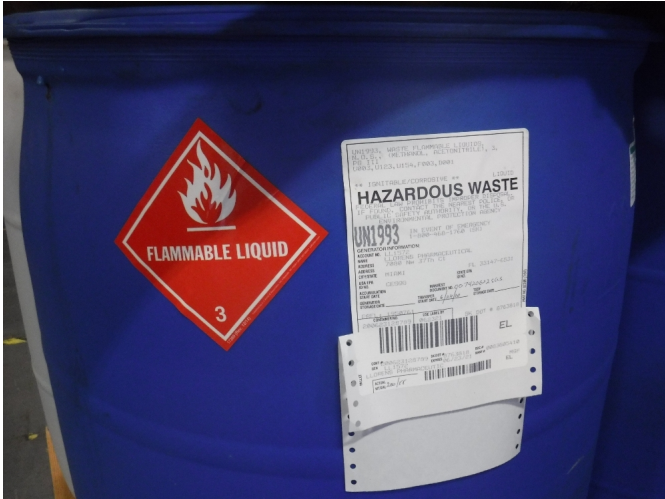
All drums were observed to be closed, properly labeled, placed over the secondary containment, and in-compliance with the 10-day storage limit.

All drums were properly labeled and closed
