**Florida Department of  
Environmental Protection  
Hazardous Waste Inspection Report**

**Facility Name:** US Ecology Tampa Inc  
**On-Site Inspection Start Date:** 10/28/2020 **On-Site Inspection End Date:** 10/28/2020  
**ME ID#:** 21659 **EPA ID#:** FLD981932494  
**Facility Street Address:** 2002 N Orient Rd, Tampa, Florida 33619-3356  
**Contact Mailing Address:** 7202 E 8th Ave, Tampa, Florida 33619-3380  
**County Name:** Hillsborough **Contact Phone:** (813) 319-3423

Routine Inspection for TSD Facility Facility

## US Ecology Tampa Inc Inspection Report

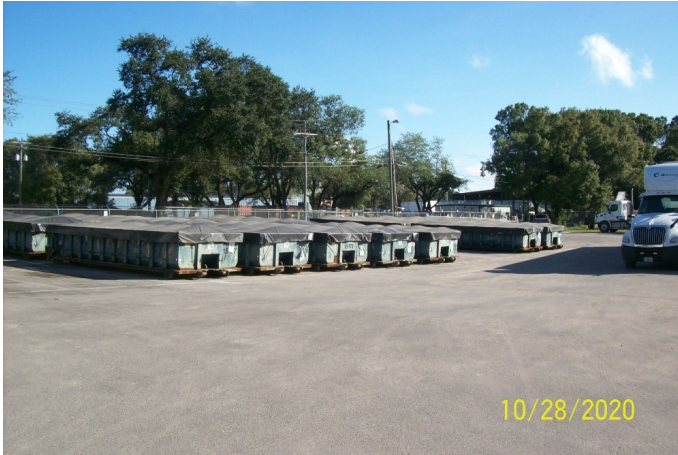
### Bulk Container Storage

Treated waste is loaded into roll-off trailers, which are then tarped and staged in three areas (A, B, and C) outside the treatment building. Each roll-off is labeled "Treated Hazardous Waste," marked with an accumulation start date, and marked with the batch and roll-off numbers. They are held in the designated bulk container storage area pending receipt of the confirmatory analytical results. After testing is complete, the boxes that meet treatment standards are re-labeled as "Treated Non-Hazardous Waste" and scheduled for transport to a landfill.

At the time of the inspection, the storage area was under the maximum capacity of 40 20-yard roll-offs (800 cubic yard). Area A contained 11 empty roll offs; 3 roll offs that were pending analysis and 5 roll offs that had passed confirmatory analysis and were awaiting transportation to the landfill. Area B was empty and Area C contained 1 roll off that had passed confirmatory analysis and were awaiting transportation to the landfill.

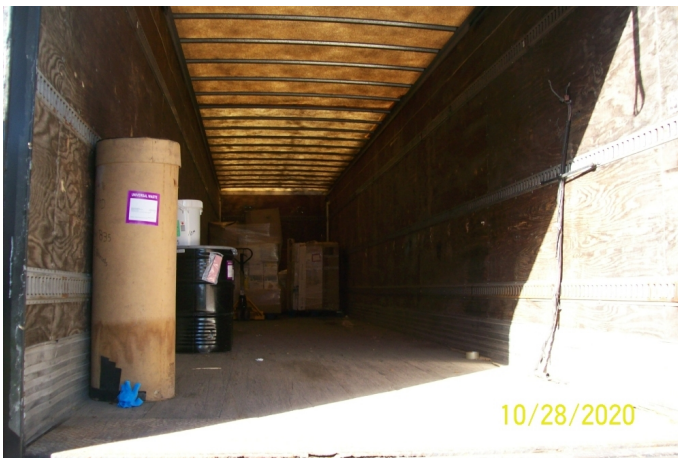
### Universal Waste Lamps

Universal waste lamps are stored in a box truck located on the North Property. The contains were closed and properly labeled.

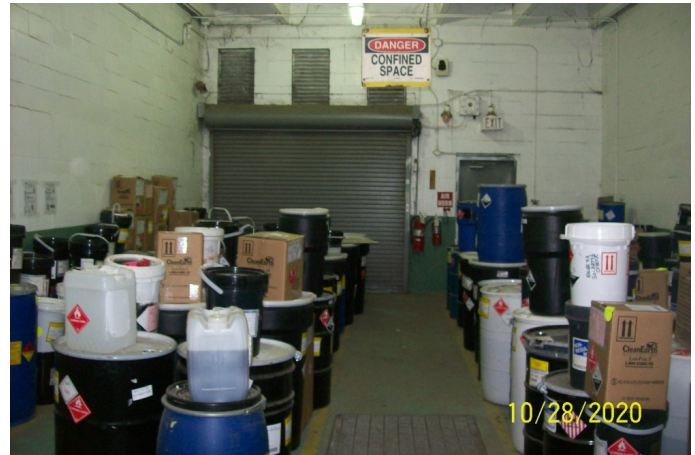
### Inside Bay 1 of the Hazardous Waste Container Storage Building

The hazardous waste container storage building was within its permitted storage capacity of 50,000 pounds of hazardous waste. The storage area is organized so that incompatible wastes are not stored together, and so that facility staff know which container have recently come in and which containers are going out. Bay 1 is used for the weighing and processing inbound waste; some consolidation of waste into new containers is done. Acid wastes are also stored in this bay. Bay 2 houses Flammable and Reactive Wastes. Bay 3 is used to store Caustic, Oxidizer and Toxic waste; most of the waste consolidation of waste into new containers is done in this bay. A walk-through of the building confirmed that all containers of hazardous waste were closed and properly labeled. None of the containers had been stored for longer than the allot one-year time limit; the oldest container observed was dated December 20, 2019. The facility uses a barcode and scanning system to keep track of hazardous waste containers.
