Re: US Ecology Tampa, Inc.
EPA ID No. FLD981932494
Hillsborough County

**Florida Department of
Environmental Protection
Hazardous Waste Inspection Report**

Inspection Date: 10/28/2020

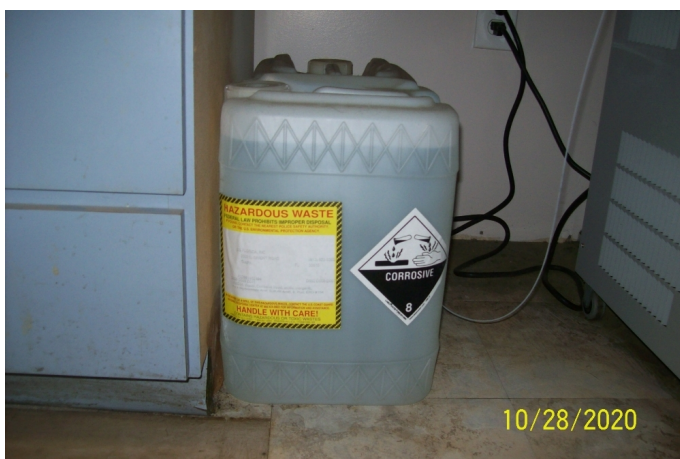
Properly Managed Laboratory ICP Waste

The laboratory is located on the bottom floor of the Administrative Building. The laboratory is used for "truthing" waste samples from customers to ensure that they match the waste profile that the customers provides. However, US Ecology does not characterize waste for customers in their laboratory. The laboratory also conducts Inductively Coupled Plasma (ICP) Bench Testing for their treated hazardous waste. Hazardous waste is generated from old samples and the Inductively Coupled Plasma (ICP) machine. Several satellite waste containers were present in this area: a 5-gallon polypropylene container of ICP waste, one 5-gallon polypropylene container of TCLP waste, a 15-gallon flip top can for the collection of gloves and other solid waste, and a number of small containers of sample waste. All containers were closed and labeled with a hazardous waste label and an indication of the hazard. Waste in this area is lab-packed and re-manifested back to US Ecology for proper disposal.

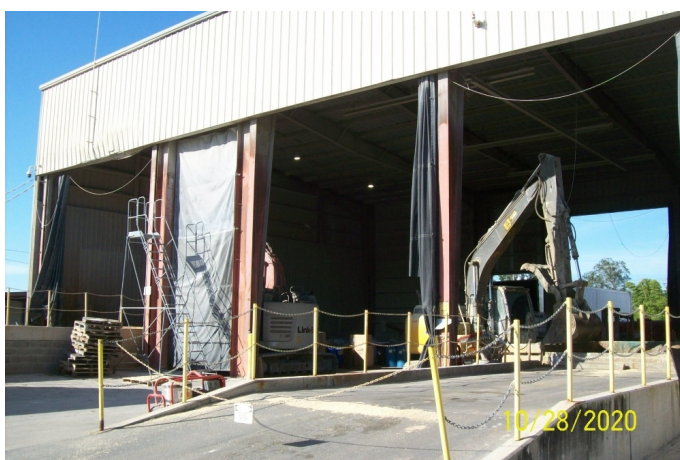
Waste Processing Building

Waste treatment building houses separate mix tubs for solid and hazardous waste. As the facility uses dedicated equipment for mixing hazardous waste, and solid waste is handled separately, decontamination of equipment between batches of hazardous waste is not needed. The hazardous waste mix tub is certified as meeting 40 CFR 265 Subpart J requirements. Hazardous waste treated include D002, D004, D011, and K062. The facility is not authorized to treat hazardous waste with organic underlying hazardous constituents. Hazardous waste is treated with a ferric and sulfide reagent. Sawdust is also added for solidification. The treatment building is authorized to store a limited number of containers of hazardous waste (4,950 gallons) prior to treatment. At the time of the inspection, a batch was undergoing treatment and the building could not be entered without respiratory protection. A light system is used to indicate when treatment is ongoing.

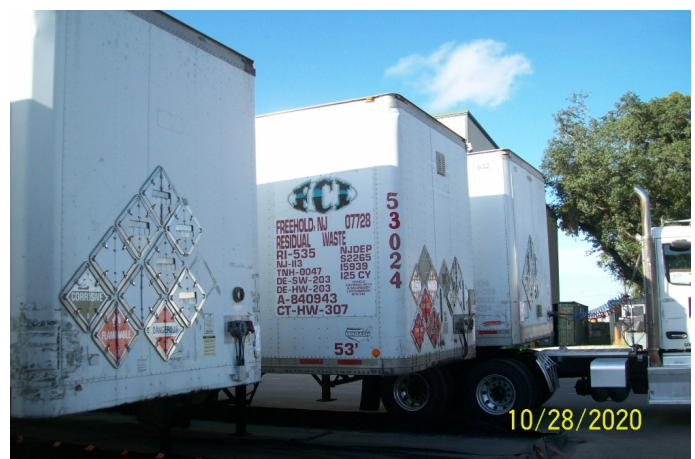
Inbound/Outbound Trailers

Trailers (between 48-foot to 53-foot in size) parked in the Inbound/Outbound staging area/10-day transfer area were marked to show the date the trailer was received or loaded, and the date by which the trailer must either be unloaded or leave the facility. No transfer waste was on-site more than 10 days. At the time of the inspection, three inbound (dated October 26, 2020, October 26, 2020, and October 27, 2020, respectively) and three outbound trailers (dated October 22, 2020, October 26, 2020, and October 27, 2020, respectively) were present in this area. The outbound trailer dated October 27, 2020 was being hooked up to the truck cab in preparation to leave. All six trailer were properly placarded. and were located in pop-up containment that was at least 110% of the capacity of the contents contained within each trailer.

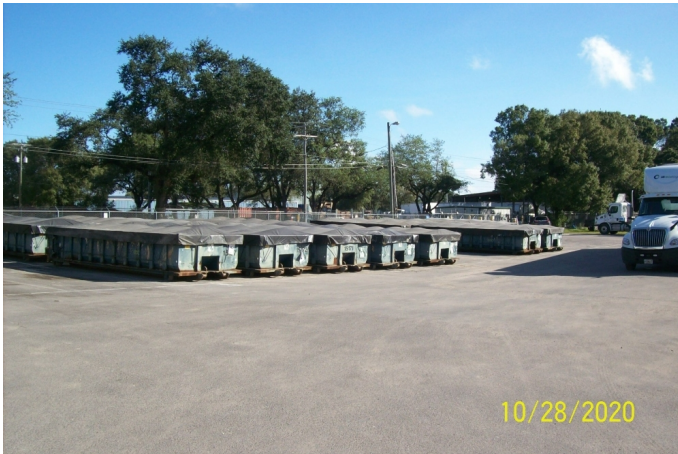
Bulk Container Storage

Treated waste is loaded into roll-off trailers, which are then tarped and staged in three areas (A, B, and C) outside the treatment building. Each roll-off is labeled "Treated Hazardous Waste," marked with an accumulation start date, and marked with the batch and roll-off numbers. They are held in the designated bulk container storage area pending receipt of the confirmatory analytical results. After testing is complete, the boxes that meet treatment standards are re-labeled as "Treated Non-Hazardous Waste" and scheduled for transport to a landfill.

At the time of the inspection, the storage area was under the maximum capacity of 40 20-yard roll-offs (800 cubic yard). Area A contained 11 empty roll offs; 3 roll offs that were pending analysis and 5 roll offs that had passed confirmatory analysis and were awaiting transportation to the landfill. Area B was empty and Area C contained 1 roll off that had passed confirmatory analysis and were awaiting transportation to the landfill.

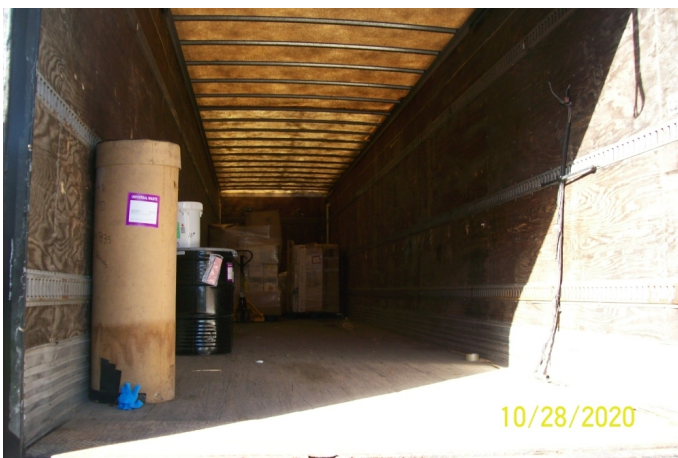
Universal Waste Lamps

Universal waste lamps are stored in a box truck located on the North Property. The contains were closed and properly labeled.

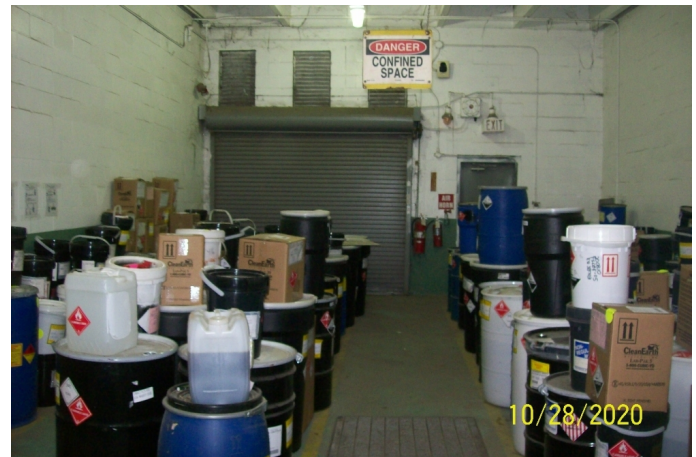
Inside Bay 1 of the Hazardous Waste Container Storage Building

The hazardous waste container storage building was within its permitted storage capacity of 50,000 pounds of hazardous waste. The storage area is organized so that incompatible wastes are not stored together, and so that facility staff know which container have recently come in and which containers are going out. Bay 1 is used for the weighing and processing inbound waste; some consolidation of waste into new containers is done. Acid wastes are also stored in this bay. Bay 2 houses Flammable and Reactive Wastes. Bay 3 is used to store Caustic, Oxidizer and Toxic waste; most of the waste consolidation of waste into new containers is done in this bay. A walk-through of the building confirmed that all containers of hazardous waste were closed and properly labeled. None of the containers had been stored for longer than the allot one-year time limit; the oldest container observed was dated December 20, 2019. The facility uses a barcode and scanning system to keep track of hazardous waste containers.
