**Florida Department of  
Environmental Protection  
Hazardous Waste Inspection Report**

**Facility Name:** Cliff Berry Inc - Miami Terminal  
**On-Site Inspection Start Date:** 11/18/2020 **On-Site Inspection End Date:** 11/18/2020  
**ME ID#:** 51668 **EPA ID#:** FLD058560699  
**Facility Street Address:** 3033 NW North River Dr, Miami, Florida 33142-6304  
**Contact Mailing Address:** PO Box 13079, Fort Lauderdale, Florida 33316-0100  
**County Name:** Miami-Dade **Contact Phone:** (954) 763-3390

## Cliff Berry Inc - Miami Terminal Inspection Report

Inspection Date: 11/18/2020

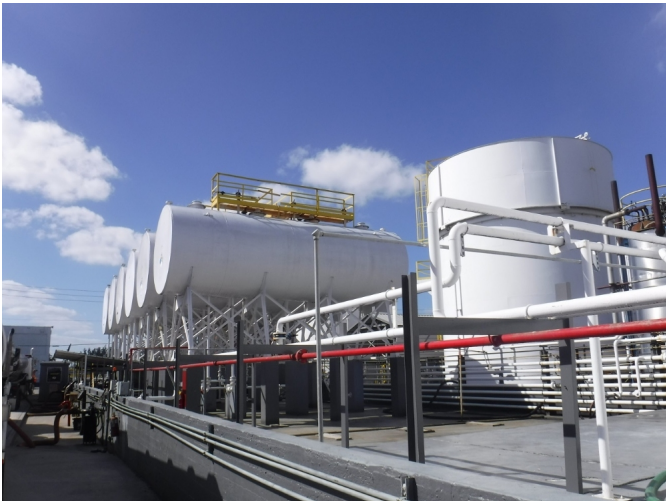
1. Tank Farms

In this area, the facility has thirty (30) -above storage tanks for their used oil processing activities and wastewater storage areas. The inspectors observed each one of the areas where these tanks were located and observed the following:

- fire extinguishers up to date
- unloading and loading areas were clean
- spill kits were accessible
- internal communication system
- properly identified as used oil or describing their contents

The inspectors observed approximately 1-3 inches of accumulated rainfall within the northern side of the secondary containment. The facility was aware of the accumulated rainfall. Paragraph 8 under Part II Subpart C – Tank and Container Conditions of CBI's permit states "the Permittee shall remove spilled or leaked waste and accumulated precipitation from the secondary containment areas within 24 hours of detection and manage the material in accordance with the Spill Prevention Control and Countermeasures Plan (SPCC) (also known as the Preparedness and Prevention Plan (PPP)) and the Contingency Plan of the permit application".

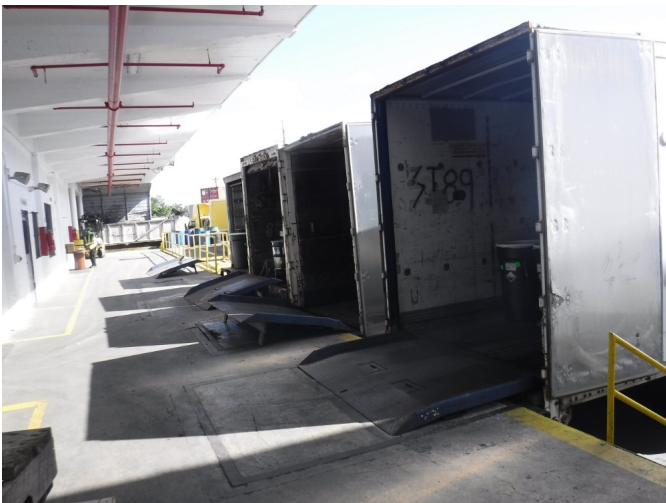
3. Trailers Holding Hazardous Waste

The inspectors observed 3 trailers holding hazardous waste. Two were being prepared to ship offsite, one was a new load to be received. The inspectors observed approximately 30 containers holding hazardous waste, all were received during the inspection. All containers were properly labeled and aisle space was observed. The inspectors noted that the area was fenced and kept separate from the other areas, properly labeled as "hazardous waste storage area" and spill kits near to this area.
