Re: Triumvirate Environmental - Compliance Assistance Offer
Facility ID No. FLD981018773
Broward County

**Florida Department of
Environmental Protection
Hazardous Waste Inspection Report**

Facility Name: Triumvirate Environmental Services Inc
On-Site Inspection Start Date: 03/18/2021 **On-Site Inspection End Date:** 03/18/2021
ME ID#: 50649 **EPA ID#:** FLD981018773
Facility Street Address: 3670 SW 47th Ave, Davie, Florida 33314
Contact Mailing Address: 3701 SW 47th Ave Ste 109, Davie, Florida 33314-2830
County Name: Broward **Contact Phone:** (954) 583-3795

Routine Inspection for Used Oil Processor Facility

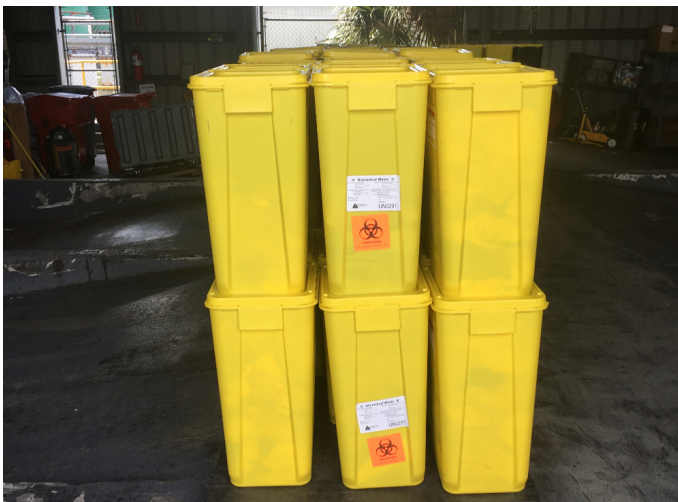
- 18 18-gallon plastic containers holding trace chemotherapy waste managed as 'Biomedical Waste'. This waste has a percentage of less than 5 % of Arsenic Trioxide (EPA Waste Code P012). The Arsenic Trioxide contaminated debris falls under the mixture rule classifying the entire mixture as P-Listed hazardous waste as stated on 40 CFR Part 261.3(a)(2)(iv). It is a mixture of solid waste and one or more hazardous wastes listed in subpart D of this part and has not been excluded from paragraph (a)(2) of this section under §§260.20 and 260.22, paragraph (g) of this section, or paragraph (h) of this section. The Transporter shall notify the generator to conduct a proper waste determination of this waste under 40 CFR Part 262.11 and manifest this waste from now on [40 CFR 263.20(a)(1)].

Arsenic Trioxide contaminated waste transported as biohazard.

Type:	Violation
Rule:	263.20(a)(1)
Explanation:	A transporter may not accept hazardous waste from a generator unless the transporter is also provided with a manifest form (EPA Form 8700-22, and if necessary, EPA Form 8700-22A) signed in accordance with the requirement of §262.23, or is provided with an electronic manifest that is obtained, completed, and transmitted in accordance with §262.20(a)(3) of this chapter, and signed with a valid and enforceable electronic signature as described in 40 CFR 262.25.
Corrective Action:	Specifically, the facility has been transported Arsenic Trioxide (EPA Waste Code P012) contaminated debris as biomedical waste. Please do not accept hazardous waste from a generator unless the generator provides a manifest form (EPA Form 8700-22, and if necessary, EPA Form 8700-22A) signed in accordance with the requirement of §262.23, or is provided with an electronic manifest that is obtained, completed, and transmitted in accordance with §262.20(a)(3) of this chapter, and signed with a valid and enforceable electronic signature as described in 40 CFR 262.25. Pending resolution.

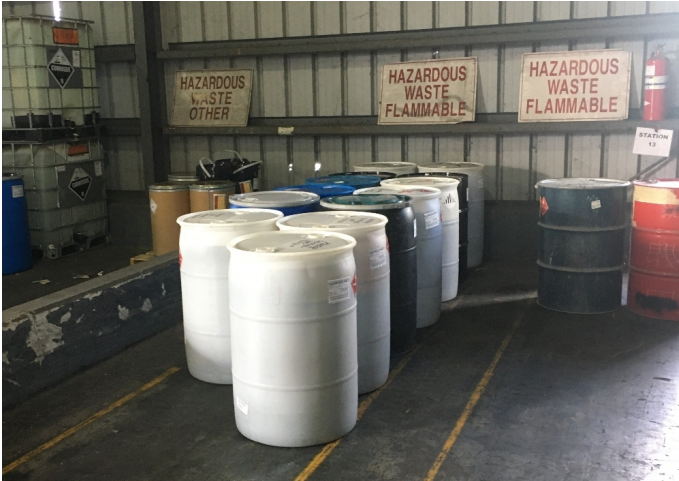
Photo No. 1: 10 day HW Storage Area.

In this area, the inspector observed:

- 12 55-gallon poly containers of hazardous waste labeled with the words "Hazardous Waste" with the accumulation start date and the hazard of its contents.

It was observed that at least one container was marked with the DOT miscellaneous pictogram which is a material that presents a hazard during transportation, but which does not meet the definition of any other indication of the hazards of the contents. The Transporter shall notify the generator that it can keep this pictogram but shall include an indication of the hazards of the contents (examples include, but are not limited to, the applicable hazardous waste characteristic(s) (i.e., ignitable, corrosive, reactive, toxic); a hazard statement or pictogram consistent with the Occupational Safety and Health Administration Hazard Communication Standard at 29 CFR 1910.1200; or a chemical hazard label consistent with the National Fire Protection Association code 704). Compliance assistance was provided to the facility and the indication of Toxic was included.

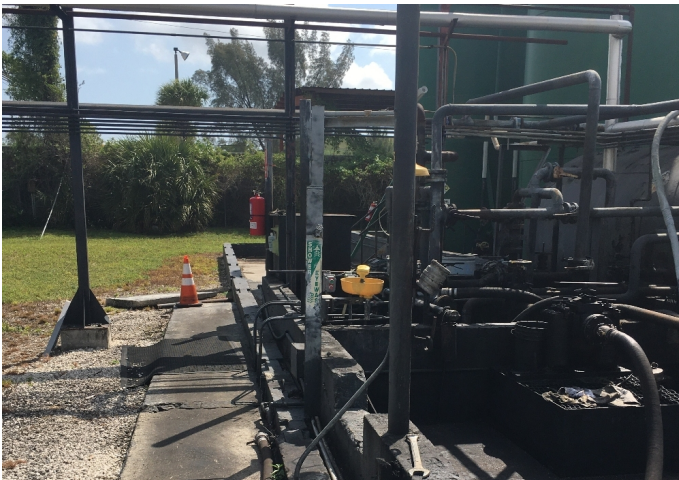
Photo No. 3: Tank Farm

Used oil and oily wastewater are received in the tank farm area located in the southeast corner of the facility. Used oil is offloaded into Aboveground Storage Tanks (ASTs) located in the tank farm. The used oil is filtered, and then allowed to sit for further oil/water separation. The processed oil is tested for compliance with on-specification standards and is sold as fuel oil to TES customers.

- One 10,000-gallon tanks for used oil properly labeled.
- Two 10,000-gallon tank for used oil properly labeled and the number 5 and 6.
- Two 6,000-gallon tank for used antifreeze properly labeled with the number 4 and used oil with the number 3.
- Two 8,000-gallon tanks. Tank 2 is for used oil and Tank 1 is an overflow tank designated for the 20,000-gallon tanks.
- Ten 20,000-gallon above ground tanks for used oil properly labeled.

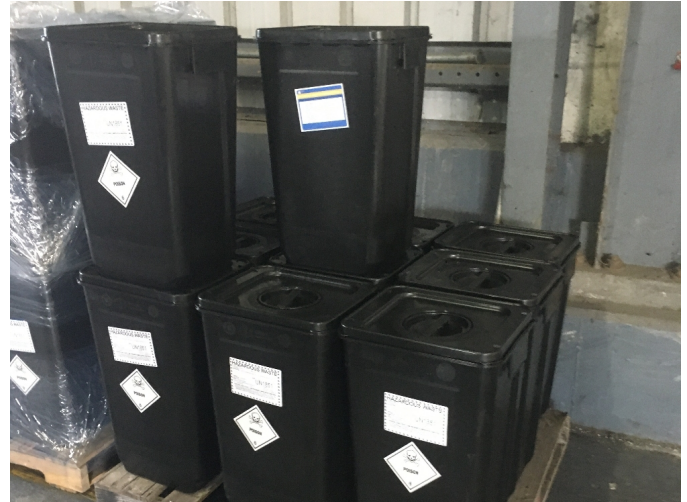
Photo No. 2: Hazardous Waste Pharms.

- 53 18-gallon poly containers of hazardous waste labeled with the words "Hazardous Waste Pharms" with the accumulation start date and the hazard of its contents.

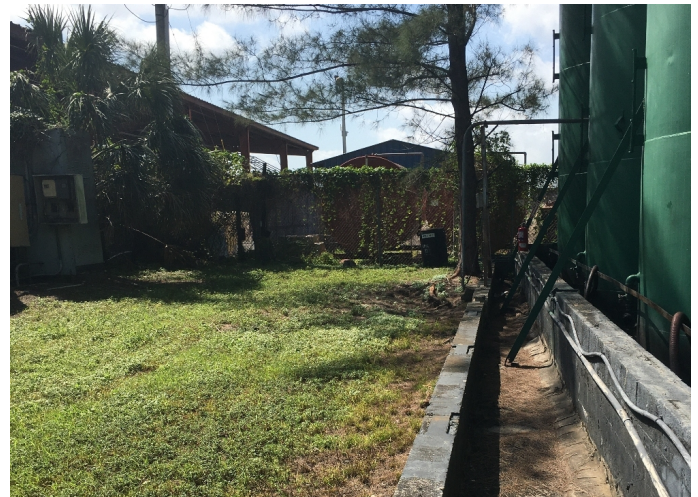
Photo No. 4: Secondary Containment of Tank Farm.

All the tanks were in a concrete secondary containment unit. The secondary containment and loading/unloading areas were clean and accessible to inspect. No deficiencies were observed. Fire extinguishers were located directly adjacent to the secondary containment.

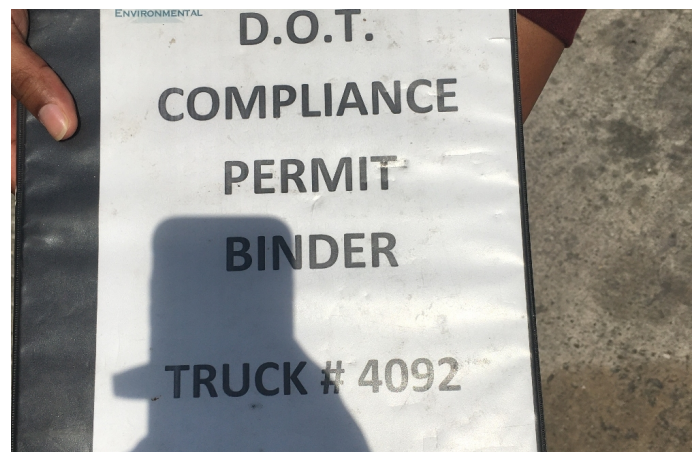
Photo No. 6: Binder Containing Recordkeeping Requirements.

- The facility conducts daily tank inspections, and the associated daily inspection checklists were available for review during the inspection. The inspection checklists included: General housekeeping, Condition of containment, equipment, spill response equipment, and alarm.
