Re: **Compliance Assistance Offer**
Crowley Liner Services, Inc.
3001 Talleyrand Avenue
EPA/DEP ID: FLR 000 054 221
Duval County – Hazardous Waste

**Florida Department of
Environmental Protection
Hazardous Waste Inspection Report**

Facility Name: Crowley Liner Services Inc
On-Site Inspection Start Date: 01/29/2021 **On-Site Inspection End Date:** 01/29/2021
ME ID#: 62506 **EPA ID#:** FLR000054221
Facility Street Address: 3001 Talleyrand Ave, Jacksonville, Florida 32206-3474
Contact Mailing Address: 2831 Talleyrand Avenue, Jacksonville, Florida 32206
County Name: Duval **Contact Phone:** (904) 727-4290

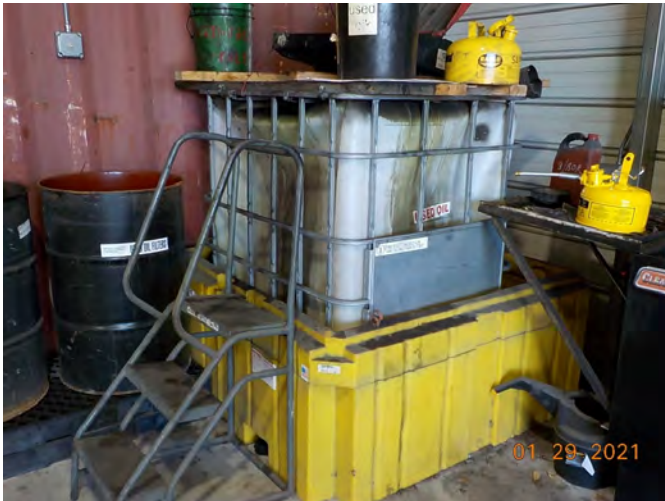
Photo 1

Used oil is collected in drip pans or mobile carts and then transferred to a 250-gallon tote inside the building (Photo 1). The tote was closed, properly labeled and had adequate secondary containment. Used oil filters are drained and collected in 55-gallon drums. At the time of the inspection, there were two 55-gallon drums of used oil filters accumulating inside the building. Both drums were properly labeled, and located on a spill pallet. Used oil, used oil filters, oily rags, and spill clean-up absorbent are managed by Cliff Berry (FLR 000 083 071).

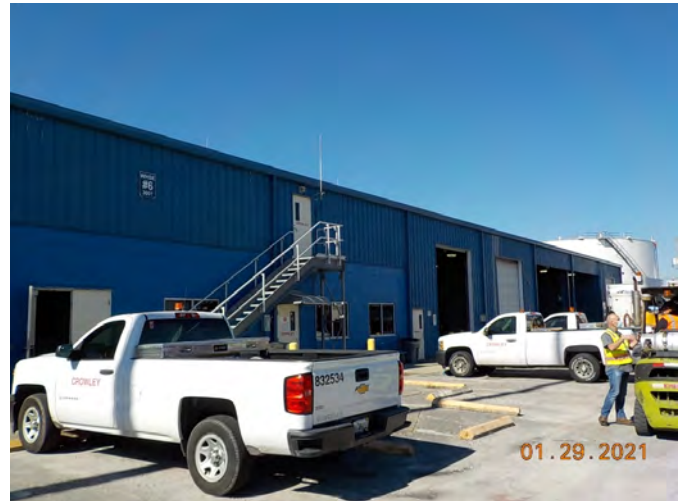
Photo 2

This building, located in the northern portion of the Crowley facility, is used for maintenance on Crowley fleet vehicles (Photo 2). The building is divided into seven maintenance bays where technicians perform routine maintenance on Crowley-owned trailers, containers, and trucks including fluid/oil and oil filter changes, tire repairs and replacement, and minor engine repair. Minor paint touch-ups are performed using the same paint products previously described but bodywork is not performed in the building. Technicians use the same lubricants and cleaners as previously described during maintenance activities in this building. Empty aerosol cans are collected and transferred to Crowley's Material Management Building, located at 1150 Talleyrand Avenue, for puncturing and scrap metal recycling. No cans were accumulating in the area at the time of the inspection.
