**Florida Department of  
Environmental Protection  
Hazardous Waste Inspection Report**

**Facility Name:** Triumvirate Environmental Services Inc  
**On-Site Inspection Start Date:** 04/06/2021 **On-Site Inspection End Date:** 04/06/2021  
**ME ID#:** 10046 **EPA ID#:** FLD980559728  
**Facility Street Address:** 10100 Rocket Blvd, Orlando, Florida 32824-8565  
**Contact Mailing Address:** 10100 Rocket Blvd, Orlando, Florida 32824-8565  
**County Name:** Orange **Contact Phone:** (407) 859-4441

Routine Inspection for TSD Facility Facility

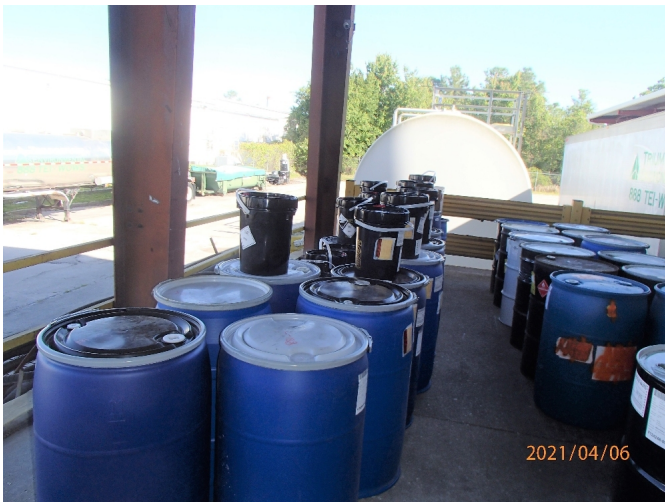
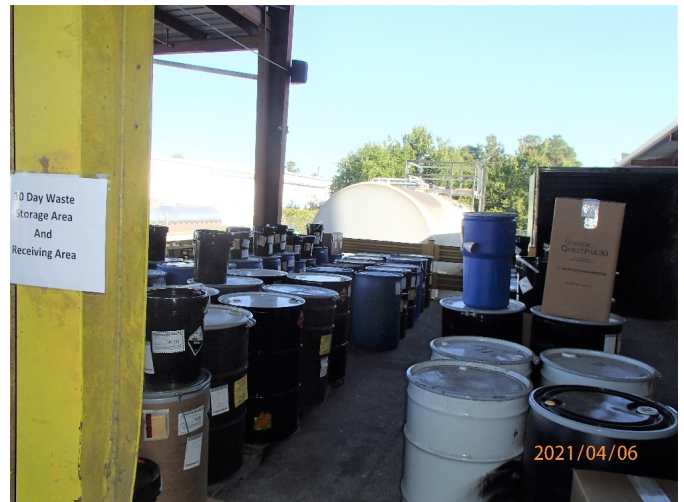
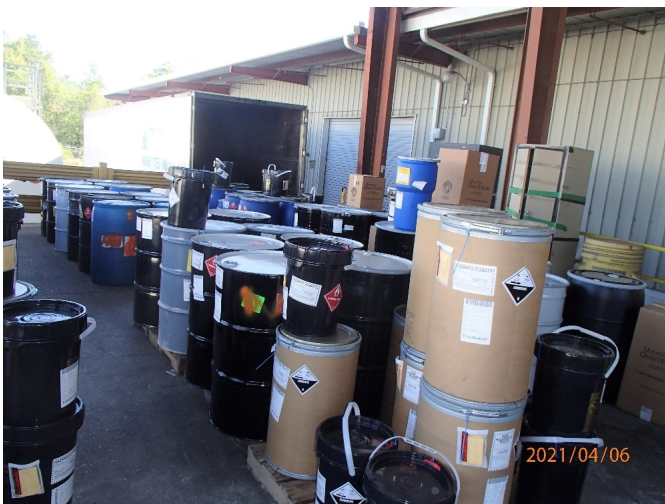
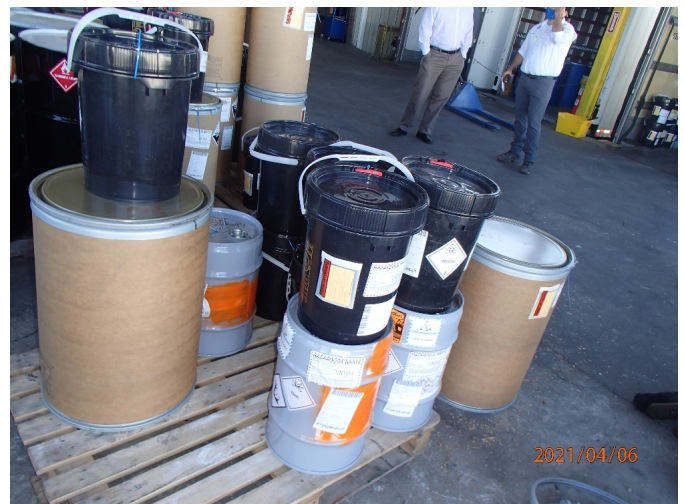
On the loading dock were approximately 112 waste containers off-loaded from arriving trucks [Figures 1-4]. The waste will be inspected, compared to the manifest(s) and profiles, and moved into the storage area. Staged adjacent to the loading dock was a 30-cubic yard container of non-hazardous solid waste [Figure 5] destined for Wheelabrator South Broward, a municipal waste-to-energy facility located in South Florida.

1. Loading Dock

2. Loading Dock

3. Loading Dock

4. Loading Dock

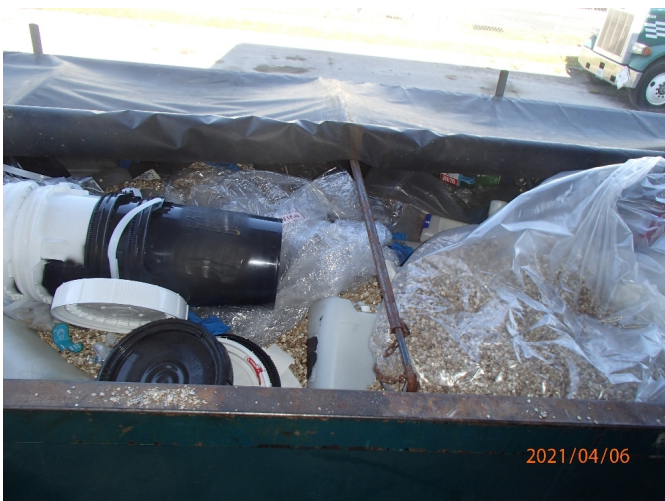
5. Non-hazardous Waste Roll-Off

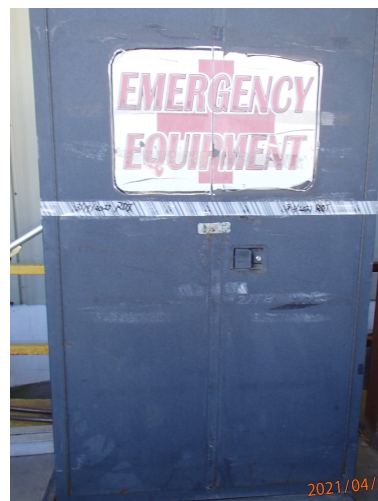
A spill kit and an emergency equipment cabinet were located on the loading dock [Figure 6]. The emergency equipment cabinet was sealed and dated 3/19/2021, the date of the last inspection. The equipment cabinet is inspected monthly to verify its contents.

6. Equipment Cabinet on Loading Dock

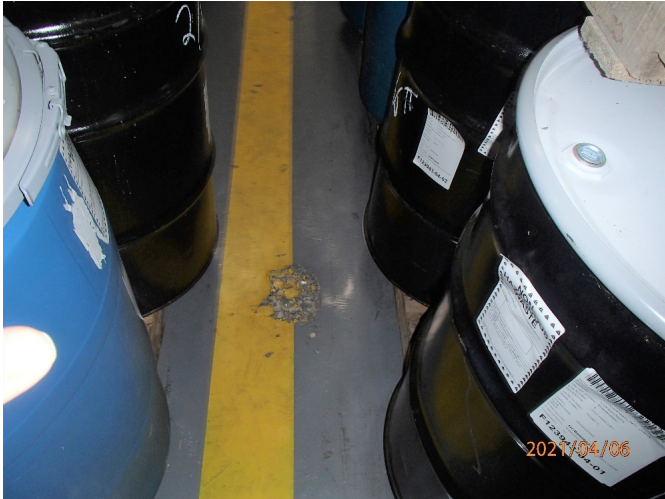
Rows 101 to 105 contained approximately 208 55-gallon drums, 12 cubic-yard bags, and several small boxes and containers of non-hazardous solid waste. The warehouse floor had been resealed in April 2020. During the inspection, floor damage was found in the north drum storage area where non-hazardous waste was stored [Figure 7]. The floor had been crushed in an area measuring approximately six inches in diameter. According to Mr. Troy, the floor was still under warranty and the contractor had been contacted to repair the damaged area. On April 8, 2021, Mr. Troy provided a photograph documenting the area had been repaired [Figure 8].

**7. Damaged Floor in Warehouse**

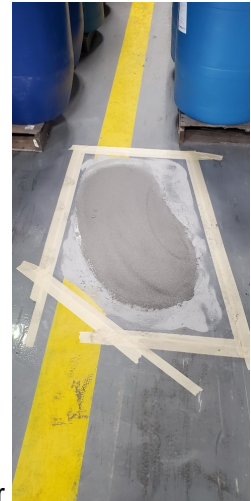
**8. Repaired Section of Floor**
