Re: Warning Letter - #WL21-00093HW06SED
Crowley Liner Services
EPAID FL0000360560
Broward County

**Florida Department of
Environmental Protection
Hazardous Waste Inspection Report**

Facility Name: Crowley Liner Services
On-Site Inspection Start Date: 06/22/2021 **On-Site Inspection End Date:** 06/22/2021
ME ID#: 21129 **EPA ID#:** FL0000360560
Facility Street Address: 4300 Macintosh Rd, Fort Lauderdale, Florida 33316
Contact Mailing Address: 4300 McIntosh Road, Ft Lauderdale, Florida 33316
County Name: Broward **Contact Phone:** (305) 470-4087

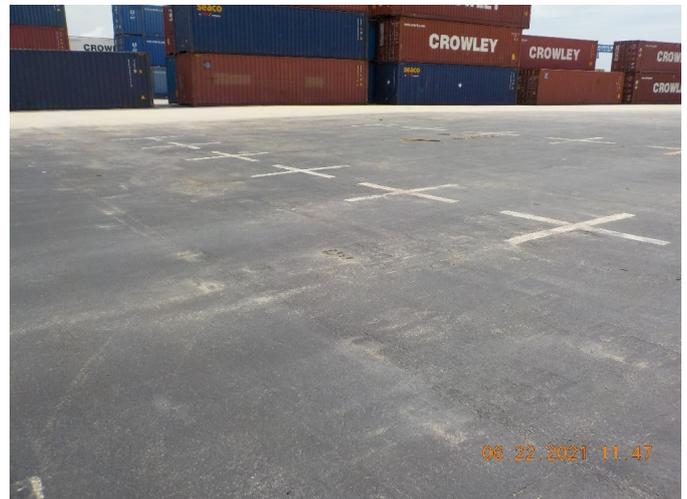
Empty hazardous waste container staging area

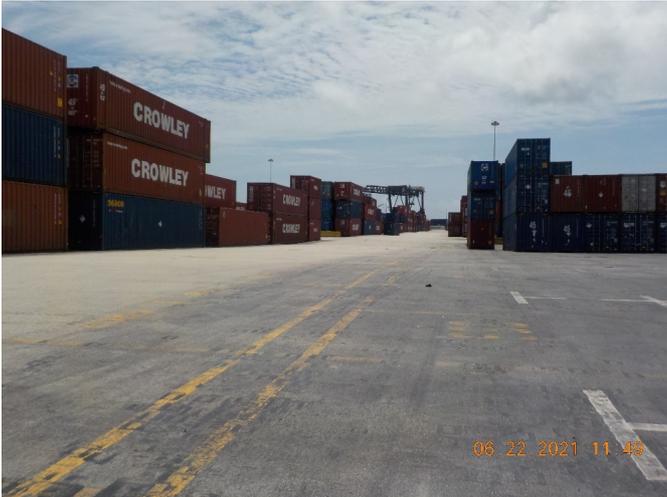
Facility does not take wastes off/out of cargo containers. They accept shipping containers, move them into the parking area, and ship them off all without unloading. The only time any of the containers are opened is if the Coast Guard or Customs mandates it for an inspection. The terminal planner receives the information for incoming shipments, and segregates hazardous waste cargo containers to the designated storage area in the processing yard. The hazardous waste storage area was empty at the time of the inspection. Crowley has a contract with Cliff Berry Inc. (CBI) which describes CBI as their cleanup contractor in case of any environmental emergency response on their property at the port.

Cargo container processing yard

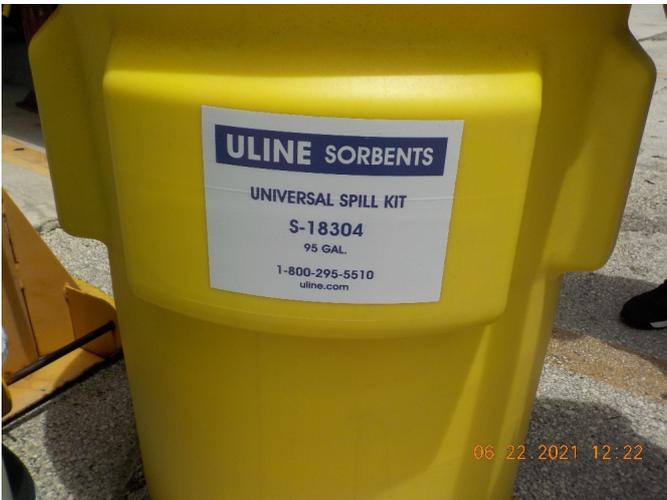
Used oil – Four 55-gallon steel drums closed and properly labeled; outdoors in a covered storage area; within secondary containment; managed by CBI. A spill kit is maintained and readily available directly adjacent to this area.

Spill kit located adjacent to used oil storage

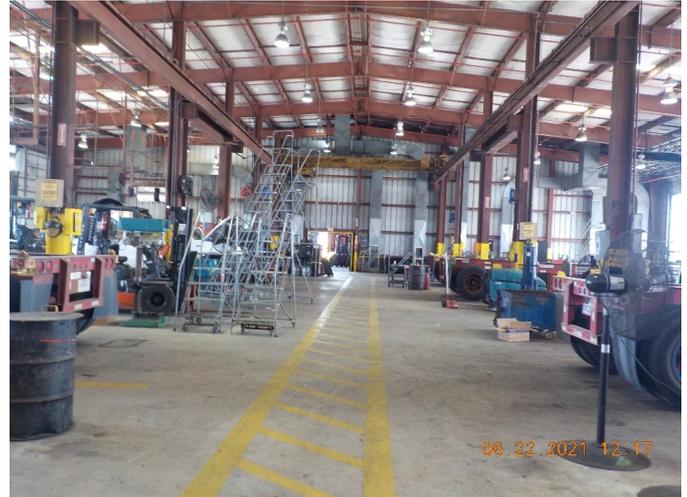
Facility performs maintenance on their own vehicles in a 12-bay maintenance shop and generates the following waste streams: Used oil, used oil filters, and spent antifreeze. At the time of the inspection, the following was observed:

Vehicle maintenance building
