Re: Perma-Fix of Florida, Inc
EPA/DEP ID: FLD980711071
Alachua County – Hazardous Waste

**Florida Department of
Environmental Protection
Hazardous Waste Inspection Report**

Inspection Date: 06/24/2021

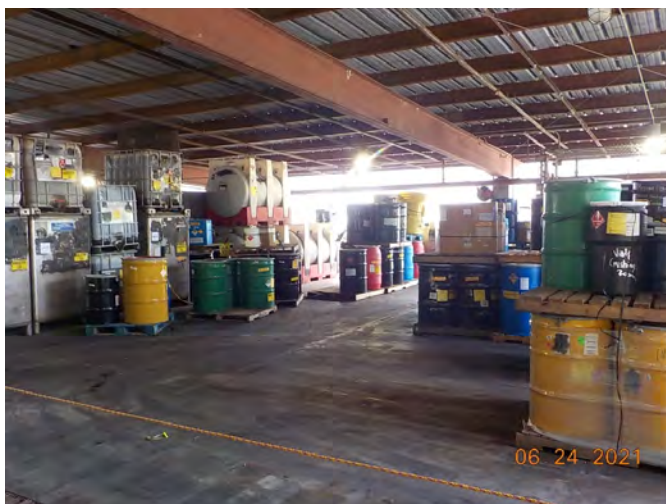
Photo 1

The area is not enclosed but is under a roof and has a containment system and concrete curbing with three different zones for storage of waste (Photos 1 and 2). This storage area is permitted to store up to 72,105 gallons of hazardous waste with a maximum container size of 718 gallons that is equivalent to a B-25 box container. At the time of the inspection, this storage area was within its permitted volume capacity and all containers observed had been accumulating for less than one year.

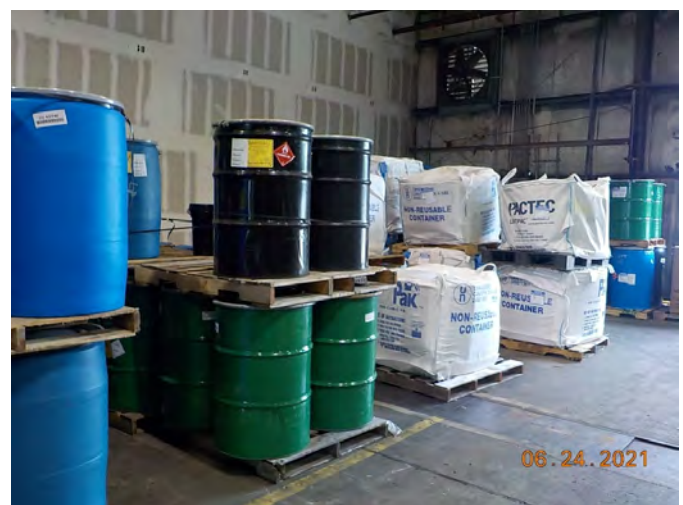
Photo 4

This storage area in the building is permitted to store up to 54,340 gallons of hazardous waste with a maximum container size of 718 gallons that is equivalent to a B-25 box container (Photo 4). At the time of the inspection, this area was within its permitted volume capacity, and all containers observed had been accumulating for less than one year. Bulking of waste paints, pesticides, aerosols and non-hazardous wastes also occurs in this area.

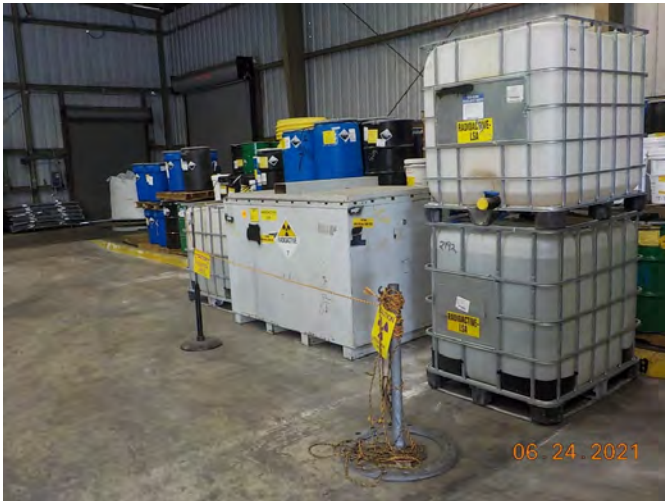
Photo 5

This building is fully enclosed with a containment system and concrete curbing. The Waste Storage Area is located in the northwest portion of the building (Photo 5); the thermal desorption and chemical treatment area is located in the northeast portion of the building (Photo 6); and a Chemical Lab is located in the southeast portion of the building. The thermal desorption and chemical treatment area is undergoing renovations and was not operating at the time of the inspection.

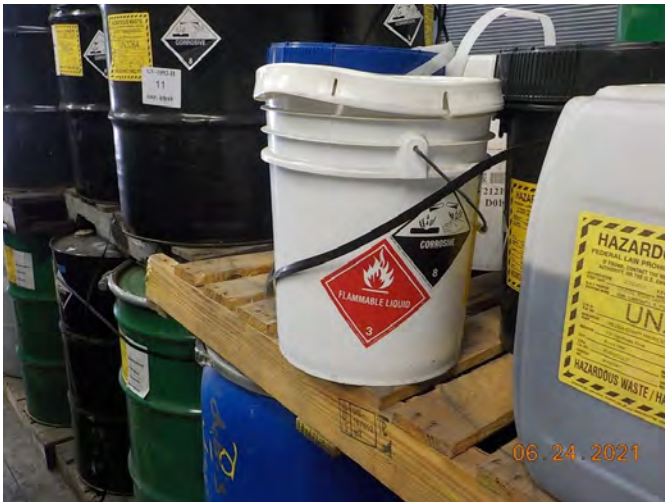
Photo 7

box container. At the time of the inspection, this area was within its permitted volume capacity and all containers observed had been accumulating for less than one year. One 5-gallon bucket of D001/D002 hazardous waste liquids received from an off-site Household Hazardous Waste Collection Center was observed. The bucket contained small bottles of hazardous waste liquid that were closed but because one bottle was taller than the bucket rim, the lid of the bucket could not be properly closed (Photo 7) [40 CFR 264.173(a)].

Type: Violation
 Rule: **264.173(a)**
 Explanation: Treatment and Operations Building: the facility failed to keep one 5-gallon bucket of D001/D002 hazardous waste liquids received from an off-site generator closed during storage of the container.
 Corrective Action: No further action is required. The facility overpacked the container during the inspection.
