**Re: Jacksonville Transflo Terminal**  
**EPA/DEP ID: FLD984253526**  
**Duval County – Hazardous Waste**

**Florida Department of  
Environmental Protection  
Hazardous Waste Inspection Report**

**Facility Name:** Jacksonville Transflo Terminal  
**On-Site Inspection Start Date:** 02/10/2022      **On-Site Inspection End Date:** 02/10/2022  
**ME ID#:** 21835      **EPA ID#:** FLD984253526  
**Facility Street Address:** 3796 Warrington St , Jacksonville, Florida 32254  
**Contact Mailing Address:** 500 Water St #J975, Jacksonville, Florida 32202-4423  
**County Name:** Duval      **Contact Phone:** (904) 259-2279

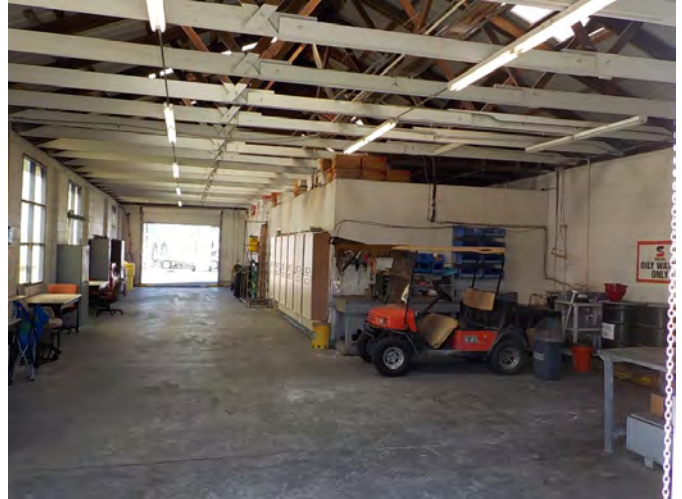
Photo 2

Mr. Trexler stated that minor maintenance is only performed on the facility's tractors in this area (Photo 2). Maintenance on the facility's pumpers and conveyors is performed by outside contractors who manage any waste generated during those activities. At the time of the inspection, one 55-gallon drum of used oil was accumulating (Photo 3), and two 5-gallon buckets of used oil filters were accumulating. All containers were closed, properly labeled, and located within secondary containment. No hazardous waste is generated in this area. All shop rags are laundered through Cintas.
