Hazardous Waste Inspection Report

**Facility Name:** US Ecology Tampa Inc  
**On-Site Inspection Start Date:** 12/22/2022 **On-Site Inspection End Date:** 12/22/2022  
**ME ID#:** 21659 **EPA ID#:** FLD981932494  
**Facility Street Address:** 2002 N Orient Rd, Tampa, Florida 33619-3356  
**Contact Mailing Address:** 7202 E 8th Ave, Tampa, Florida 33619-3380  
**County Name:** Hillsborough **Contact Phone:** (813) 319-3433

Routine Inspection for TSD Facility Facility

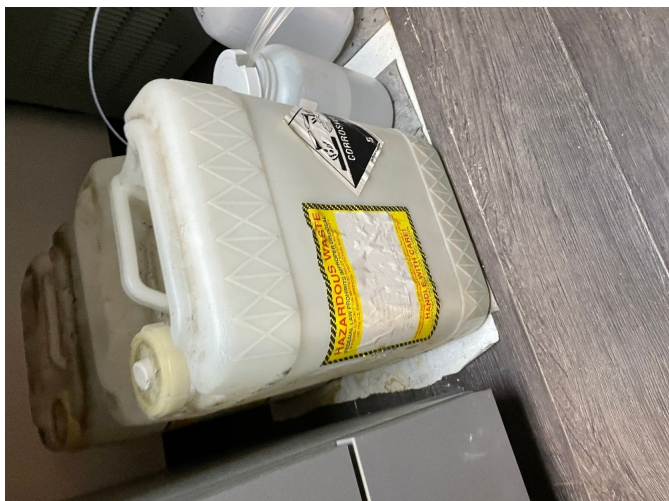
Inductively Coupled Plasma satellite accumulation jug

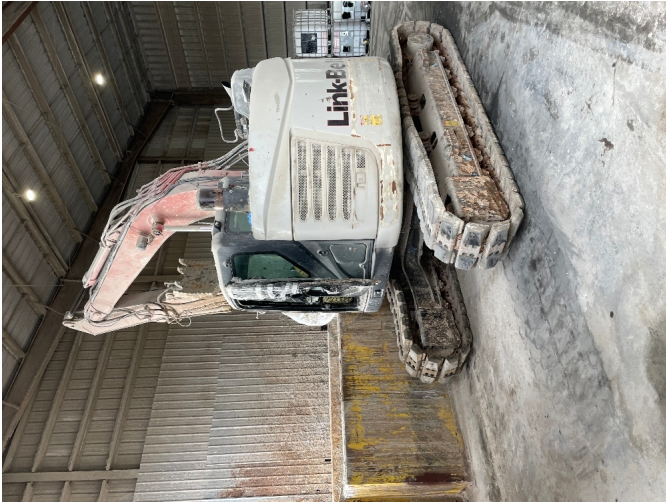
## Excavator in the Hazardous Waste Treatment Building

The waste treatment building houses separate mix tubs for solid and hazardous waste. The facility uses two excavators for mixing waste. Each excavator is dedicated to either hazardous or solid waste mixing, therefore decontamination of equipment between batches of hazardous waste is not needed. The hazardous waste mix tub is certified as meeting 40 CFR 265 Subpart J requirements. Hazardous waste codes associated with the hazardous wastes treated in this building include D002, D004, D011, and K062. The facility is not authorized to treat hazardous waste with organic underlying hazardous constituents. Hazardous waste is treated with a ferric and sulfide reagent. Ash kept in a silo behind the building is added to the hazardous waste mix tub for solidification during processing. Sawdust is added to the solid waste mix tub during processing for solidification. The treatment building is authorized to store a limited number of containers of hazardous waste (4,950 gallons) prior to treatment. At the time of the inspection, the treatment building was not actively treating batches of hazardous waste and the volume of hazardous waste stored in the building was under under the 4,950 gallons

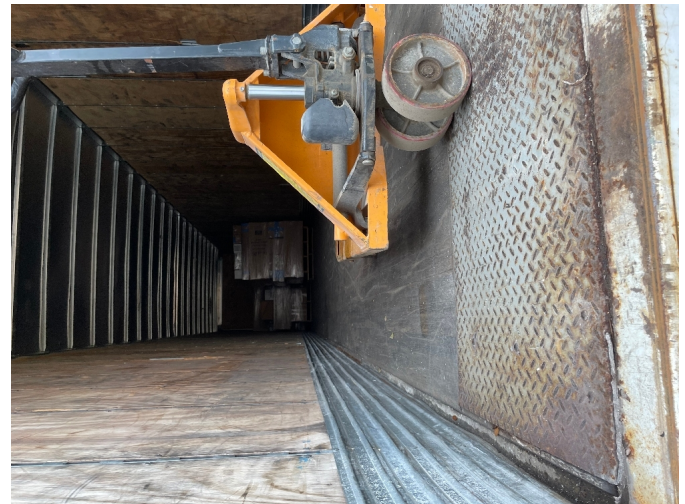
Universal waste storage box truck

Universal waste lamps are stored in a box truck located on the North Property. The containers were closed and properly labeled. Containers of universal waste batteries were staged in front of Bay 3. The containers were
