Seminole County – HW
Photographic Waste Control
RCRA Inspection Report

HAZARDOUS WASTE INSPECTION REPORT

FACILITY NAME Photographic Waste Control EPA ID # FLD984229609

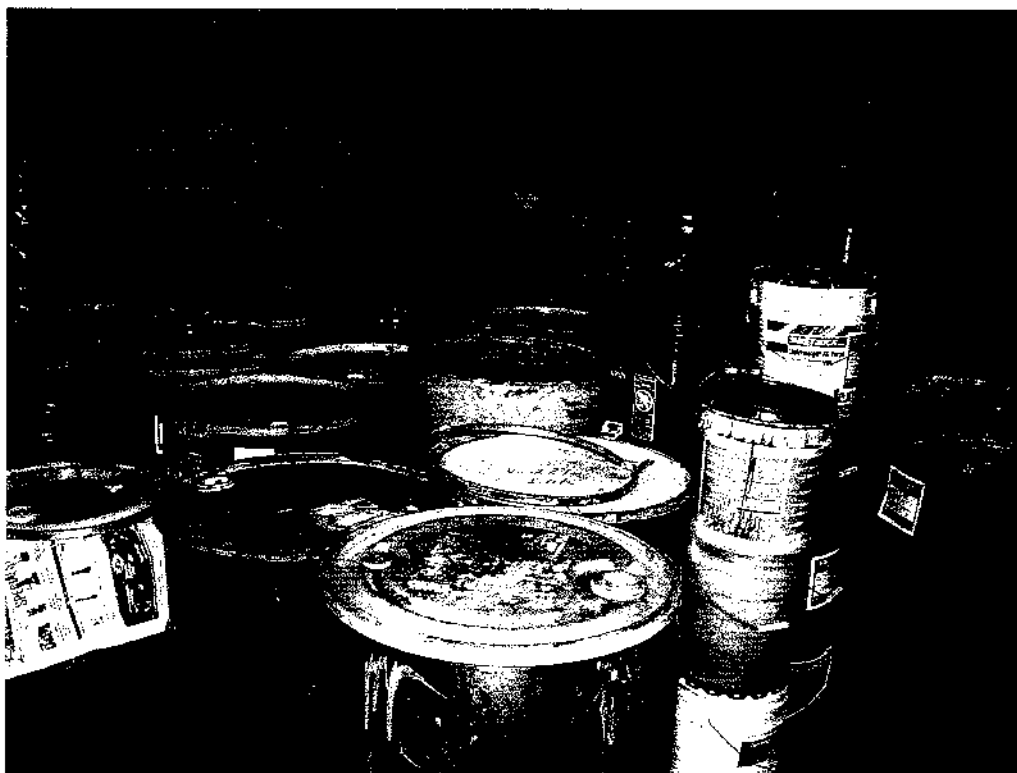
In the second bay, developer is kept separately. This allows PWC to check the contents to look for cross contamination with petroleum products. In the back of the bay non-hazardous waste inks are stored. The inks are checked to verify they do not contain solvents prior to shipment to a non-hazardous waste landfill.

Figure 4. Ink solids destined for non-hazardous waste landfill.

The collection, segregation and shipping for disposal of non-hazardous wastes may require a solid waste transfer facility permit. Please contact Mr. George Cheryan, or Mr. James Bradner, with the Department's Solid Waste Program to determine if a permit is required for this activity under Chapter 62-701, Florida Administrative Code.
