## **ATTACHMENT NO. 28**

### **NATURAL COMMUNITY DESCRIPTION**

**LIDO KEY HURRICANE AND STORM DAMAGE REDUCTION PROJECT  
BENTHIC RESOURCE INVESTIGATION  
FIELD OBSERVATION REPORT  
SEPTEMBER 2014**

**Date:** September 23-25, 2014  
**Project:** Lido Key Hurricane and Storm Damage Reduction Project  
Benthic Resource Investigation  
**Location:** Lido Key, Sarasota County, Florida  
**Commission No.:** 153076.03  
**Field Representatives:** Katy Brown (biologist), Judd French (field support), Ben Alcocer (field support), and Scott Tillman (captain)

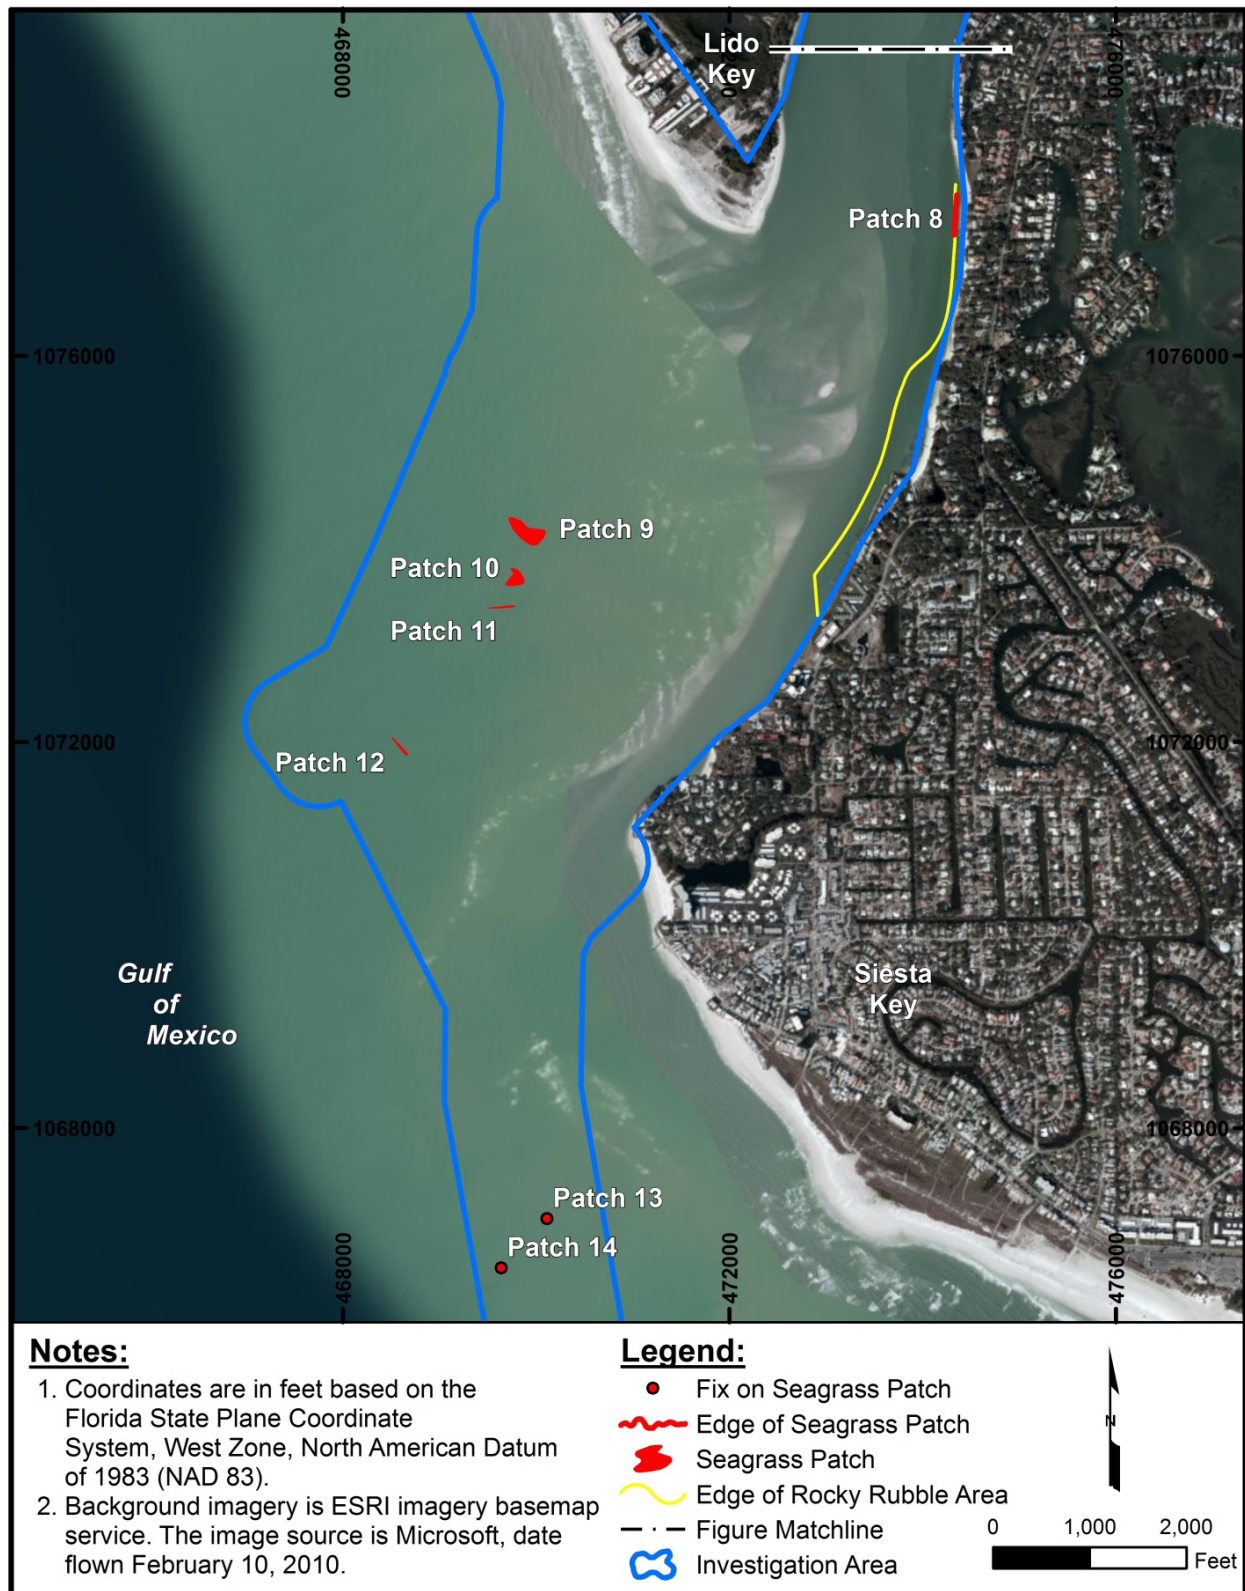
**Figure 2b. Location of seagrass patches (Patches 8-14) observed along the seawall on the north end of Siesta Key, on the southwest portion of the Big Sarasota Pass ebb shoal, and in the southern portion of the investigation area (offshore of Siesta Key). The location of the rock/rubble resources along the southern seawall is also shown.**

On the southwest portion of the Big Sarasota Pass ebb shoal, four large patches (Patches 9, 10, 11 and 12) of *H. wrightii* were observed during the towed video survey and confirmed by diver verification (Figures 2b and 6). Cover by *H. wrightii* was sparse, less than 5% at each of the patches, and depths ranged from 2-3 m (9-11 ft). The substrate consisted mostly of fine sand with areas of shell hash and dense aggregations of sand dollars (*Mellita tenuis*). To ensure the areas surrounding Patches 9-12 were adequately surveyed, intersecting towed video lines were conducted and fixes were taken to confirm the outer limits of each patch (see lines C1-C7 in Figure 1).

In the southern portion of the investigation area, located southwest of the north end of Siesta Key, two small patches (Patches 13 and 14) were observed during the towed video survey and subsequently confirmed by diver verification (Figures 2b and 7). Fixes were taken at the center

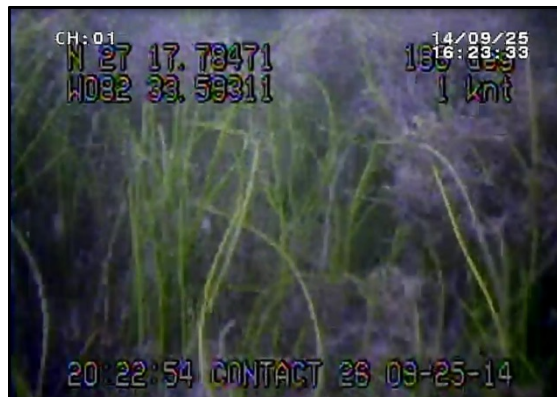
Figure 5. Image of Patch 8 recorded during the towed video survey within the channel in Big Sarasota Pass.

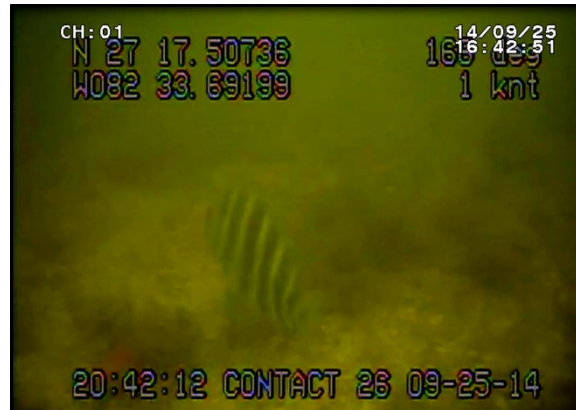
**Figure 10.** *Archosargus probatocephalus* (sheepshead) were one of the fish species recorded during the towed video survey within the channel in Big Sarasota Pass.

(Figures 1 and 2b). Figure 8 shows representative images of the rock and rubble resources recorded during the towed video. Diver verification was attempted within the channel and a few photographs were taken, however due to the strong tidal currents the diving activities were limited for safety reasons. The benthic resources in this location consisted of large rocks, rubble, and debris that supported growth of sponges (e.g., *Cliona celata*, *Pione lampa*), macroalgae (e.g., *Caulerpa* sp.), and octocorals (e.g., *Leptogorgia virgulata*) (Figures 8 and 9). Fish species, such as sheepshead (*Archosargus probatocephalus*), were also observed utilizing this habitat (Figure 10).
