RE: Volusia County – Tomoka Farms Road Landfill

Class I – North Cell Toe Drain and Temporary Runoff Containment Berm

Certification of Construction Completion Permit Number: SF64-0078767-027

TOE DRAIN AND TEMPORARY RUNOFF CONTAINMENT BERM CONSTRUCTION ON CLASS I - NORTH CELL TOMOKA FARMS ROAD LANDFILL

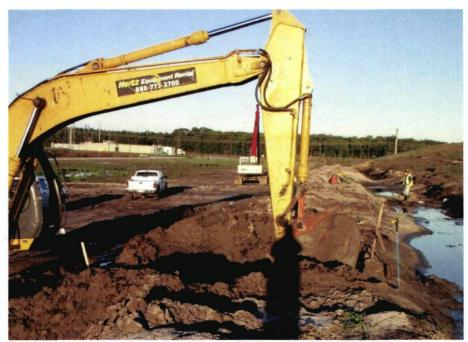
4/6/2011: Locating liner reference points and dewatering existing ditch, looking West.

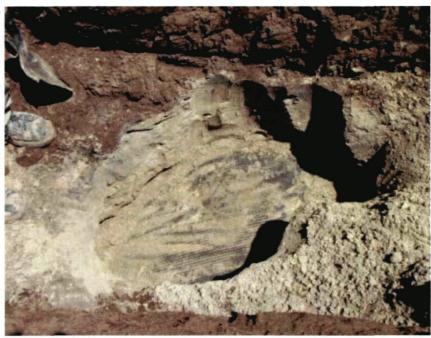
4/6/2011: Exposing liner reference point 2 (west).

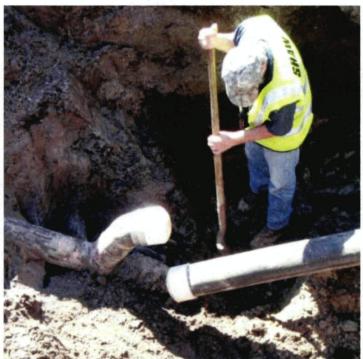
4/7/2011: Exposing existing LCO3 riser and cut & capped gas pipe line.

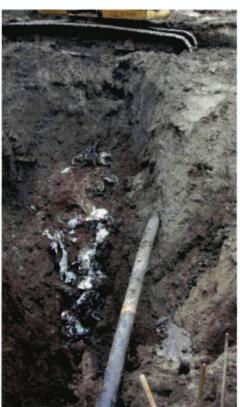
4/7/2011: Exposing gas pipe line for second cut and permanent cap and locating waste limits, looking North. Orange paint on gas pipe indicates 20 ft from center liner reference point.

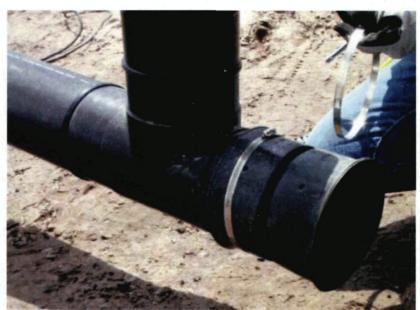
4/7/2011: Replacement 6" HDPE SDR 17 LCO3 riser with 6" CPP coupling joint.

The existing LCO3 riser was originally constructed using a combination of HDPE and CPP piping. This riser was replaced with an HDPE pipe with two pre-welded (machine welded) tie-in junctions; the upper junction is permanently capped and will be available to reconnect the gas extraction pipe in the future. The lower junction was installed to connect the leachate collected in the toe drain to the leachate collection system. Approximately 24.5 feet of riser was replaced and connected to the existing CPP pipe using a CPP coupling joint just past the lower tie-in junction. The outside of the HDPE pipe connection end was wrapped twice with rubber tape, inserted inside the coupling joint, and cinched with three stainless steel band clamps for a tighter fit into the coupling joint. A stainless steel band clamp was cinched around the CPP pipe end of the coupling joint for a more secure fit to the CPP pipe. The inner edge of the base liner anchor berm, adjacent to the LCO3 riser pipe (center reference point), was reexposed and a survey tube inserted at the inner berm point for surveyors.

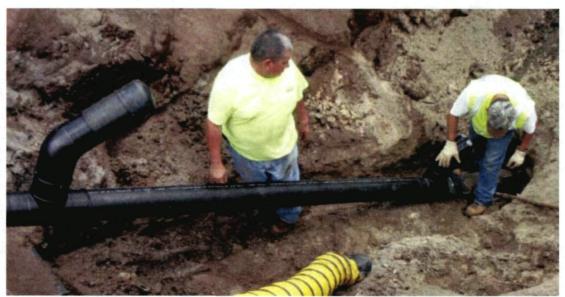
4/7/2011: Connecting replacement HDPE LCO3 riser pipe to existing CPP LCO3. Upper tie-in for future gas pipe line connection and lower tie-in for toe drain connection.

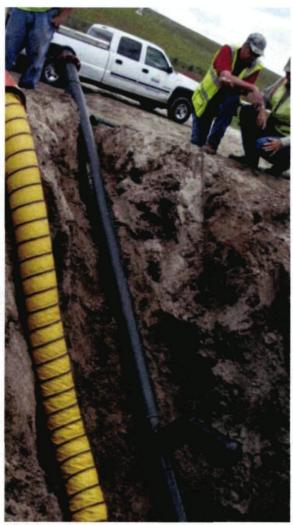
4/7/2011: Replacement HDPE LCO3 riser pipe with gas pipe tie-in for future connection.

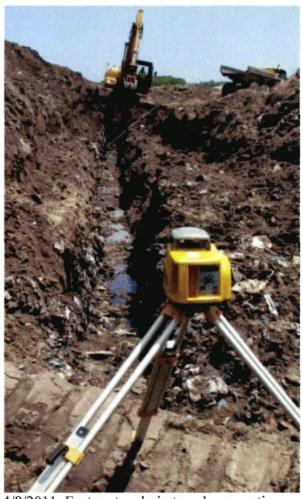
4/8/2011: Eastern toe drain trench excavation and slope identification equipment, looking East.

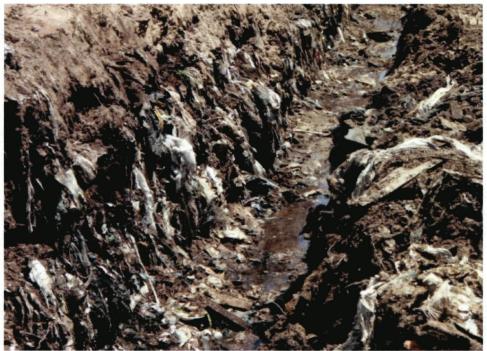
4/8/2011: Eastern toe drain trench in at least 2 ft of waste, looking East.

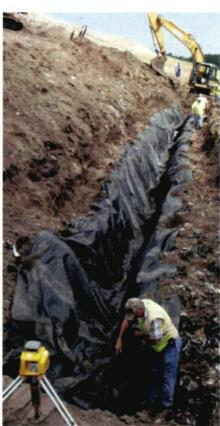
4/8/2011: Geotextile being installed into eastern toe drain trench, looking East.

After the eastern trench was fully excavated, 6 oz. woven geotextile (12 ft width) was installed with the lengthwise center line of the geotextile lying on the center bottom of the trench. Next, 6 inches of FDOT #57 non-calcareous stone was placed into the eastern trench over the geotextile using an excavator. The stone was then spread until the 0.7% slope was achieved. Pre-welded (machine welded) 6-inch SDR 17 HDPE pipe with three rows of 5/8-inch holes along the two sides and bottom of the pipe was installed in the eastern trench. A HDPE tee fitting at the center low point end with 6-inch SDR 17 HDPE solid piping attached for connection to LCO3 and a 5 ft solid HDPE riser pipe with a permanent cap was installed at the east end of the toe drain pipe. More stone was placed until it was uniformly 1 foot (minimum) above the top of the toe drain pipe. Survey tubes were placed at the center low point, eastern middle, and eastern end of the top of toe drain pipe. The geotextile was then folded over the top of the stone; first the southern geotextile flap was laid down then the northern flap was overlapped on the southern flap so that no stone was exposed. In areas where the flaps could not cover the stone entirely, additional strips of geotextile were laid across the top of the stone before folding the flaps.

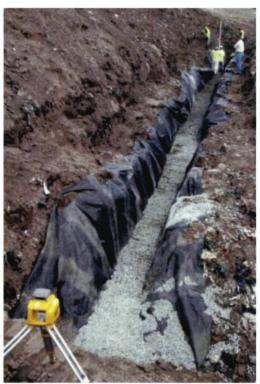
4/8/2011: Placing 6" #57 stone at 0.7% slope over geotextile in eastern toe drain trench, looking East.

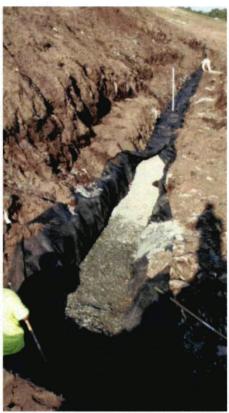
4/8/2011: Overlapping geotextile flaps over eastern toe drain trench. Survey tubes at mid- and end-points of top of pipe along eastern toe drain trench, looking East.

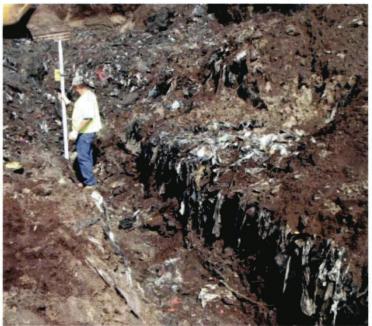
4/9/2011: Excavating western toe drain trench at 0.7% slope in 2 ft waste, looking West.

An excavator was used to dig the western toe drain trench from the center low point due west approximately 125 ft at a 0.7% upward slope. Slope was established using an electronic laser surveyor tool programmed at 0.7% slope. Excavated waste was hauled to the active landfill face for disposal while soil free of debris was stockpiled nearby. Waste was not at a uniform depth so to construct in waste, the western trench jogged north approximately 2 ft in two locations, 35 ft and 82 ft west of the center low point.

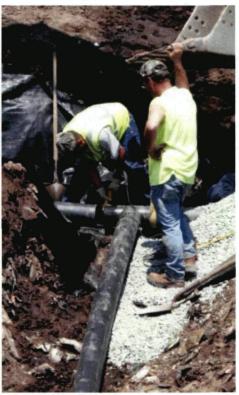
4/9/2011: Electrofusion welding west toe drain pipe to east toe drain pipe, looking North.

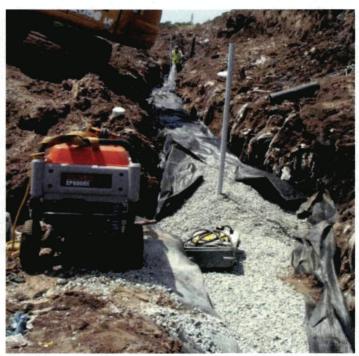
4/9/2011: Overlapping geotextile flaps over western toe drain trench with survey tubes at midand end-points of top of pipe along western toe drain trench and at the tie-in center low point of toe drain trench, looking West.

More stone was placed until it was uniformly 1 foot (minimum) above the top of the toe drain pipe. Survey tubes were placed at the western middle and western end of the top of toe drain pipe. The geotextile was then folded over the top of the stone; first the southern geotextile flap was laid down then the northern flap was overlapped on the southern flap so that no stone was exposed. In areas where the flaps could not cover the stone entirely, additional strips of geotextile were laid across the top of the stone before folding the flaps.

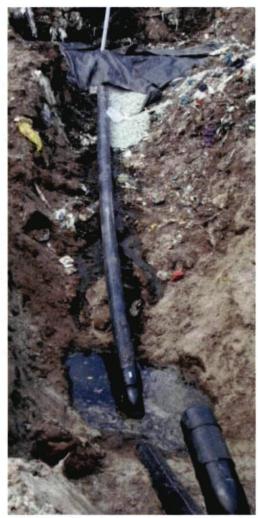
4/9/2011: Toe drain connection pipe electrofusion welded to replacement HDPE LCO3 riser pipe tie-in point, looking North.

The HDPE pipe connecting the toe drain to LCO3 was electrofused at the lower tie-in junction on LCO3 so that the toe drain system was complete and leachate collected by the toe drain could begin draining

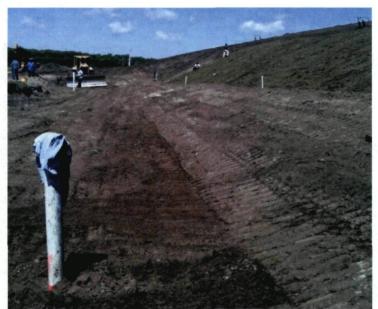
4/14/2011: Completed temporary run-off containment berm, looking West. Left side survey tubes mark the liner reference points, right side survey tubes mark the toe drain pipe.

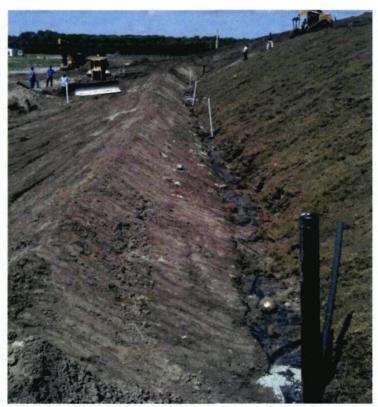
4/14/2011: Toe drain trench with survey tubes and completed temporary run-off containment berm, looking West. Rolled sod for erosion control being placed atop landfill side slope (north of trench). Volusia County staff are standing next to the replacement LCO3 riser pipe.

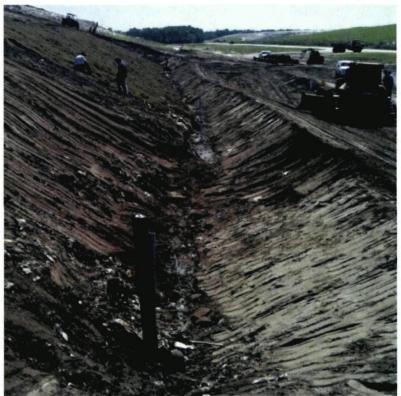
4/14/2011: Toe drain trench and temporary run-off containment berm, looking East. Sod still being placed on landfill side slope (north of trench). Excavator accidentally slid down landfill side slope onto toe drain trench near west end of the toe drain trench (disturbed soil over trench and berm).

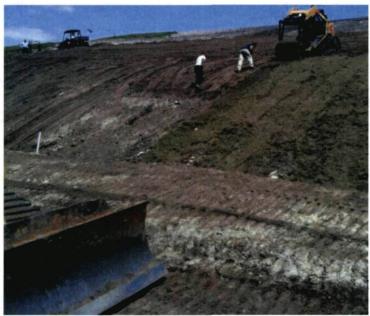
4/14/2011: Completing landfill side slope sodding for erosion control, looking Northwest.
