**Re: Citrus County Central Landfill – Permit No. 21375-018-SO/01  
Landfill Gas Monitoring**

Subject: Landfill Gas Monitoring Report, Third Quarter 2011  
Central Landfill, Citrus County, Florida

Figure 1. Landfill Gas Monitoring Probe Locations, Central Landfill, Citrus County, Florida

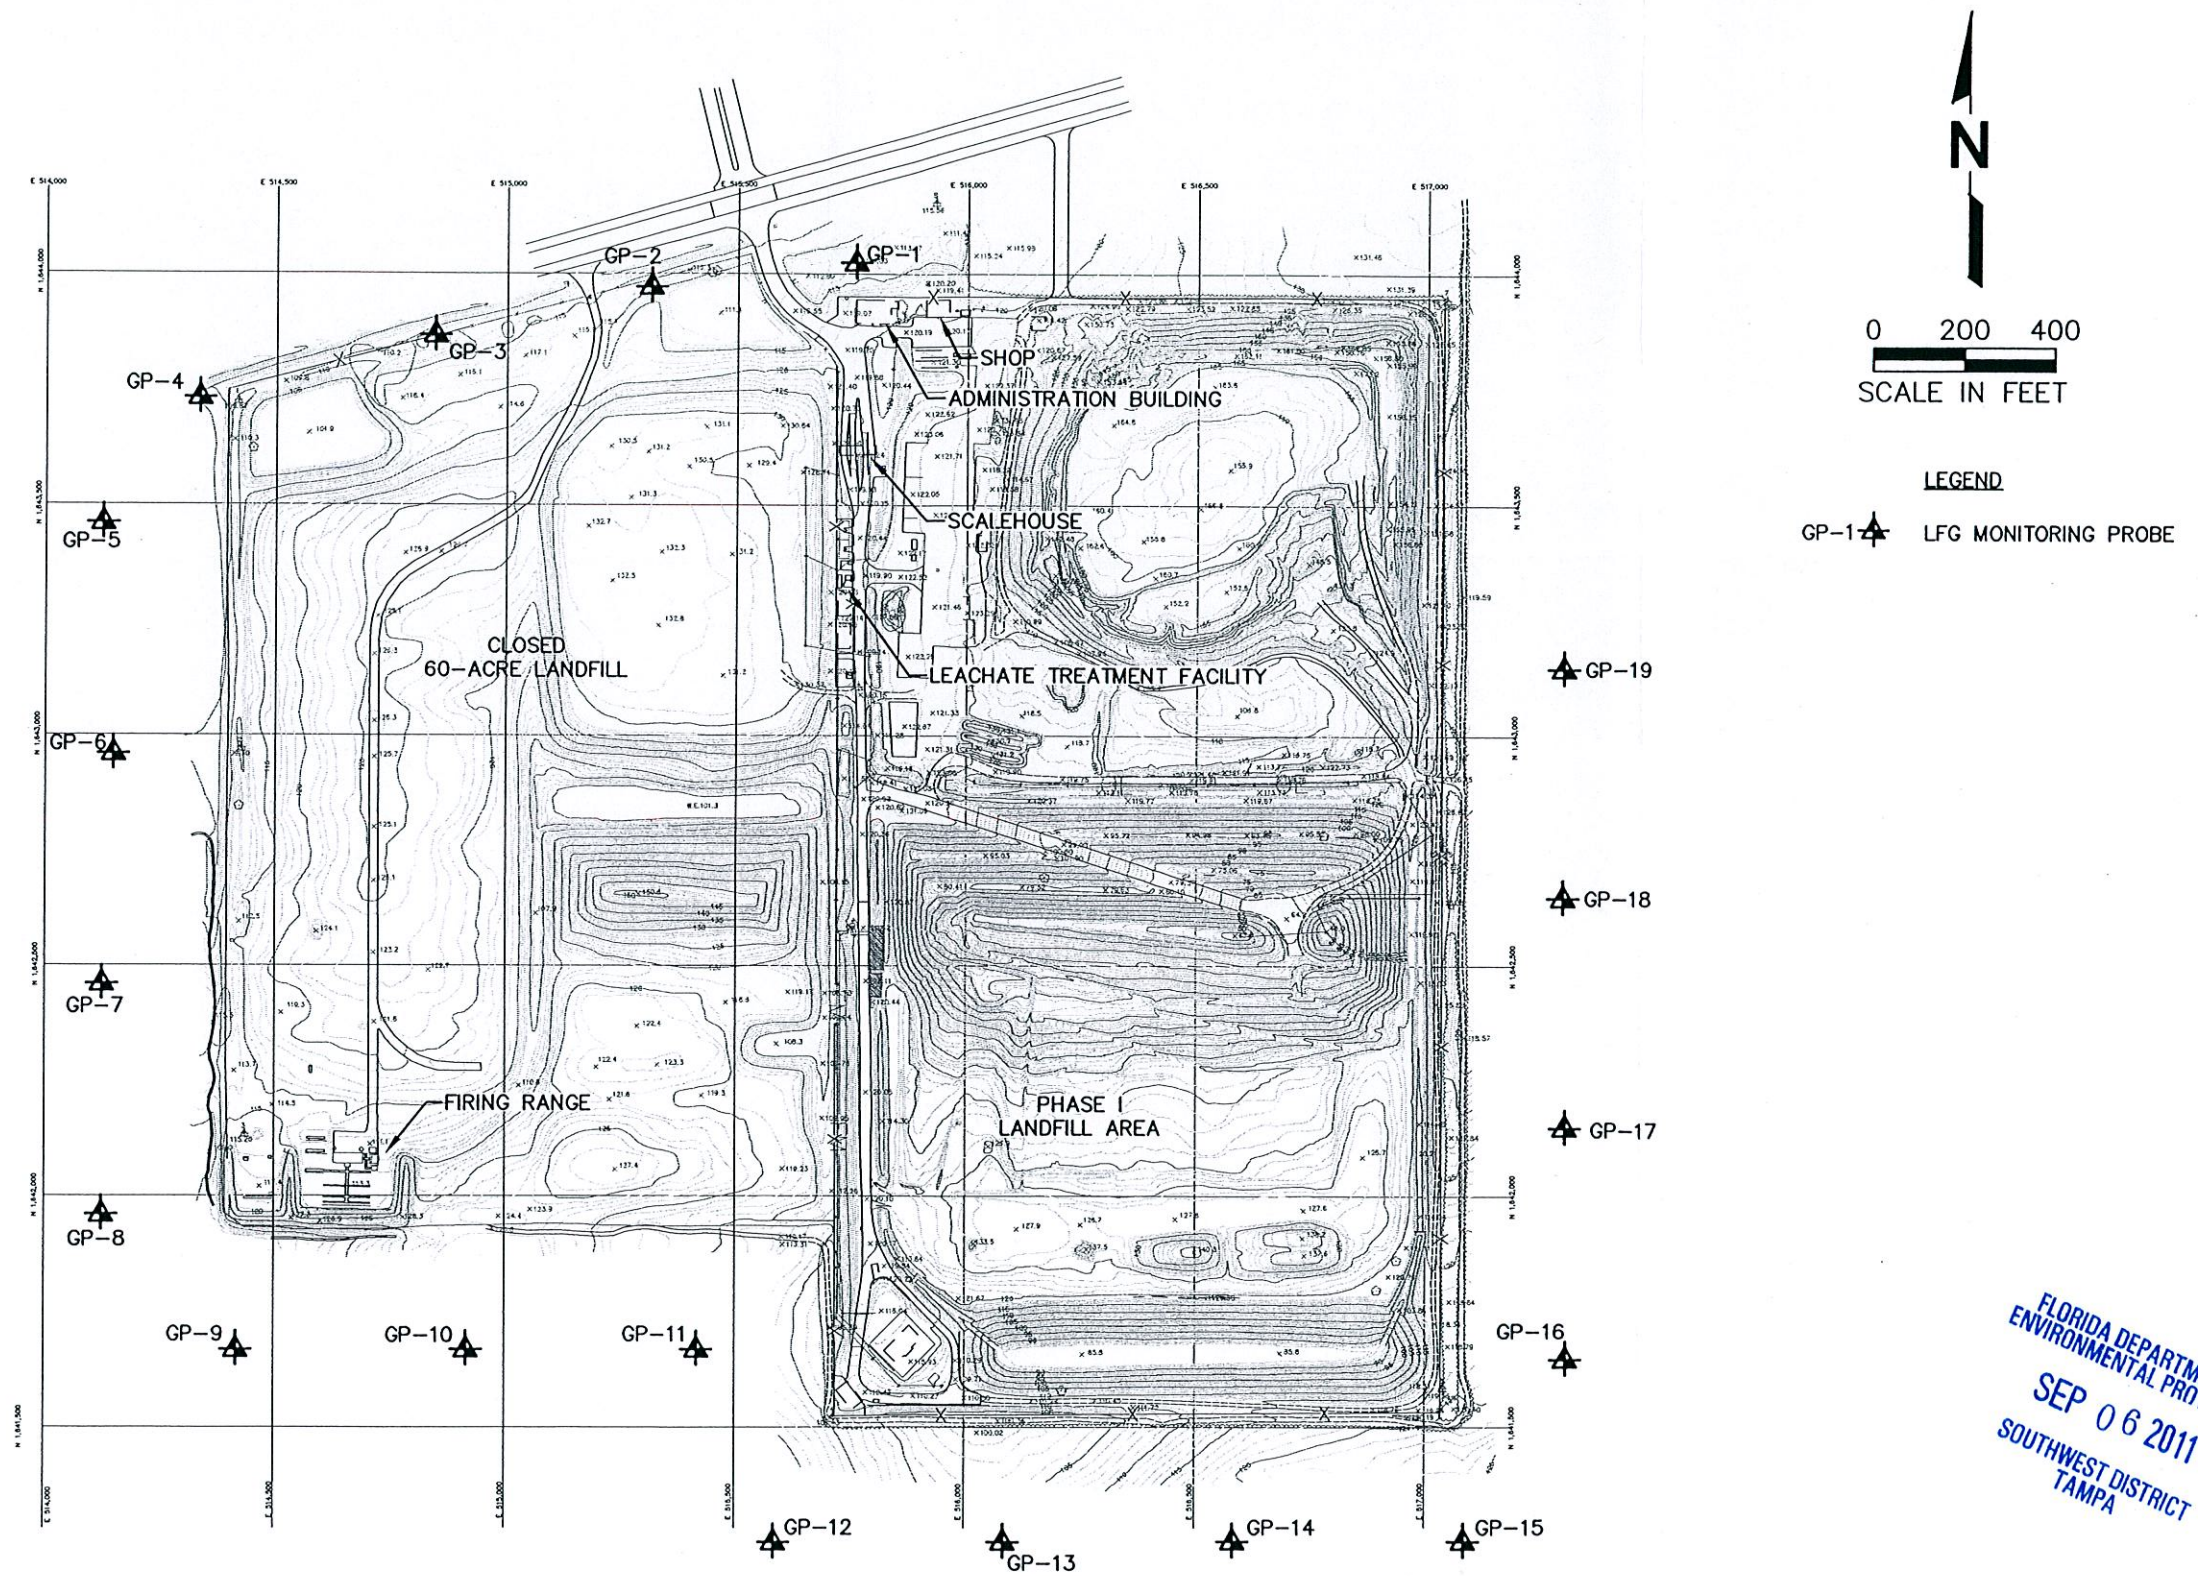
In April 2007, the Florida Department of Environmental Protection (FDEP) approved extending the compliance boundary for LFG migration monitoring at the site to coincide with the boundaries of the 2006 lease agreement between Citrus County and the Florida Division of Forestry. As a result, 18 LFG monitoring probes installed along the new property boundary were to serve as the compliance points for migration monitoring. The remaining 62 permanent LFG probes and 12 interim probes have been abandoned in place and are no longer monitored on a quarterly basis. In November 2010, as part of the Phase III cell expansion, GP-19 was installed. Figure 1 in Attachment 1 includes a site map that shows all LFG monitoring probe locations.

Table 1 of Attachment 2 shows the readings obtained from the 19 probes along the property boundary. Methane was not detected in any of the monitoring probes. A site plan showing the probe locations is included in Attachment 1.

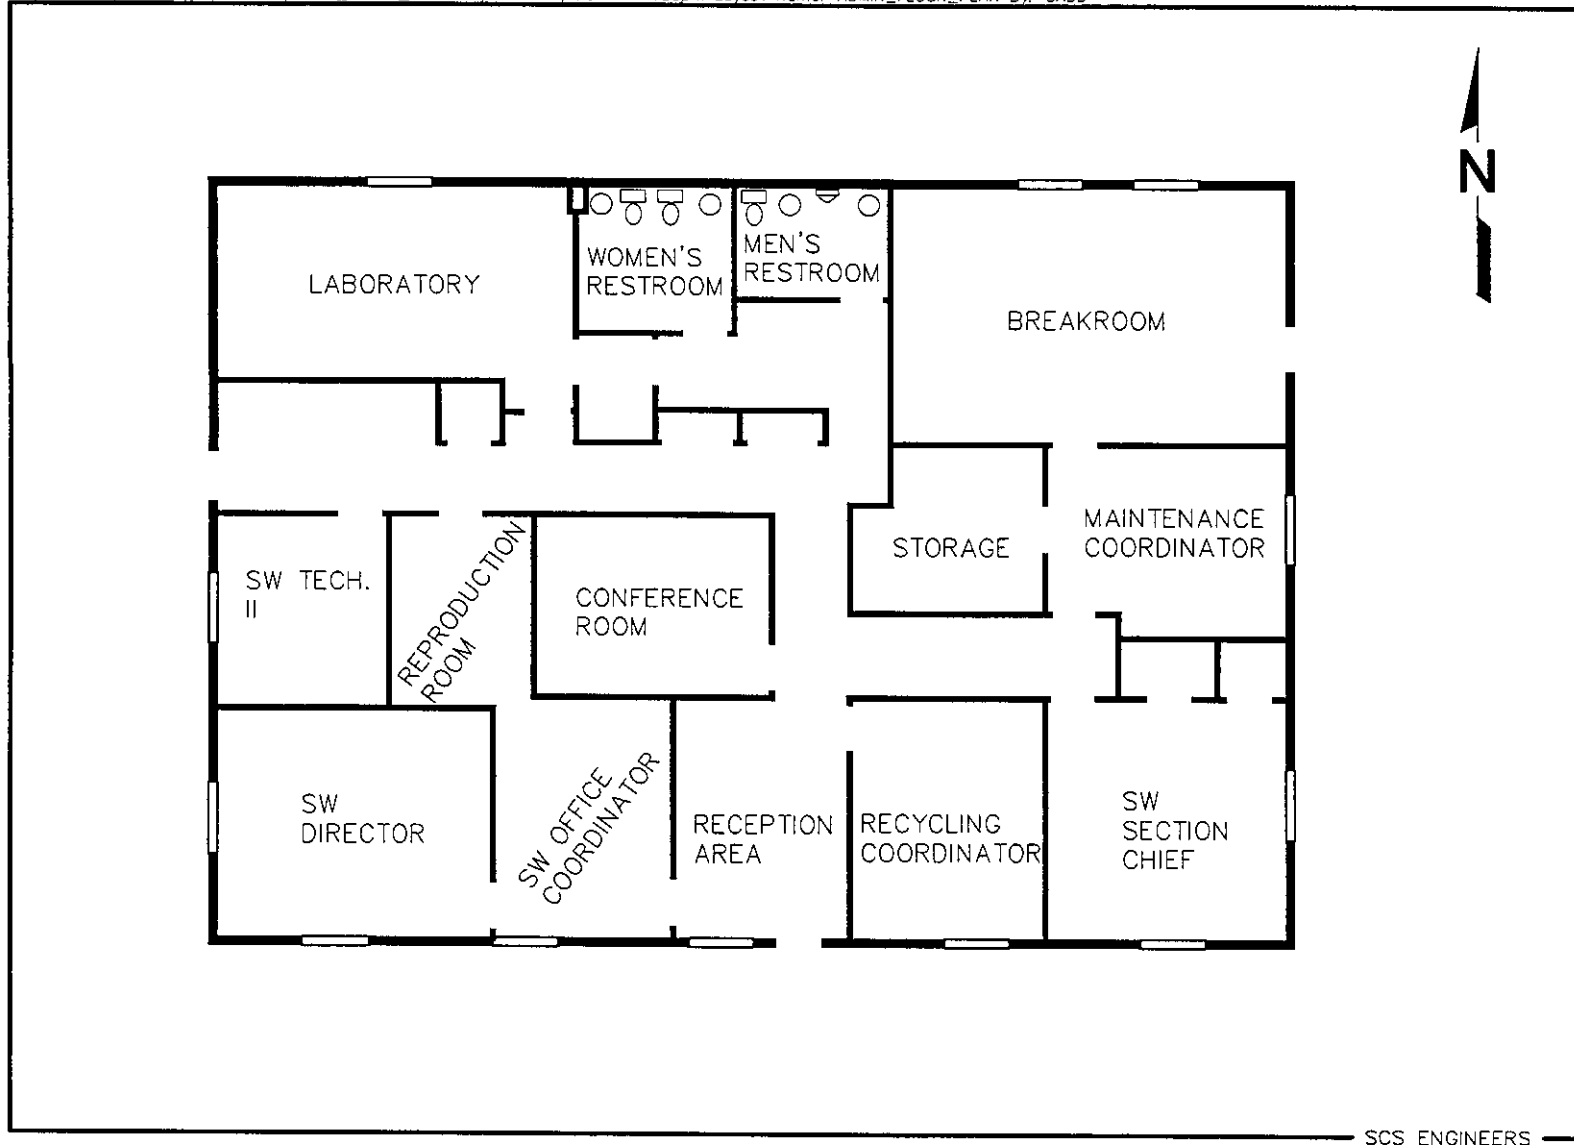
Figure 2. Administration Building Floor Plan

No methane was detected in the scalehouse, administration building, shop, leachate treatment facility, or firing range as shown in Table 1 of Attachment 2. Floor plans of the scale house and the administration building are included in Attachment 1.

SCS monitored in the restrooms of the administration building, as well as in select closets, the break room, conference room, and hallways. In the scalehouse, SCS monitored the main work area, cabinets, the restroom, and at electrical outlets. Monitoring of the leachate treatment facility included around the base of structures, at the control panel, and inside the electrical room.
