**Re: Sarasota County
Central County Solid Waste Disposal Complex
Phase II Cell 2 Gas Vent Repairs
WACS No. SWD/58/51614
Permit No. 130542-007-SO/01**

PHASE II GAS VENT REPAIR
FIGURES

Central County Solid Waste
Disposal Complex
Phase II Class I Landfill

**Temporary Gas Vent Removal and
Liner Repair**

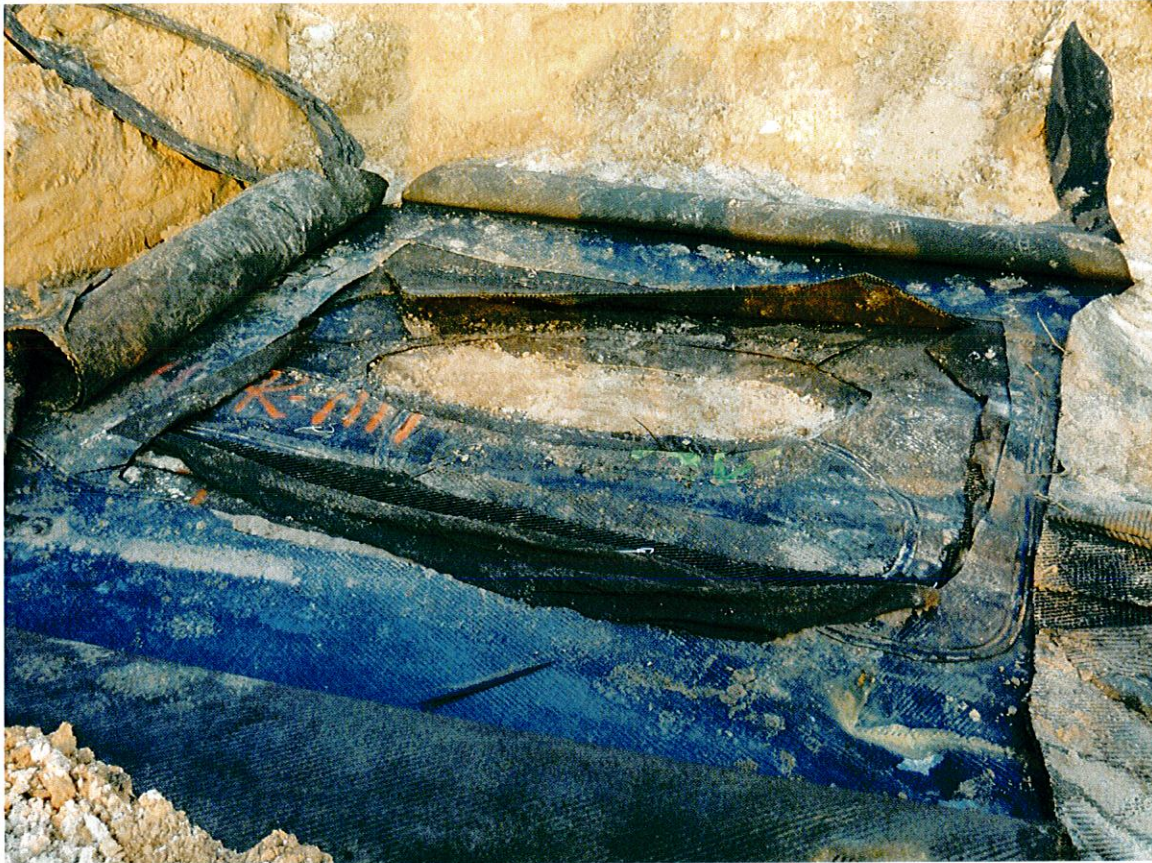
1. May 30, 2012 – Gas vent location with gas vent removed and geosynthetic layers exposed.

1. The sand layer surrounding the vents was carefully removed to the liner.
2. The gas vent piping was removed from the liner surface and the subgrade.
3. Additional soil added to subgrade to provide a flat surface (please note that very little soil was required in the locations, only a few shovels full).
4. Liner layers were cut away to provide sufficient overlap for the patches for each layer.
5. The GCL was patched using GSE NWL 60 Bentoliner. The GCL was obtained from GSE with the certification/testing reports and product data sheets provided in Attachment B.

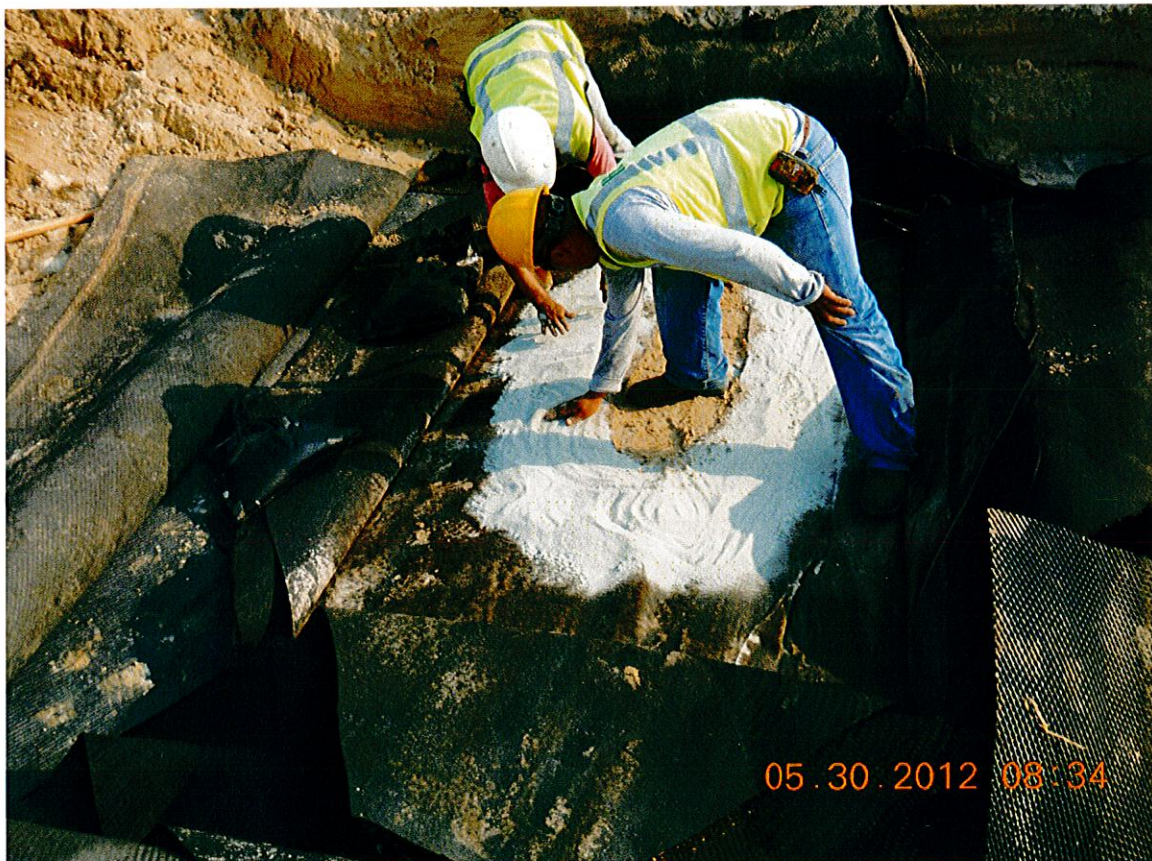
2. May 30, 2012 – Placing supplemental bentonite at GCL overlap.

- Before placing the patch with a minimum 18-inch overlap, GSE approved granular bentonite was poured in the overlap area as supplement bentonite for the patch.

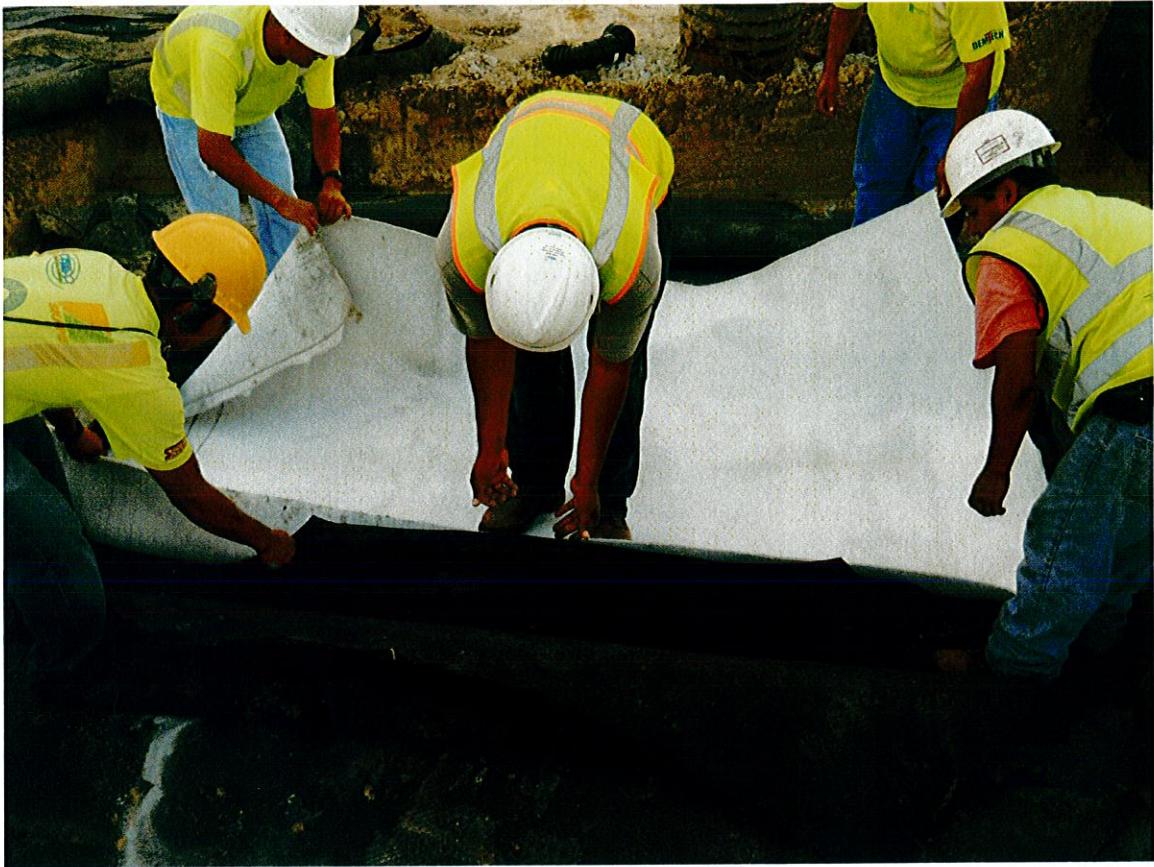
3. May 30, 2012 – Installing GCL patch.

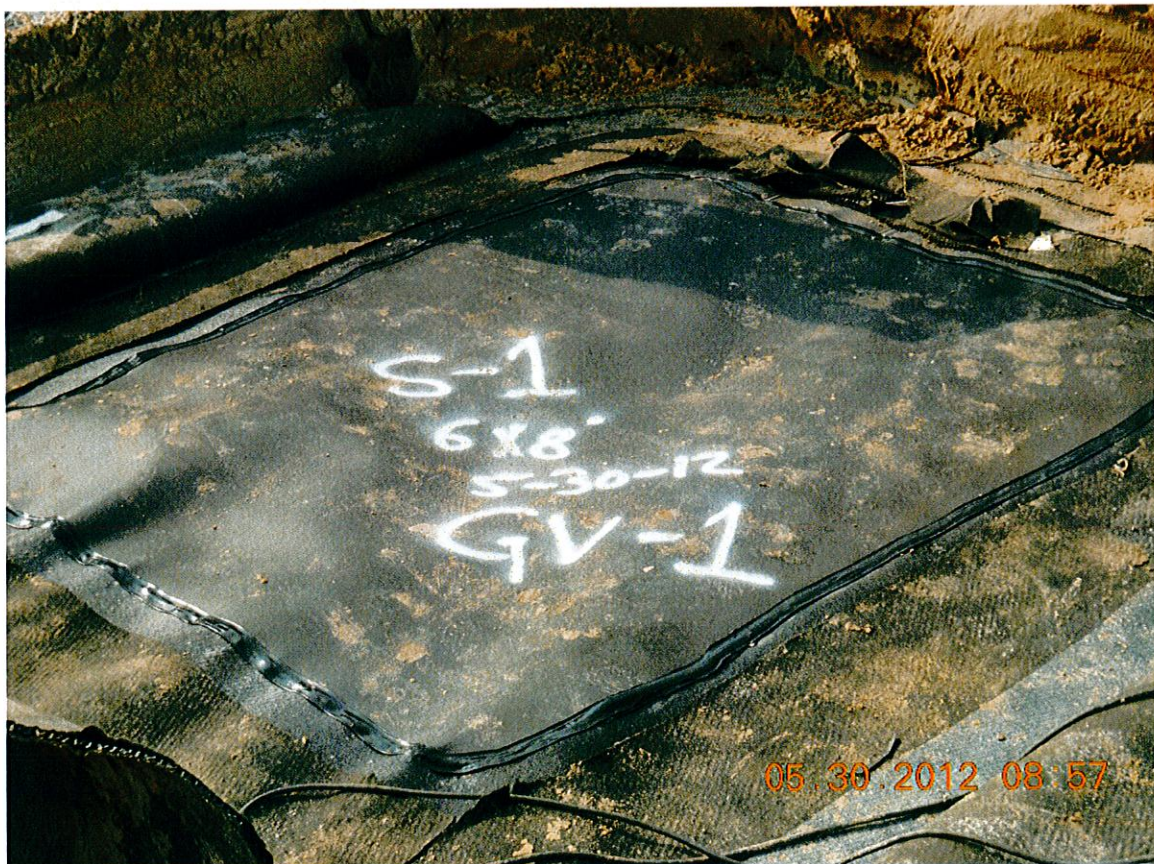
4. May 30, 2012 – Secondary geomembrane patch extrusion welded.

6. After installation of the GCL, the secondary 60-mil HDPE liner was patched using 60-mil Agru HDPE, same material used for the Phase II overliner on the west slope of Phase I. Before welding the liner, Hallaton performed extrusion trial welds between the existing GSE 60-mil HDPE liner and the Agru 60-mil HDPE liner. Upon completion of the extrusion weld patch on the secondary liner, the weld was vacuum box tested (testing reports and trial weld reports are provided in Attachment C).

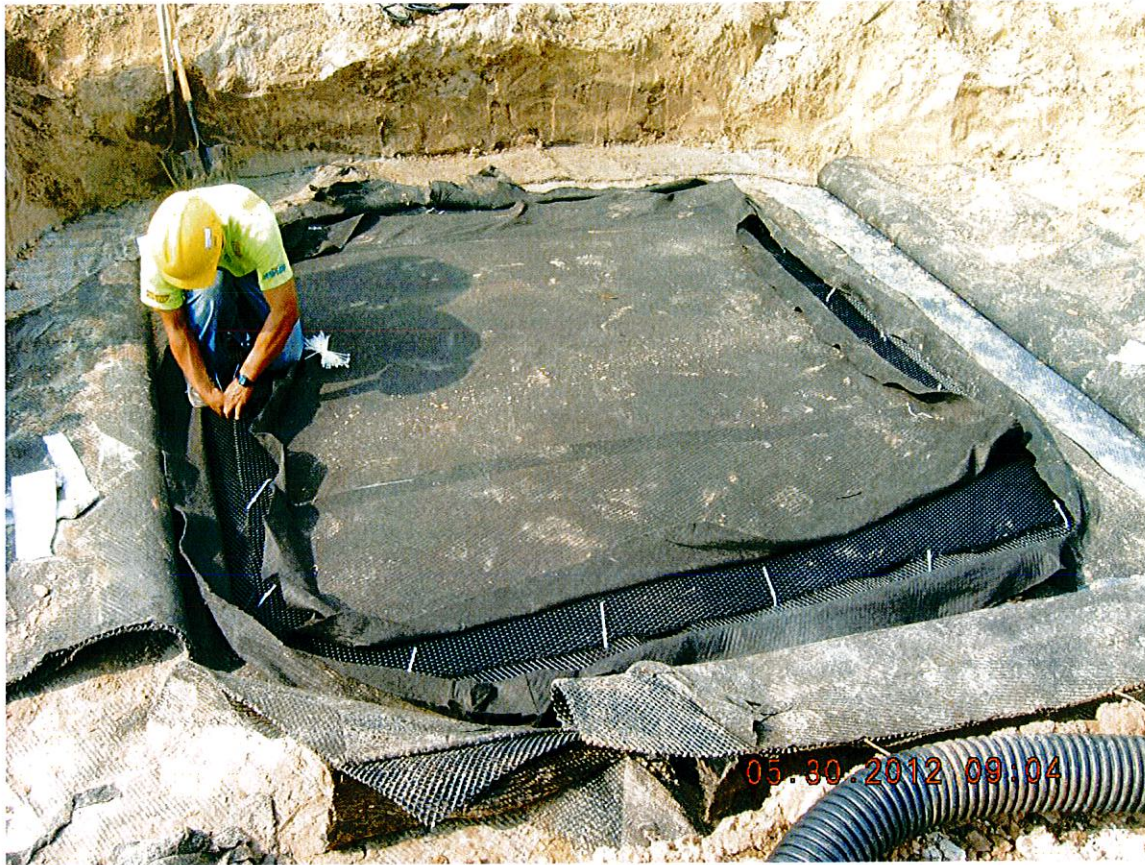
5. May 30, 2012 - Installing secondary geocomposite patch.

7. The secondary geocomposite was then patched using GSE Permanet from the Phase II overliner on the west slope of Phase II (please note that this was the same material used in the Phase II bottom liner construction). The geocomposite was overlapped and tied per the project specifications and the geotextile heat welded over the seam.

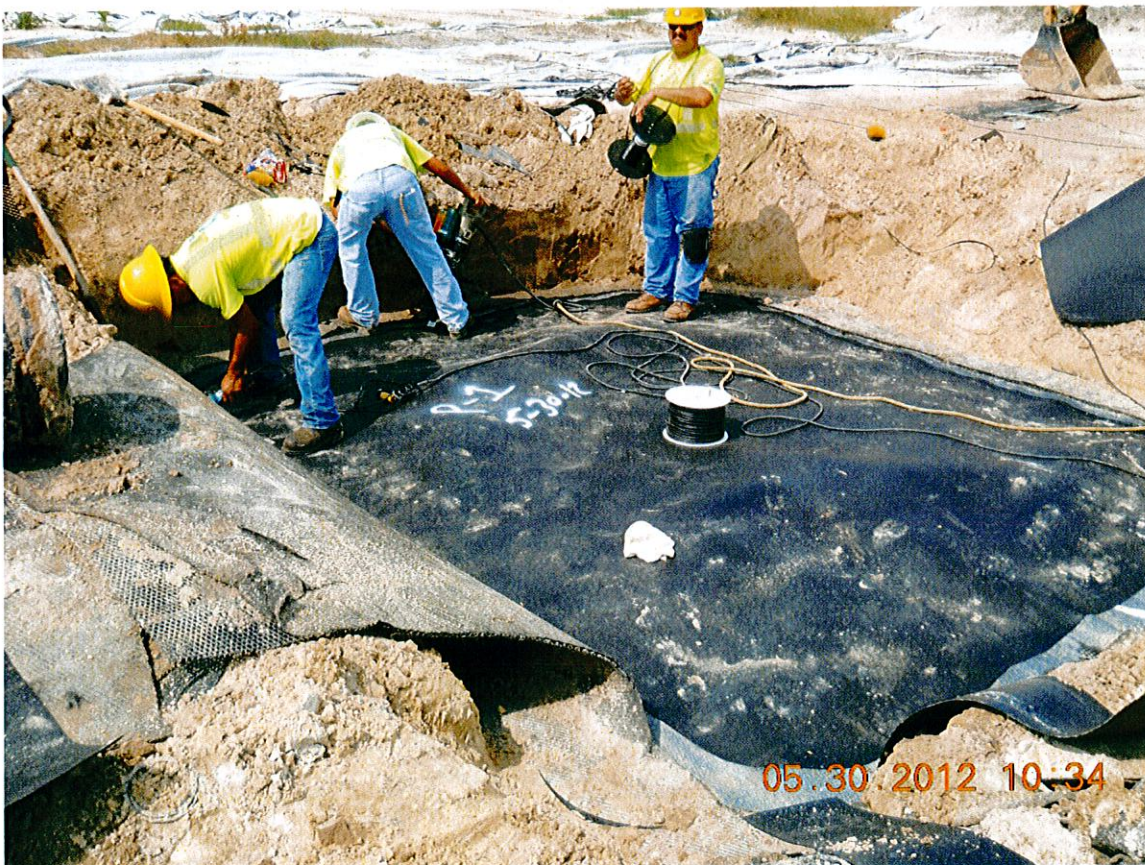
6. May 30, 2012 - Installing primary geomembrane patch.

8. The primary 60-mil HDPE liner was then patched and welded using the same methods as discussed in Step 6 for the secondary liner and the primary geocomposite was patched using the same methods as discussed in Step 7.

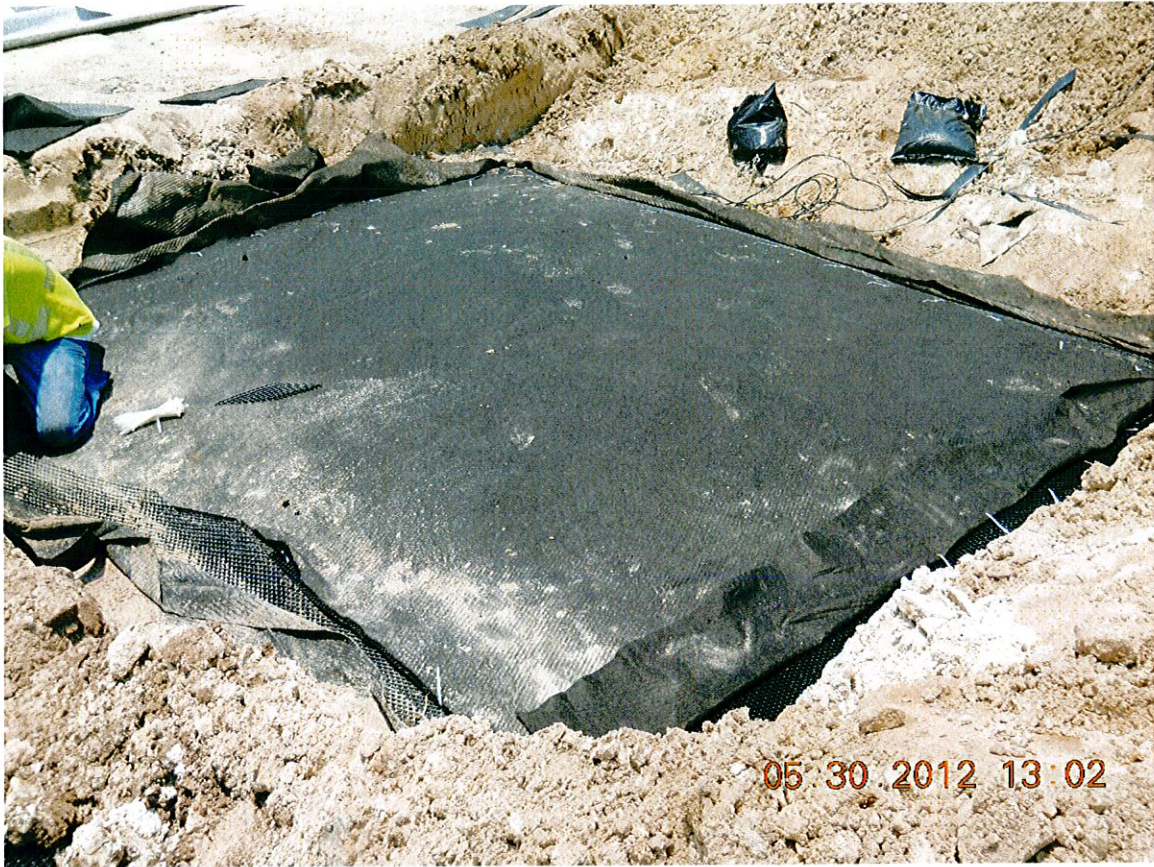
7. May 30, 2012 – Installing primary geocomposite patch.

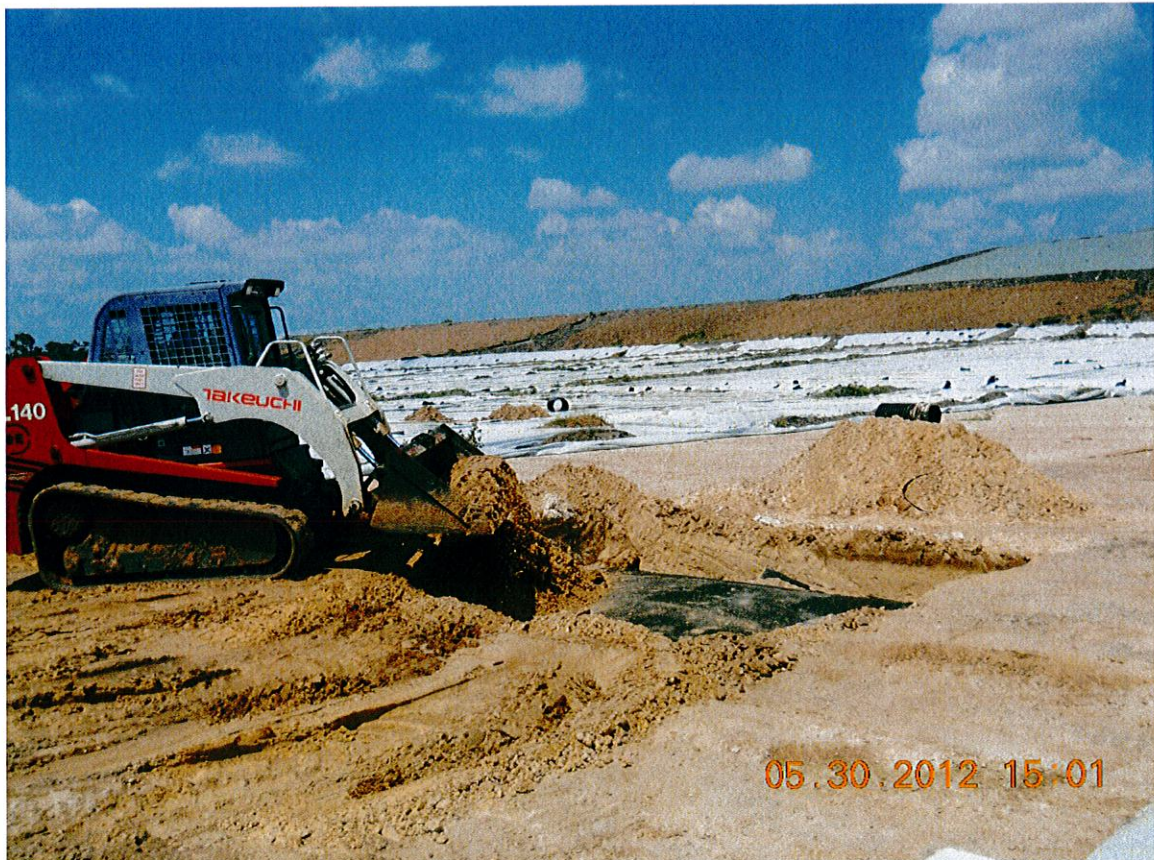
8. May 30, 2012 – Replacing sand over patch area.

9. Following completion of the patches and required vacuum box testing, the protective sand layer was replaced by Thalle.
