**Geotechnical and Geosynthetic  
Construction Quality Assurance Report  
for CCSWDC, Phase I Closure  
Sarasota County, Florida**

March 22, 2013  
Ardaman File No. 09-7375

Subject: **Geotechnical and Geosynthetic Construction Quality Assurance Report  
CCSWDC, Phase I Closure, Sarasota County, Florida**

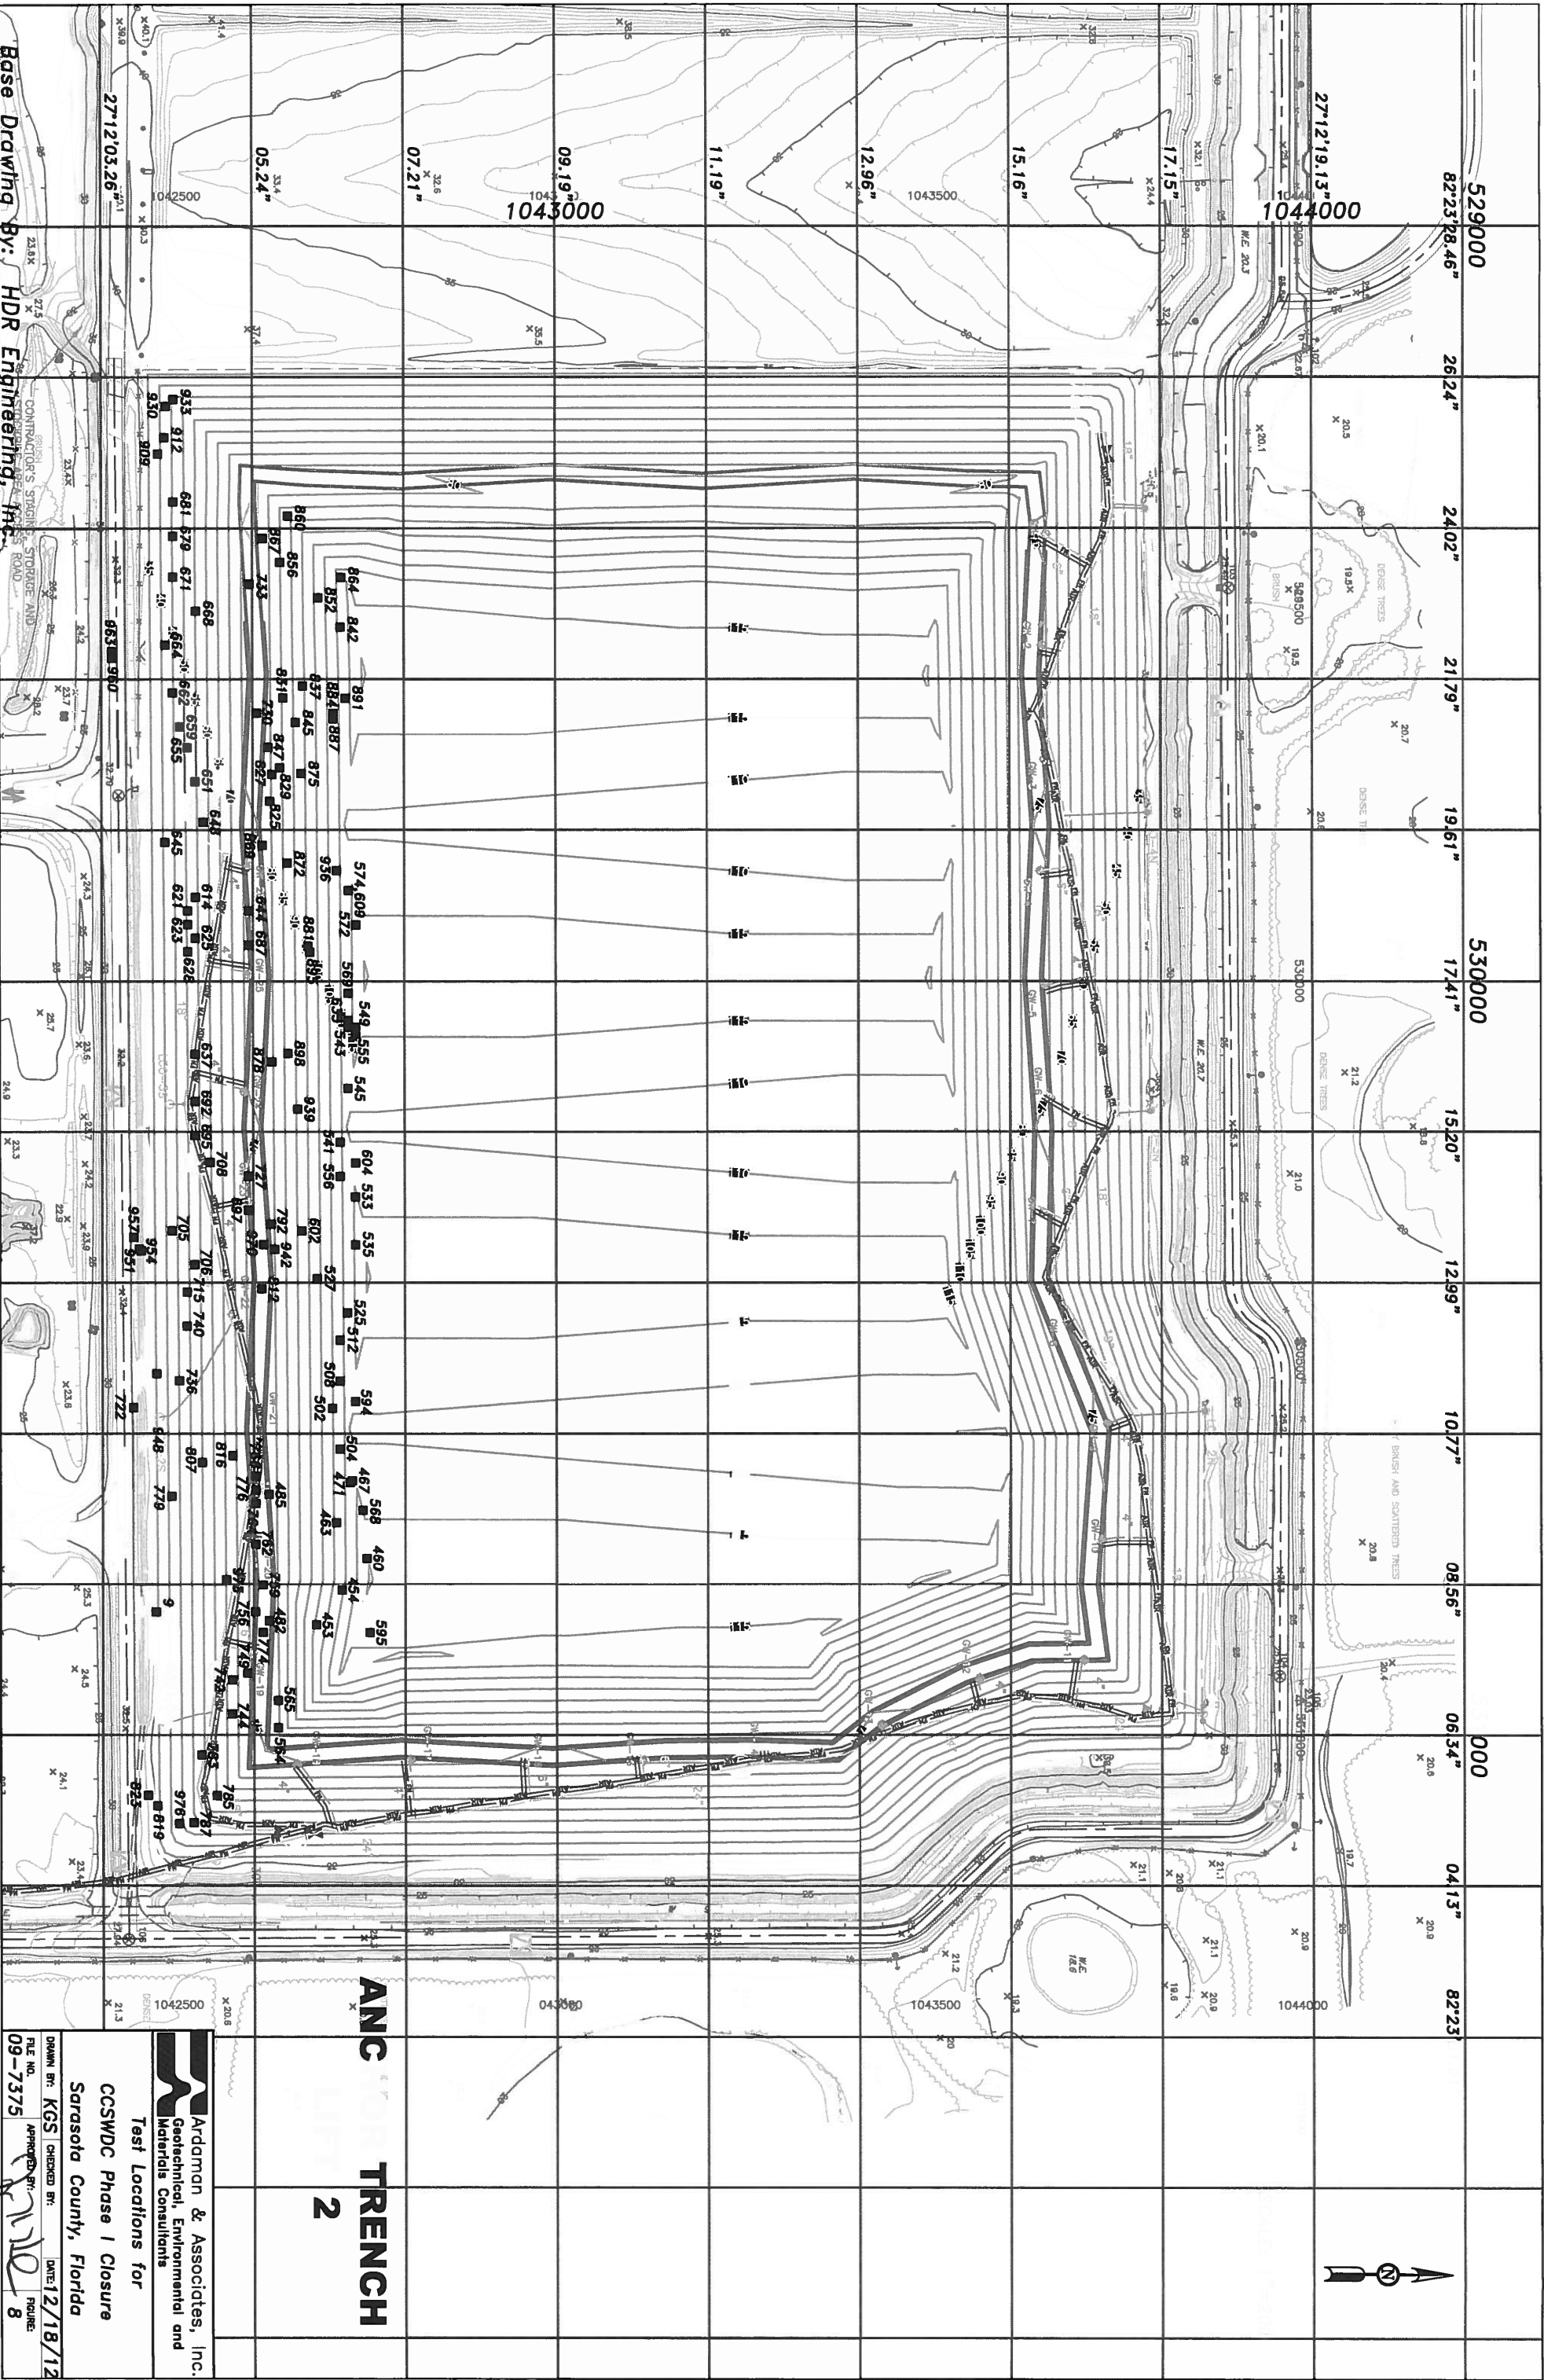
DRAWN BY: KGS  
CHECKED BY: [Signature]  
FILE NO: 09-7375  
DATE: 12/18/12  
FIGURE: 8

The latitude/longitude of the field density test locations were determined by utilizing a handheld GPS. These were subsequently transferred onto **Figures 1 to 11**, which show the locations superimposed onto the HDR design plan. The majority of the compaction tests were performed using the nuclear density gage method (ASTM D2922). At periodic intervals, a drive cylinder test (ASTM D2937) was performed in lieu of the nuclear test, a jar sample was obtained of the fill at the test location and an oven moisture content test (ASTM D2216) was performed on this sample. The correlation between the methods was good.

Test Locations for  
CCSWDC Phase I Closure  
Sarasota County, Florida
