**PHASE IV TEMPORARY PUMP STATION NO. 5
CONSTRUCTION OBSERVATIONS
AND DOCUMENTATION REPORT**

**SOUTHEAST COUNTY LANDFILL
HILLSBOROUGH COUNTY, FLORIDA**

September 29, 1995
Job No. 0990018.35

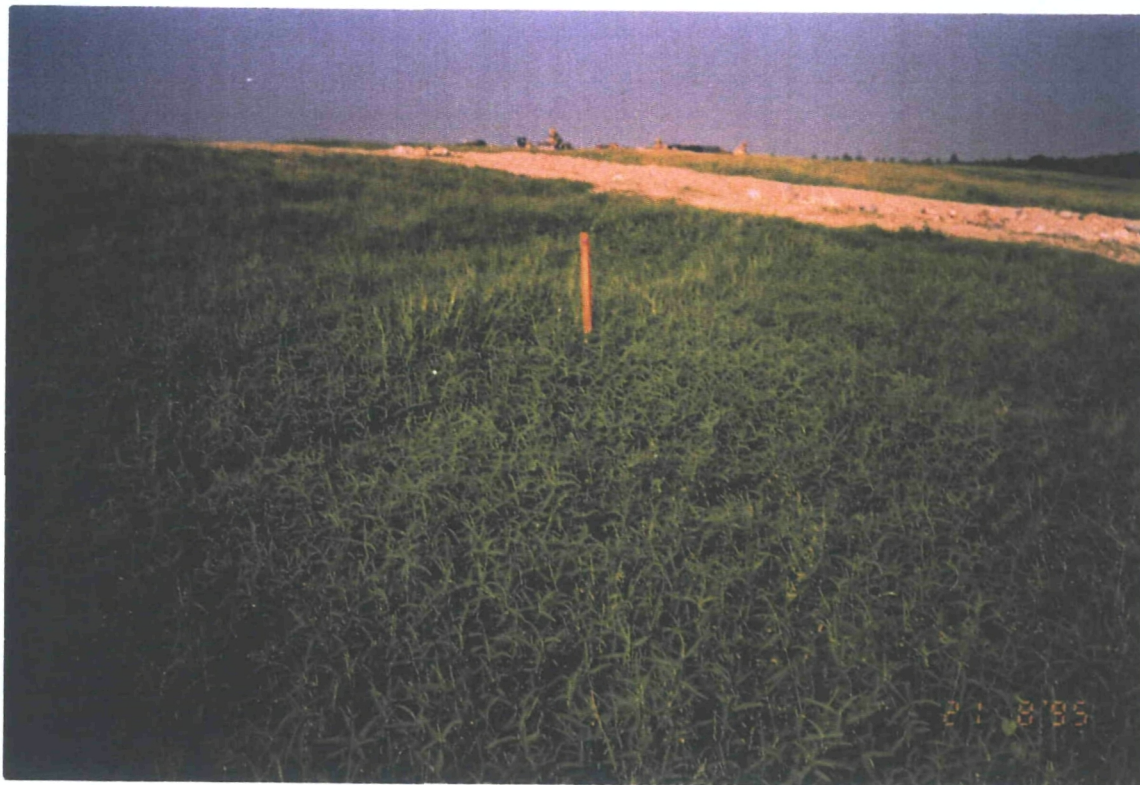
Photo No. 1

Date: 8/21/95 Location: NE corner of Phase IV, Southeast County Landfill.
Description: Looking southwest at surveyed location of E-W leachate collection header.

Excavation began on August 21, 1995, approximately 90 feet north of the TPS-3 in the area flagged by the Hillsborough County Surveyor as representative of the approximate location of the PVC header of the existing LCRS (Photos No. 1 & 2, see Plan on Drawing No. 1, Appendix B). Excavation was accomplished by use of a John Deere track excavator. The intermediate cover was stockpiled adjacent to the excavation area. Approximately 460 cubic yards (CY) of soil and waste was excavated and approximately 210 CY was transported for disposal at the active landfill area in Phase I. The remaining excavated waste was stockpiled adjacent to the excavation area and used as backfill when the connections to the LCRS were completed. During construction, the stockpiled waste was covered with a tarp at the end of the day and temporary swales were constructed around the working area to prevent any stormwater runoff into other areas of Phase IV (Photo No. 3).

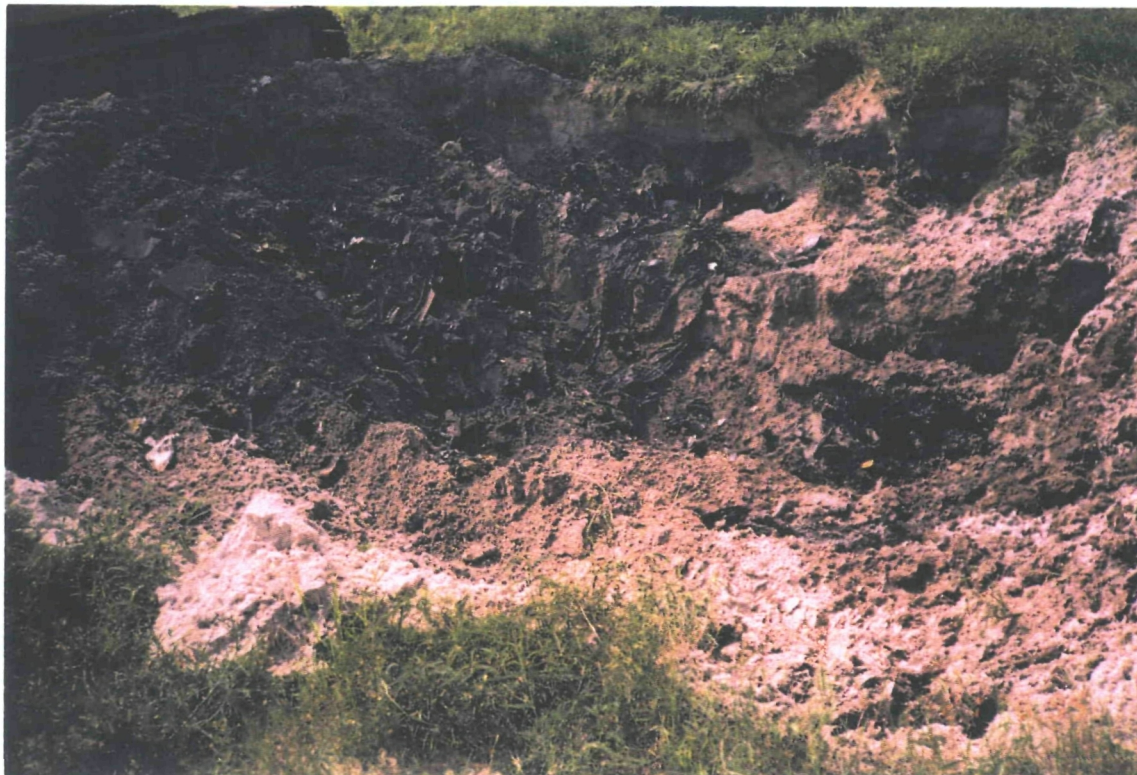
Photo No. 2

Date: 8/21/95 Location: NE corner of Phase IV, Southeast County Landfill.
Description: Looking southeast at beginning of excavation.

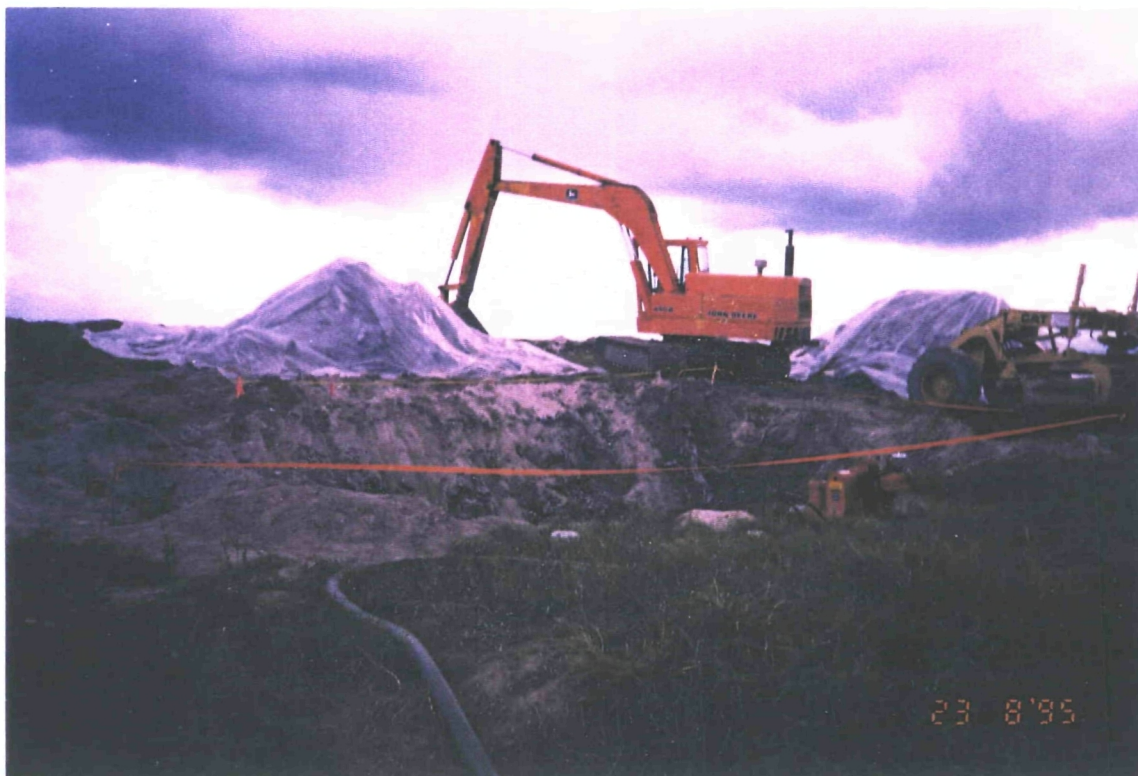
Photo No. 3

Date: 8/23/95 Location: NE corner of Phase IV, Southeast County Landfill
Description: Looking south at stockpiled excavated waste covered with tarp.

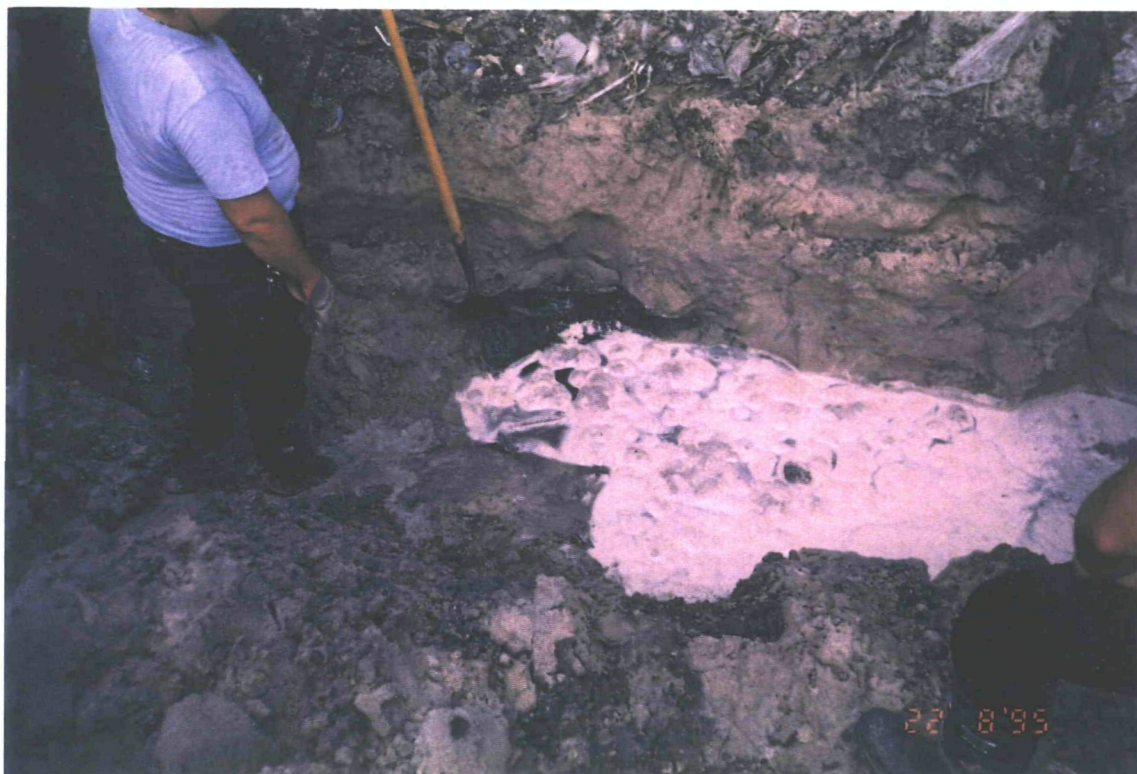
Photo No. 4

The leachate depth varied during construction. Leachate was not encountered until the excavation reached the gravel trench (Photo No. 4). At times, the leachate depth was just below the top of the granite rock trench (Photos No. 4, 5 & 6). With the dewatering pump in operation, leachate flow within the PVC headers appeared to be approximately 2 inches (Photos No. 8 & 9). At the end of connecting the wye riser (on August 26, 1995), the dewatering pump was turned off and the leachate depth stabilized at approximately 2 inches above the leachate header pipe (Photos No. 15 & 16). The top elevation of the PVC header was surveyed at 119.13 feet NGVD; therefore, leachate depth in the excavation area appeared to range between 120.05 and 119.30 feet NGVD.

Date: 8/22/95 Location: NE corner of Phase IV, Southeast County Landfill
Description: Looking south at first location of gravel trench around E-W leachate header.
Beginning of leachate flow into excavation.

The primary objective of the initial excavations were to locate the gravel pack surrounding the LCRS PVC pipe header, making sure to stay at least 20 feet from the liner between Phases IV and VI (Photo No. 4). Once the gravel pack was located on August 22, leachate flow into the excavation area began and a sump was created approximately 5 feet to the east to dewater the excavation area. The leachate from the excavation area was pumped directly into the existing TPS-3. The excavation then proceeded in a westerly direction to locate the "tee" connection that would be modified by the new TPS-5 riser. Once the "tee" was found on August 23, the excavation proceeded downward in approximately 6-inch lifts and the header pipe was uncovered. A HCDSW employee checked the excavation for confined space entry and the presence of landfill hydrogen sulfide and combustible gases. Once the excavation area was cleared for entry, the Hillsborough County Public Utilities employee proceeded to clean the leachate header for approximately 165 feet with a pressure hose (Photos No. 5 & 6). As the excavation to expose the leachate header for approximately 15 feet proceeded, an excavation area with side slopes ranging from approximately 2H:1V to 3H:1V was created to allow for safe entry. On August 25, the excavation was stopped due to rain and a malfunction of the pump being used for dewatering. Excavation was resumed on August 26, and preparation of the header pipe began (Photo No. 7).

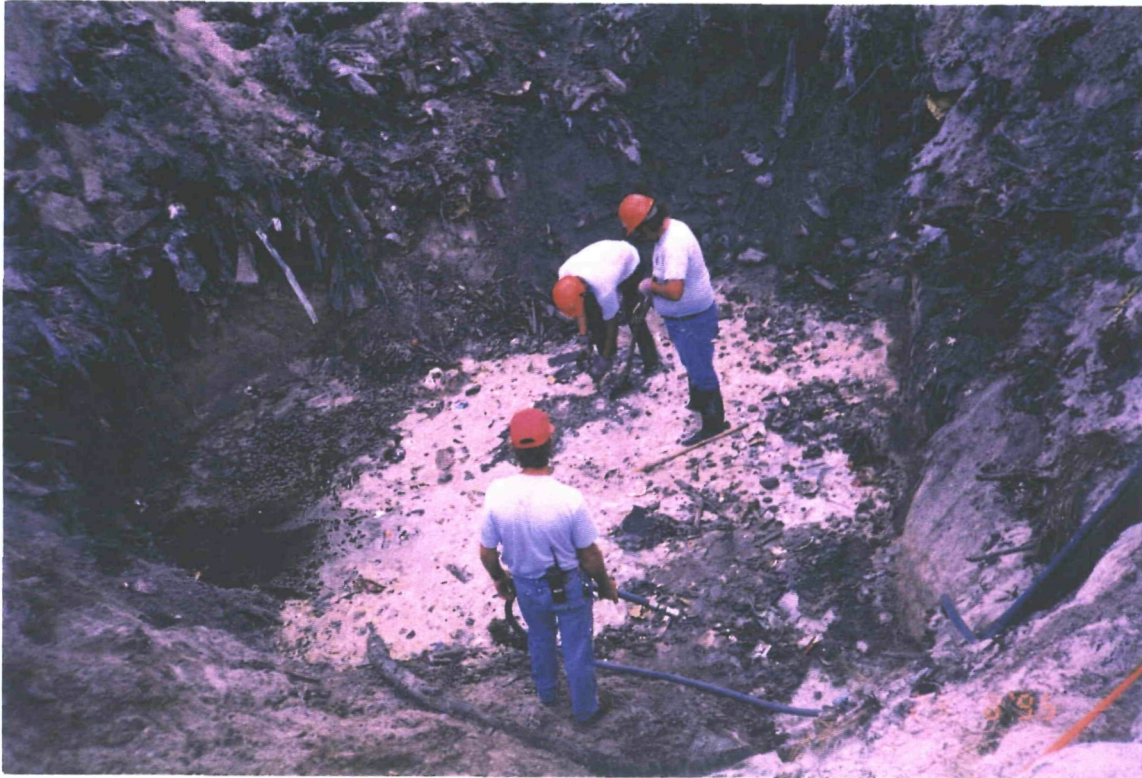
Photo No. 5

Date: 8/23/95 Location: NE corner of Phase IV, Southeast County Landfill
Description: Looking west, punching hole on N-S header to insert cleaning pressure hose.

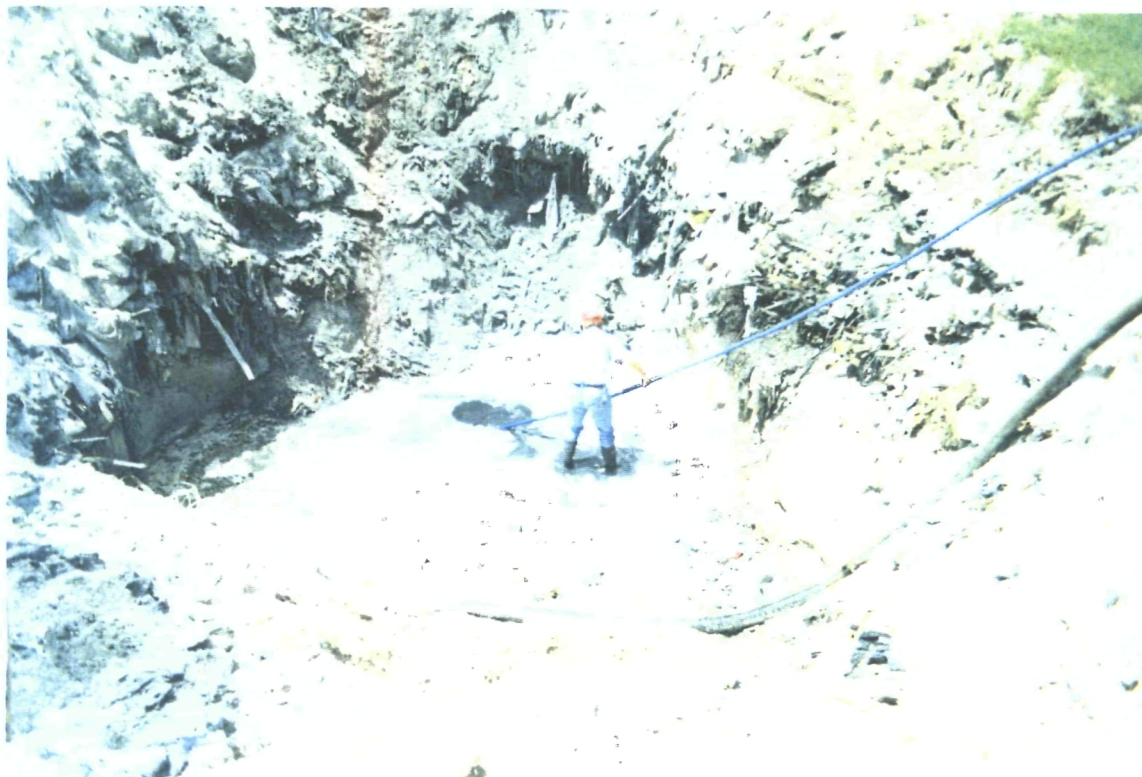
Photo No. 6

Date: 8/23/95 Location: NE corner of Phase IV, Southeast County Landfill
Description: Looking southwest, cleaning N-S leachate header with pressure hose.

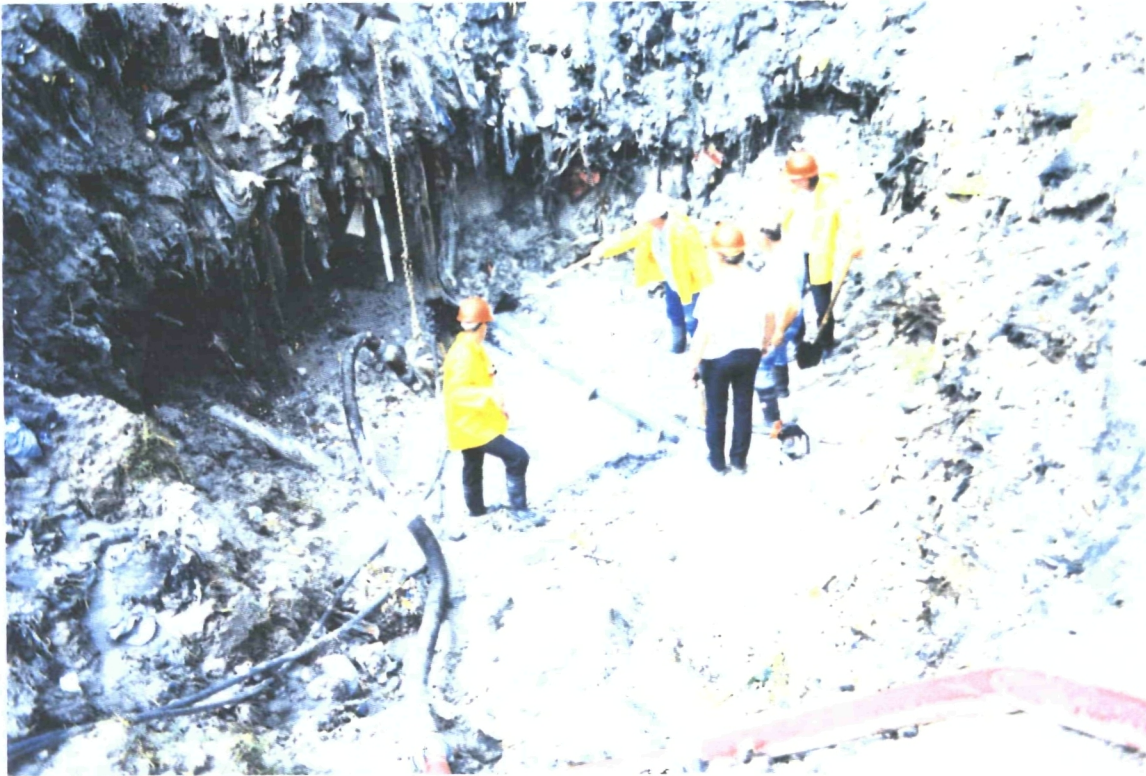
Photo No. 7

Date: 8/26/95 Location: NE corner of Phase IV, Southeast County Landfill.
Description: Looking southwest at N-S leachate header exposed approximately 15 feet.

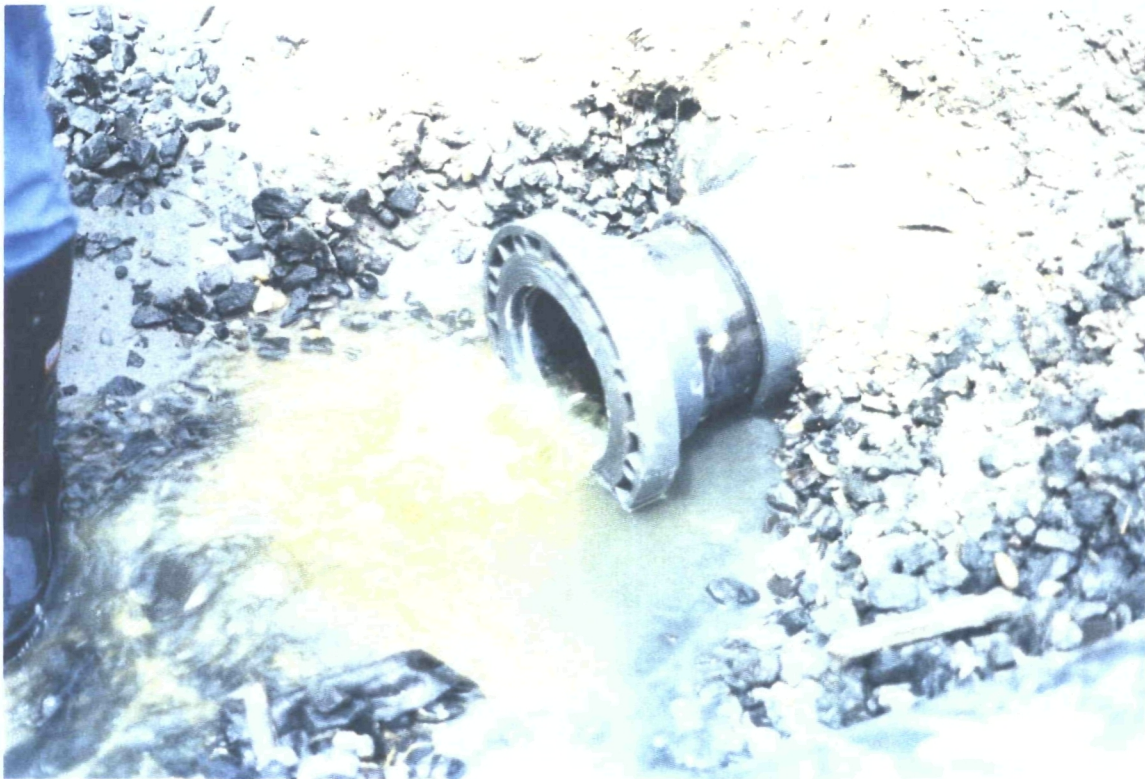
Photo No. 8

Date: 8/26/95 Location: NE corner of Phase IV, Southeast County Landfill.
Description: Looking NW at "tee" connection of leachate headers E-W and N-S. View of glue-on PVC flange.

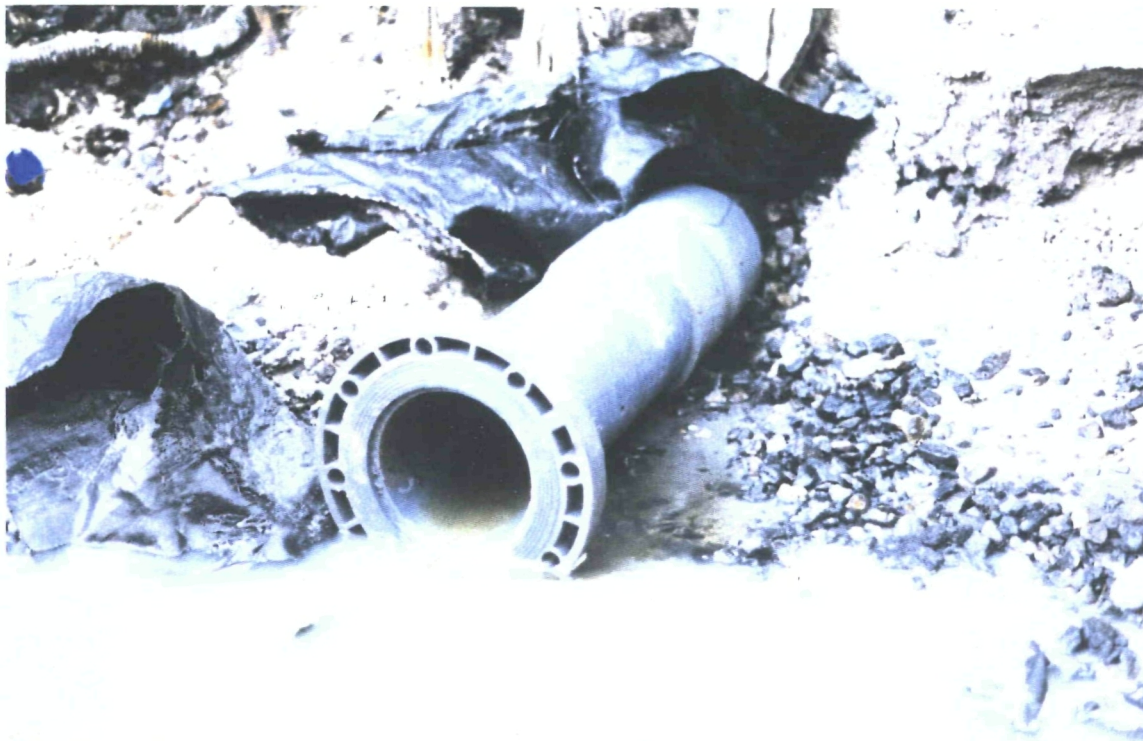
Photo No. 9

Date: 8/26/95 Location: NE corner of Phase IV, Southeast County Landfill
Description: Looking southeast at glue-on PVC flange and coupling on N-S leachate
header.

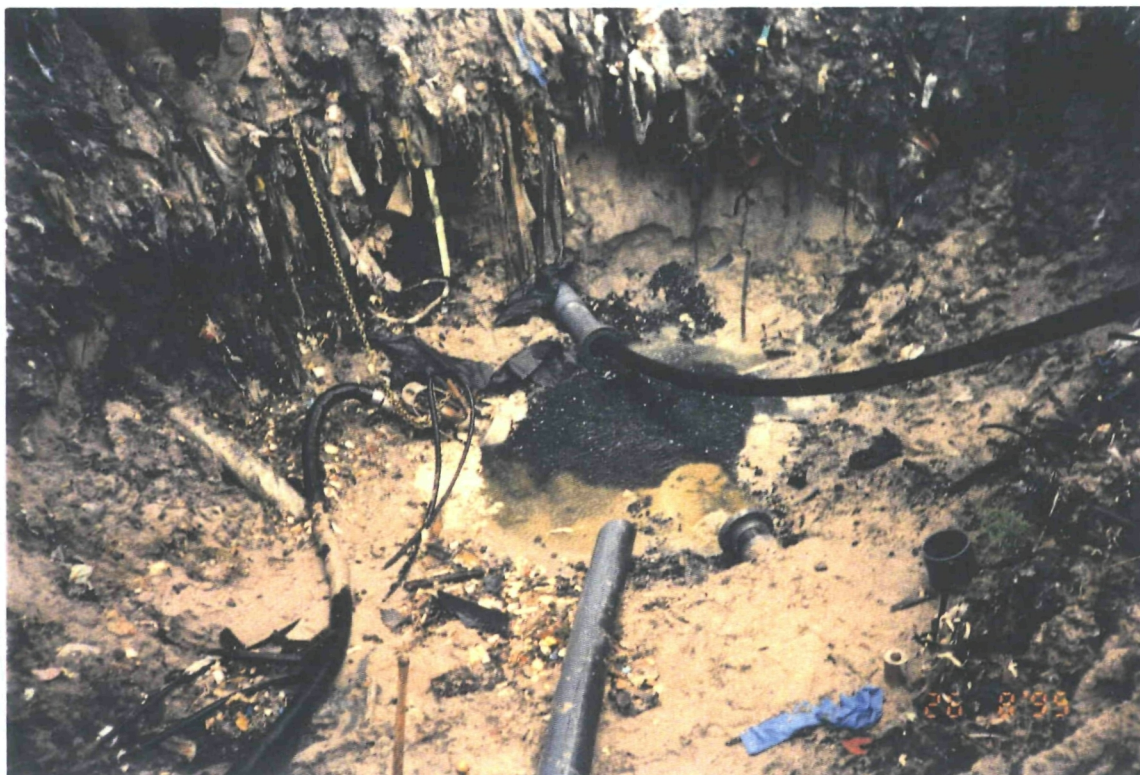
Photo No. 10

Date: 8/26/95 Location: NE corner of Phase IV, Southeast County Landfill
Description: Looking southwest at 4-inch diameter HDPE suction line into N-S 8-inch
diameter PVC leachate header.

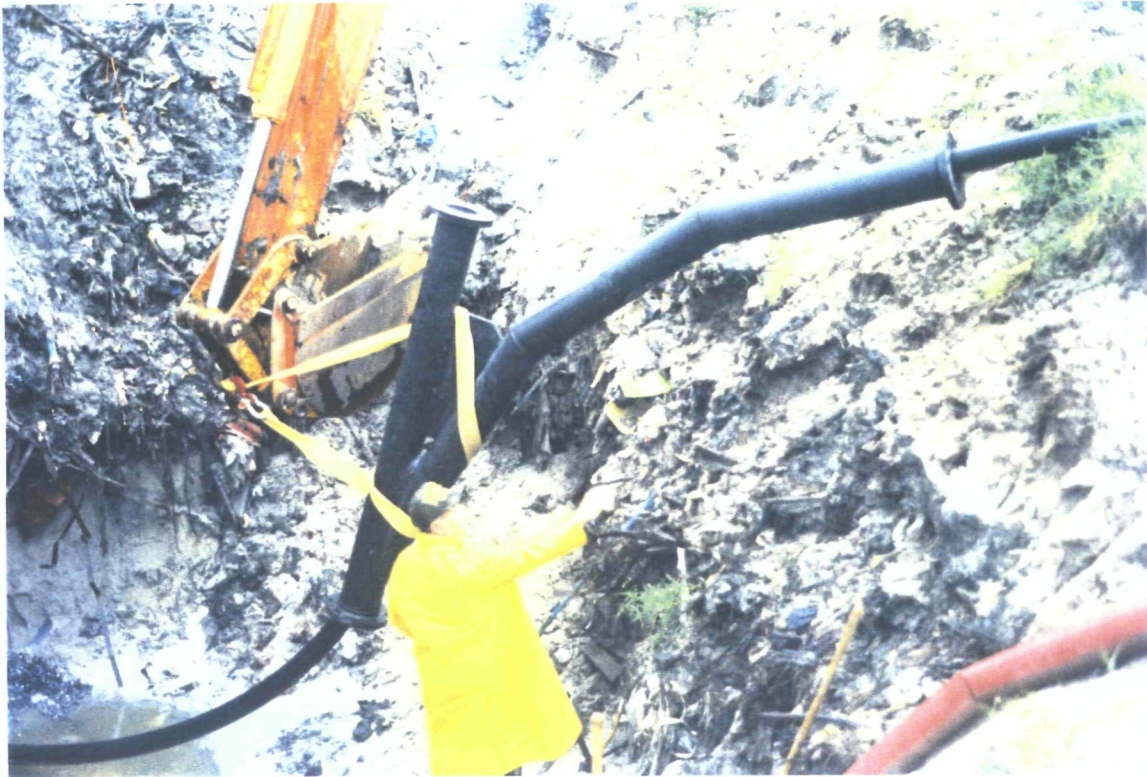
Photo No. 11

Date: 8/26/95 Location: NE corner of Phase IV, Southeast County Landfill.
Description: Looking west at 8-inch diameter HDPE "wye riser" being lowered into
alignment with N-S leachate header.

On August 26, 1995, the existing LCRS was fully exposed, the header pipe was cut with a chain saw. PVC all purpose cement was used to connect the 8-inch diameter coupling and the PVC flanges to the existing PVC header pipe. The coupling was necessary to provide a section of pipe to make the opening 7'-3" face to face between flanges so that the fabricated wye riser would fit tight and lock in place the new joints (Photos No. 8 & 9). After the flanges were in place, HCDSW personnel pushed in the 4-inch diameter HDPE pipe into the 8-inch PVC header approximately 145 linear feet (Photo No. 10). The track excavator was used to hoist the wye into the air for proper alignment. The flanges were connected with stainless steel bolts (Photos No. 11 & 12).

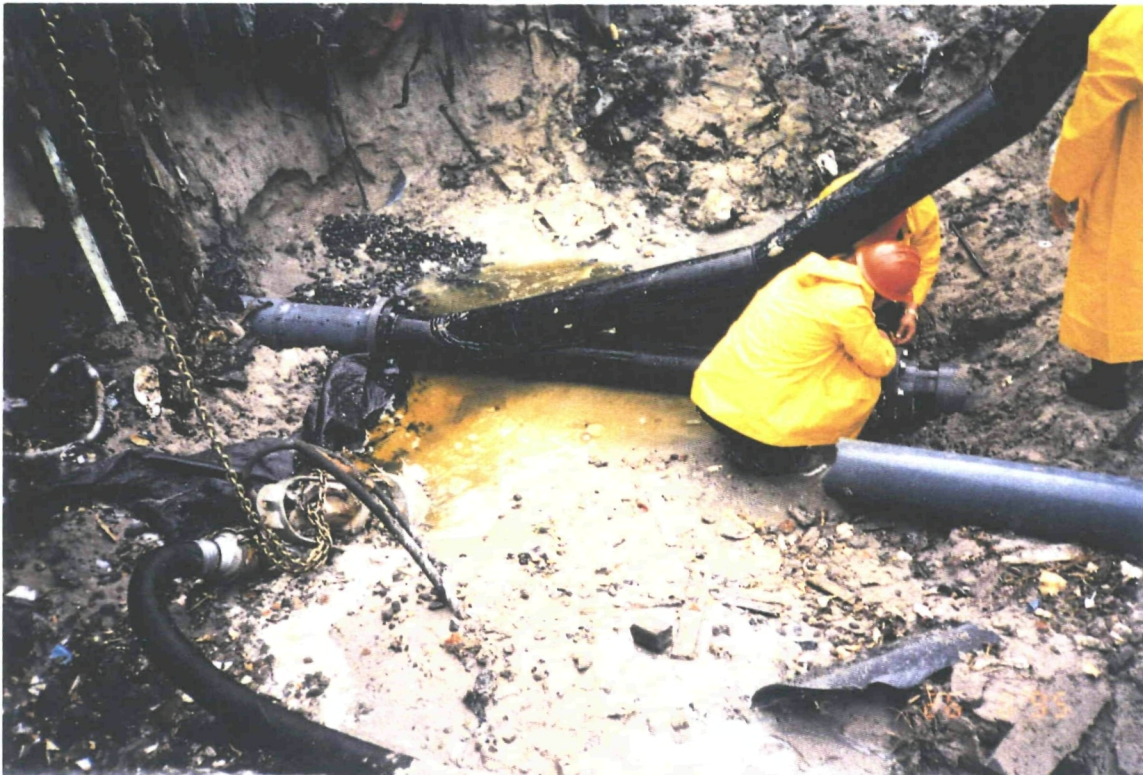
Photo No. 12

Date: 8/26/95 Location: NE corner of Phase IV, Southeast County Landfill.
Description: Looking west at wye riser being bolted to N-S leachate header.

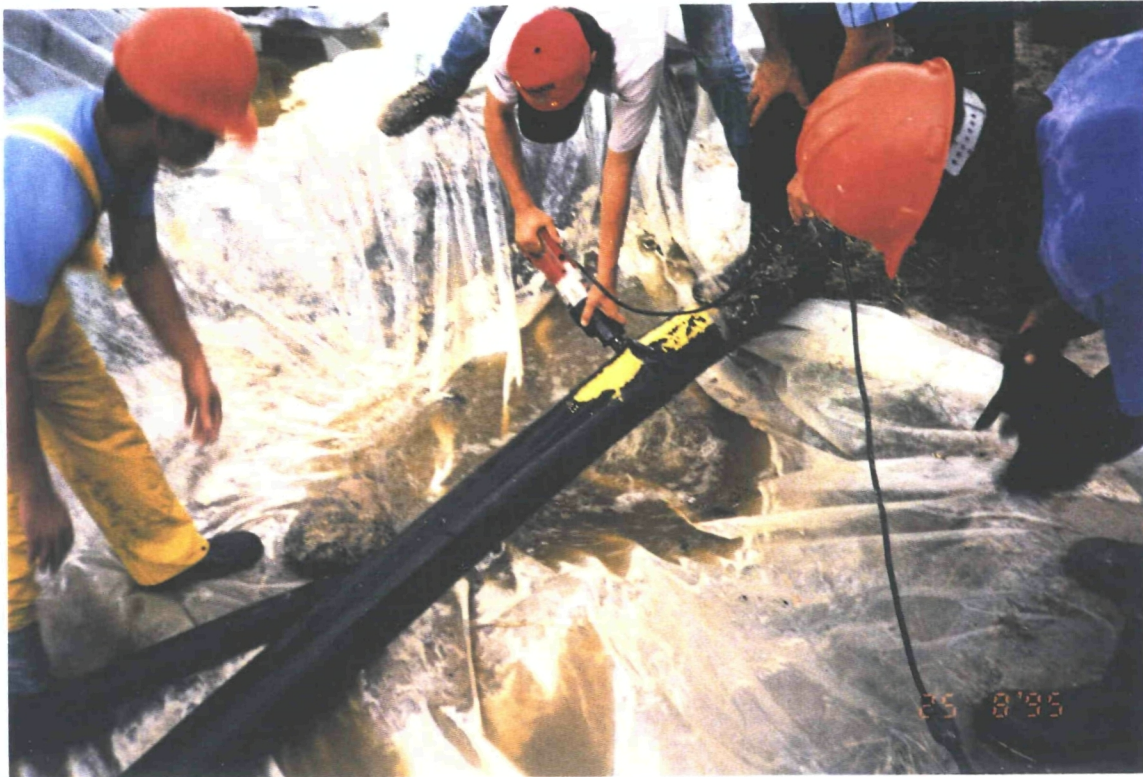
Photo No. 13

Date: 8/25/95 Location: SE corner of Phase VI, Southeast County Landfill.
Description: Looking southeast at existing 6-inch diameter HDPE leachate header being cut and leachate containment. Installation for flow meter location.

On August 24, 1995, the existing 6-inch diameter HDPE Leachate Force Main (LFM) was excavated. The excavation locations are as shown on Details 1 and 2 on Drawing No. 1, Appendix B. The excavated areas were lined with plastic and the pump in TPS-3 was shut off during construction of the fittings. Any leachate that leaked from the LFM onto the plastic, was pumped into TPS-3 (Photos No. 13 & 14).

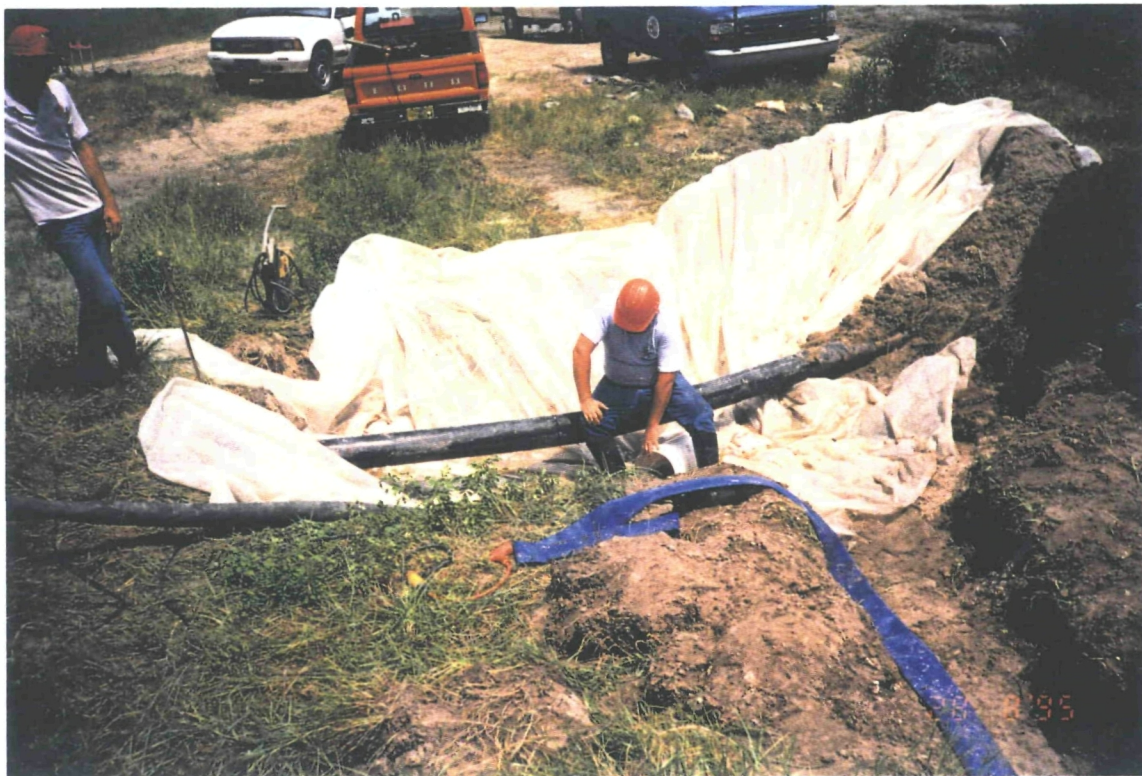
Photo No. 14

Date: 8/28/95 Location: SE corner of Phase VI, Southeast County Landfill
Description: Looking north at existing 6-inch diameter HDPE leachate header being cut and leachate containment. Installation of new 4-inch diameter HDPE discharge from new pump.

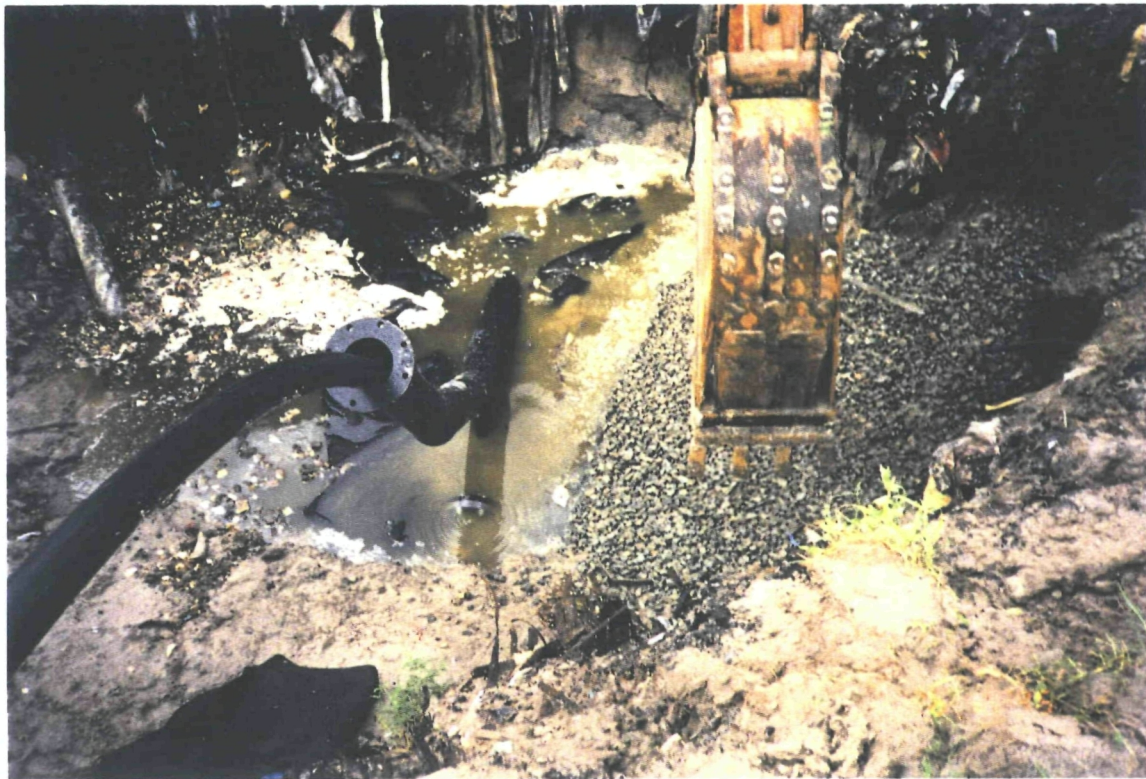
Photo No. 15

Date: 8/26/95 Location: NE corner of Phase IV, Southeast County Landfill.
Description: Looking south at excavator restoring granite rock trench around N-S leachate header. Bottom filter fabric installed.

On August 26, 1995, at 2:00 p.m., the track excavator began to backfill the portions of the gravel trench that were disturbed during construction. A filter fabric was placed below the header and on top of the gravel trench after it was completed. Approximately 10 CY of granite rock was replaced (Photos No. 15 & 16).

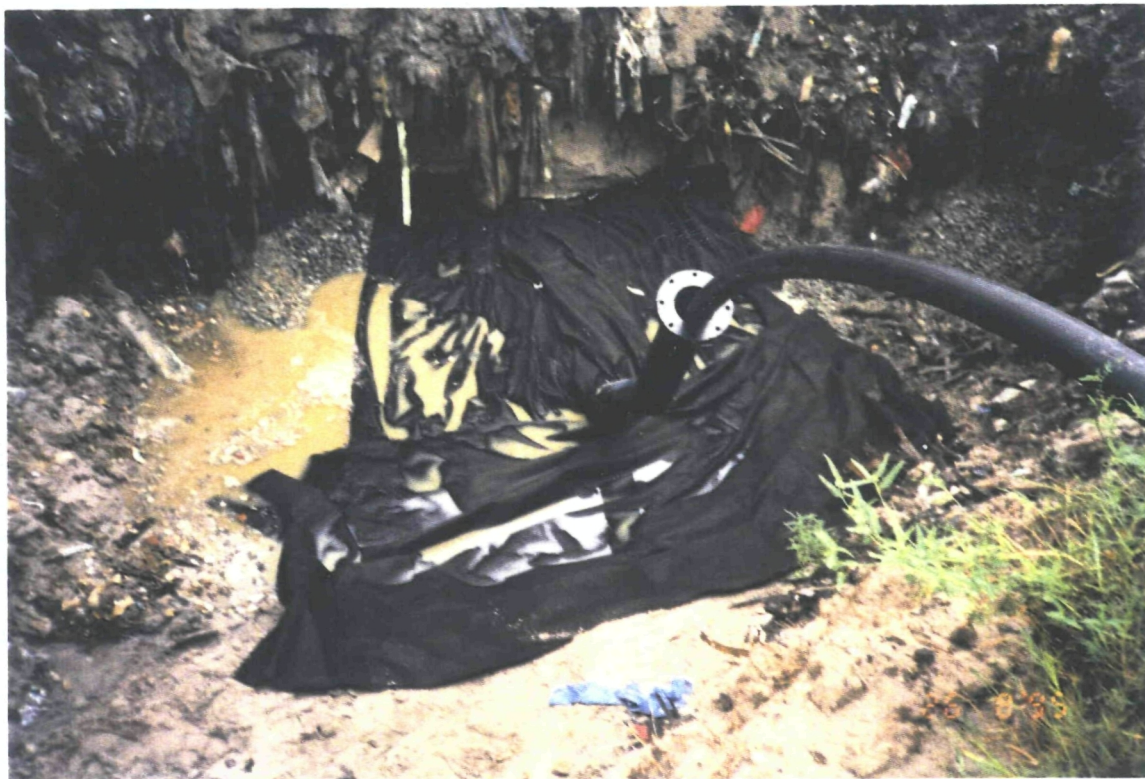
Photo No. 16

Date: 8/26/95 Location: NE corner of Phase IV, Southeast County Landfill
Description: Looking southwest at filter fabric over granite rock trench.

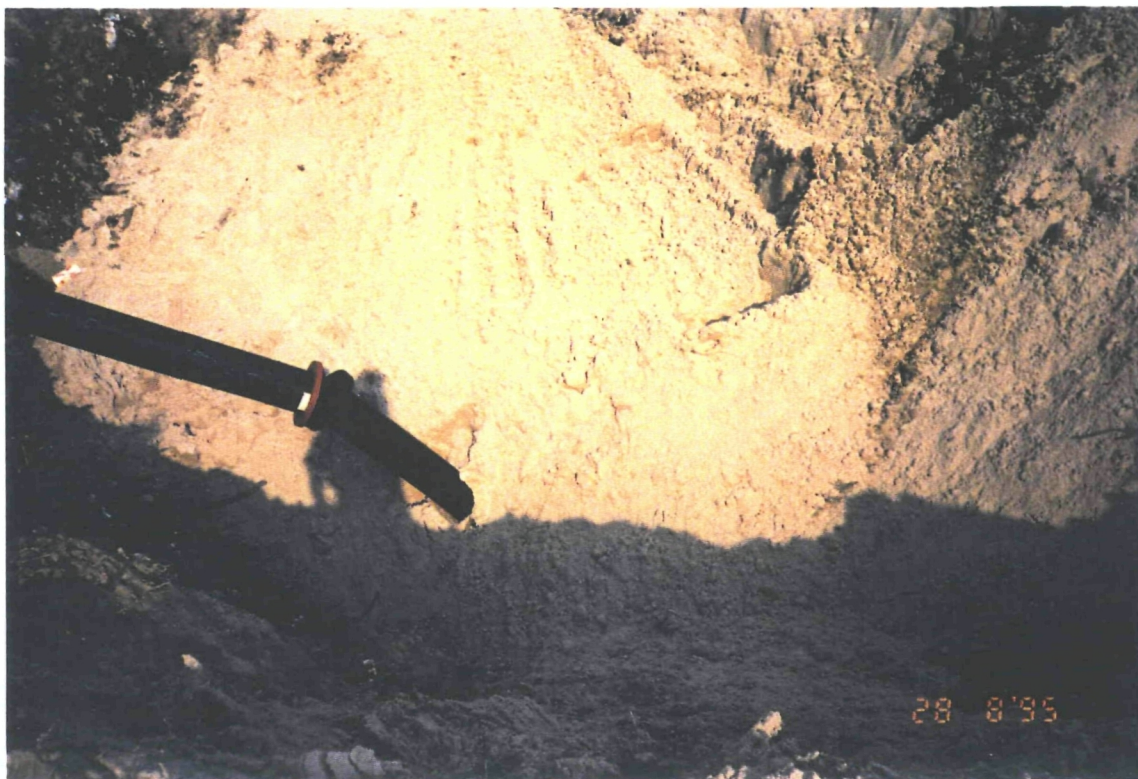
Photo No. 17

Date: 8/28/95 Location: NE corner of Phase IV, Southeast County Landfill.
Description: Looking southwest at sand layer backfill.

On August 28, backfilling continued by placing a 3 feet thick layer of clean sand over the bottom of the excavation area. The excavated refuse was then used to backfill the excavation area using a track dozer. The remainder of the excavation was backfilled with clayey sand from the borrow area (Photos No. 17 & 18). Backfilling, regrading, and seeding of the area around the excavation was completed on August 30, 1995.

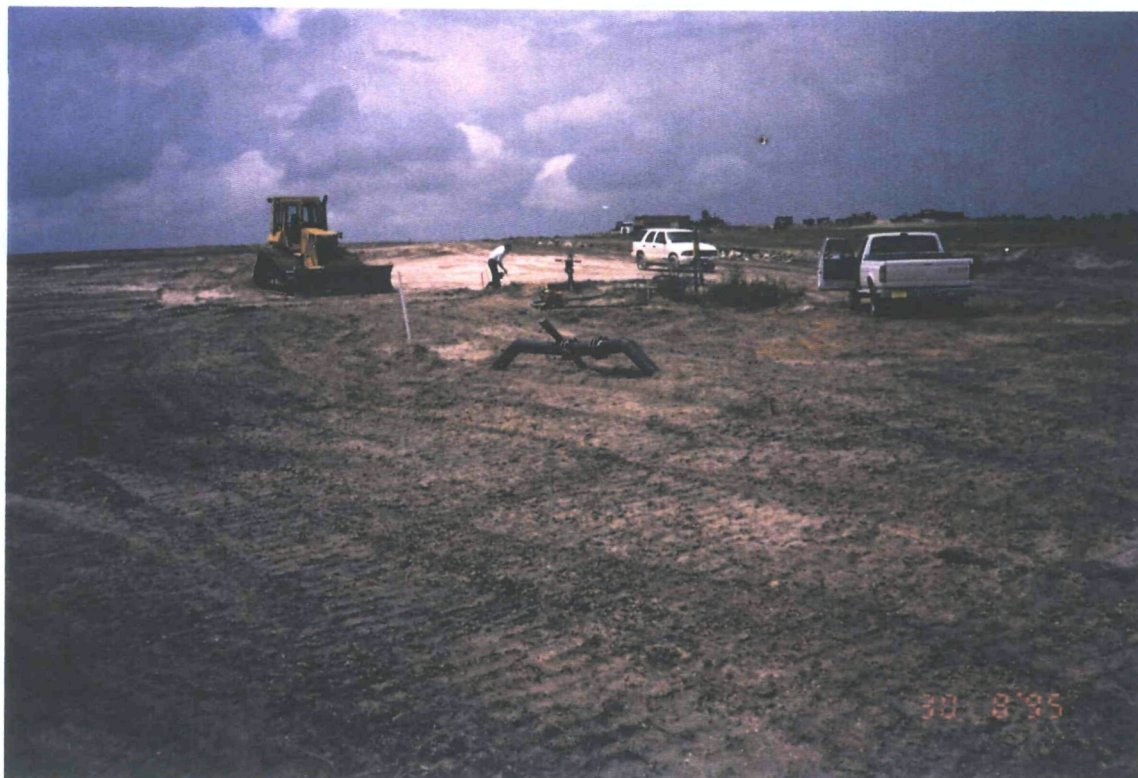
Photo No. 18

Date: 8/30/95 Location: NE corner of Phase IV, Southeast County Landfill.
Description: Looking southwest at clayey sand completion and regrading.

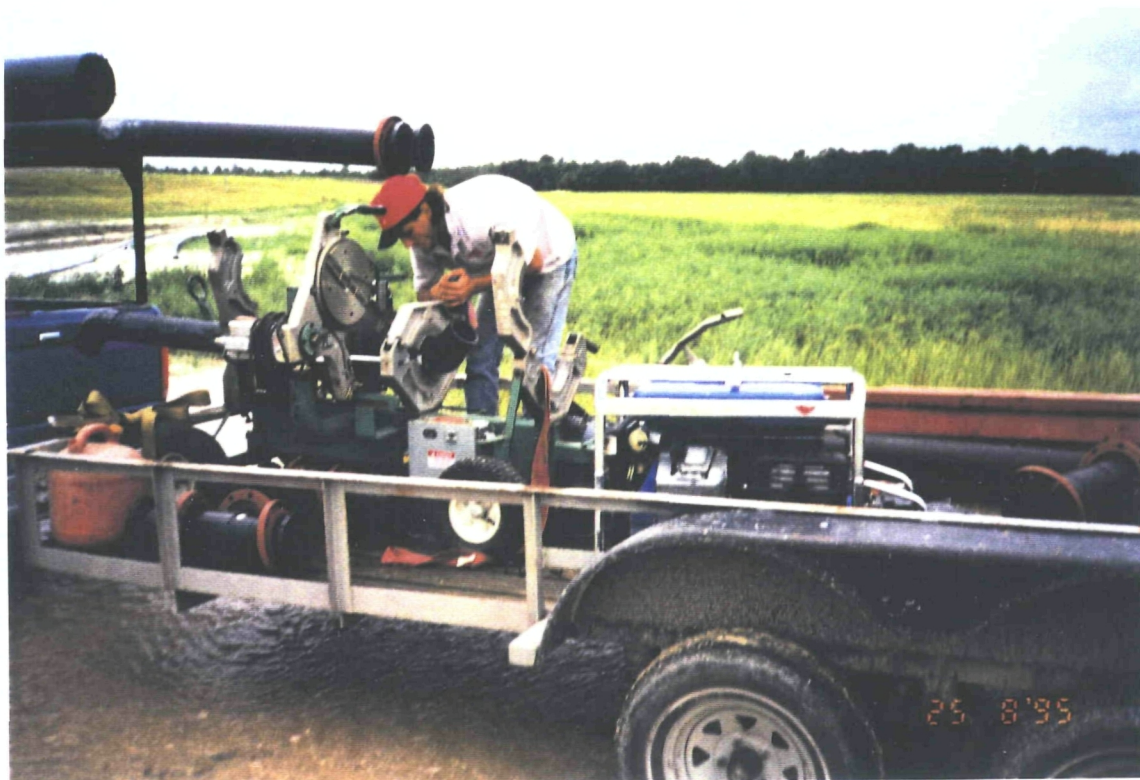
Photo No. 19

Date: 8/25/95 Location: SE corner of Phase VI, Southeast County Landfill
Description: Looking west at FIFE pipe fittings fusion.

FIFE fabricated the non-perforated 8-inch diameter HDPE pipe riser and other fittings necessary for connection to the existing force main. The fittings were fabricated with the materials specified below and in accordance with FIFE fabrication specifications (Photo No. 19 & 20):

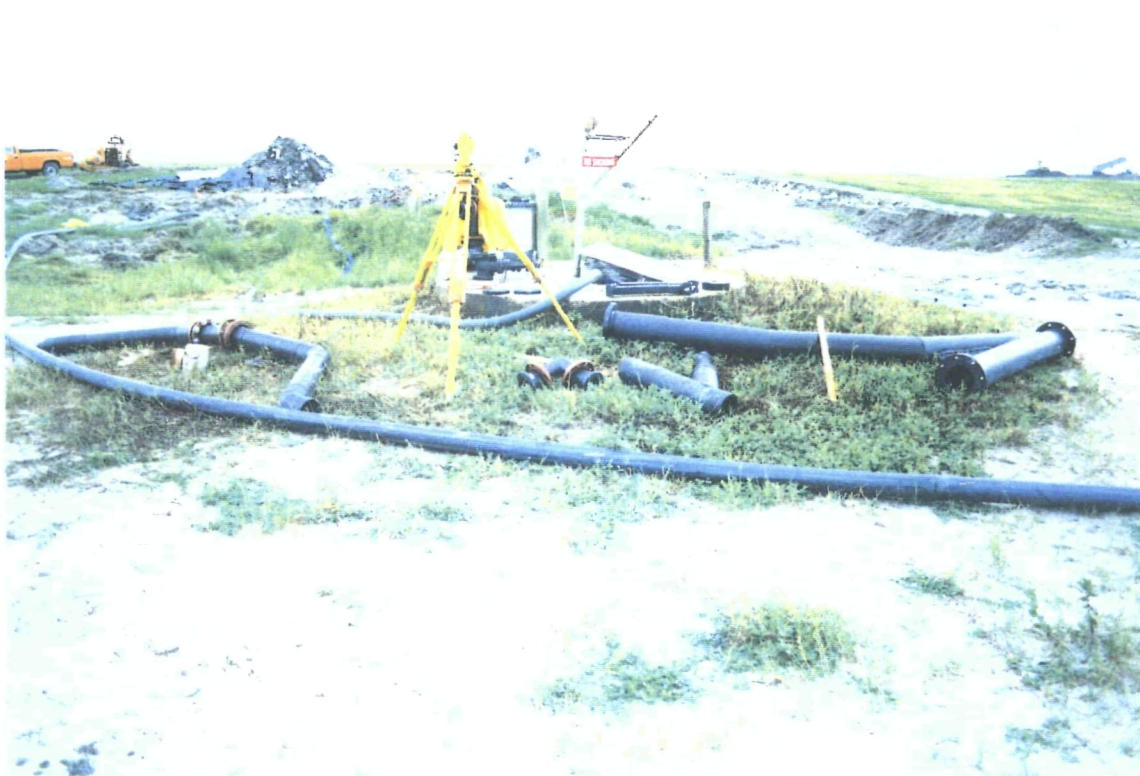
Photo No. 20

Date: 8/25/95 Location: SE corner of Phase VI, Southeast County Landfill.
Description: Looking south at several fused and fabricated HDPE fittings.

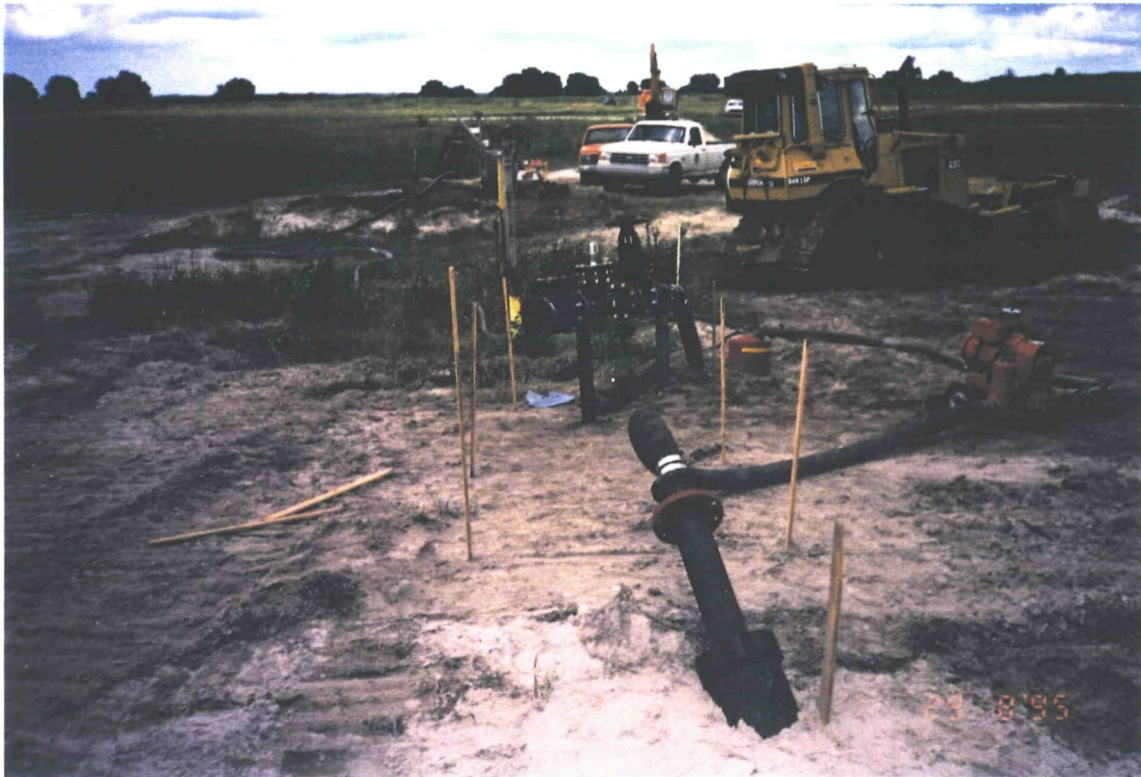
Photo No. 21

Appendix B contains information showing the location of the installed TPS-5 connections. The existing leachate collection header tee was surveyed by the HCDSW surveyor while the excavation was open. TPS-5 connections to the existing LCRS were completed by August 30, 1995 with the following exceptions (Photo No. 21):

1. Pump: a temporary pump was installed until the ordered permanent pump arrives.
2. Concrete pad for permanent pump.
3. Electric panel for permanent pump.
4. Pump control well.
5. Gauges and flow meter: ordered.

Date: 8/29/95 Location: NE corner of Phase IV, Southeast County Landfill.
Description: Looking north at completed connections at the new pump location. Stakes
for concrete pad and temporary pump.
