**BEST MANAGEMENT PRACTICES PLAN
- REVISION I
FLORIDA CRUSHED STONE COMPANY
FLY ASH RECYCLING
BROOKSVILLE, FLORIDA**

**FLORIDA CRUSHED STONE COMPANY
Brooksville, Florida**

**021074-0100
JANUARY 2003**

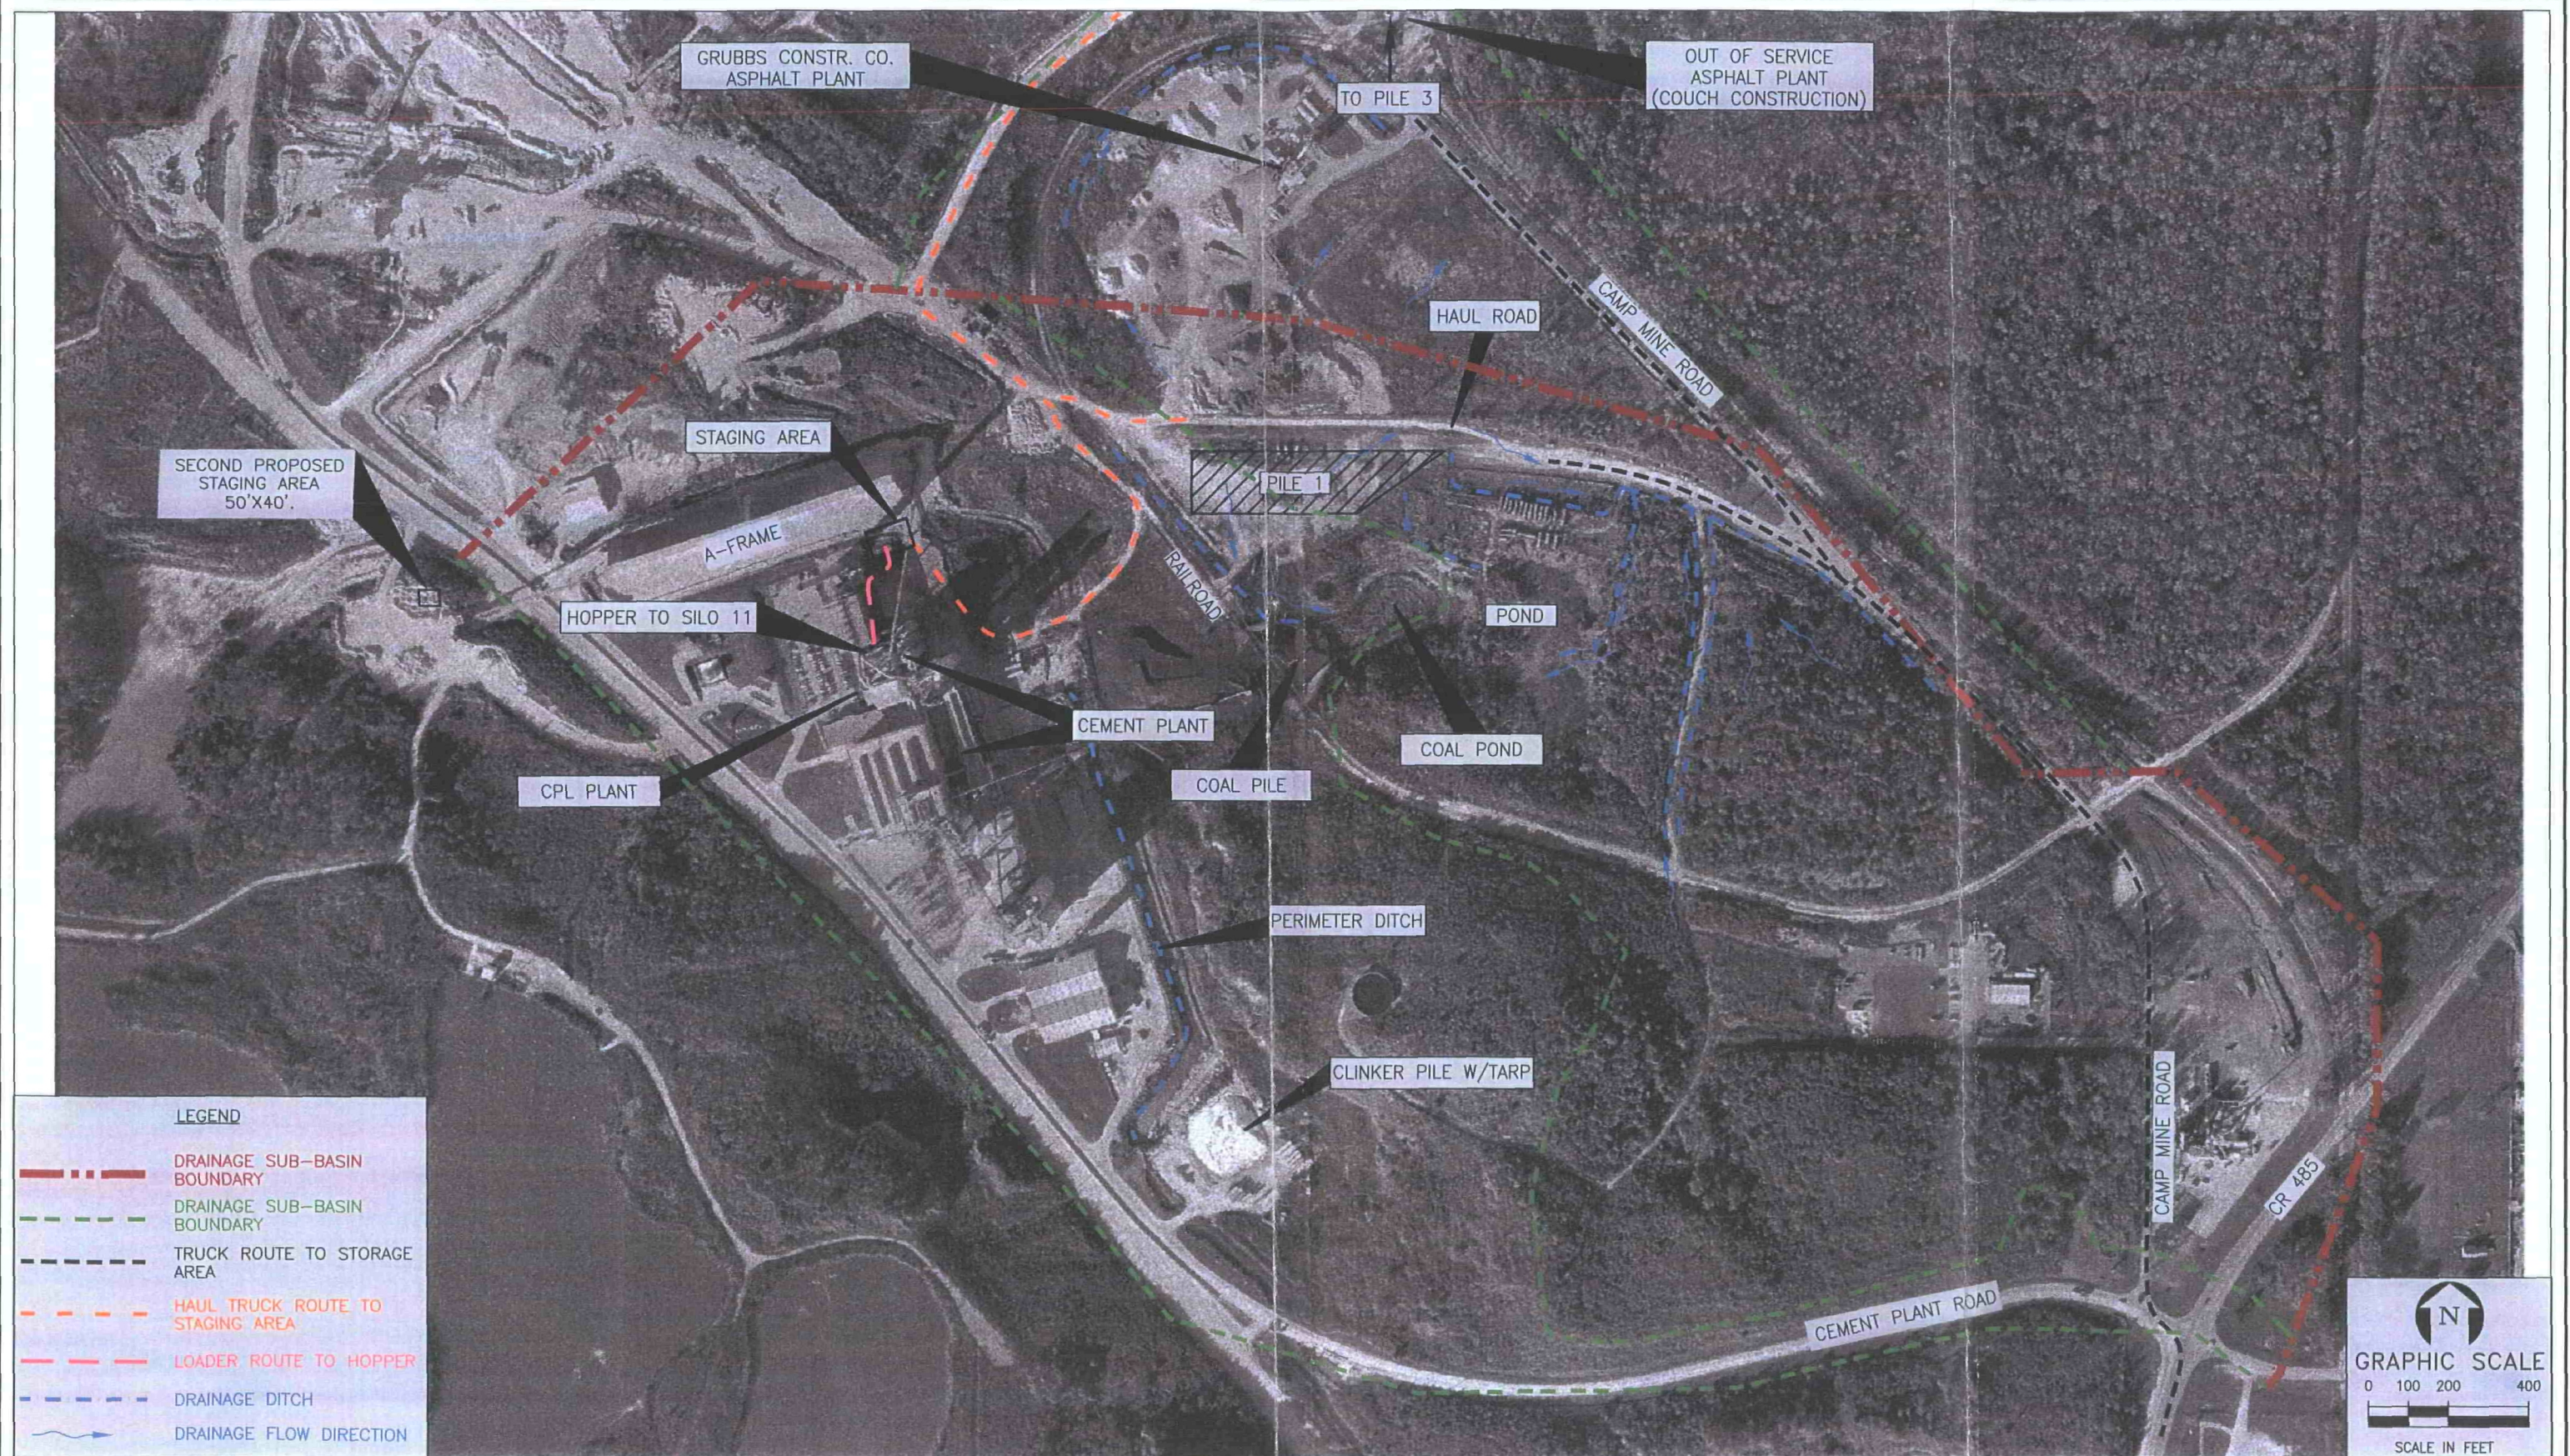
FIGURE 2.
FACILITY OVERVIEW - INCLUDING ENTRANCE
FLORIDA CRUSHED STONE
BROOKSVILLE, FLORIDA

Figure 2 presents an aerial photograph map providing an overview of the FCS facility excluding Pile 3, which is located in a more remote area to the north. **Figure 3** depicts the location of Pile 3. Access to onsite facilities is provided by Cement Plant Road, the eastern end of which intersects CR 485 near Yontz Road and extends in a northwest direction through the center of the property, and Camp Mine Road, which parallels Cement Plant Road to the northeast.

In order to expedite use of the remaining material on site, FCS proposes construction of a second staging area at the location shown in **Figure 2**. This second staging area will be adjacent to the conveyor belt that feeds materials into the A-frame storage area. Once inside the A-frame storage area, the fly ash material will be mixed with other rock materials stored in the A-frame storage area and incorporated into the cement process. The proposed second staging area is proposed to be constructed with a concrete pad floor and retaining walls on three sides similar to the construction of the existing staging area. The size of the proposed staging area is approximately one-half of the size of the existing staging area.
