Florida Department of  
Environmental Protection  
Inspection Checklist

Facility Name: TOMOKA FARMS ROAD LANDFILL  
On-Site Inspection Start Date: 02/21/2014  
On-Site Inspection End Date: 02/21/2014  
WACS No.: 27540  
Facility Street Address: 1990 TOMOKA FARMS ROAD  
City: PORT ORANGE  
County Name: VOLUSIA  
Zip: 32128

Construction Completion Certification Inspection for Landfill - Class I facility

Landfill Gas Collection System Construction - Phase I

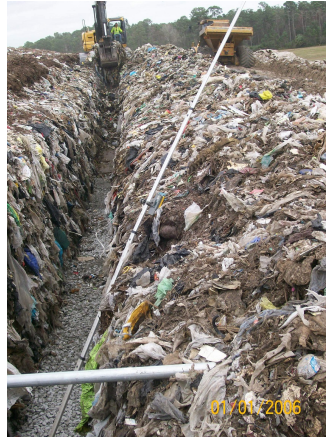
Horizontal 10A - pic 1

LGCS phasing drawings were reviewed and discussed. The western lateral work on the Phase I drawing will be pushed to Phase II. Phase I LGCS eastern horizontal collector installation was underway at the time of this inspection. Horizontal 10A (north section) was being installed approximately 12' into existing waste at the time of this inspection. Minor adjustments in location

were made to horizontal 10 to accommodate existing conditions. Flagging was evident in the construction area; will be covered upon completion. Blown litter was evident on the north side due to high winds at the time of inspection; litter fences were in place and functioning well.
