Subj: Sumter County Closed Class I Landfill  
Stabilization Assessment Report  
Long-Term Care Permit No. 22926-003-SF/14  
WACS Facility I.D. #53008  
Sumter County, Florida  
TCG Project No. P-505

SUMTER COUNTY CLOSED CLASS I LANDFILL  
STABILIZATION ASSESSMENT REPORT

## Technical Memorandum

TO: Rick Potts, P.G.  
FROM: Bob Mackey *BEM*  
DATE: April 8, 2014  
RE: Stabilization Report  
Sumter County, Sumter County Landfill

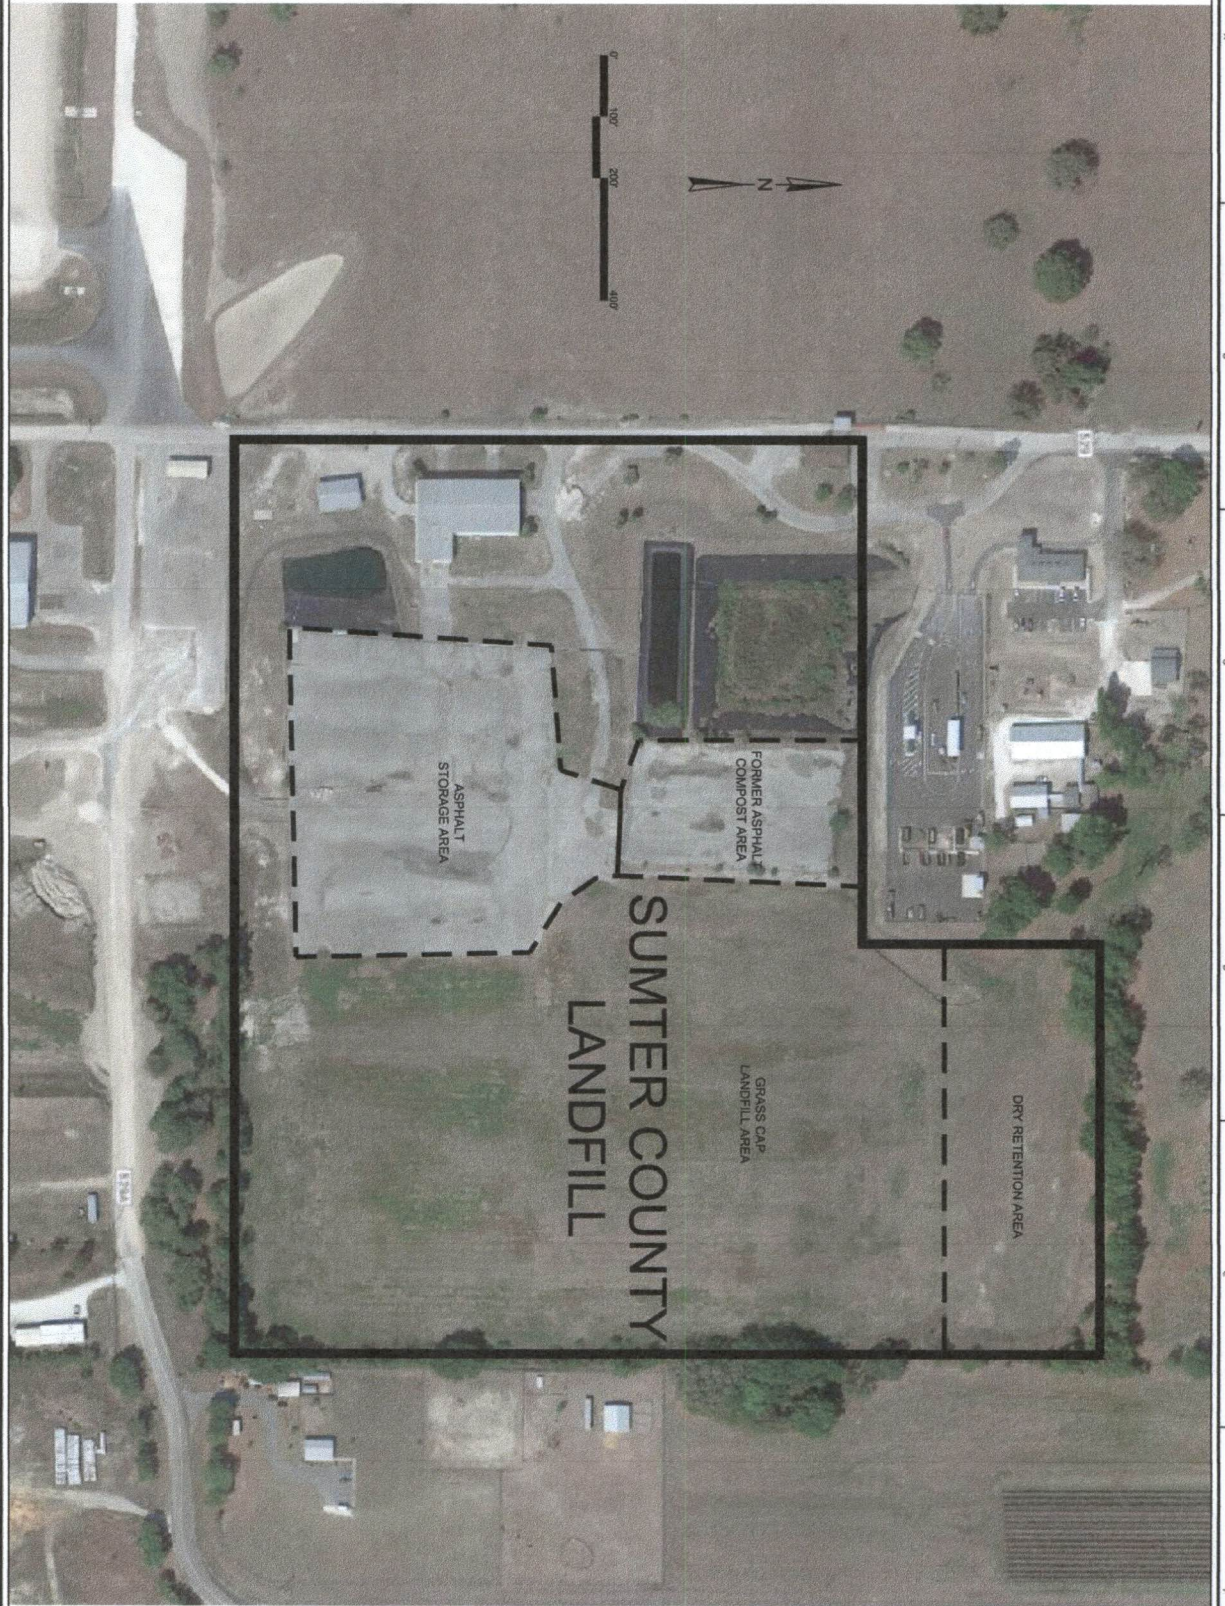
1  
 OF  
 1

S2Li's first visit occurred immediately after a storm event. Access to the top of the closed landfill can be achieved from the primary paved entrance road just north of the large onsite building, traveling west to east (Photo 1). There is also a minor access road located in the center southern edge of the paved area. The overall integrity of this asphalt area was good, considering its age of service and issues to be denoted in the following text (Photos 2, 3 and 4). This landfill area was designed to drain to a lined pond off the southwest corner of the asphalt storage area (Figure 1 and Photo 5).

The Northern Asphalt Area (Figure 1) had only minor undulations across the area, with slight ponding of water and minimal cracking (Photos 15 and 16). This area was formerly used for a composting operation. It was contoured to collect stormwater and allow it to flow to the long lined pond off its southwest corner (Photo 17). During the composting operation, water was pumped from this pond and sprayed on the compost pile. This pond and pump are no longer being operated. Once this pond fills with stormwater, it drains to an adjacent lined cell to its north through a depression in its northern berm (Photo 19). Both these lined areas show damage and deterioration of their containment ability and vegetative growth at numerous locations (Photos 17 through 21). These lined areas can be considered non-functional as containment systems. However, they are outside the landfill footprint and do not appear to be impacting the waste disposal area. The integrity of the Northern Asphalt Area appears good.

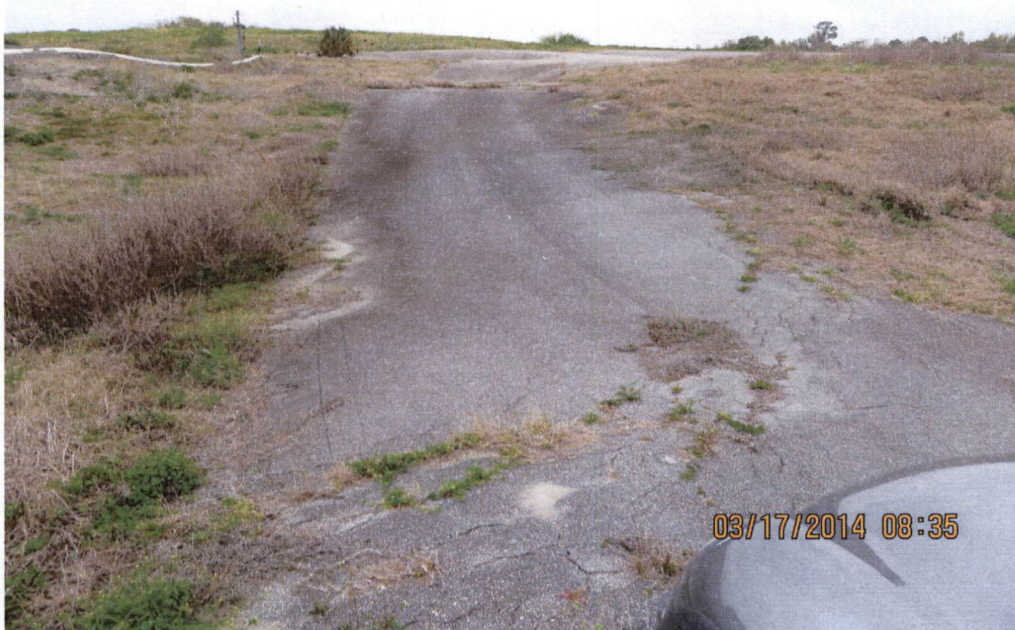
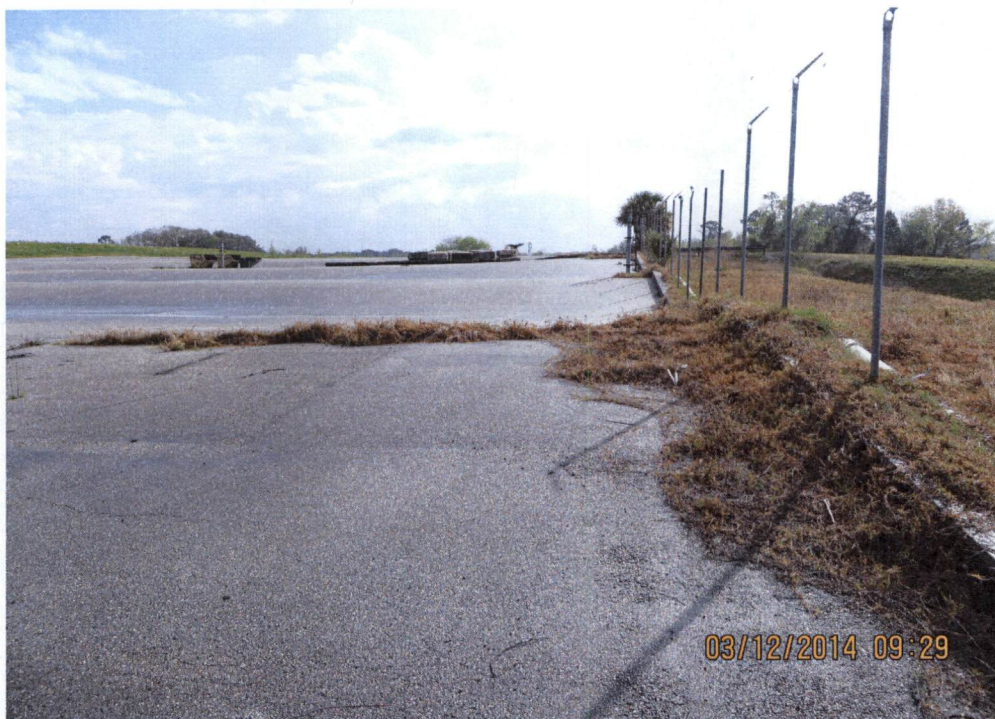
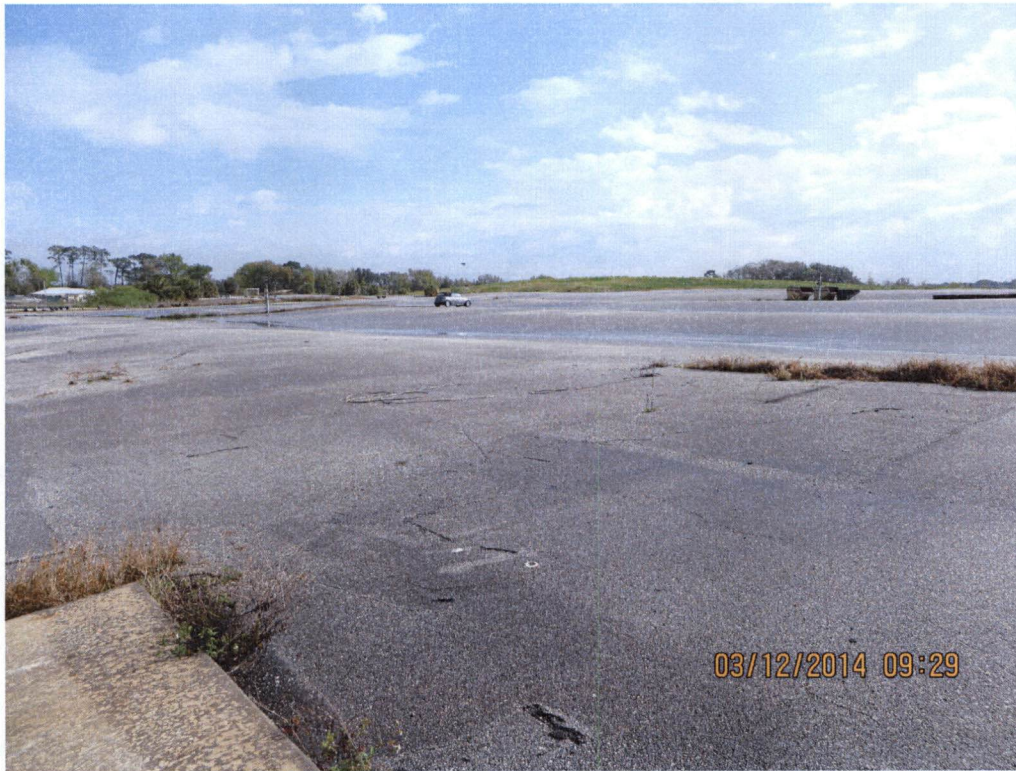
Due to the decomposition of the underlying waste over time, the existing asphalt contours include several ridges and valleys (Photos 1, 2 and 3). These ridges and valleys are aligned in a north-south direction. Cracks were observed in the asphalt cap along the ridges. No cracks were found within the valleys. These cracks were recently sealed to mitigate the possible stormwater intrusion into and through these openings in the asphalt cap (Photos 6, 7 and 8). Water was found ponding within the valleys (Photos 9, 10 and 12). Although the County has constructed asphalt channels (Photo 11) in an attempt to allow the water to flow from an upper valley to a lower valley, this effort has had minimal effect in promoting drainage off the asphalt cap. The County has also filled some of the valleys through the placement of additional asphalt (Photo 9), also with minimal effect.

S2Li believes that cracks that may form along the ridges of the asphalt will not have a significant impact on the current integrity of the asphalt cap, although the sealant may be expected to degrade over time. The purpose of the asphalt cap is to keep rainwater from percolating into the waste and promote runoff to the stormwater pond (Photo 5). It is unlikely that cracks within the asphalt extend completely through the cap cross-section. S2Li believes the cracks will only extend through the asphalt layer and not through the asphalt subbase, typically composed of limerock.

Although asphalt will promote stormwater runoff, it is not completely impermeable. Ponding in the valleys will allow more water to seep through the asphalt layer, through its subbase, and into the underlying waste. The additional water seeping into the waste in the area of the valleys increases waste decomposition. This decomposition has occurred at a greater rate than that experienced as a result of the lower seepage rates in the area of the ridges. This results in increased settlement of waste under the asphalt valleys, and a continually expanding depth of the valleys.

S2Li does have some concerns regarding the Southern Asphalt Area. Although it is currently functioning as a protective layer, the asphalt's ability to continue to function as designed is expected to slowly degrade over time. Ponding water will accelerate the deterioration of the asphalt by removing or degrading the oils within the asphaltic matrix. This will cause a gradual increase of seepage through the asphaltic barrier to the landfill. These low areas will eventually exhibit a texture resembling that of a gravel layer rather than an asphaltic binder.

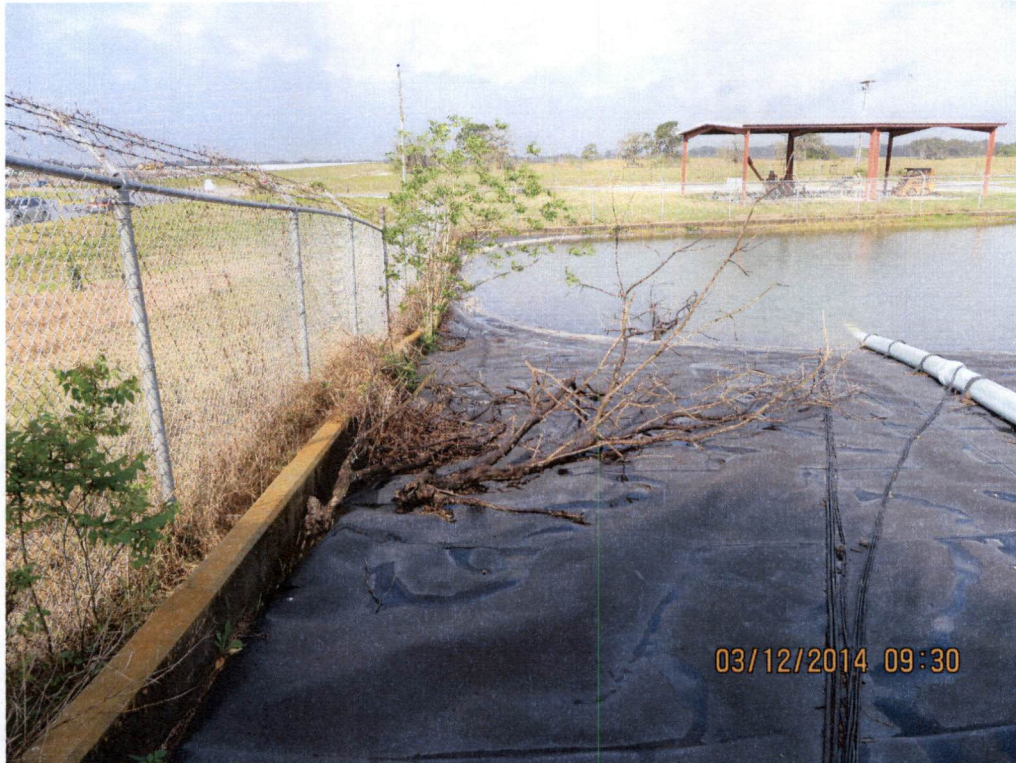
Photo 22

Please note that the southwest lined stormwater pond displayed no damage or deterioration of the liner and appeared to be functioning properly. Due to the presence of dead branches within the pond's fenced in area, there is indication that maintenance of this pond has not been recently performed (Photo 22).

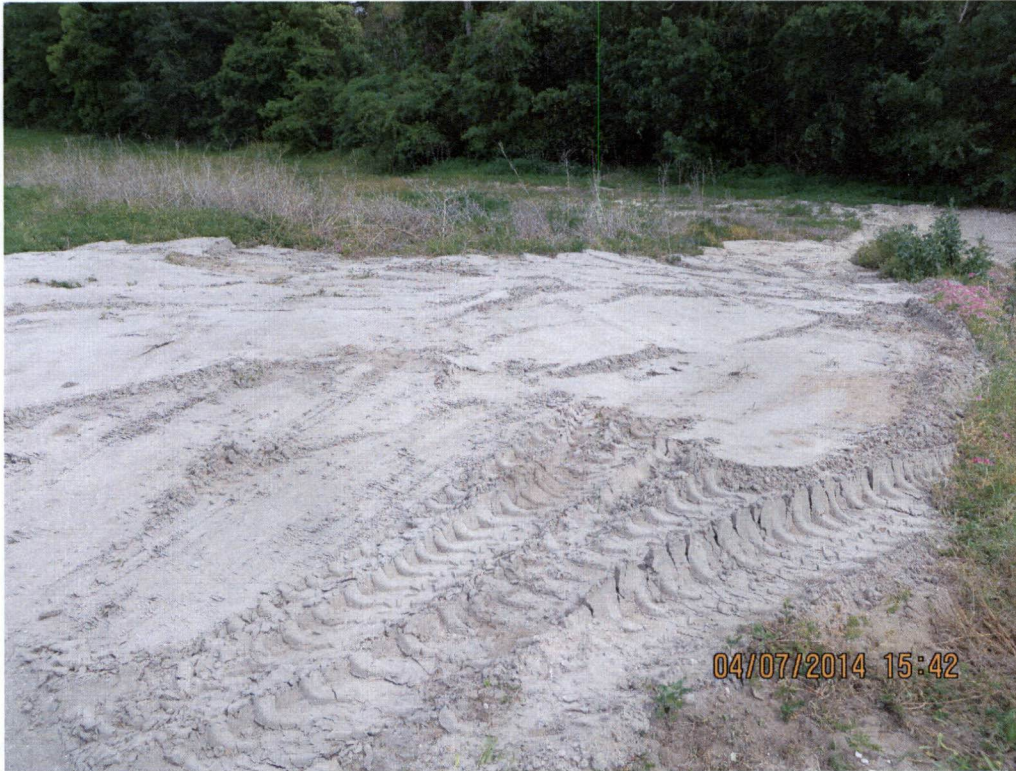
Photo 23

The largest landfill mound area is the eastern portion of the closed Class I landfill. This area was well vegetated. There was one location along the southern face that was recently repaired to address erosion (Photo 23). No evidence of buried waste was seen within the eroded area. S2Li found evidence of a single buried tire (Photo 24) at the toe of the southern landfill perimeter. All other areas of the landfill mound appeared well covered with no waste visible.

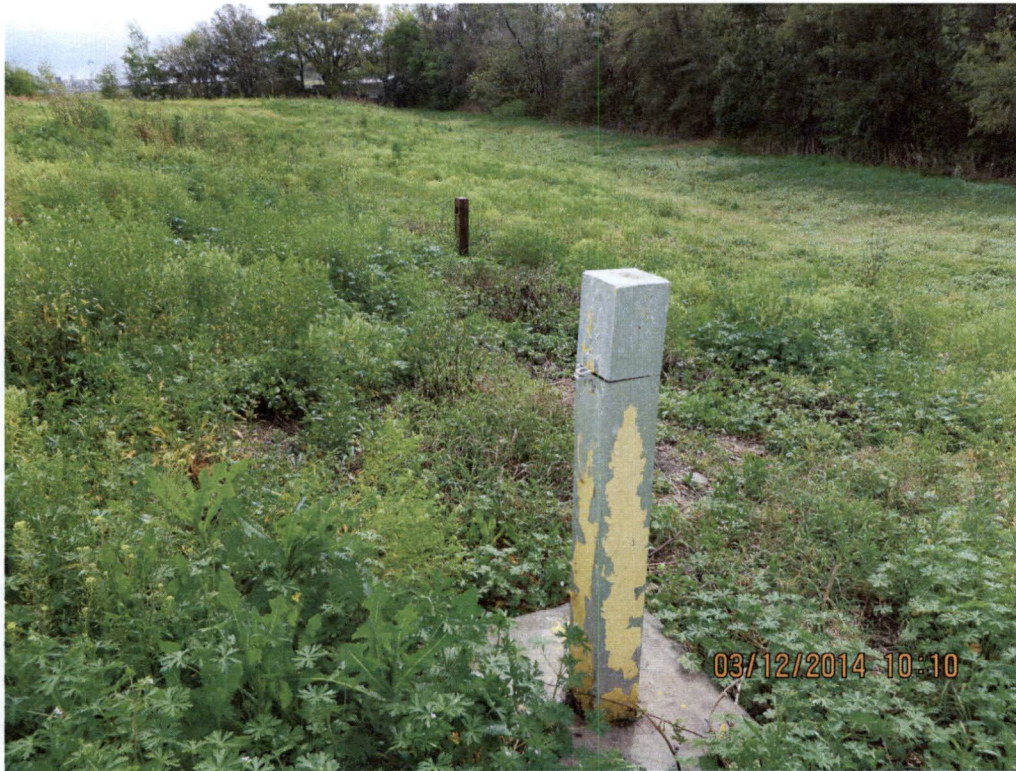
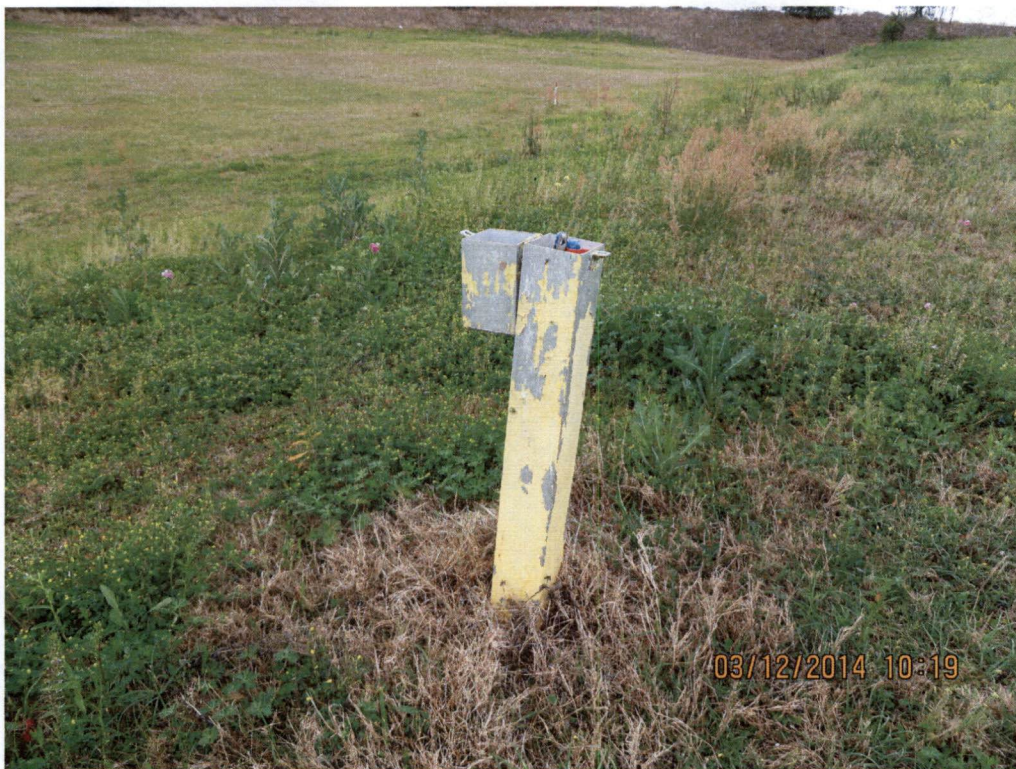
S2Li observed several monitoring wells (Photos 25 and 26) and piezometers (Photo 27) around the perimeter of the landfill mound. North of the landfill mound is a well vegetative dry retention area in good condition, with no erosion present (Photo 28). There was also no erosion found within the stormwater swales that channel water to the dry retention area (Photo 29).

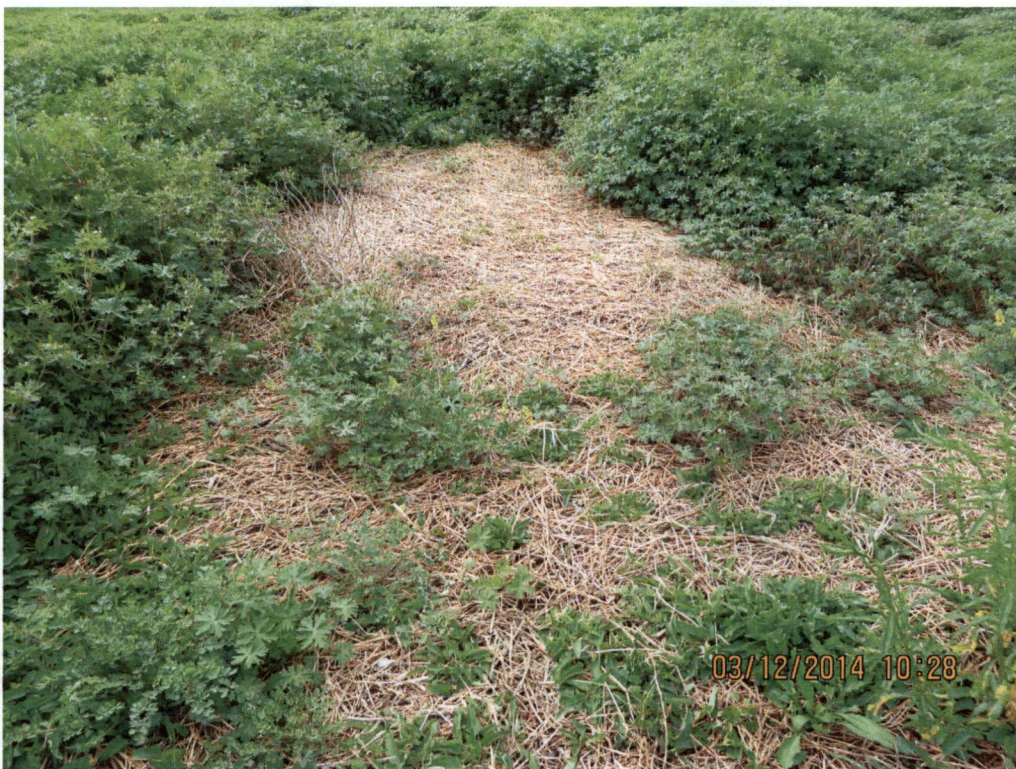
Photo 30

The landfill mound appeared to have maintained its gradual contours with no appreciable differential settlement. Any pooling found on top of the landfill mound appeared extremely small in area and probably a result of the earlier storm event. There were extremely few areas of stressed vegetation (Photo 30) and these were small in their dimensional area. S2Li observed passive LFG vents of various heights (Photos 31 and 32). With increased vegetative growth, many of these LFG vents could be visually obscured by the vegetation. This could result in damage to the LFG vents during mowing operations, if such operations are continued. Based on S2Li's field observations and a December 2013 figure attached ("Year 2013 Annual Landfill Gas Migration Monitoring), several of the LFG vents are missing, supporting the above assessment.
