TRAIL RIDGE LANDFILL
MITIGATION MONITORING REPORT NO. 3
DER PERMITS 161821182 AND SC16-184444

April 6, 1994

Trail Ridge Landfill Mitigation Monitoring

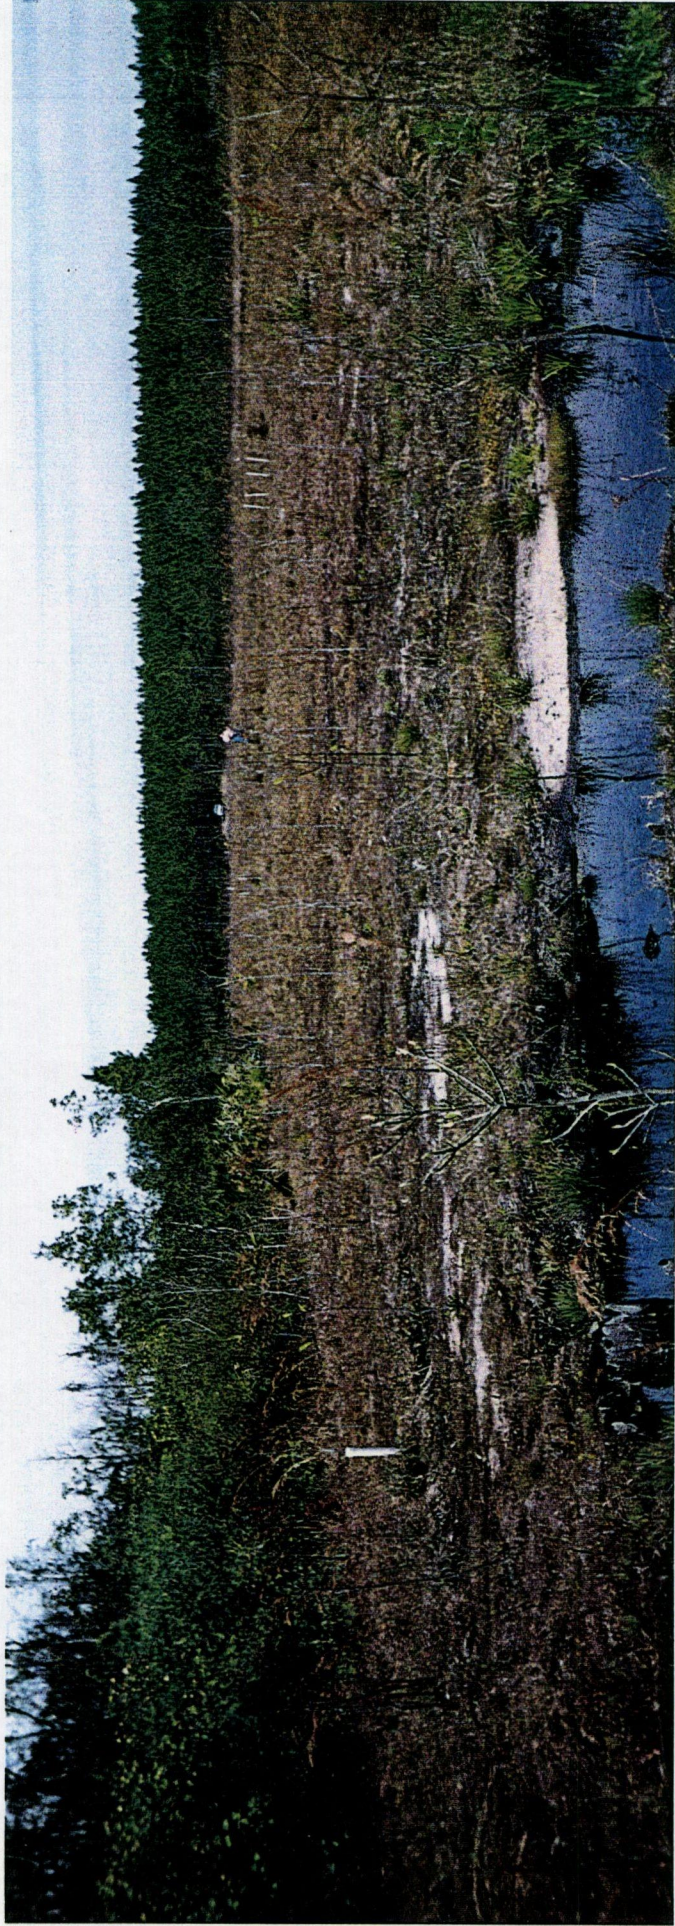
Hydrologic Conditions. Piezometer data is provided in Table 3. The submerged zones contained ponded water and saturated soil. The water table in the transitional zones ranged from 0.5 to 1.7 feet below the surface. The water levels in the mitigation area reflect the below average rainfall conditions for the preceding month and the fact that March and April are normally dry months.

Photo 9 - Transect #5 (Note standing water)

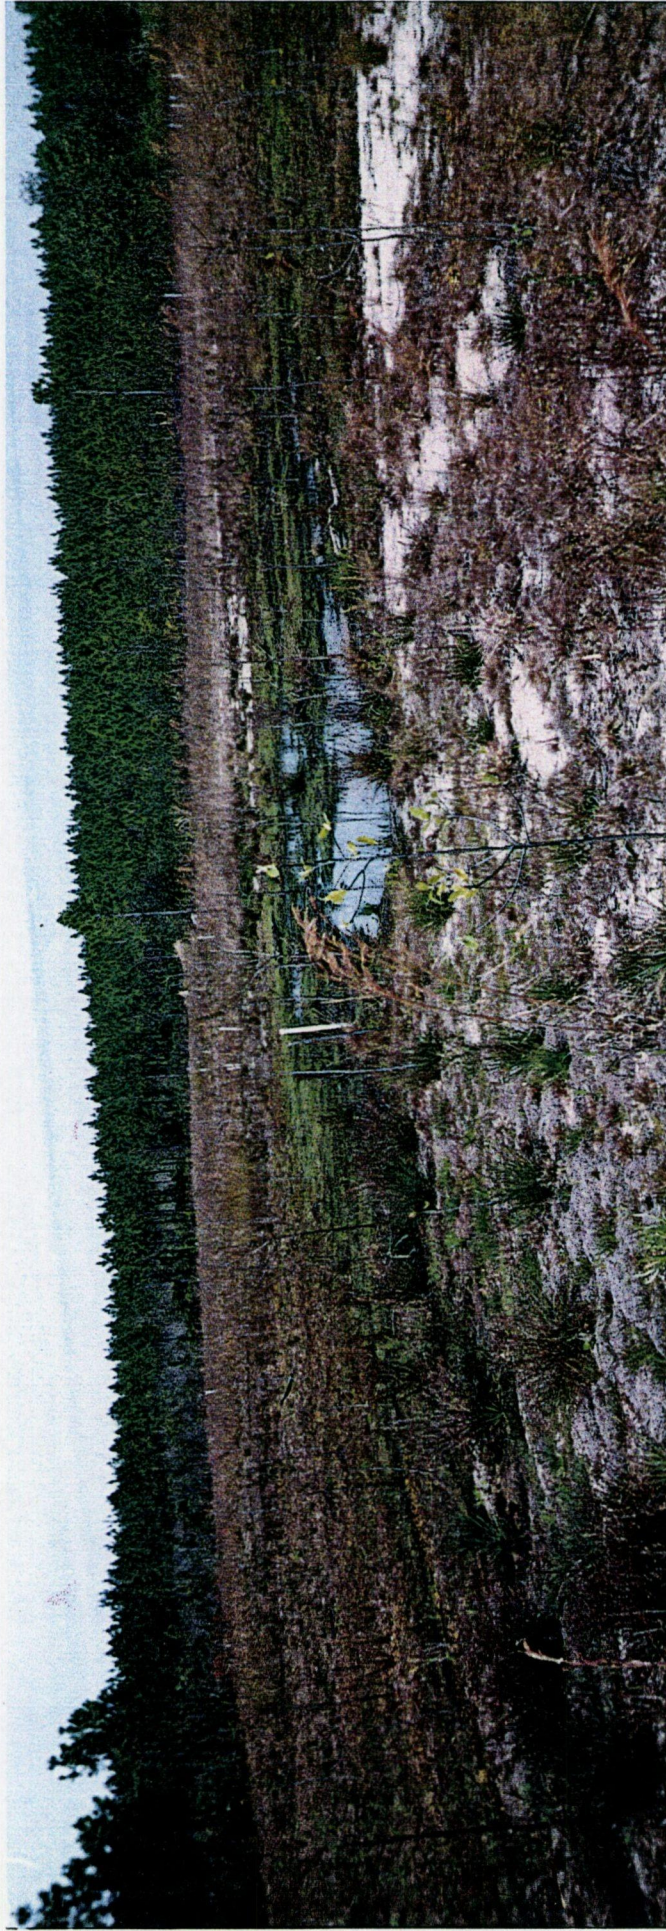
Photo 12 - Transect #7 (Note standing water)

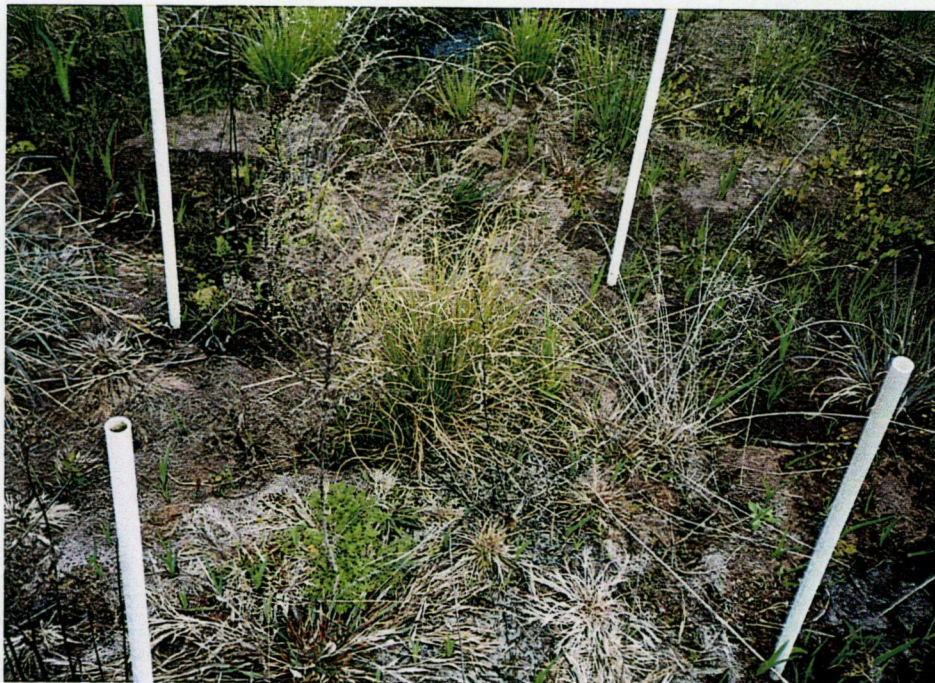
Photo 18 - Sample Quadrant (Note saturated soil)
