GAS MONITORING REPORT SECOND QUARTER 2018 FDEP PERMIT #: 69684-005-SF/14

UNIVERSAL DOOR SITE / LANDFILL VETERANS EXPRESSWAY PROJECT TAMPA, HILLSBOROUGH COUNTY, FLORIDA WACS FACILITY #: SWD/29/44718

2nd Quarter Methane Report June 2018

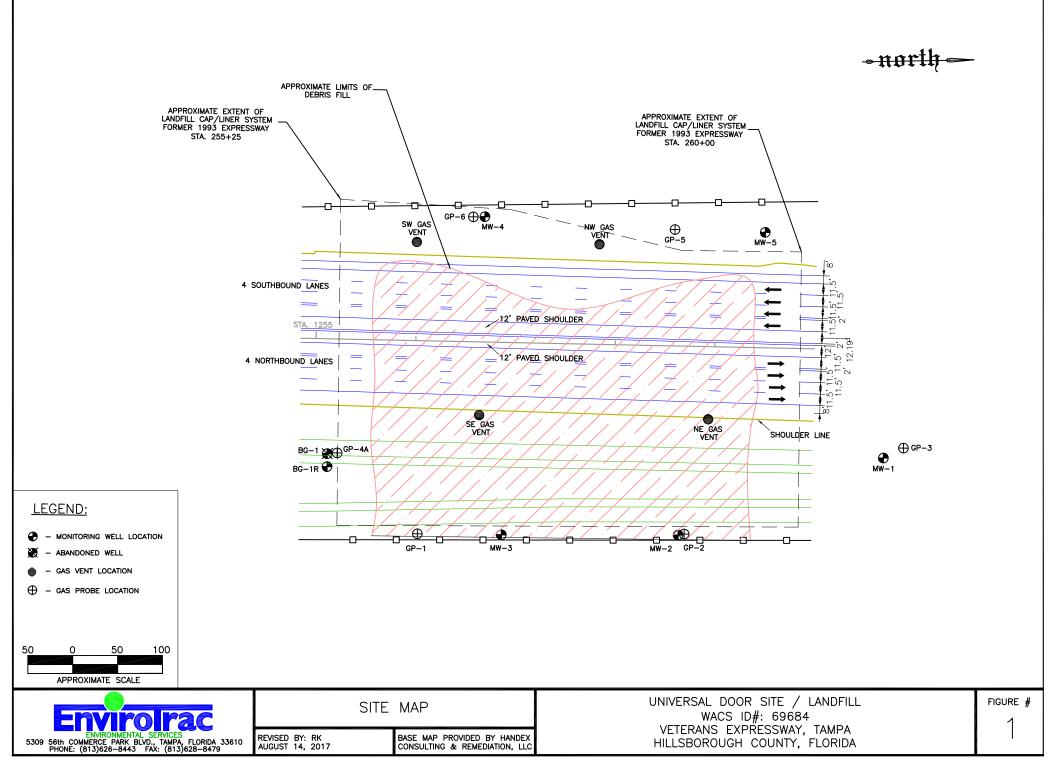
FIGURE 1

The Florida Department of Transportation (FDOT) has implemented a routine methane gasmonitoring program at the Universal Door Site, located in Section 3.1 of the Veterans Expressway project. The Universal Door Site consists of a former landfill located in Hillsborough County. Permit No. 69684-005-SF/14 was issued on August 6, 2014 for long term care of the site. Section 2 - Specific Conditions E. Gas Management System Requirements details the quarterly monitoring of methane in vadose zone soils. Monitoring is completed to demonstrate compliance with the criteria established in Rule 62-701.530(1)(a), F.A.C., (less than 25% of the lower explosive limit (LEL) for combustible gases at or beyond the property boundary). Monitoring is accomplished by measuring the percent LEL in air samples collected from vadose zone gas probes located at the site boundaries; see **Figure 1**.

Gas monitoring probes GP-1 through GP-6 were installed on March 21, 1993, at the locations shown on **Figure 1**. Gas probe GP-4 was destroyed in August 1997 and replaced with GP-4A

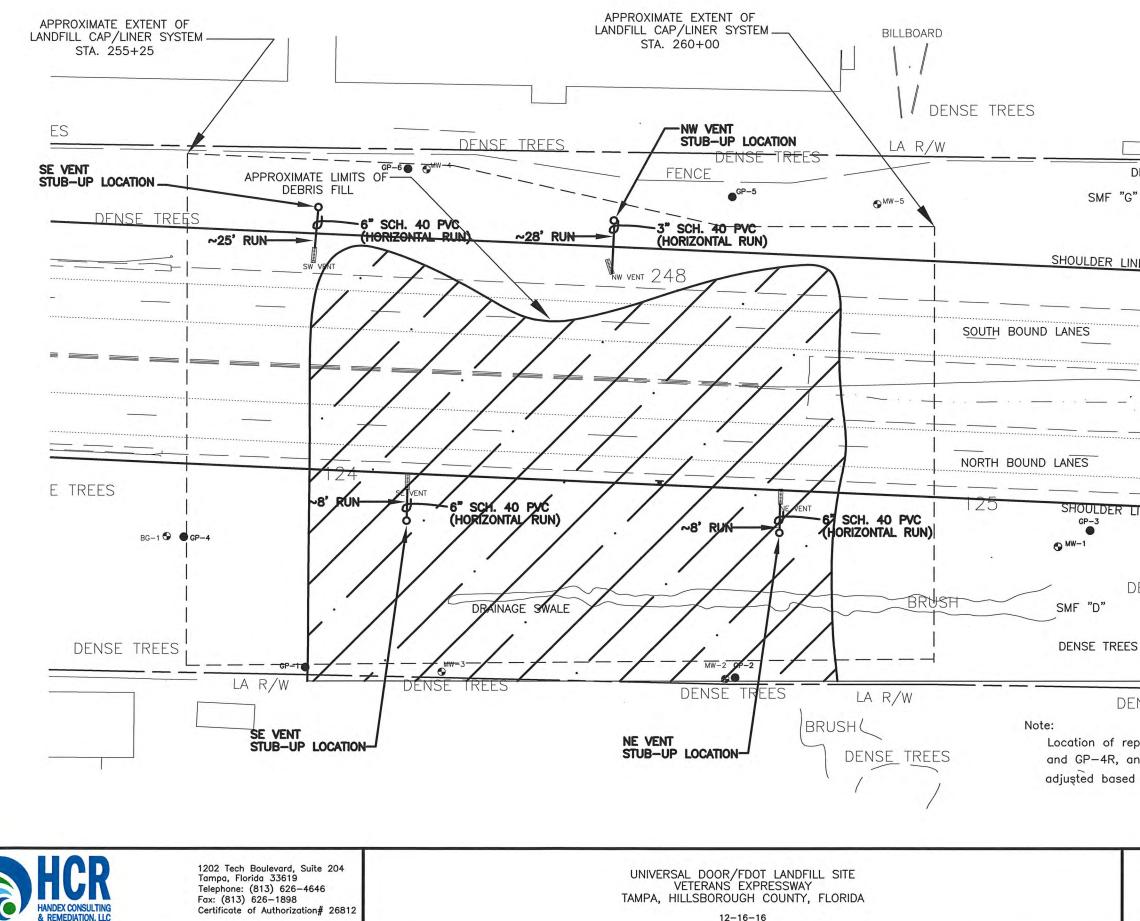
FIGURE 2 CURRENT SITE PLAN

Due to construction activities and the roadway layout, the four passive vents (NE, SE, NW, SW) were extended away from the roadway. The NE and SE vents were extended approximately eight (8) feet to the east while the NW and SW vents were extended approximately 25 feet to the west. Construction details of the passive vents along with the new locations are shown on **Figures 2, 3, and 4** located in **Appendix A**.

Location of replacement wells MW-1R and BG-1R, gas points GP-3R and GP-4R, and vent stub-ups are proposed. Actual locations may be adjusted based on the final completion of construction activities.
