**SCS ENGINEERS**

Subject: Construction Completion, Phase VI Activation  
Southeast County Landfill, Hillsborough County, Florida  
Operation Permit No. SO29-256427

**ATTACHMENT 1  
CERTIFICATION OF CONSTRUCTION COMPLETION  
OF A  
SOLID WASTE MANAGEMENT FACILITY**

**ATTACHMENT 2  
CONSTRUCTION PHOTOGRAPHS**

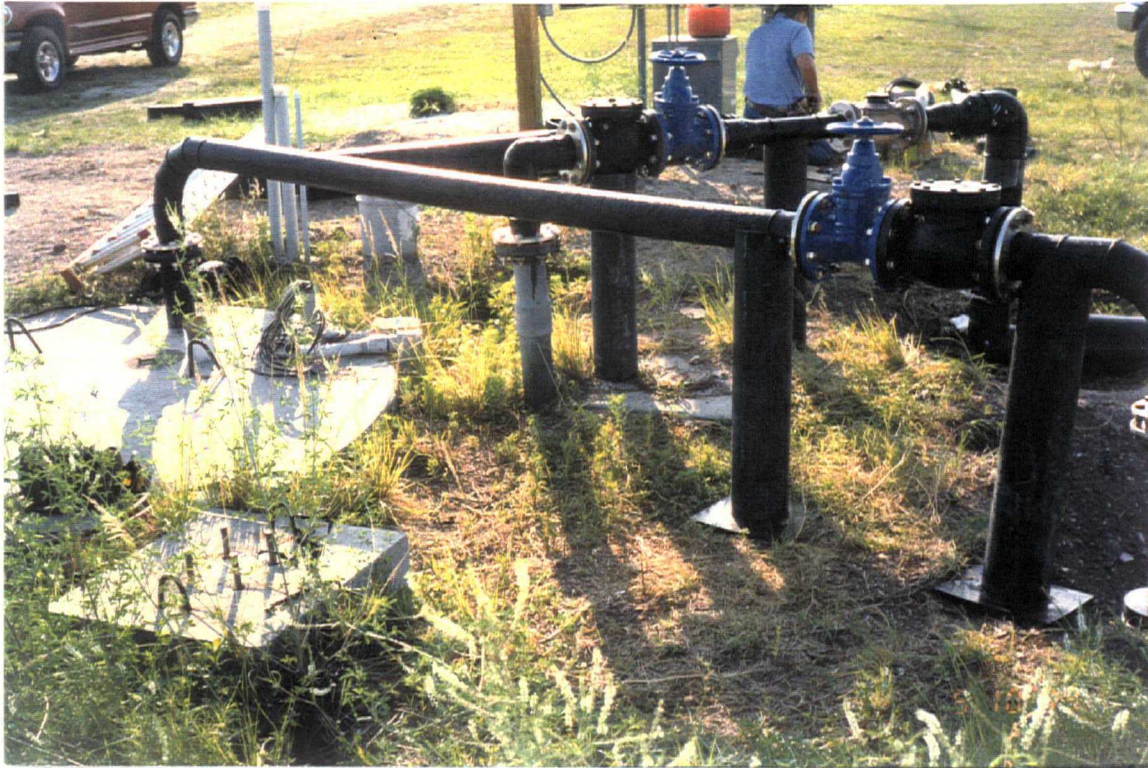
**Photograph Number 1**

**Date:** May 10, 1999      **Site:** Southeast County Landfill, Hillsborough County, FL  
**Description:** PPS-A completed piping system (looking northeast).

The connection was completed on May 6, 1999 (Photograph No. 1).

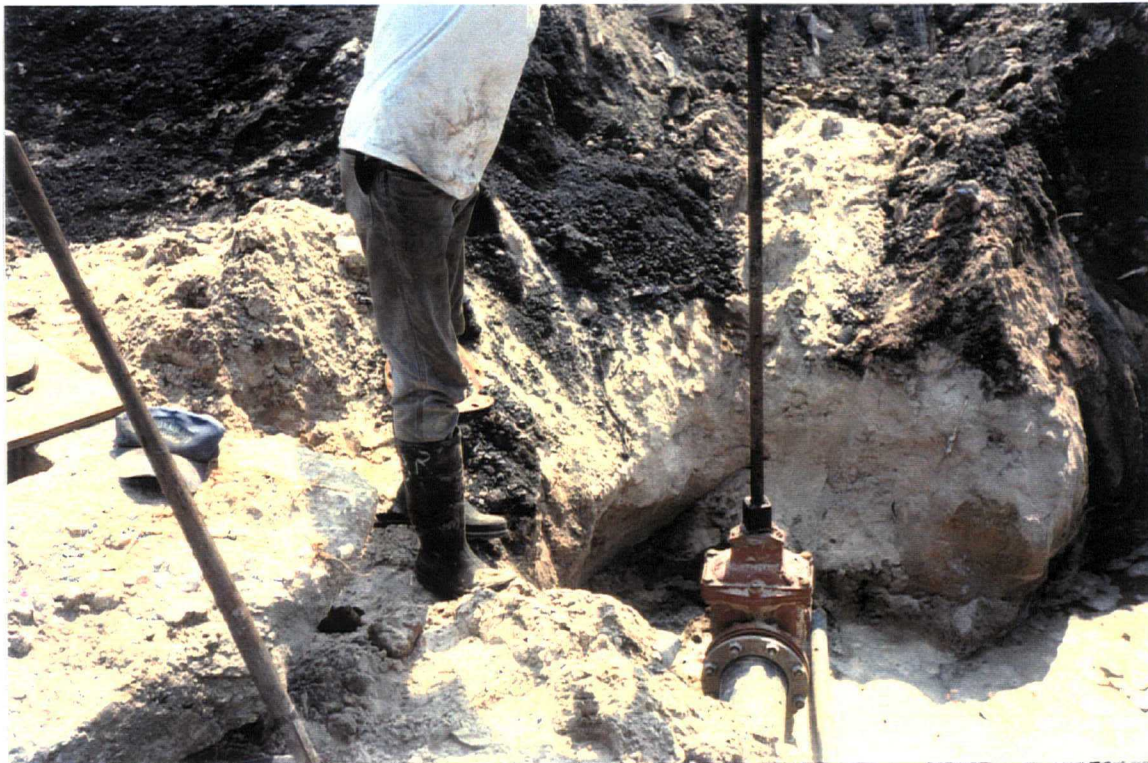
**Photograph Number 2**

**Date:** May 11, 1999      **Site:** Southeast County Landfill, Hillsborough County, FL  
**Description:** Opening Valve Number 6 (looking west).

Valve Number 6 was opened on May 11, 1999, and Valves No. 1, 2, and 3 were opened on May 25, 1999 (Photographs No. 2 through No. 5).

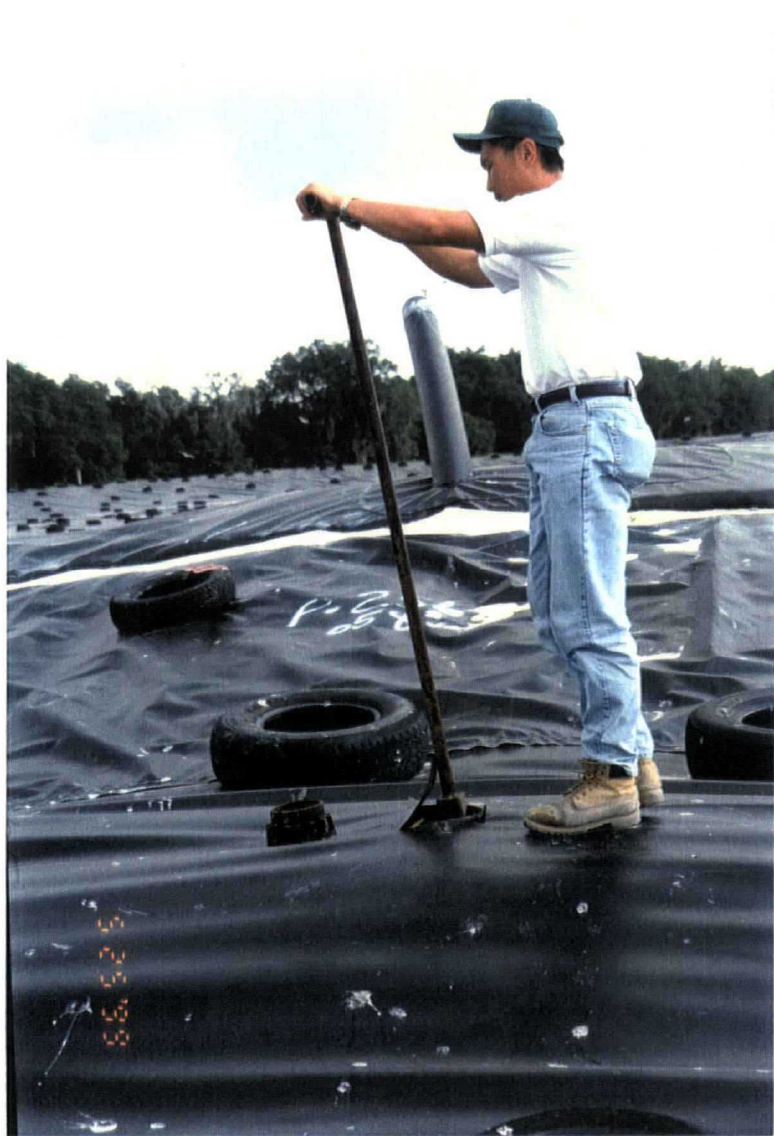
Photograph Number 3

**Date:** May 25, 1999    **Site:** Southeast County Landfill  
Hillsborough County, FL  
**Description:** Opening valve No. 1 (looking north).

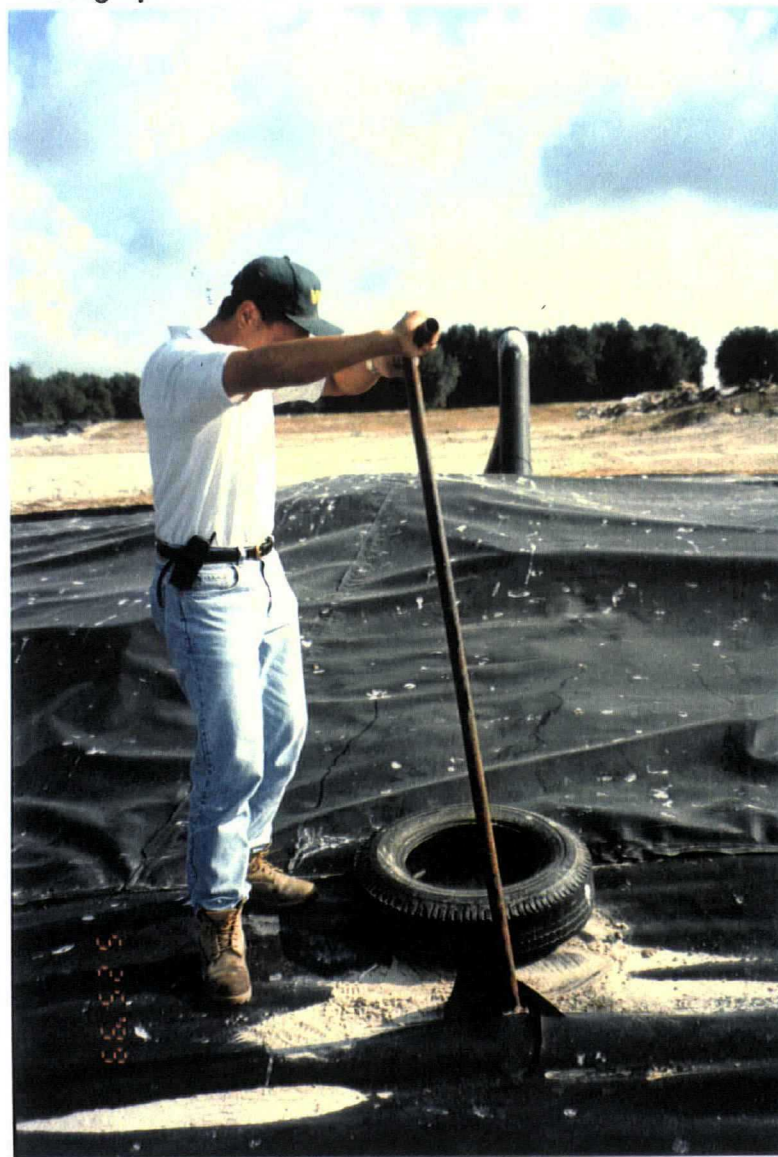
Photograph Number 4

**Date:** May 25, 1999    **Site:** Southeast County Landfill  
Hillsborough County, FL  
**Description:** Opening valve No. 2 (looking north).

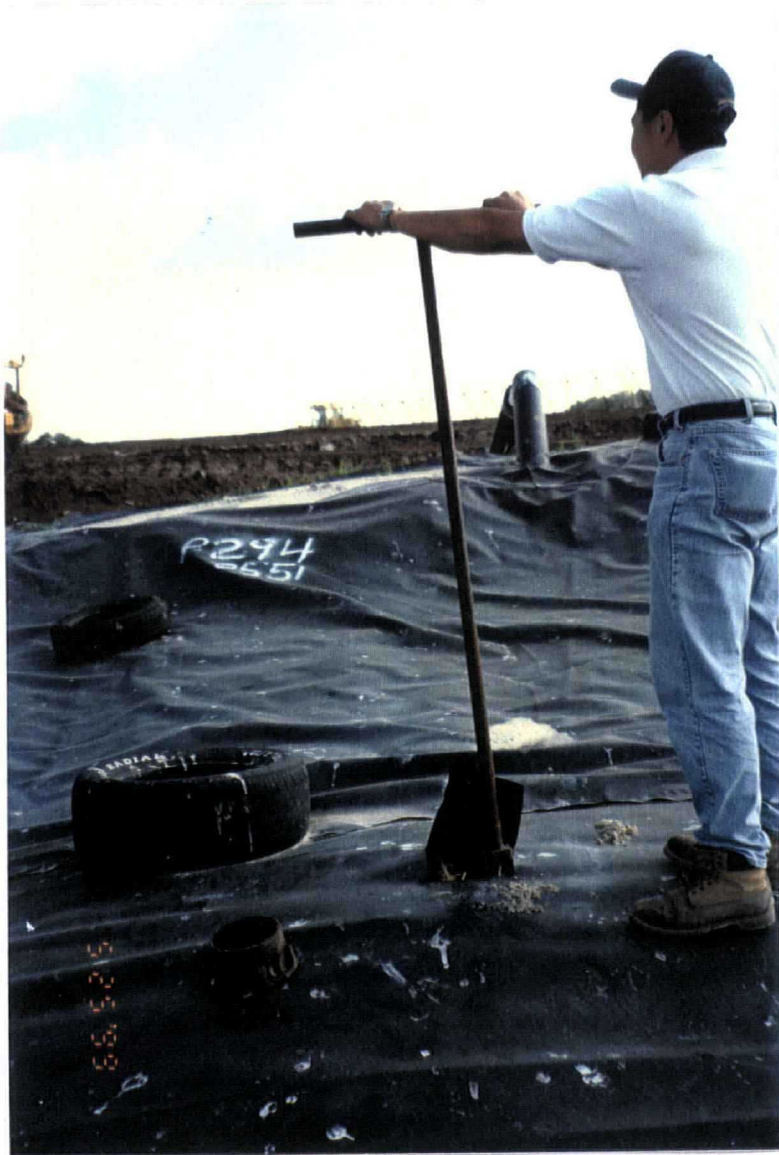
Photograph Number 5

**Description:** Opening valve No. 3 (looking north).

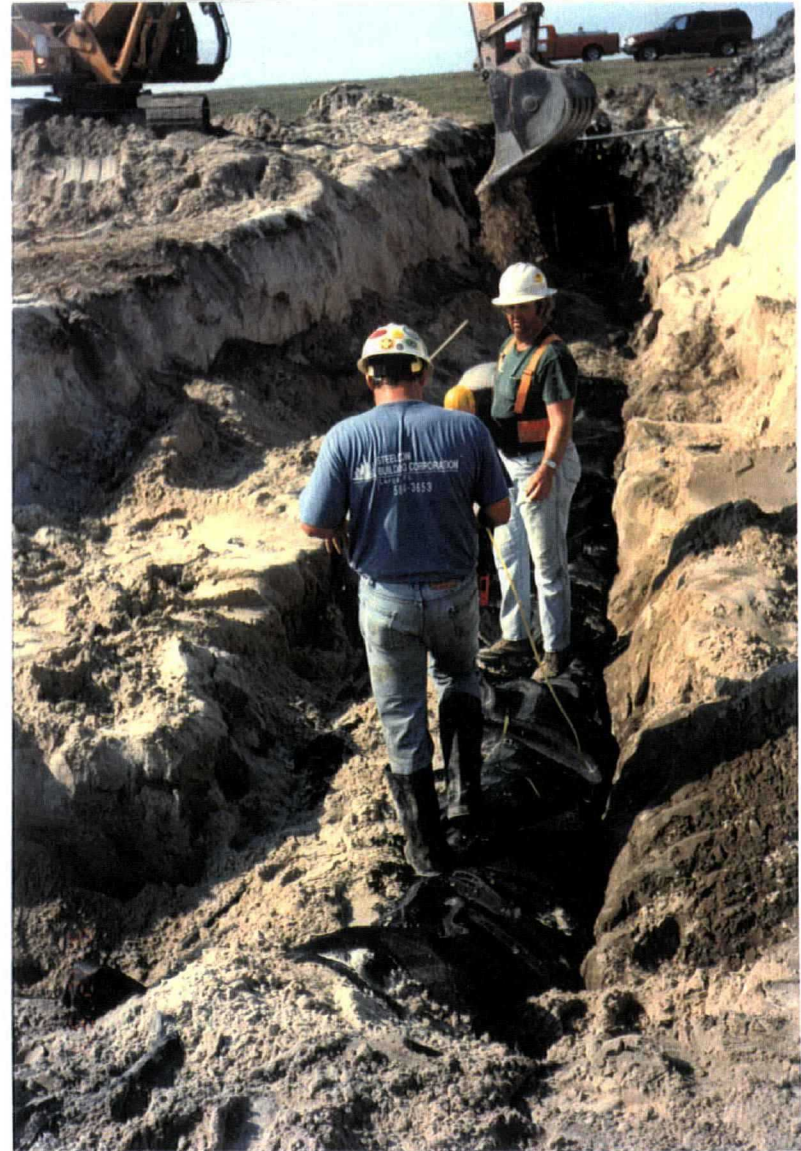
Photograph Number 6

**Description:** Completed internal berm chipped tire Trench  
No. 15 (looking south).

- PLACE MIRAFI 401 WOVEN GEOTEXTILE IN TRENCH 15; EXCAVATED TO TOP OF CLAY.
- INSTALL TIRE CHIPS. GEOTEXTILE OVERLAP = 2 FT
- TIE IN TO PH VI; BACKFILL FIRST WITH CLEAN SAND. COMPLETED TRENCH #15 = 119'
- EXCAVATE TO LEACHATE HEADER. TRENCH 16 EXCAVATE TO TOP OF CLAY; TIE IN TO HEADER PLACING GEOTEXTILE AND TIRE CHIPS. INSTALL TRENCH 16 TOWARDS TIE IN AT PHASE VI.
- TRENCH 16 INCOMPLETE
- WORK SLOWED BUT EXCAVATION CONTINUED UNTIL 16.30 DUE TO RAIN & STORM

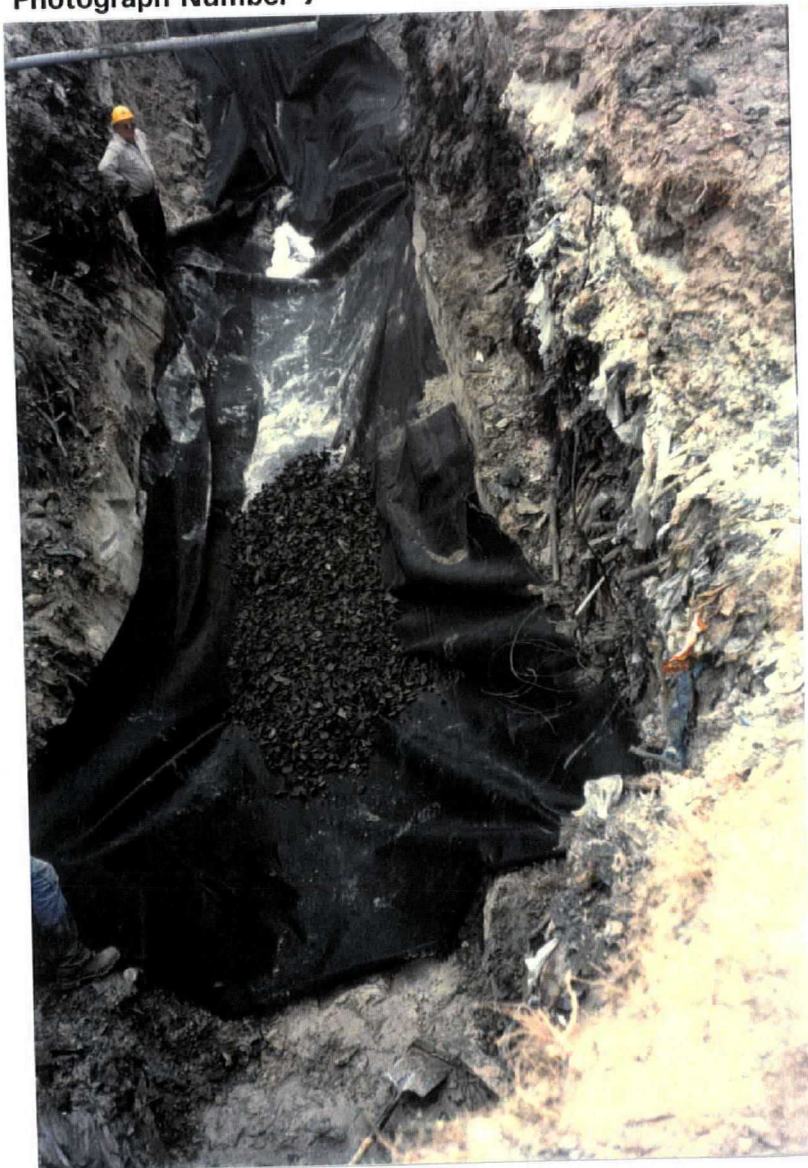
Photograph Number 7

**Description:** Beginning internal berm chipped tire Trench No. 16 (looking north).

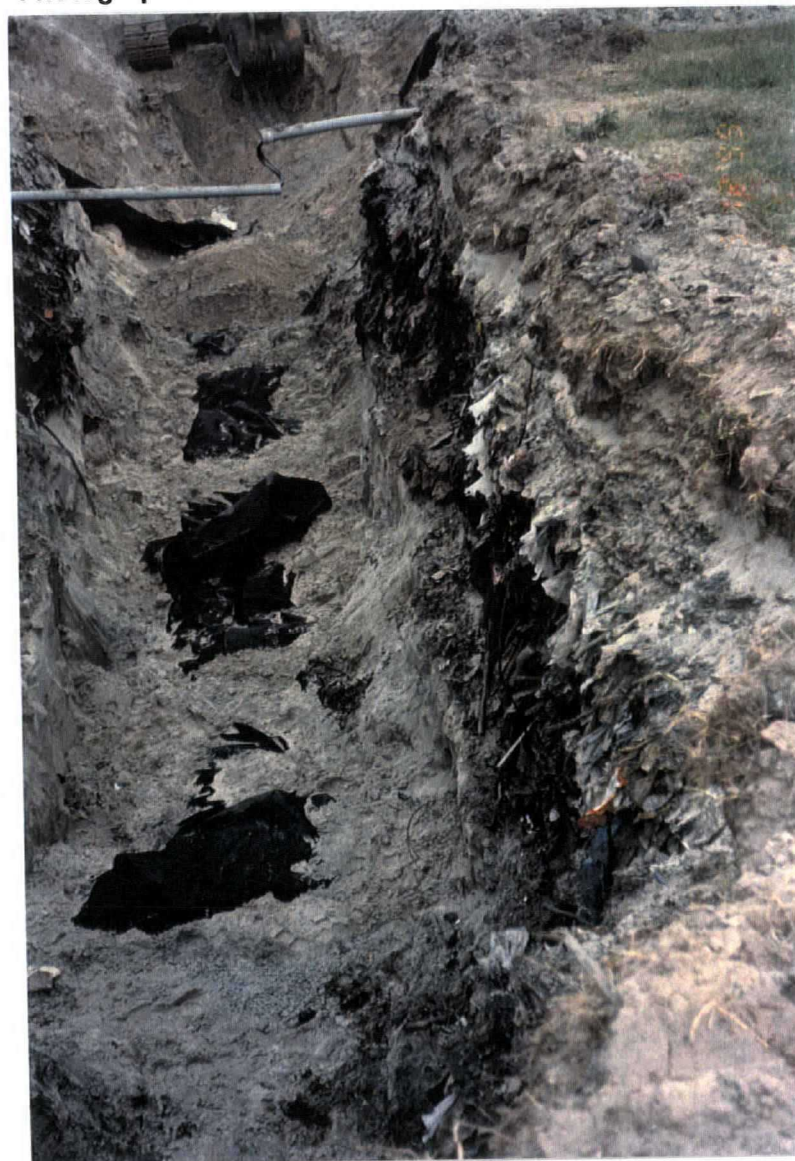
Photograph Number 8

**Description:** Completed internal berm chipped tire Trench No. 16 (looking north).

- EXCAVATE TO CLAY, TRENCH 14; INSTALL GEOTEXTILE AND TIRE CHIPS
- TIE INTO TIRE TRENCH Ph VI
- LENGTH OF TRENCH 14 = 115 FT
- BACKFILL SW TRENCHES 14 & 15 AFTER PLACING 2 FT CLEAN SAND ON TOP OVER TIRE TRENCHES.
- EXCAVATE AND INSTALL CHIPPED TIRES AND GEOTEXTILE IN TRENCH 16. TIE INTO Ph VI
- LENGTH OF TRENCH 16 = 120 FT

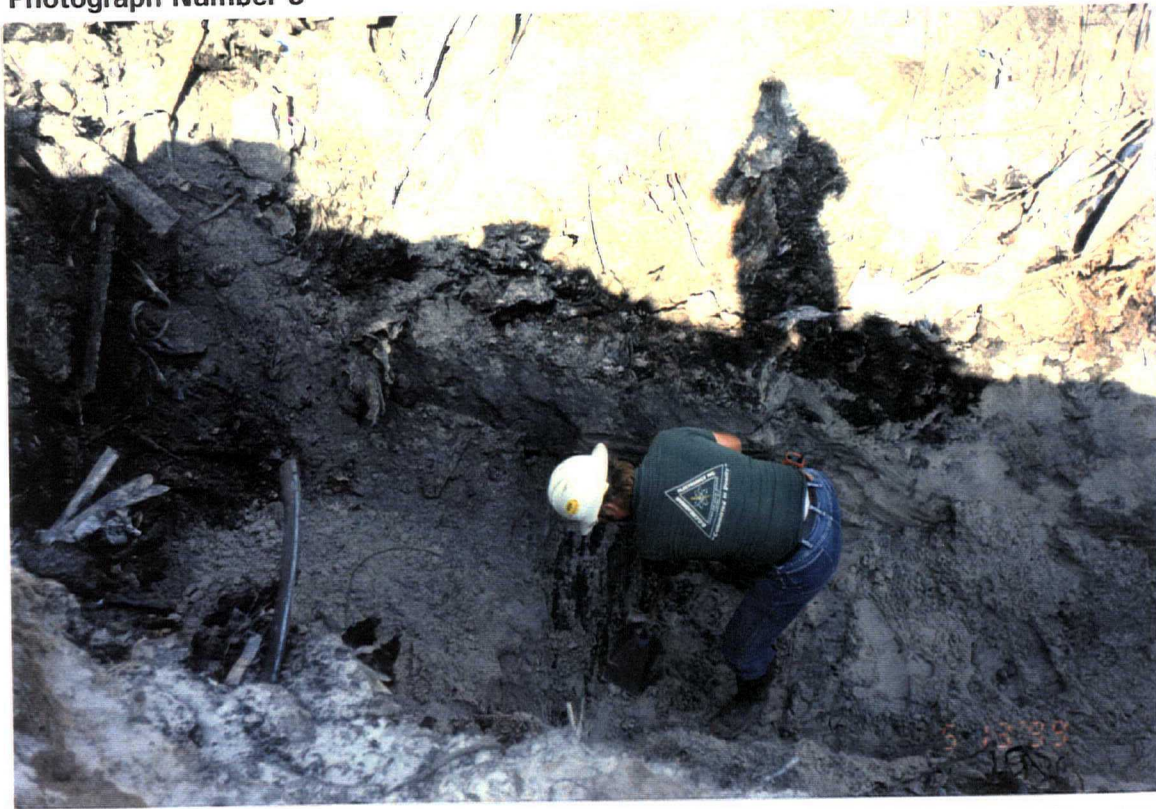
**Photograph Number 9**

**Date:** May 13, 1999      **Site:** Southeast County Landfill, Hillsborough County, FL  
**Description:** Phase IV internal berm chipped tire Trench No.14 (looking west).

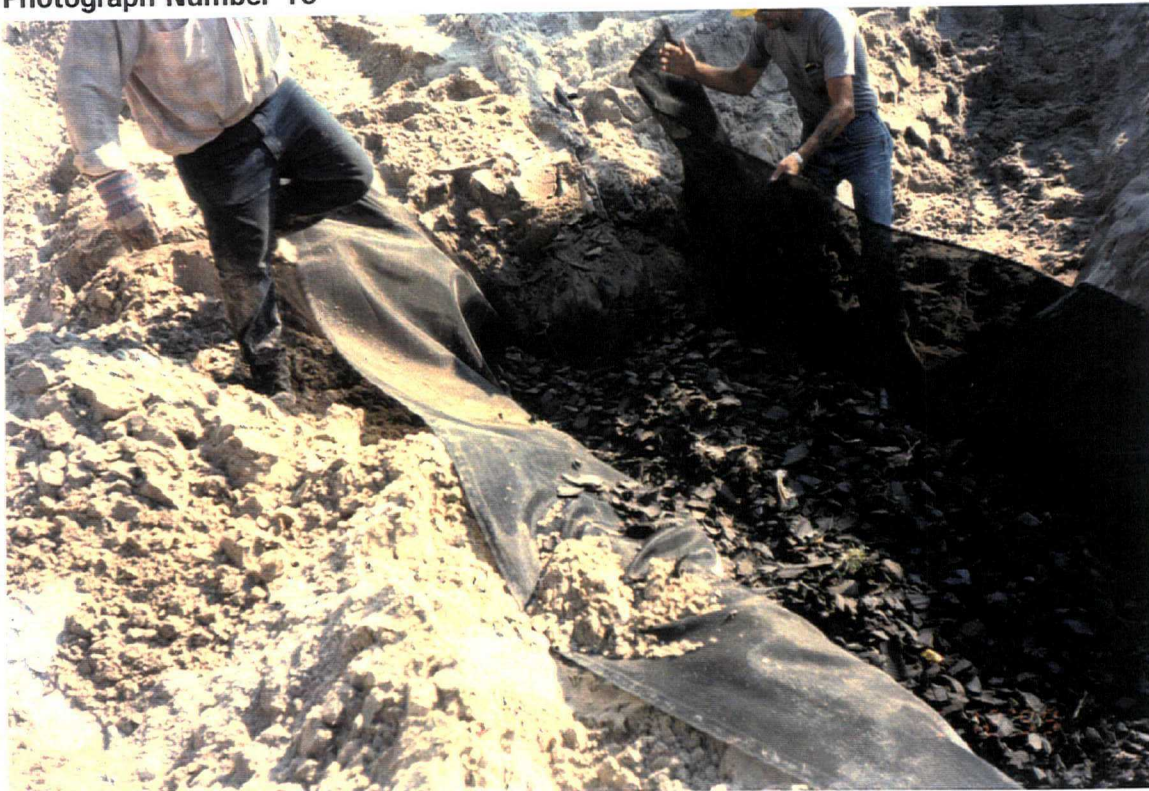
**Photograph Number 10**

**Date:** May 14, 1999      **Site:** Southeast County Landfill, Hillsborough County, FL  
**Description:** Phase VI internal berm chipped tire Trench No. 14 (looking northeast).

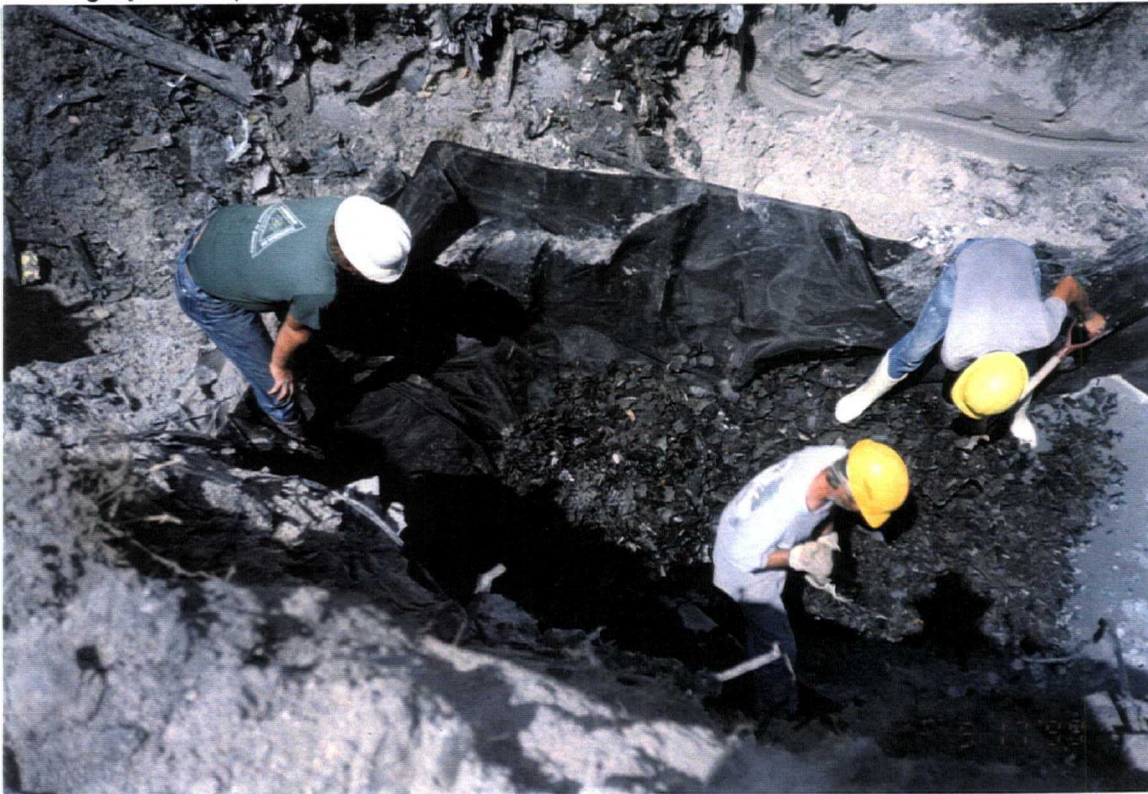
**Photograph Number 11**

**Date:** May 17, 1999      **Site:** Southeast County Landfill, Hillsborough County, FL  
**Description:** Phase IV internal berm chipped tire Trench No. 13 (looking southwest).

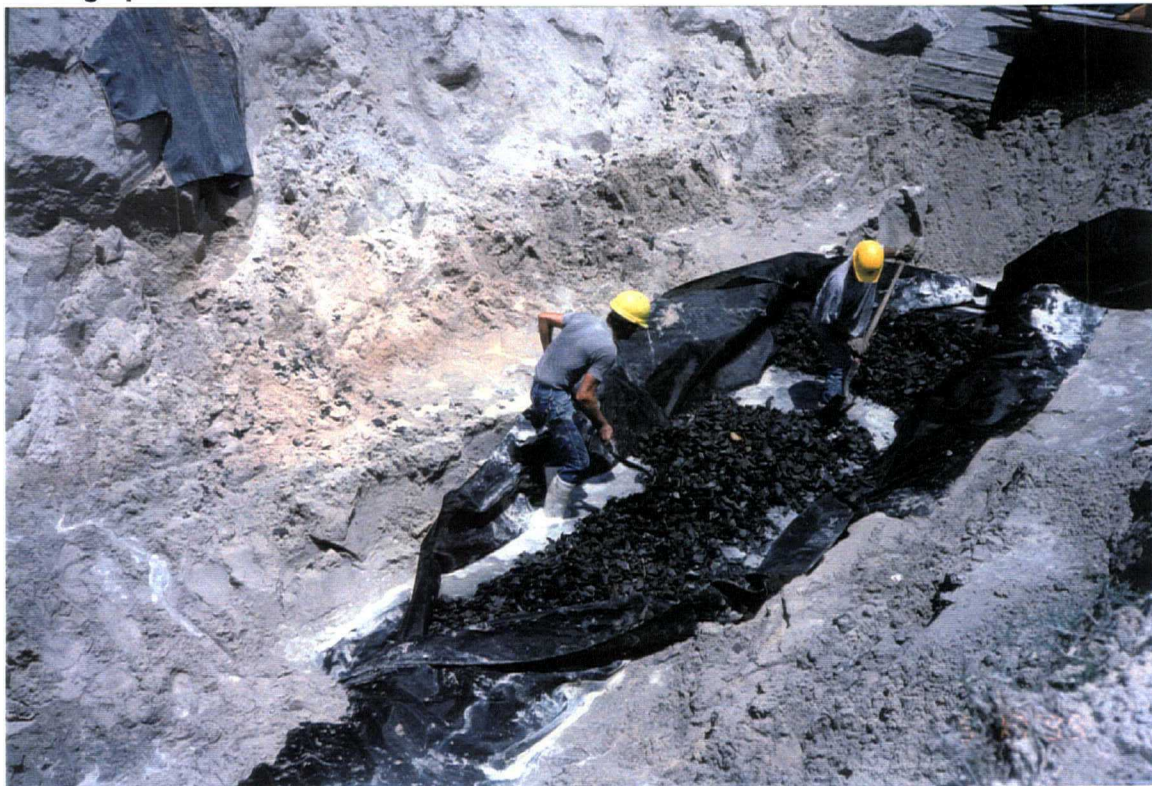
**Photograph Number 12**

**Date:** May 17, 1999      **Site:** Southeast County Landfill, Hillsborough County, FL  
**Description:** Phase VI internal berm chipped tire Trench No. 13 (looking west).

- EXCAVATE AT TIRE TRENCH 13: LOCATE TRENCH IN Ph VI
- EXCAVATE TOWARD Ph IV; BREAK THROUGH BERM,
- LOCATE AND TIE IN TO GRAVEL TRENCH IN Ph IV.
- INSTALL TIRE TRENCH AT TOP OF CLAY FROM
- Ph IV - Ph VI, TIE IN TO Ph VI
- COMPLETED TRENCH 13 = 105 LF
- SIMILAR CONSTRUCTION FOR TRENCH 12 AS
- FOR TRENCH 13.
- COMPLETED TRENCH 12 = 80 LF
- BACKFILL AND CLEANUP AT TRENCHES
- 14, 15, & 16

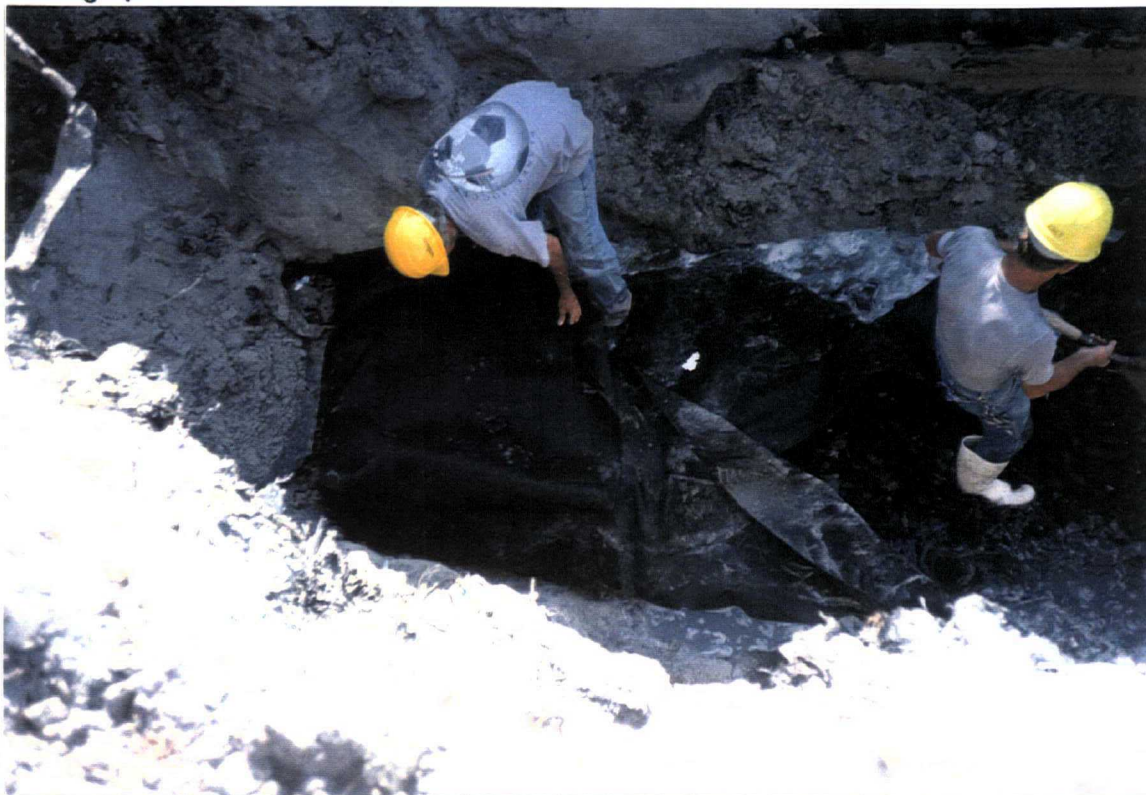
**Photograph Number 13**

**Date:** May 17, 1999      **Site:** Southeast County Landfill, Hillsborough County, FL  
**Description:** Phase IV internal berm chipped tire Trench No. 12.

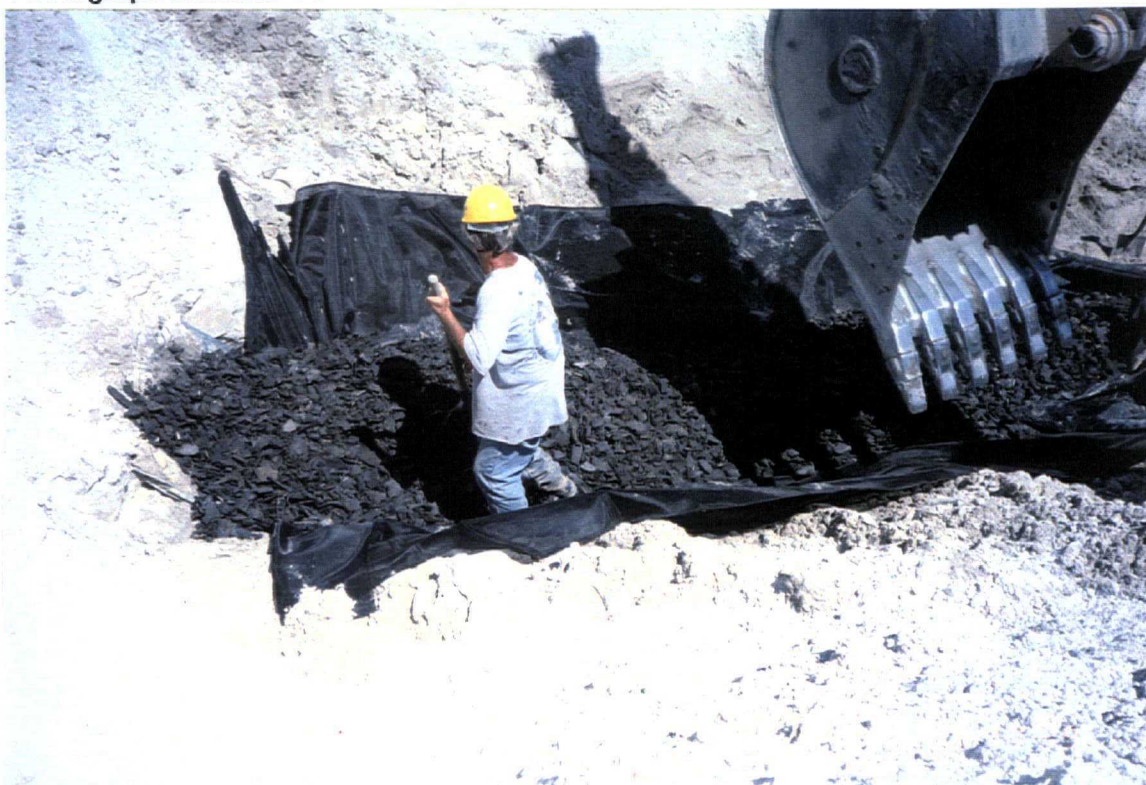
**Photograph Number 14**

**Date:** May 17, 1999      **Site:** Southeast County Landfill, Hillsborough County, FL  
**Description:** Phase VI internal berm chipped tire Trench No. 12 (looking east).

- BACKFILL TRENCH NO. 12 W/ 2 FT OF SAND OVER GEOTEXTILE; REPLACE SW IN PH IV AND SAND IN PH VI
- EXCAVATE ATTIRE TRENCH NO. 11, LOCATE TIRE TRENCH IN PH VI AND GRAVEL TRENCH IN PH IV. EXCAVATE TO CLAY LAYER BETWEEN PH IV, PH V AND INSTALL CHIPPED TIRES WRAPPED IN GEOTEXTILE.
- COMPLETED TRENCH NO. 11 = 57 LF
- BACKFILL TRENCH W/ 2' CLEAN SAND
- EXCAVATE TRENCH NO 10; LOCATE TRENCH IN PH A, III

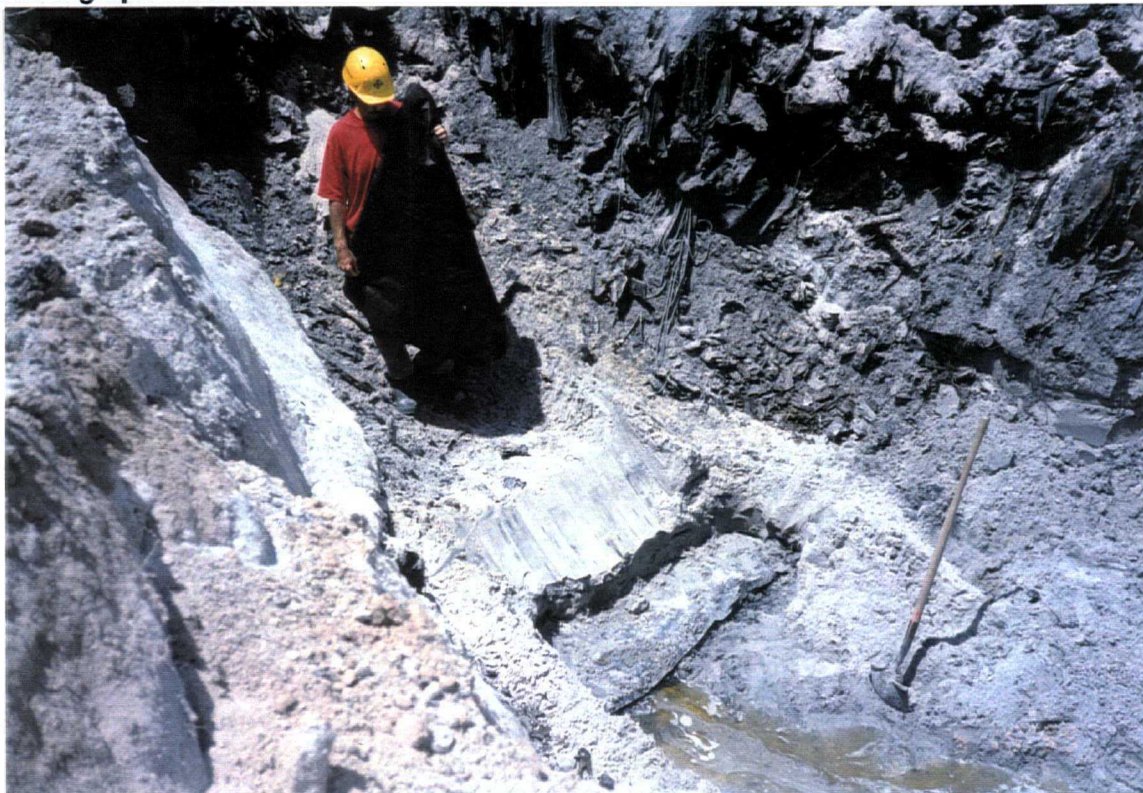
**Photograph Number 15**

**Date:** May 18, 1999      **Site:** Southeast County Landfill, Hillsborough County, FL  
**Description:** Phase IV internal berm chipped tire Trench No.11 (looking southwest).

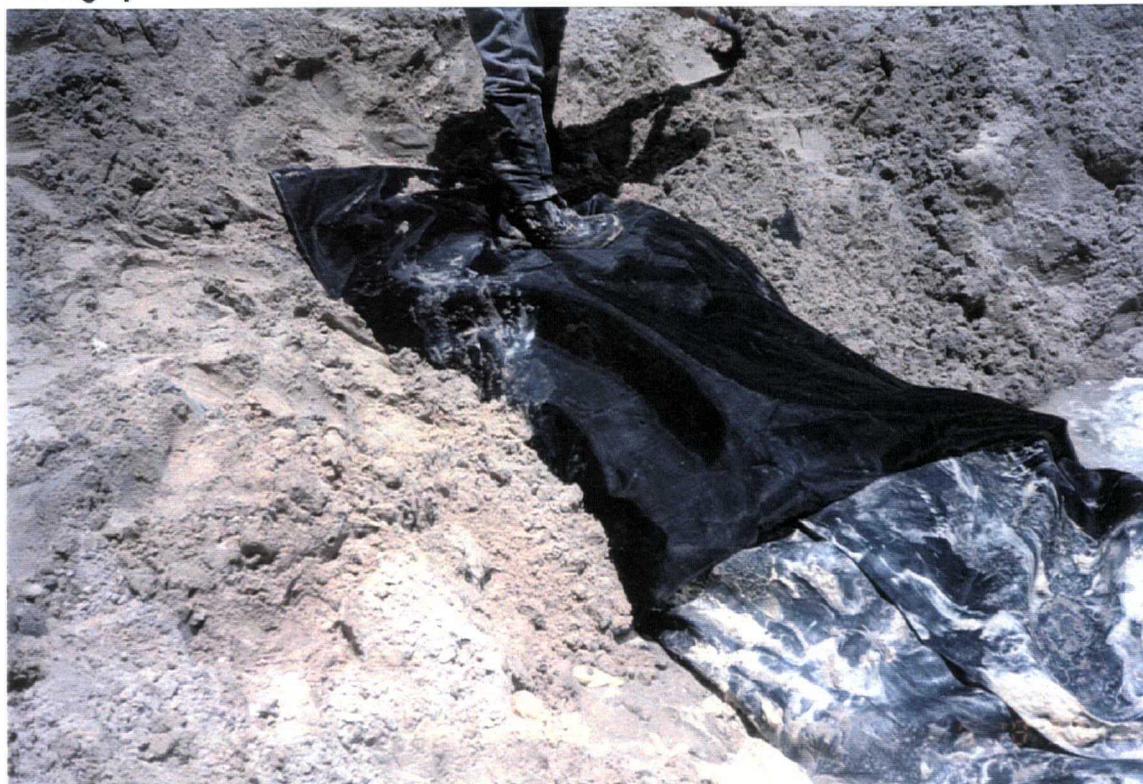
**Photograph Number 16**

**Date:** May 18, 1999      **Site:** Southeast County Landfill, Hillsborough County, FL  
**Description:** Phase VI internal berm chipped tire Trench No. 11 (looking northeast).

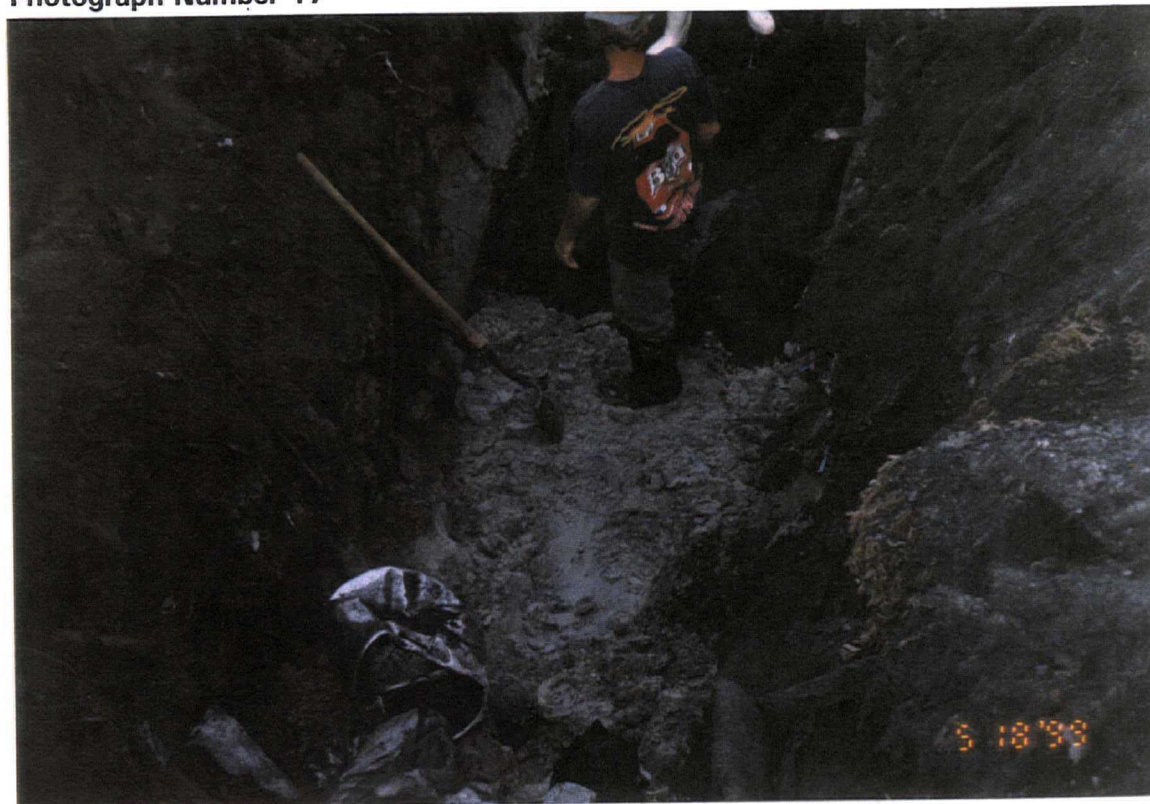
**Photograph Number 17**

**Date:** May 19, 1999      **Site:** Southeast County Landfill, Hillsborough County, FL  
**Description:** Phase III internal berm chipped tire Trench No. 10 (looking west).

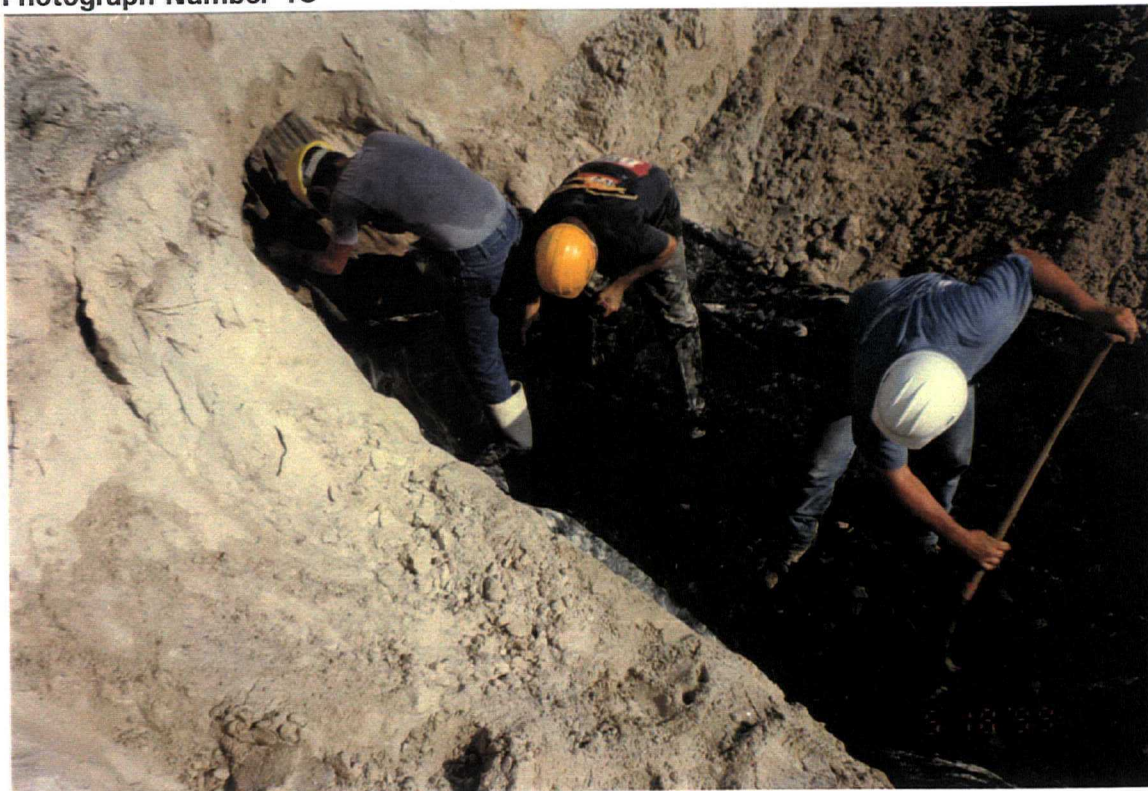
**Photograph Number 18**

**Date:** May 19, 1999      **Site:** Southeast County Landfill, Hillsborough County, FL  
**Description:** Phase VI internal berm chipped tire Trench No. 10 (looking north).

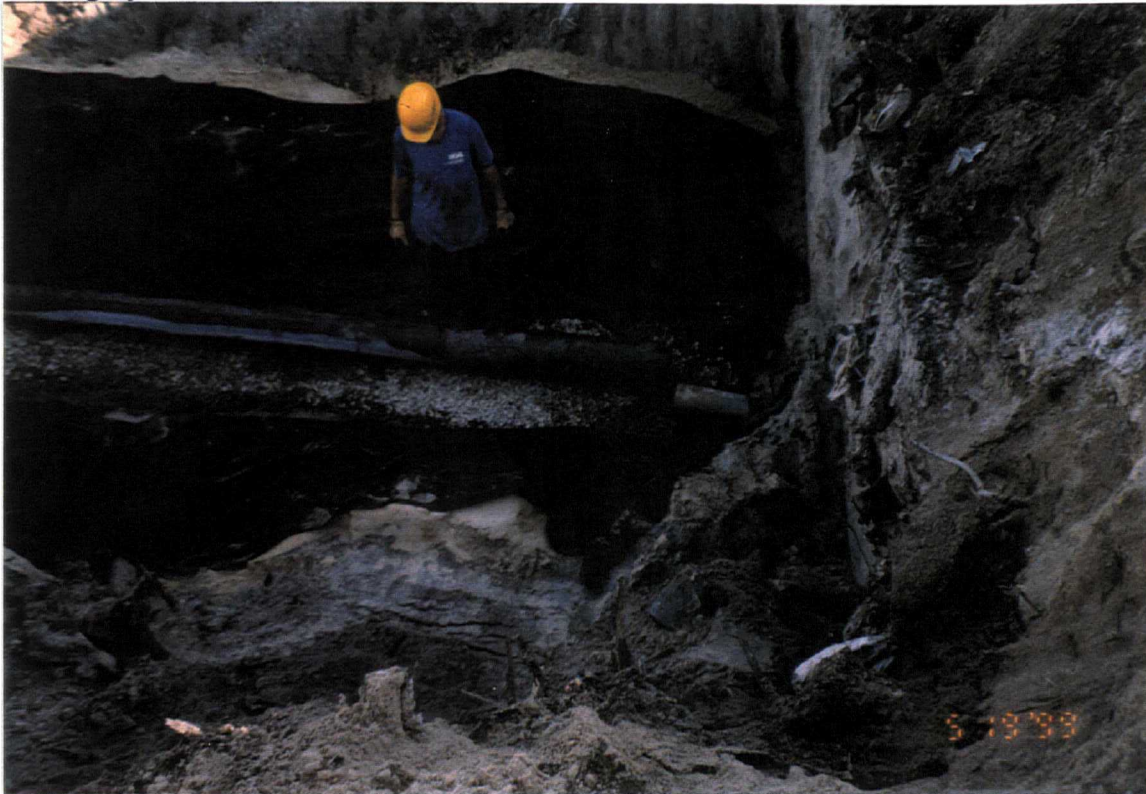
**Photograph Number 19**

**Date:** May 20, 1999      **Site:** Southeast County Landfill, Hillsborough County, FL  
**Description:** Phase III internal berm gravel Trench No. 2 (looking north).

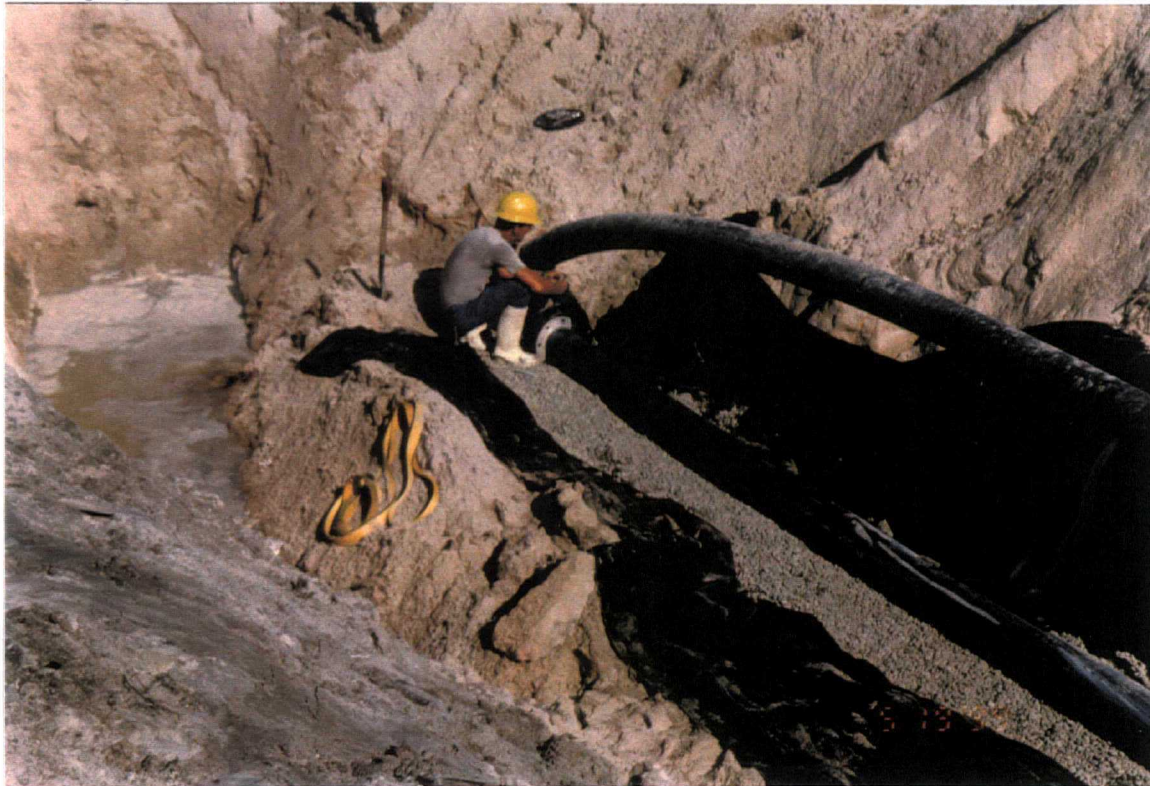
**Photograph Number 20**

**Date:** May 20, 1999      **Site:** Southeast County Landfill, Hillsborough County, FL  
**Description:** Phase VI internal berm gravel Trench No. 2 (looking northwest).

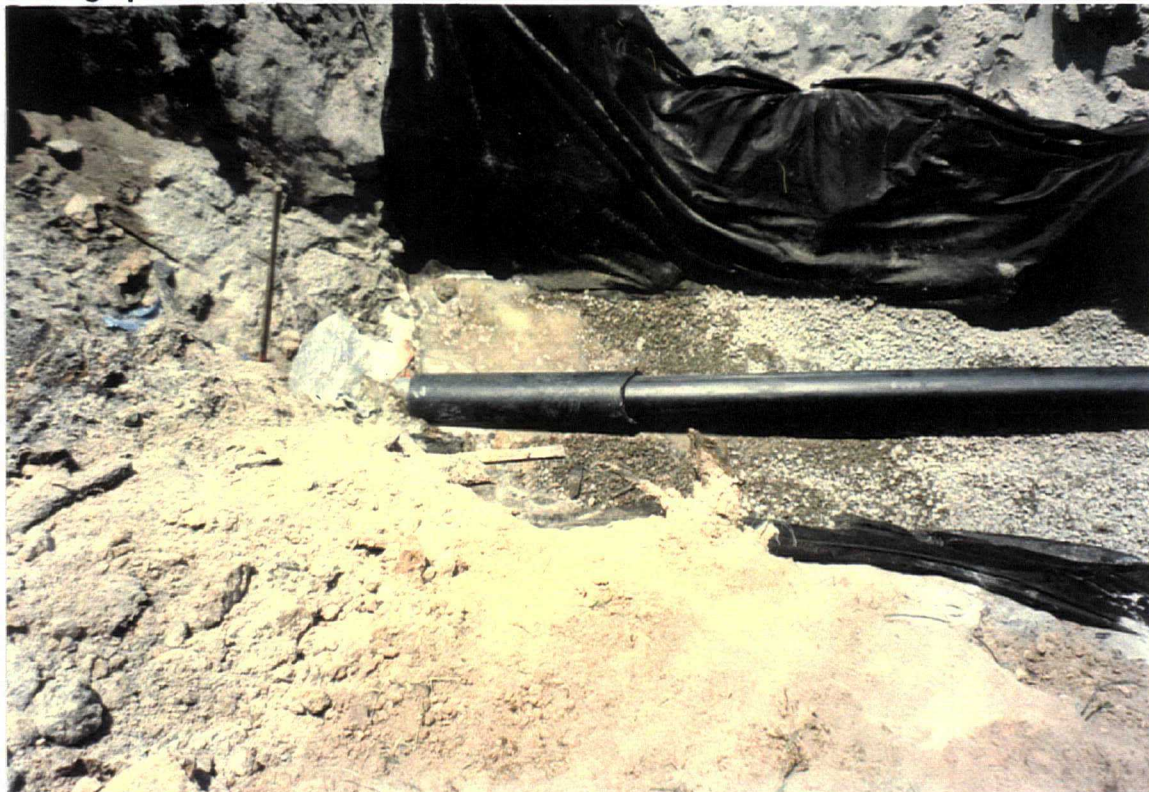
Photograph Number 21

Description: Phase III internal berm gravel Trench No. 3 (looking south).

10:30 Comanco excavated trench 3 to the clay, exposing Phase III pipe. They then installed 40' of 8" Perforated HDPE pipe in the trench, placed on a 4" bed of gravel over the geotextile wrap. Gravel was placed over and around the pipe and it was wrapped in the geotextile with at least 2' of overlap. Comanco then backfilled over the pipe with ~~about~~ 3' of sand and then replaced the excavated waste.

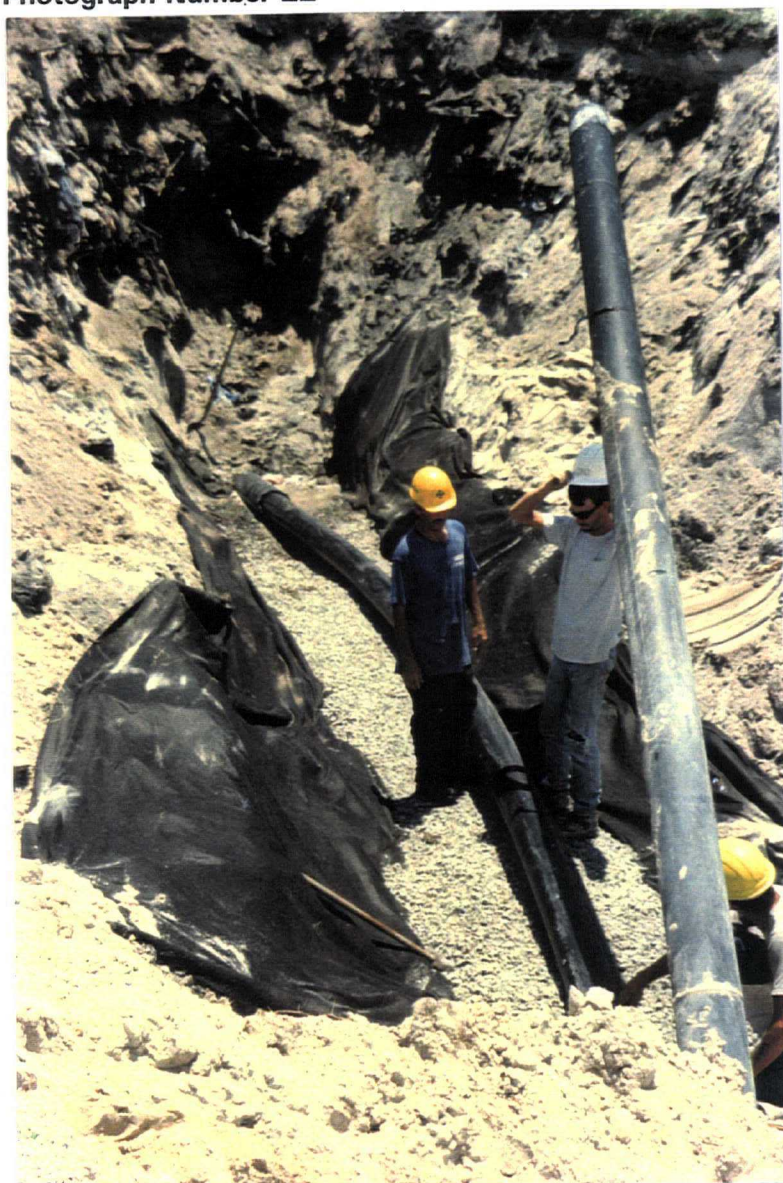
Photograph Number 22

**Date:** May 20, 1999      **Site:** Southeast County Landfill, Hillsborough County, FL  
**Description:** Adjusting pipe length for tie in to Phase VI internal berm gravel Trench No. 3 (looking east).

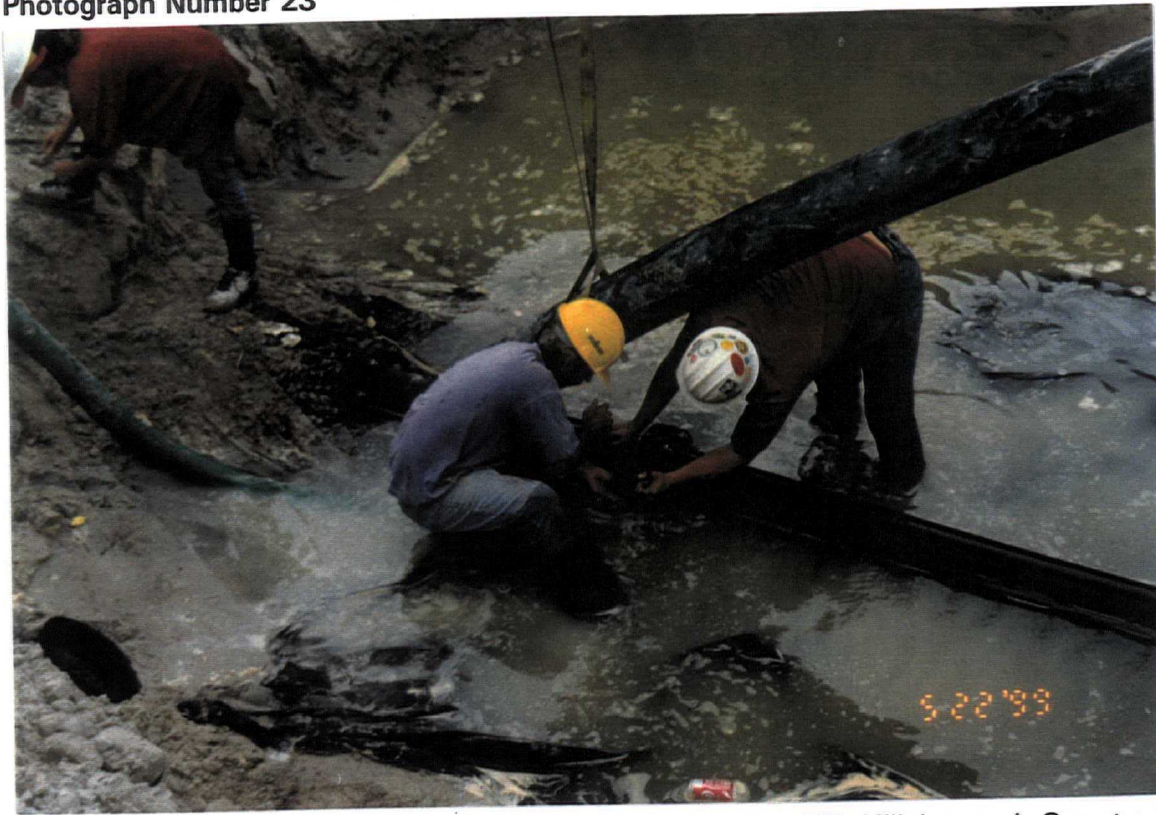
Photograph Number 23

**Date:** May 21, 1999      **Site:** Southeast County Landfill, Hillsborough County, FL  
**Description:** Phase VI internal berm gravel Trench No. 5 (looking northeast).
