**SCS ENGINEERS**

Subject: Construction Completion, Phase VI Activation  
Southeast County Landfill, Hillsborough County, Florida  
Operation Permit No. SO29-256427

**ATTACHMENT 1  
CERTIFICATION OF CONSTRUCTION COMPLETION  
OF A  
SOLID WASTE MANAGEMENT FACILITY**

**ATTACHMENT 2  
CONSTRUCTION PHOTOGRAPHS**

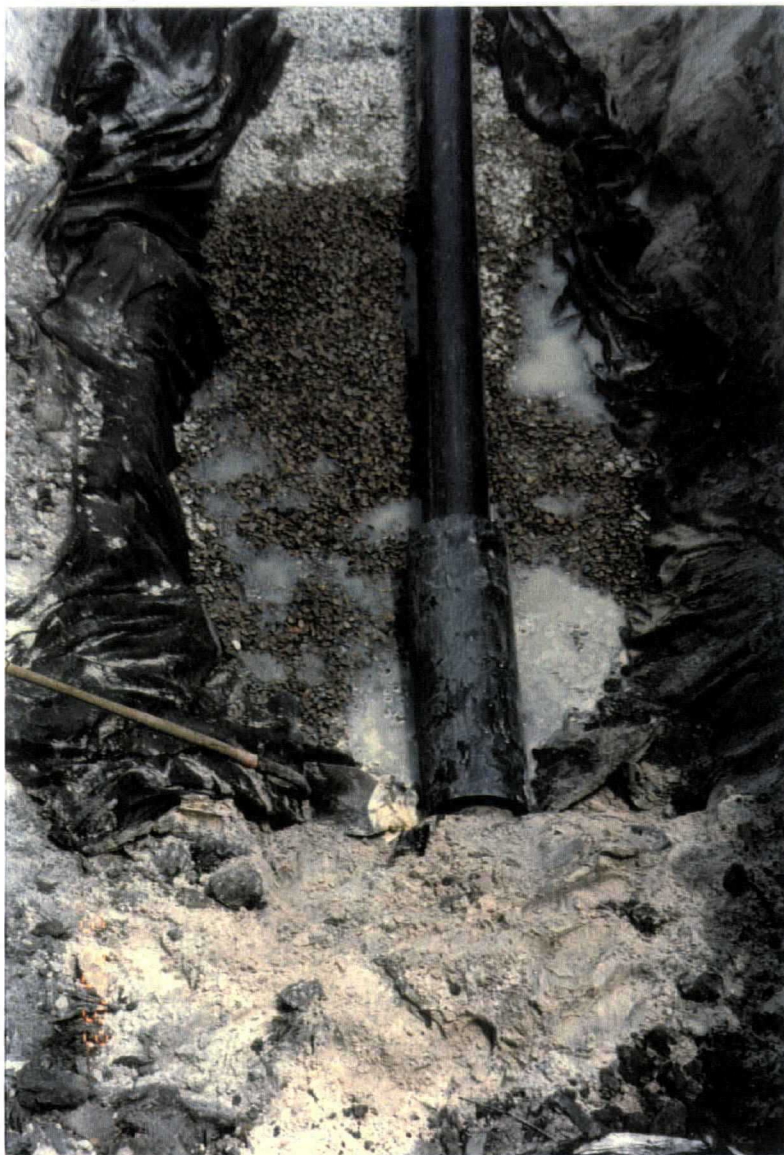
Photograph Number 24

**Date:** May 21, 1999    **Site:** Southeast County Landfill  
Hillsborough County, FL  
**Description:** Phase IV internal berm gravel Trench No. 6  
(looking north).

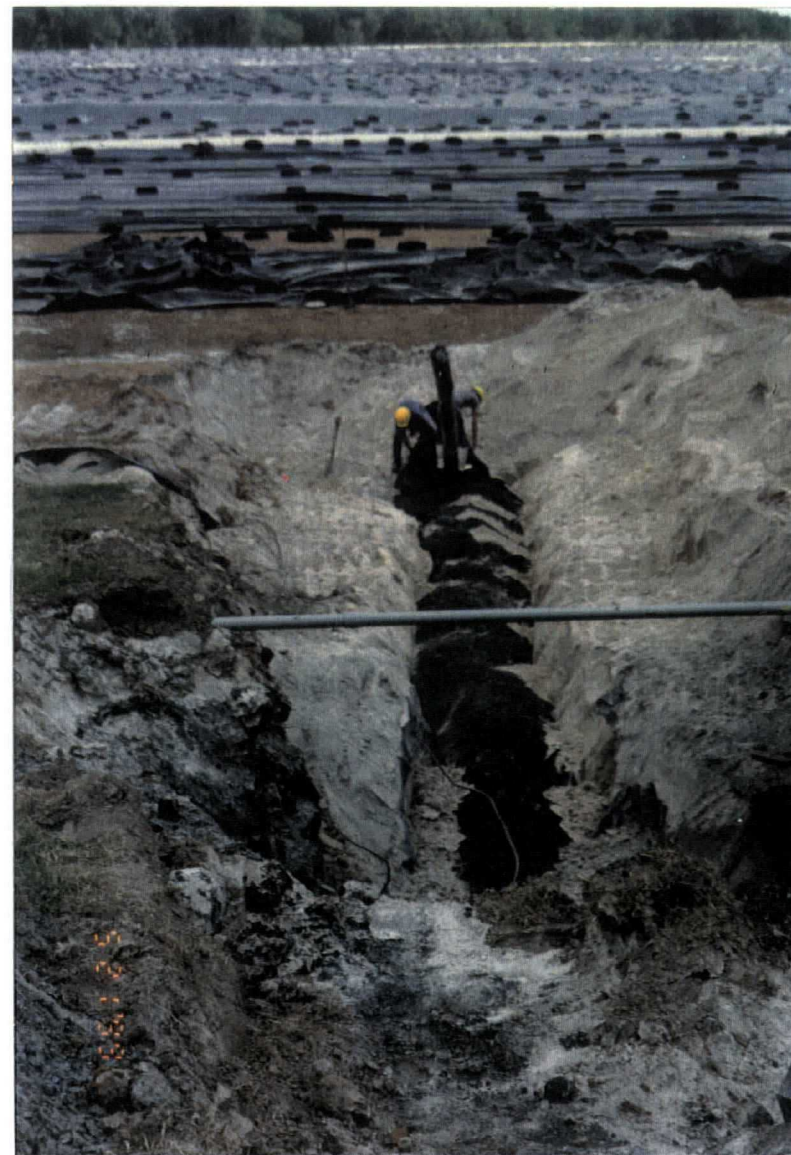
Photograph Number 25

**Date:** May 21, 1999    **Site:** Southeast County Landfill  
Hillsborough County, FL  
**Description:** Completed Phase VI internal berm gravel  
Trench No. 6 (looking north).

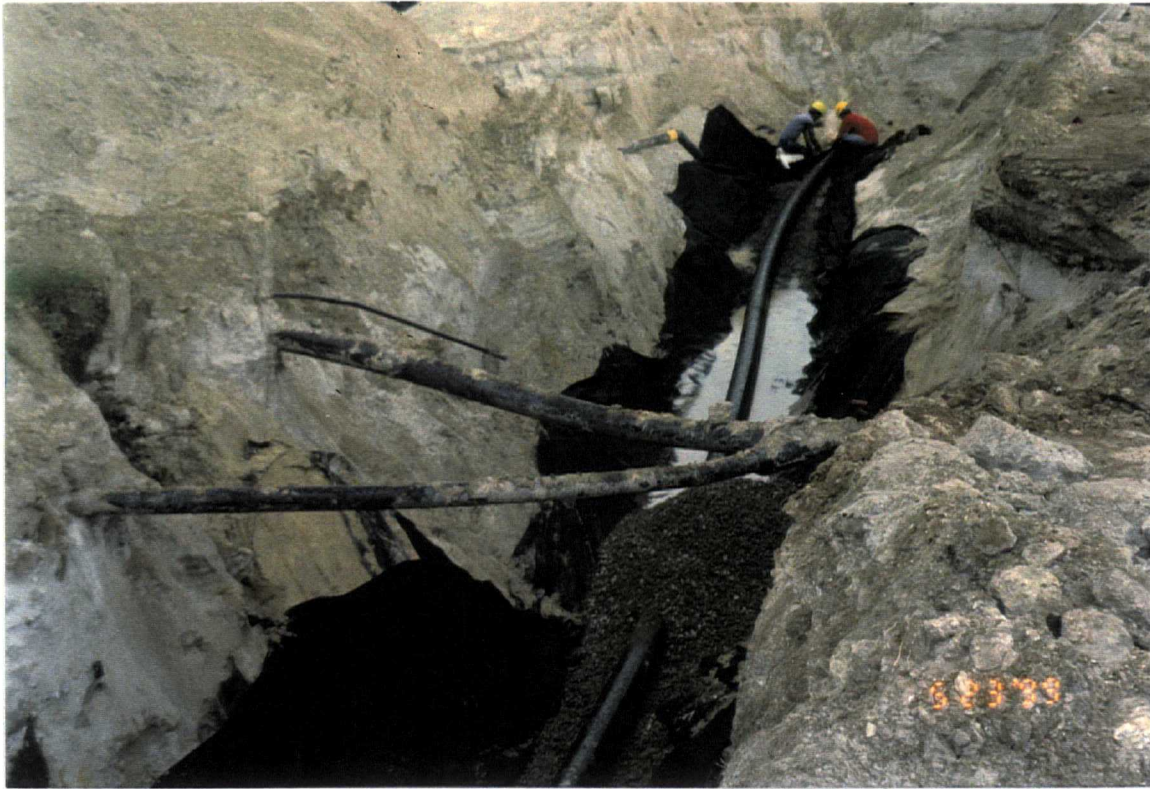
Photograph Number 26

Date: May 22, 1999 Site: Southeast County Landfill, Hillsborough County, FL  
Description: Phase VI internal berm gravel Trench No. 4 (looking northwest).

- REMOVE BROKEN "T" IN LCRS HEADER, PH IV, TRENCH NO. 4
- REPLACE WITH "WYE" TIED IN TO PH IV PIPE WITH RUBBER BOOTS AND CLAMPS.
- CONNECT "WYE" TO PH VI LCRS WITH A 4 FT SLIPJOINT. WRAP NONWOVEN GEOTEXTILE AROUND THE JOINT TIGHTLY OVERLAPPING THE "WYE" AND PH VI LCRS PIPE BY 2 FT. GEOTEXTILE AROUND THE SLIPJOINT OVERLAPPED > 2 FT
- BACKFILL WITH GRAVEL AND COVER WITH NONWOVEN GEOTEXTILE, AND CLEAN SAND.

NOTE: WORK PERFORMED TO REPLACE BROKEN TEE ON 5-22-99

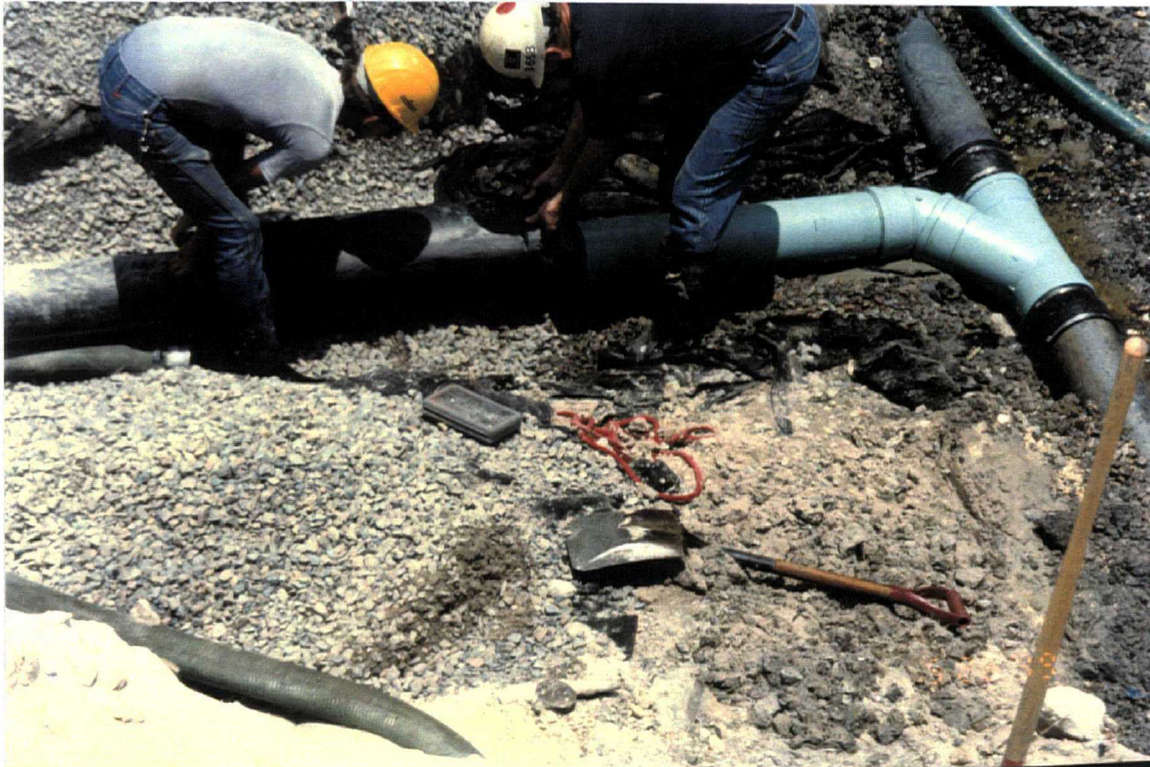
Photograph Number 27

Date: May 25, 1999 Site: Southeast County Landfill, Hillsborough County, FL  
Description: Phase IV internal berm gravel Trench No. 4 (looking east).

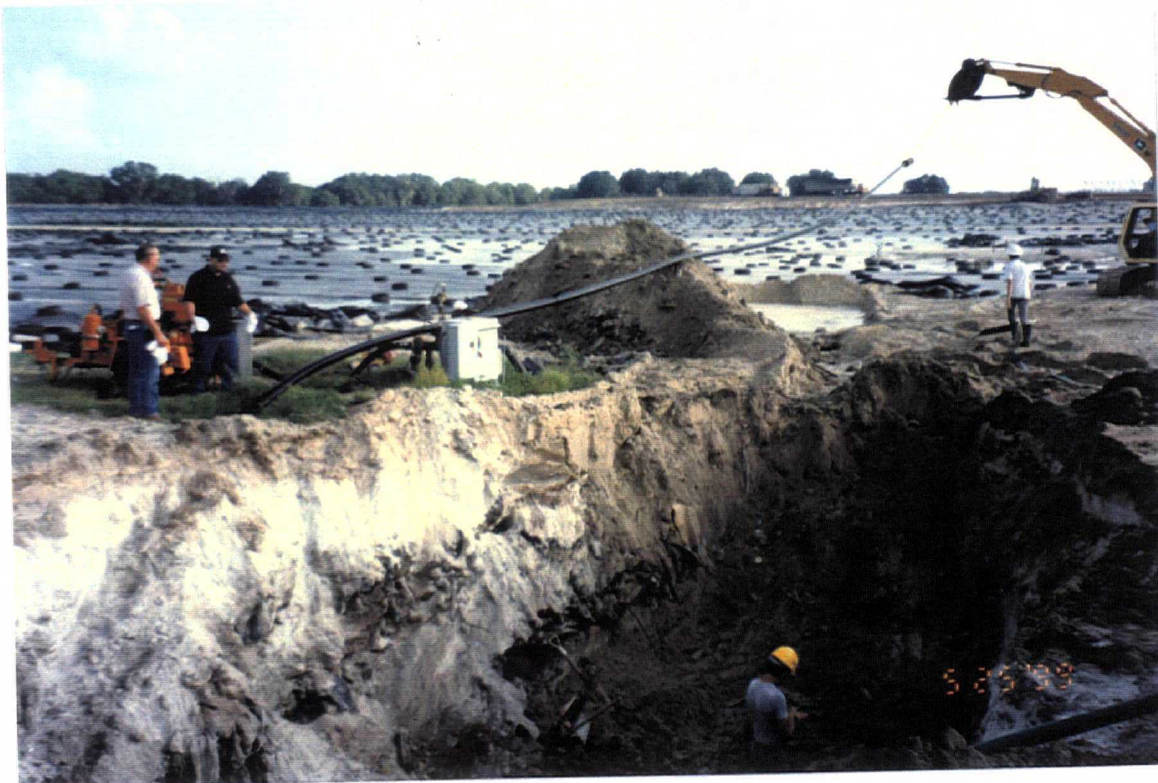
Photograph Number 28

**Date:** May 25, 1999      **Site:** Southeast County Landfill, Hillsborough County, FL  
**Description:** Removal of TPS-5 suction line (looking northwest).

Removal of Temporary Pump Station No. 3 (TPS-3) and Temporary Pump Station No. 4 (TPS-4) began on May 12 and was completed on May 14, 1999. Temporary Pump Station No. 5 (TPS-5) was removed on May 25, 1999.
