**HILLSBOROUGH COUNTY
SOUTHEAST COUNTY LANDFILL
EFFLUENT/LEACHATE STORAGE TANK
CERTIFICATION OF CONSTRUCTION
COMPLETION**

**ENVIRONMENTAL RESOURCE PERMIT
NO. 29-0270881-003**

**HILLSBOROUGH COUNTY
SOUTHEAST COUNTY LANDFILL
EFFLUENT/LEACHATE STORAGE TANK**

**CERTIFICATION OF CONSTRUCTION
COMPLETION**

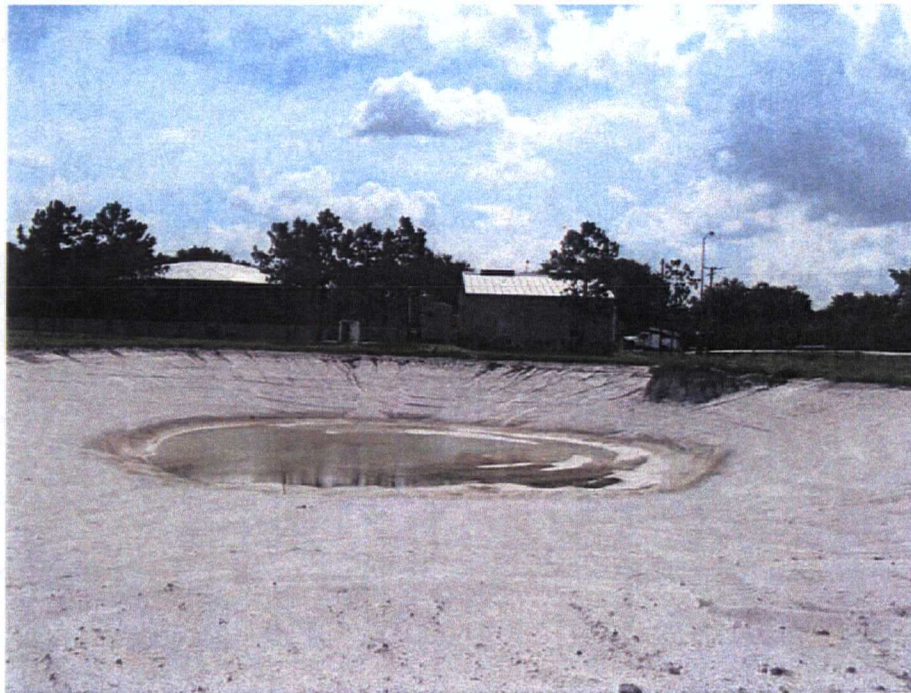
August 12, 2008. The Effluent/Leachate Storage Tank Excavation Area Preconstruction Photo - Facing east towards the LTRF. This area has been excavated by the SWMD for the sand material and work will continue by Woodruff.

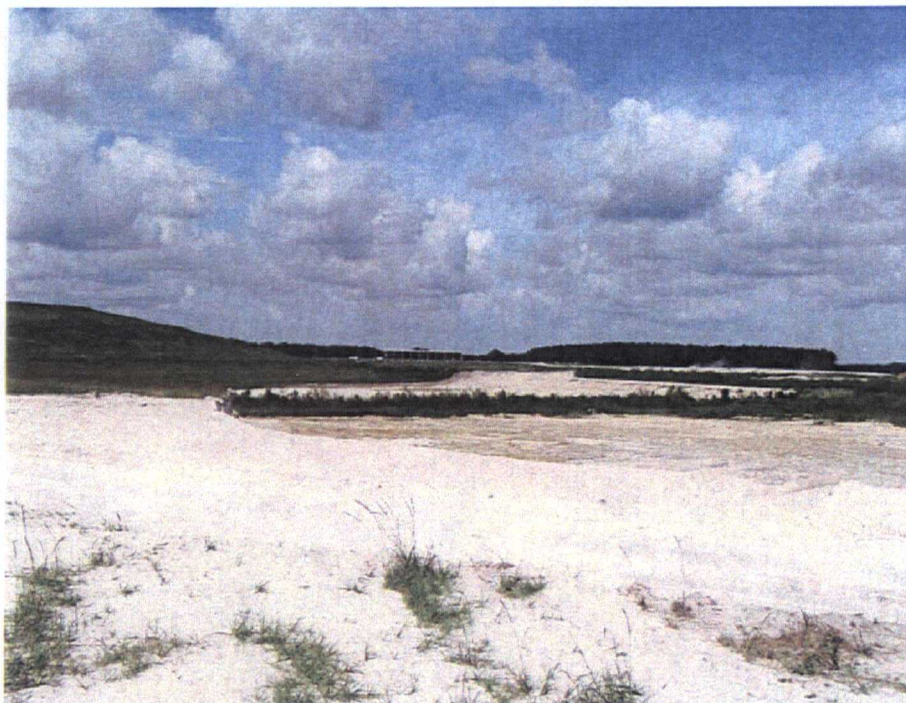
August 12, 2008. Effluent/Leachate Storage Tank Preconstruction Photo - Work area including the site for the truck loading facility facing west towards the tire site and the north side of Sections 8 and 9.

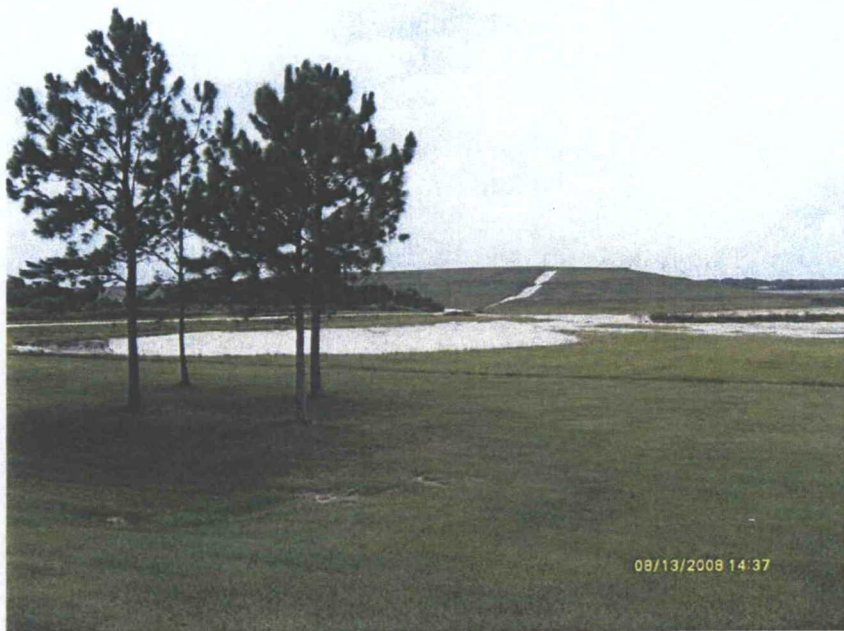
August 13, 2008. The Effluent/Leachate Storage Tank Excavation Area Preconstruction Photo – This photo is facing west from the LTRF to Section 8 across the entire Effluent/Leachate Storage Tank work area. This area has been excavated by the SWMD for the sand material and work will continue by Woodruff.

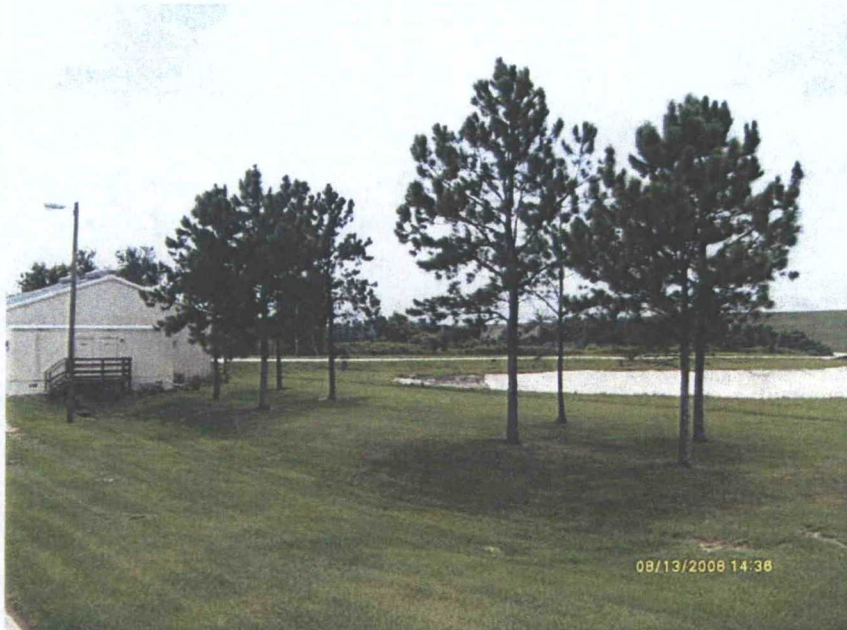
August 13, 2008. Effluent/Leachate Storage Tank Preconstruction Photo - Work area for the Effluent/Leachate Storage Tank project facing south from the LTRF. The existing maintenance building at the LTRF is shown to the left.

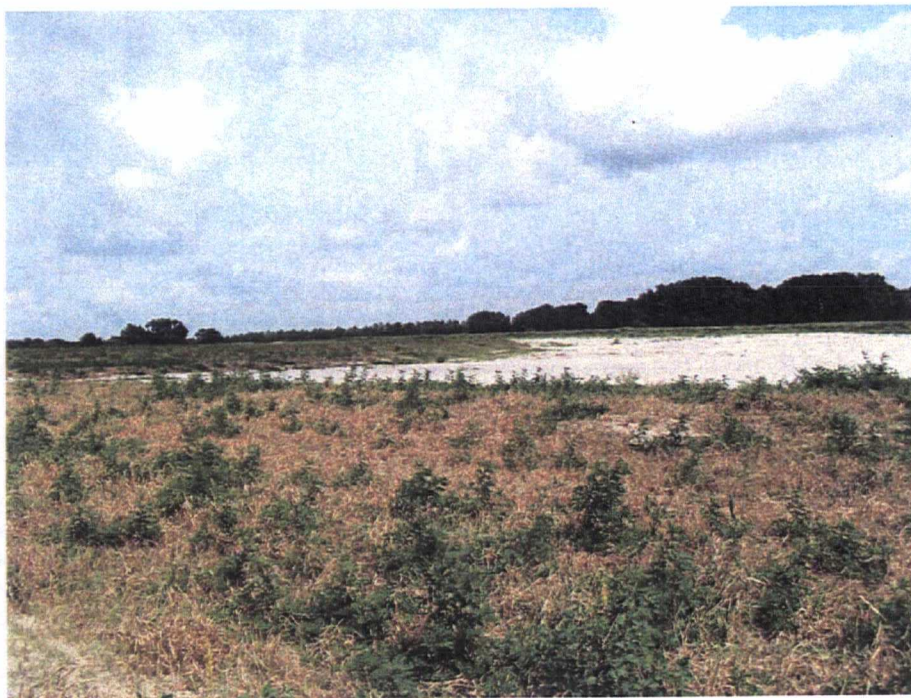
August 12, 2008. Soil Recovery Area Preconstruction Photo – Depicting the Soil Recovery Area before excavation work for the subgrade material for the tank has begun. This photo is facing north.

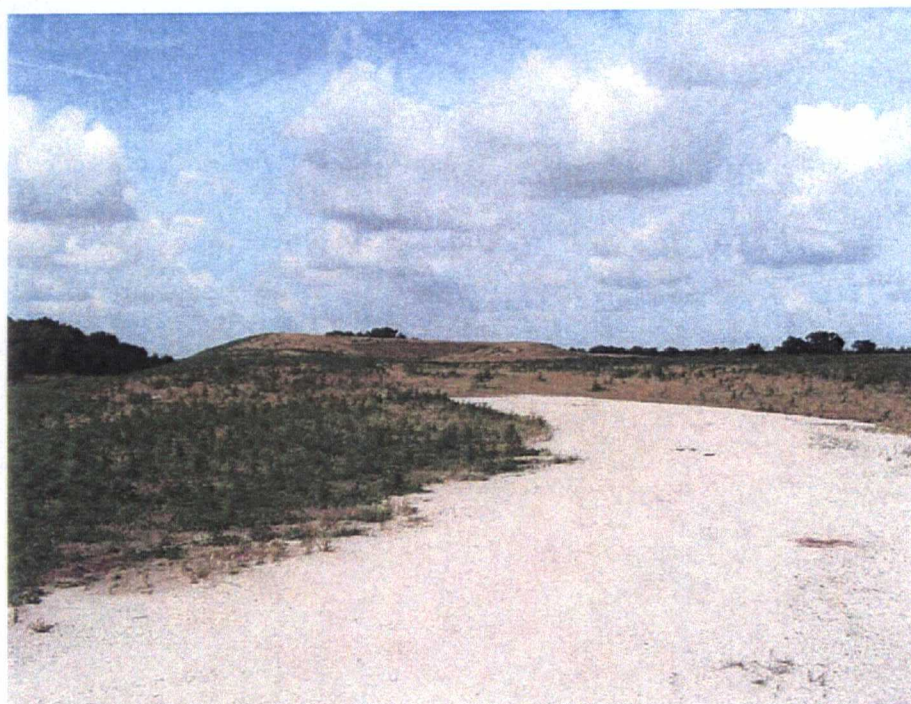
August 12, 2008. Soil Recovery Area Preconstruction Photo – Depicting the Soil Recovery Area before excavation work for the subgrade material for the tank has begun. This photo is facing west.

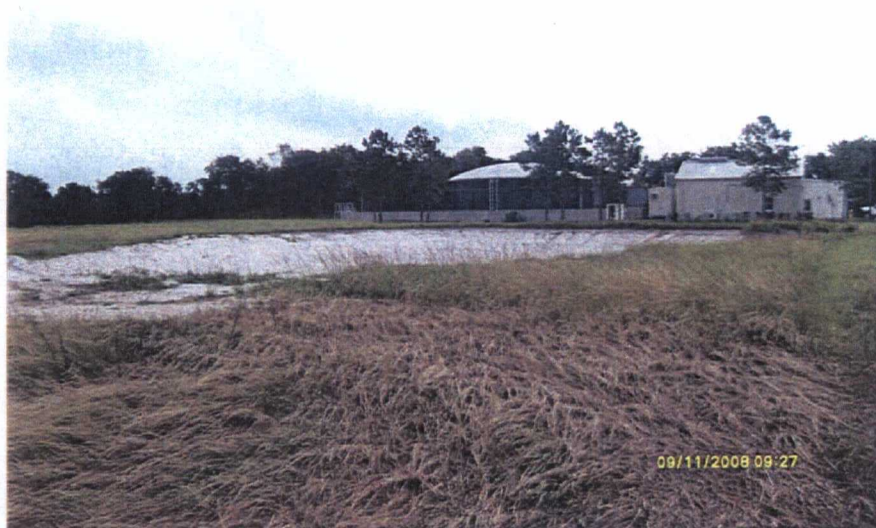
September 11, 2008. The Effluent/Leachate Storage Tank Excavation Area Preconstruction Photo - Facing east towards the LTRF. This area has been excavated by the SWMD for the sand material and work will continue by Woodruff.

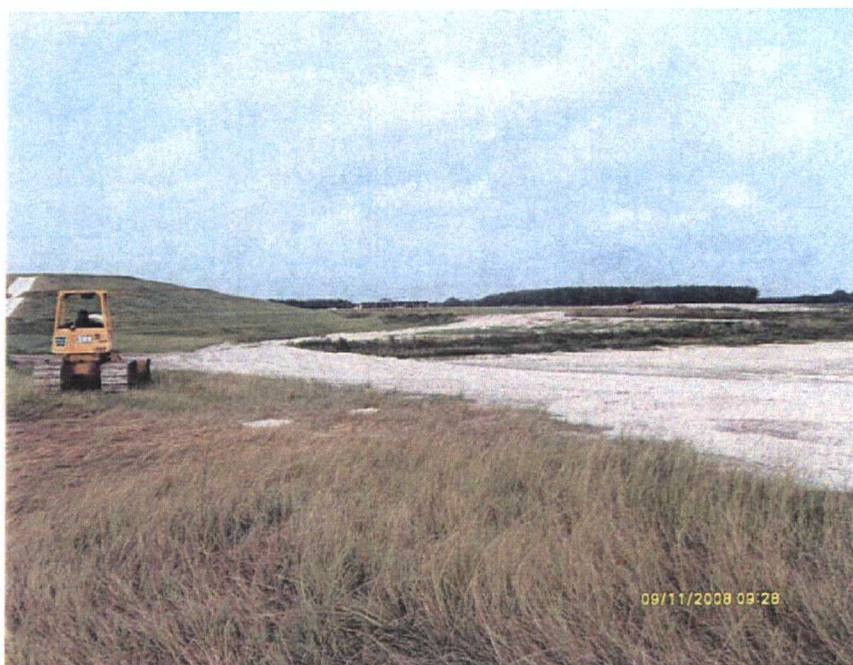
September 11, 2008. Effluent/Leachate Storage Tank Preconstruction Photo - Work area including the site for the truck loading facility facing west towards the tire site and the north side of Sections 8 and 9.

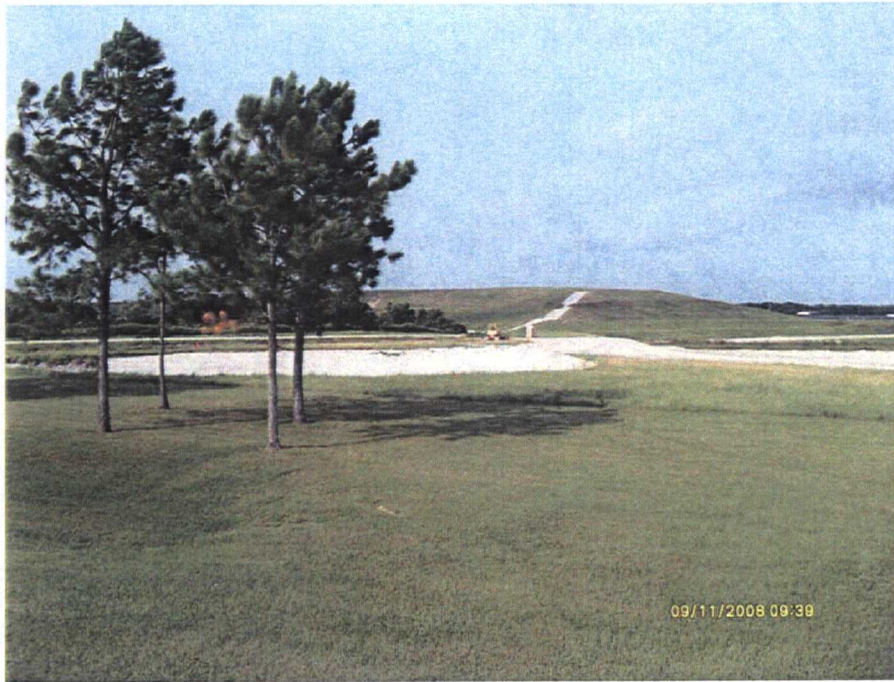
September 11, 2008. The Effluent/Leachate Storage Tank Excavation Area Preconstruction Photo – This photo is facing west from the LTRF to Section 8 across the entire Effluent/Leachate Storage Tank work area. This area has been excavated by the SWMD for the sand material and work will continue by Woodruff.

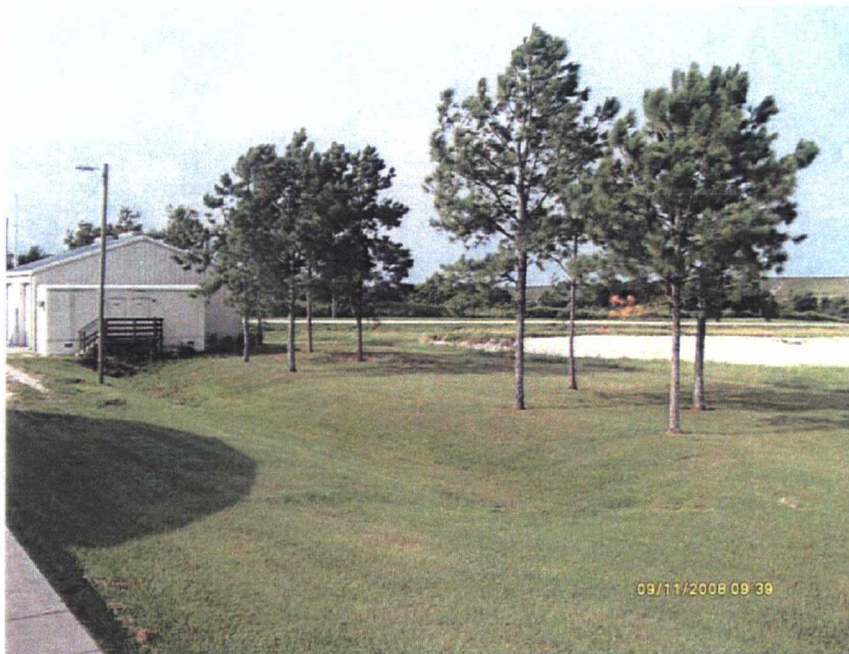
September 11, 2008. Effluent/Leachate Storage Tank Preconstruction Photo - Work area for the Effluent/Leachate Storage Tank project facing south from the LTRF. The existing maintenance building at the LTRF is shown to the left.

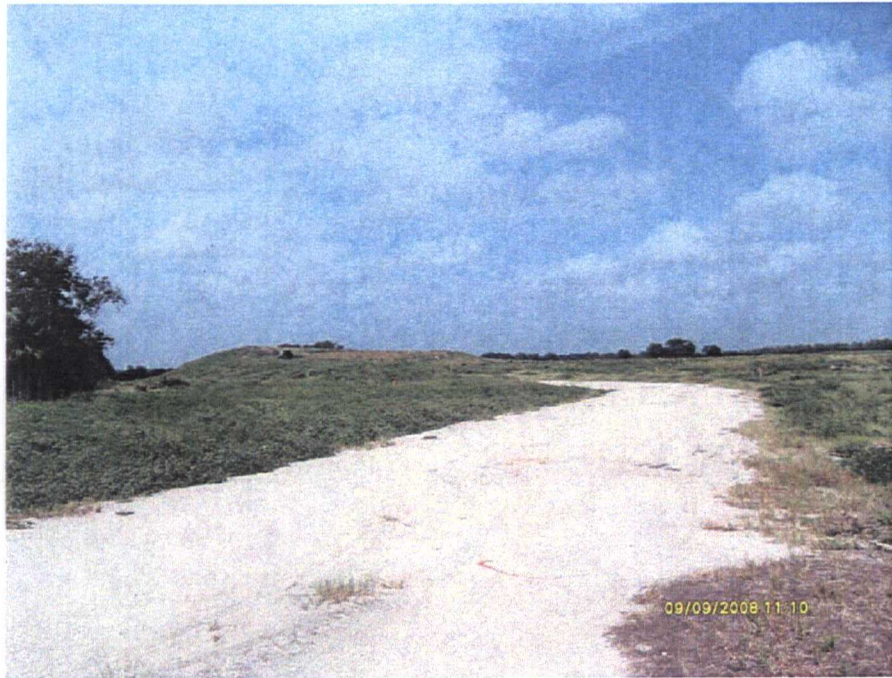
September 9, 2008. Soil Recovery Area Preconstruction Photo – Depicting the Soil Recovery Area before excavation work for the subgrade material for the tank has begun. This photo is facing west.

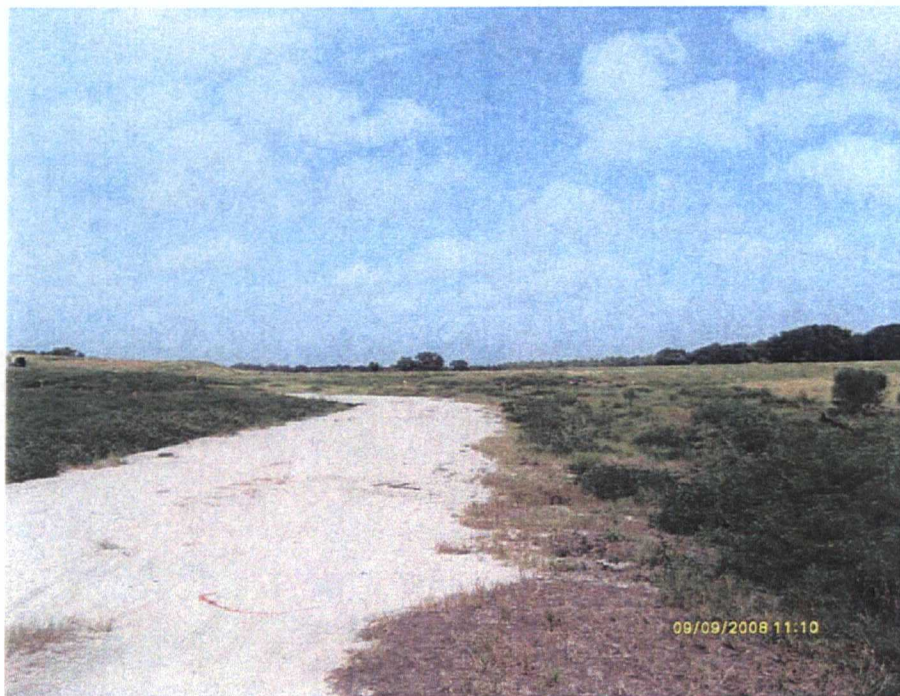
September 9, 2008. Soil Recovery Area Preconstruction Photo – Depicting the Soil Recovery Area before excavation work for the subgrade material for the tank has begun. This photo is facing northwest.

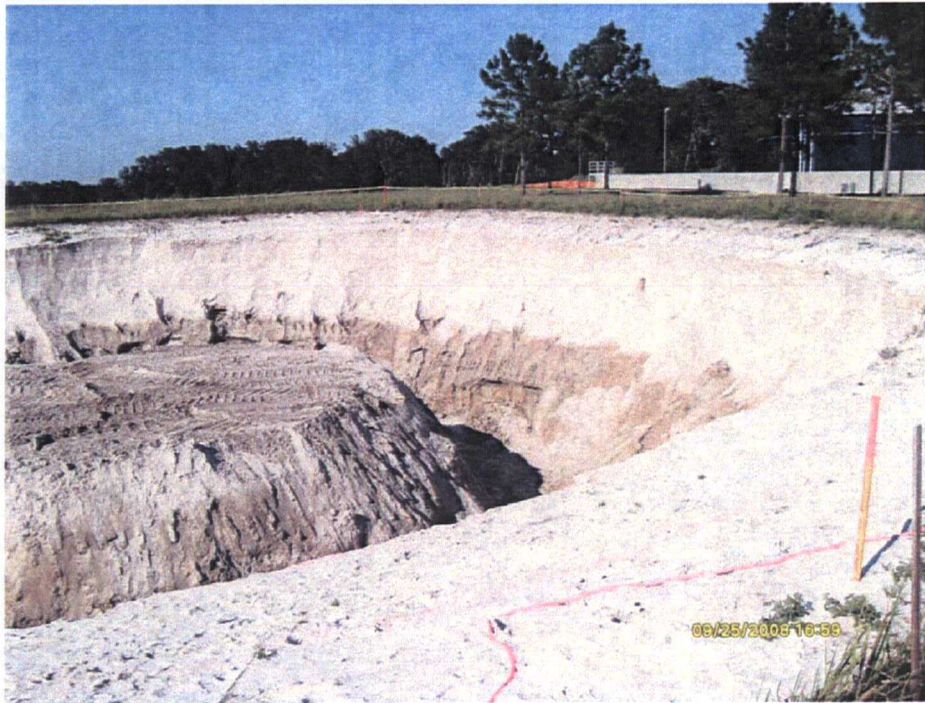
September 25, 2008. The Effluent/Leachate Storage Tank Beginning Excavation/Dewatering - Facing east towards the LTRF. WSI has constructed a rim ditch in the area to begin initial dewatering investigations and pumping.

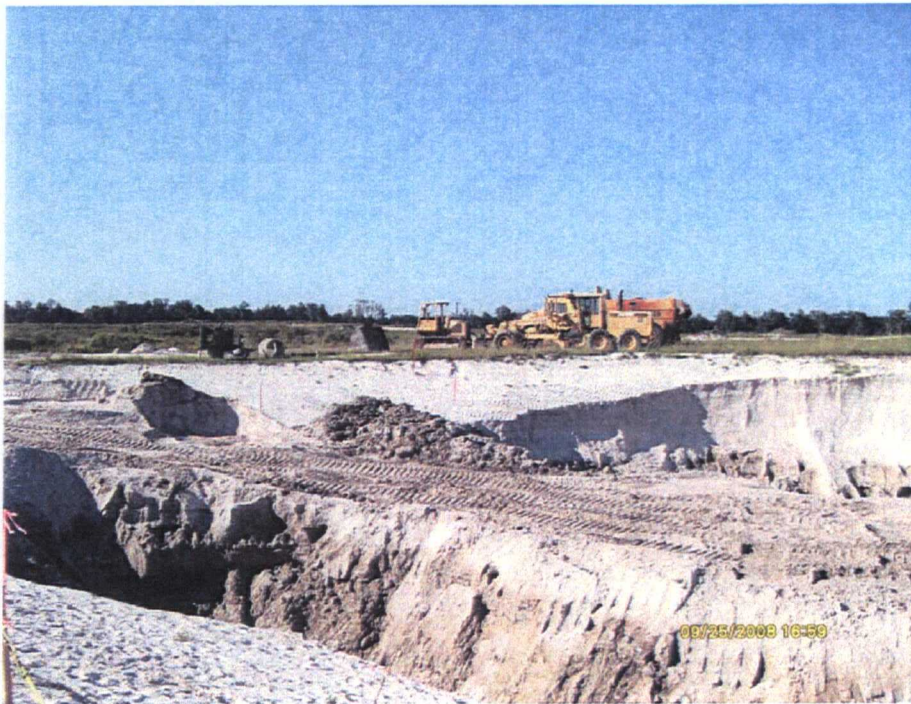
September 25, 2008. Effluent/Leachate Storage Tank Beginning Excavation/Dewatering - Work area including the site for the truck loading facility looking to the northwest.

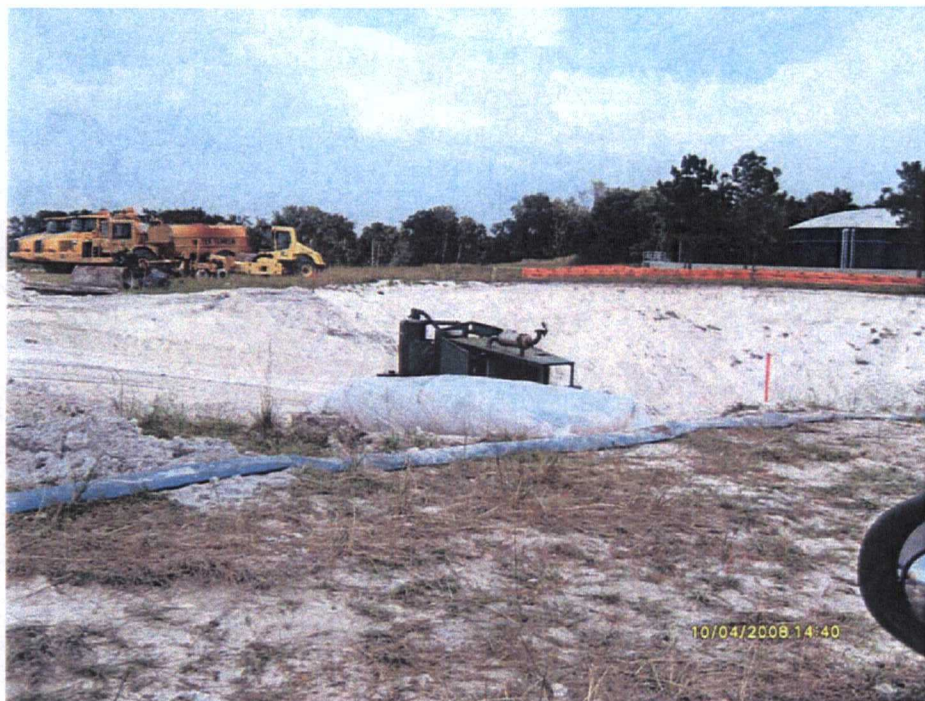
October 4, 2008. The Effluent/Leachate Storage Tank Excavation Area – Looking to the east to the LTRF showing the excavation and dewatering pump.

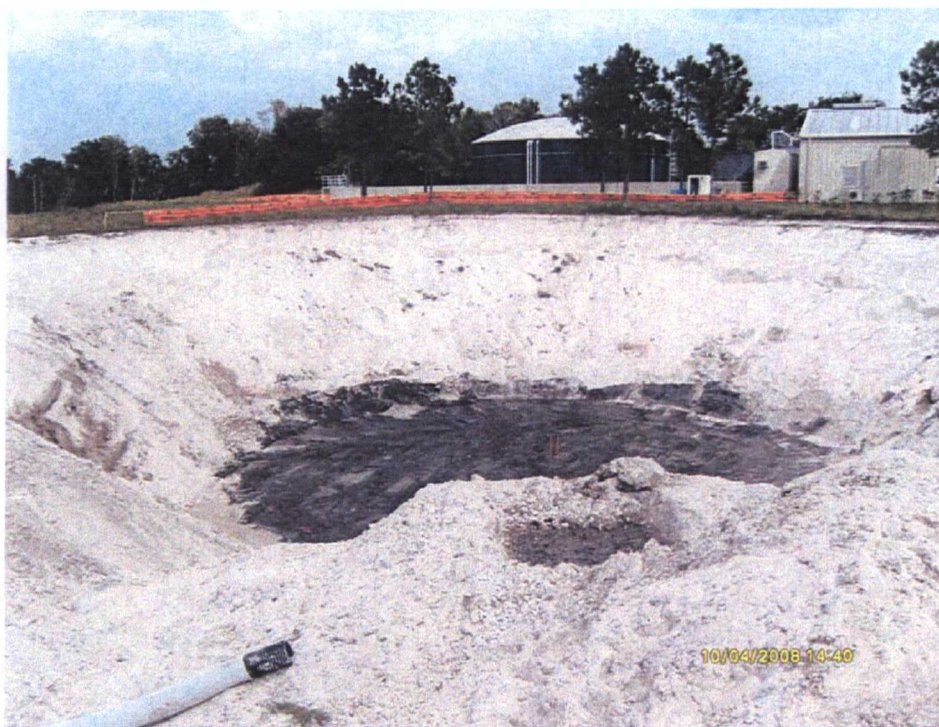
October 4, 2008. Effluent/Leachate Storage Tank Excavation – The bottom of the tank excavation is shown. The waste clays have been removed from the site and the natural ground (dark soil) is at the bottom. The site has been dewatered and the water level is below the excavation bottom.

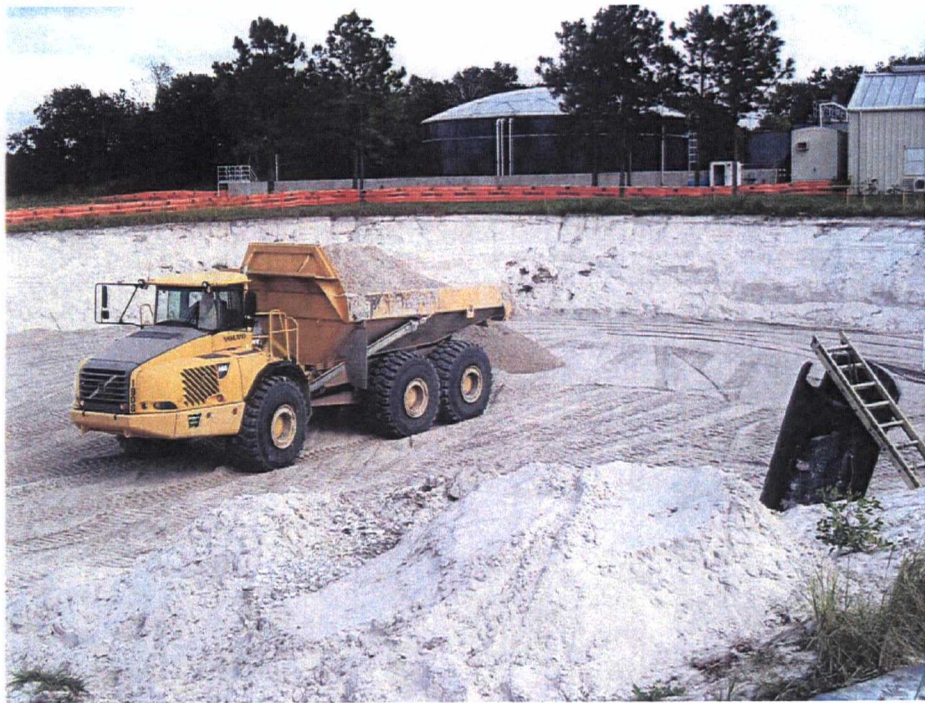
October 14, 2008. The Effluent/Leachate Storage Tank Excavation Backfill Operations – Looking to the east to the LTRF showing the backfill operations for the excavation area. The Kelly Well used for dewatering operation is also shown on the right side of the photo.

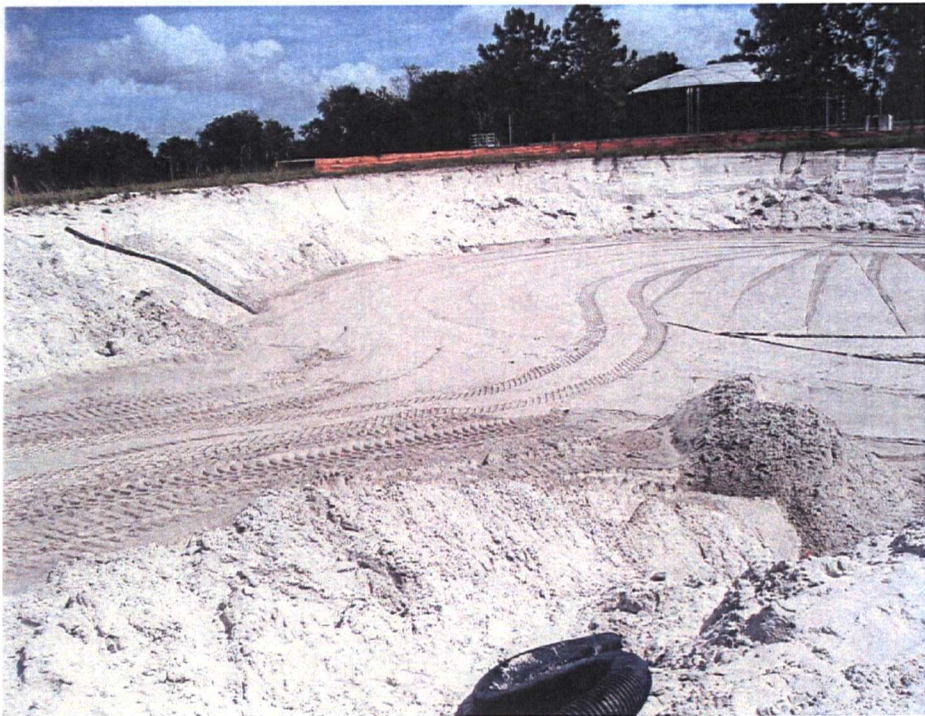
October 14, 2008. Effluent/Leachate Storage Tank Backfill – Backfill in the effluent/leachate storage tank area.

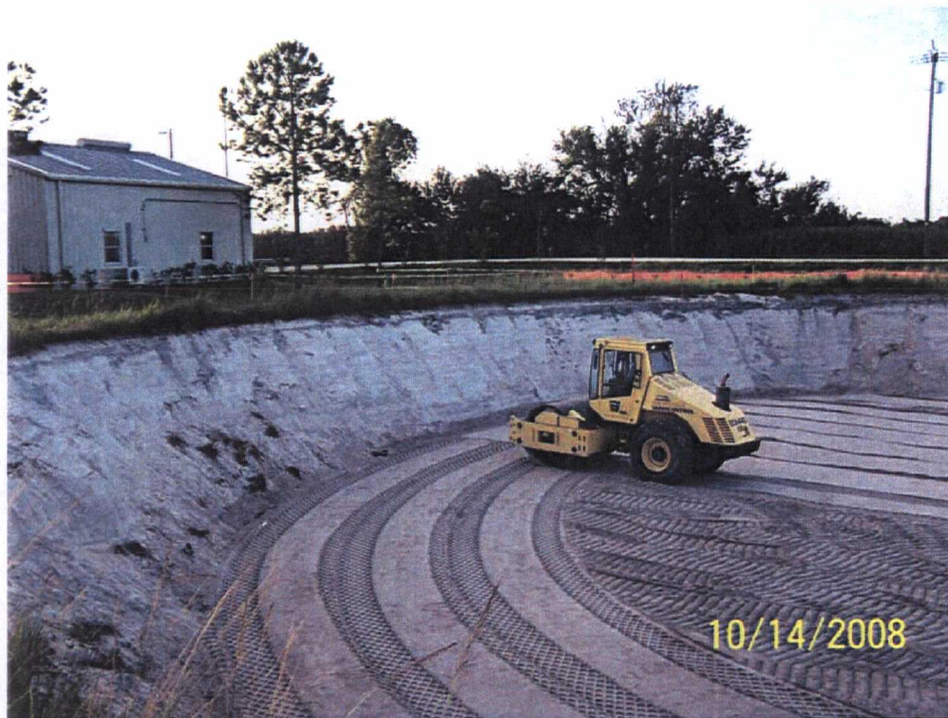
October 14, 2008. Effluent/Leachate Storage Tank Backfill - Facing east towards the LTRF. Compaction of subgrade and subbase material for tank area.

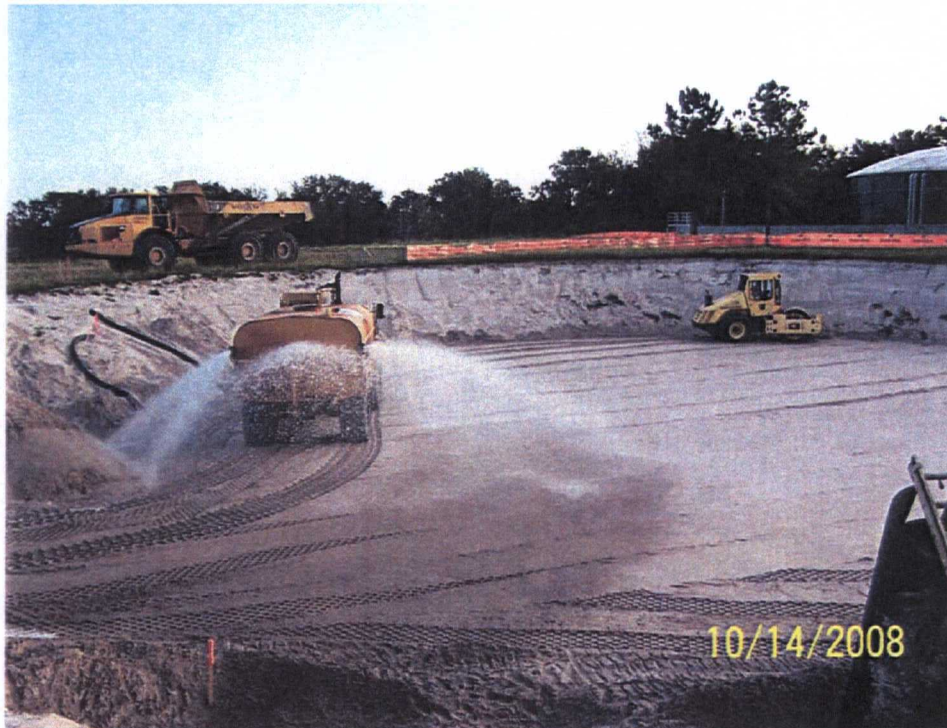
October 14, 2008. Effluent/Leachate Storage Tank Backfill - Facing east towards the LTRF. Compaction of subgrade and subbase material for tank area including watering.

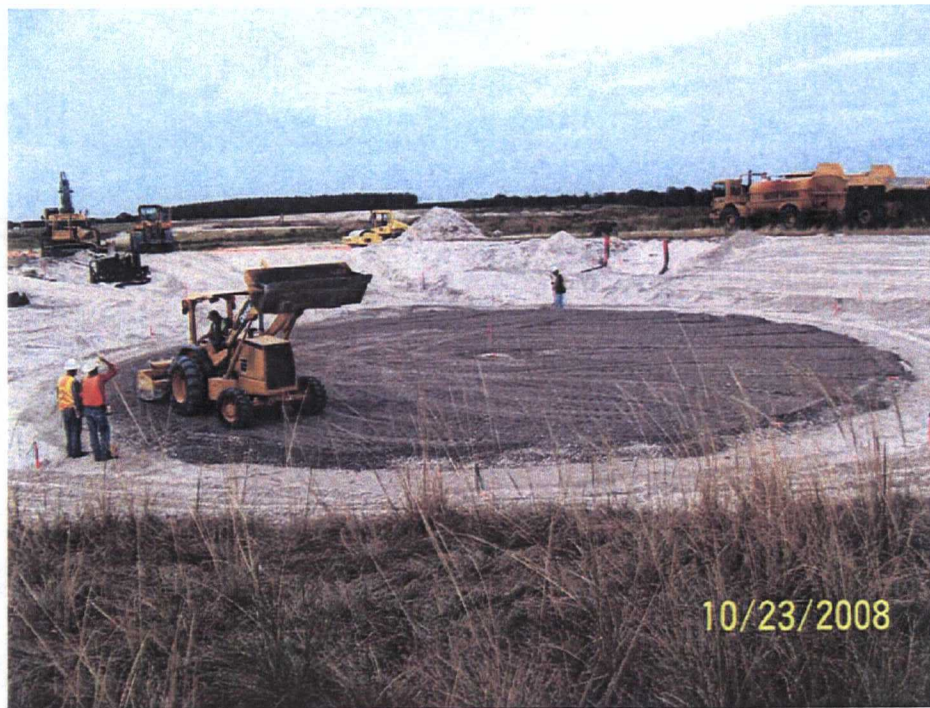
October 23, 2008. Effluent/Leachate Storage Tank Backfill - Facing west towards the borrow area. Compaction and placement of crushed rock for concrete pad foundation.

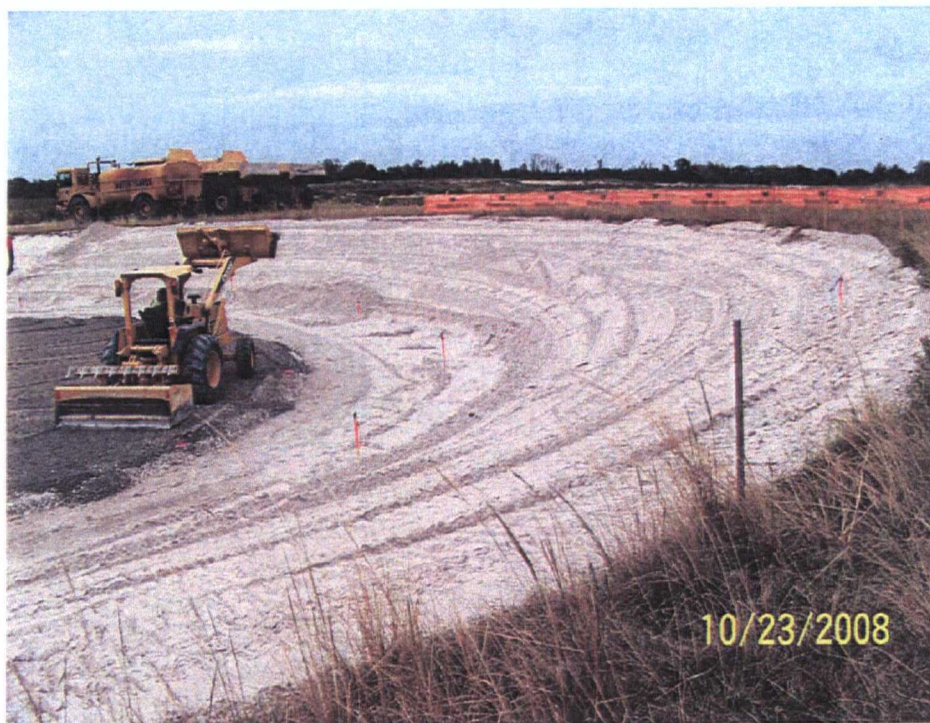
October 23, 2008. Effluent/Leachate Storage Tank Backfill - Facing west towards the borrow area. Compaction and placement of crushed rock for concrete pad foundation.

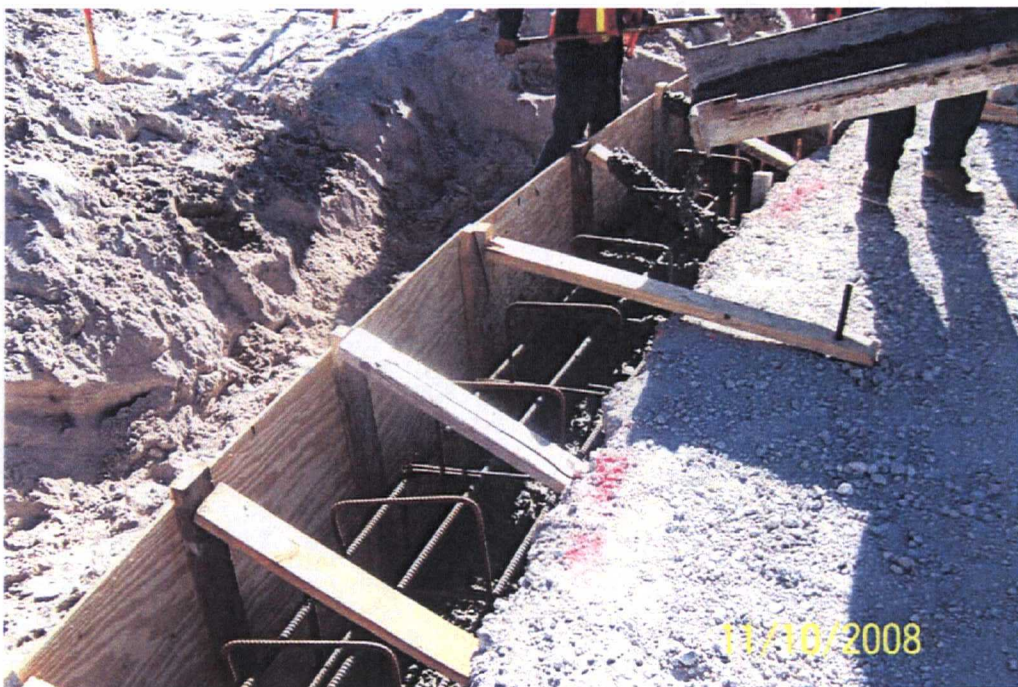
November 10, 2008. Effluent/Leachate Storage Tank Ring Wall Foundation Installation – Form boards and rebar for ring wall.

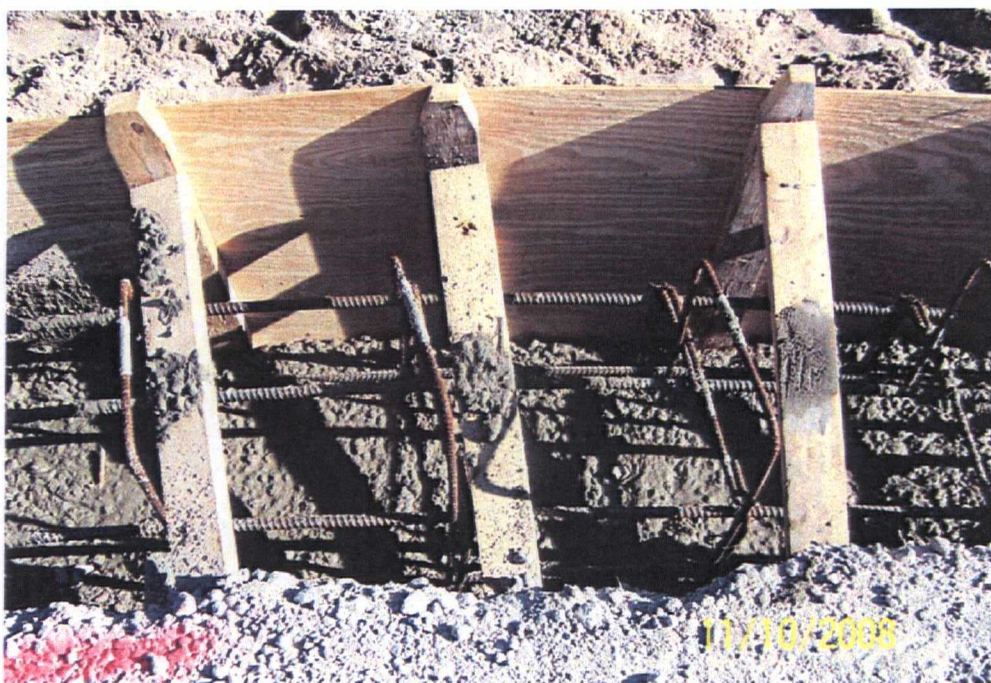
November 10, 2008. Effluent/Leachate Storage Tank Ring Wall Foundation Installation – Form boards and rebar for ring wall. Concrete pour into ring wall footer forms.

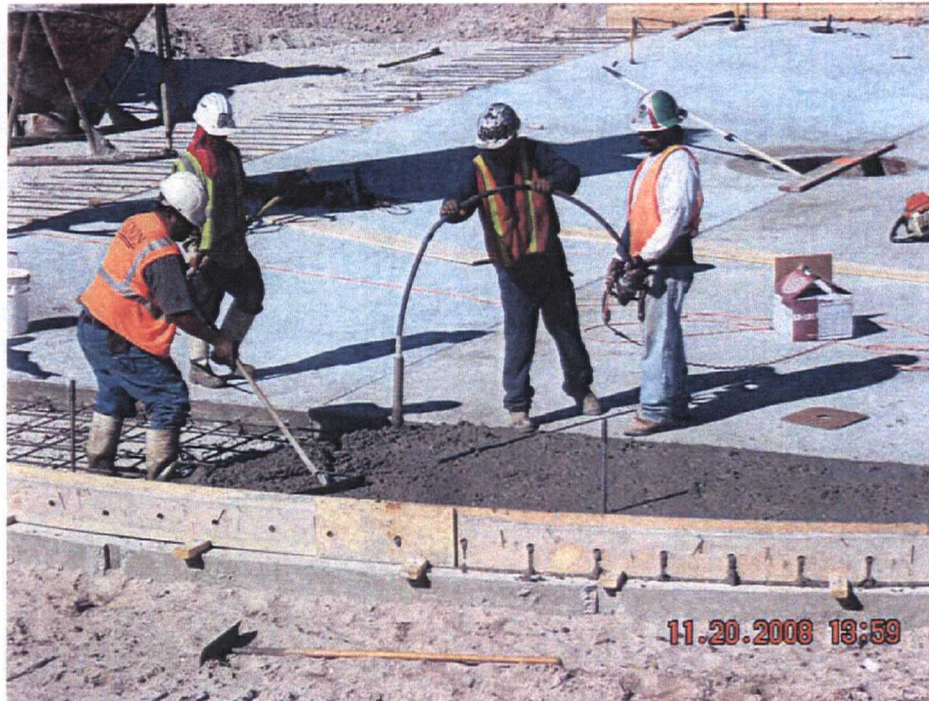
November 20, 2008. Effluent/Leachate Storage Tank Concrete Slab – Working on the tie in area on the south side of the tank site.

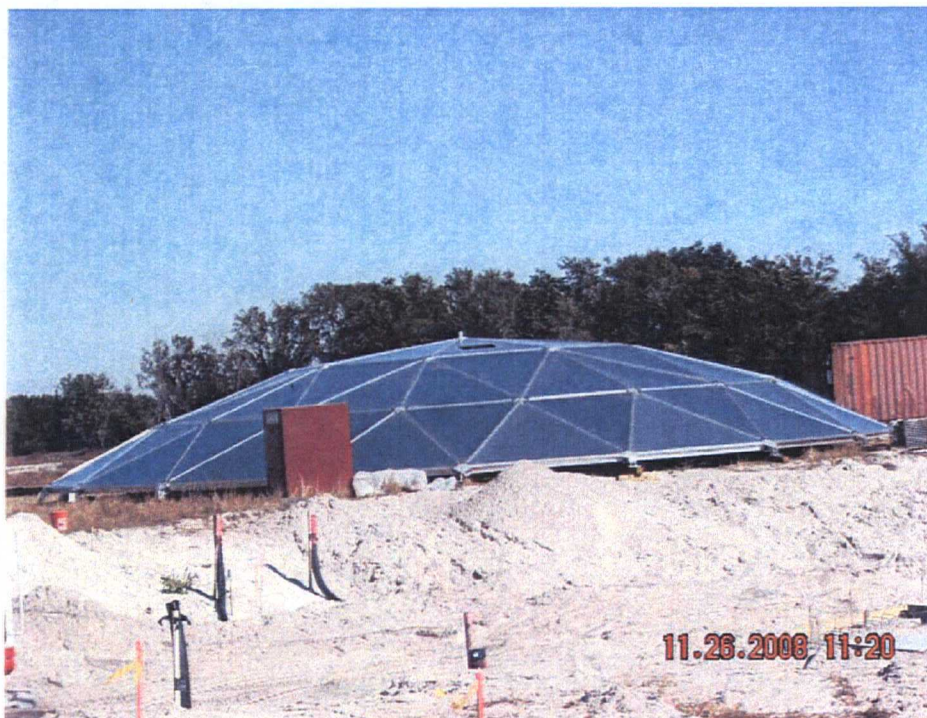
November 26, 2008. Effluent/Leachate Storage Tank Alumadome Roof – Facing north from the tank site. The roof construction is completed.

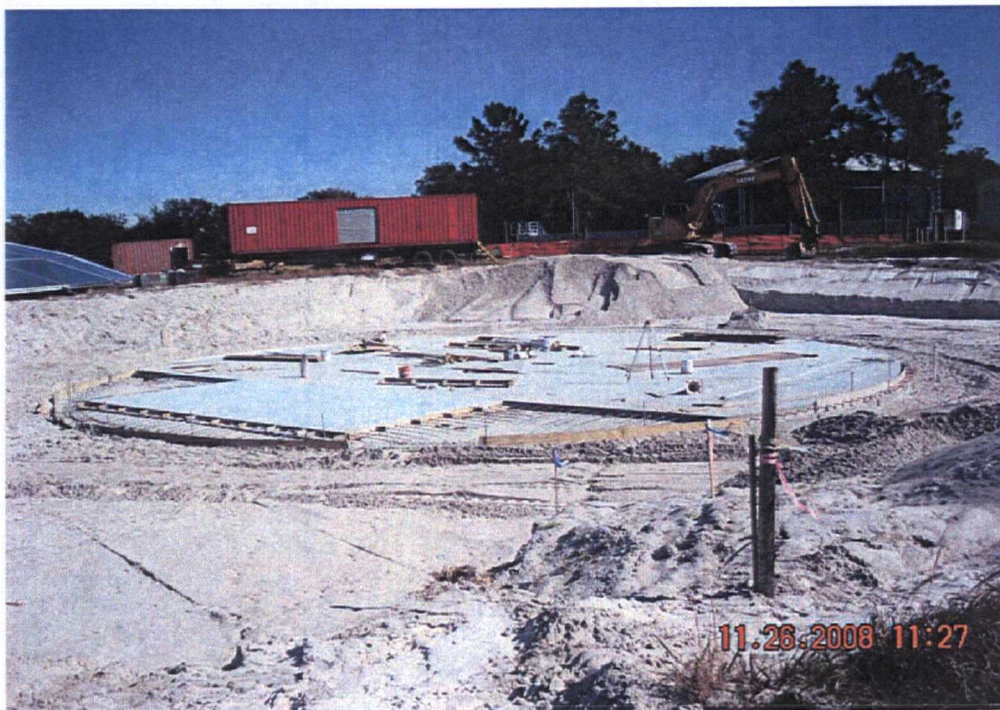
November 26, 2008. Effluent/Leachate Storage Tank Concrete Slab - Facing east towards the LTRF. The final tie-in areas are left to pour.

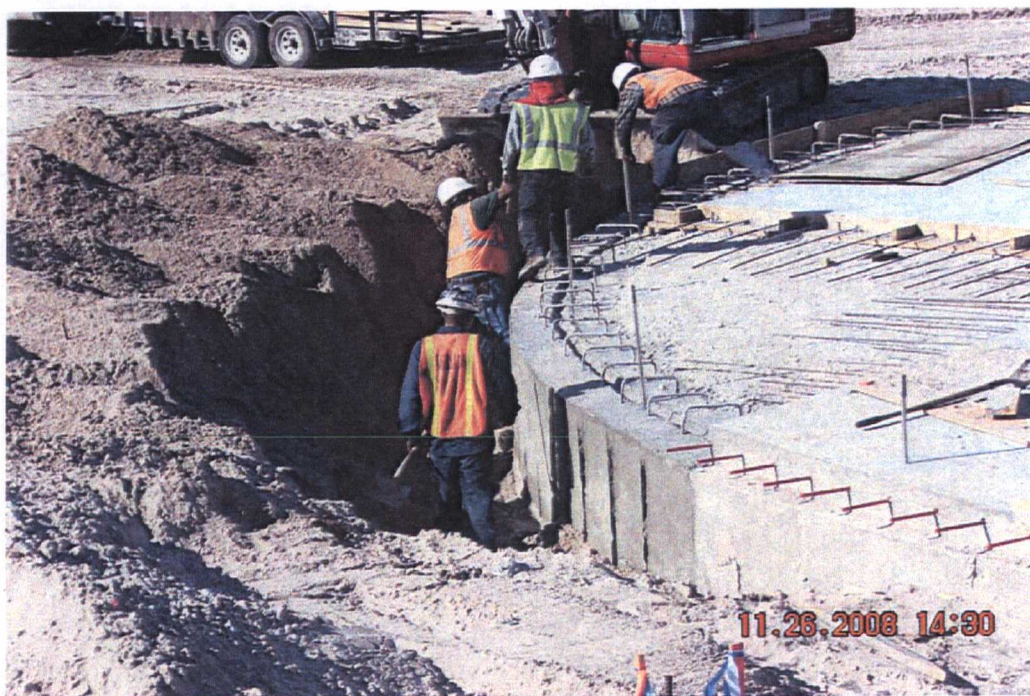
November 26, 2008. Effluent/Leachate Storage Tank Concrete Slab Construction - Facing west towards the borrow area.

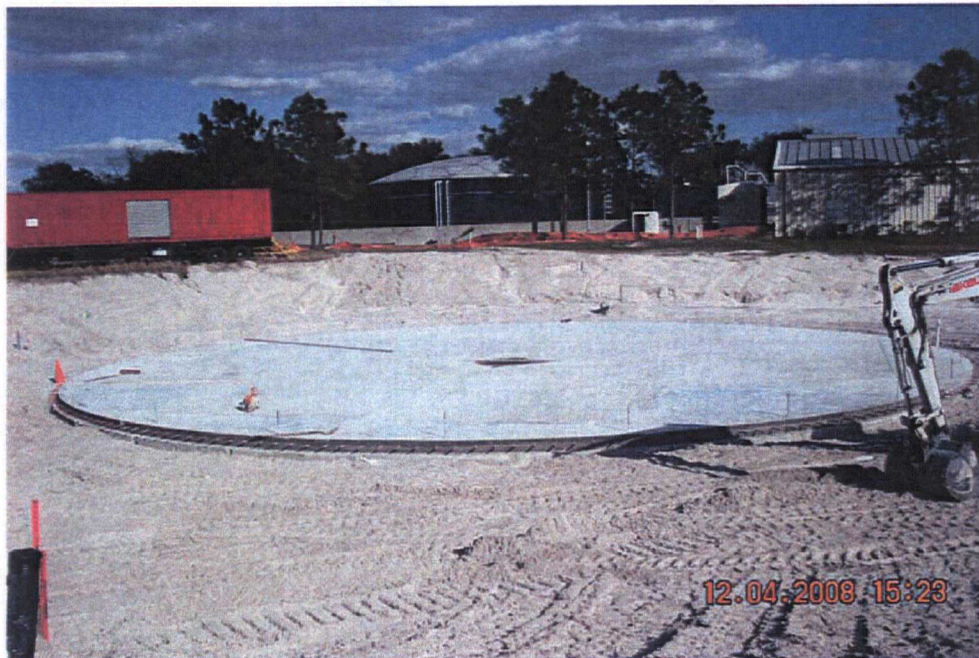
December 4, 2008. Effluent/Leachate Storage Tank Concrete Slab – Finished concrete slab. All pours completed.

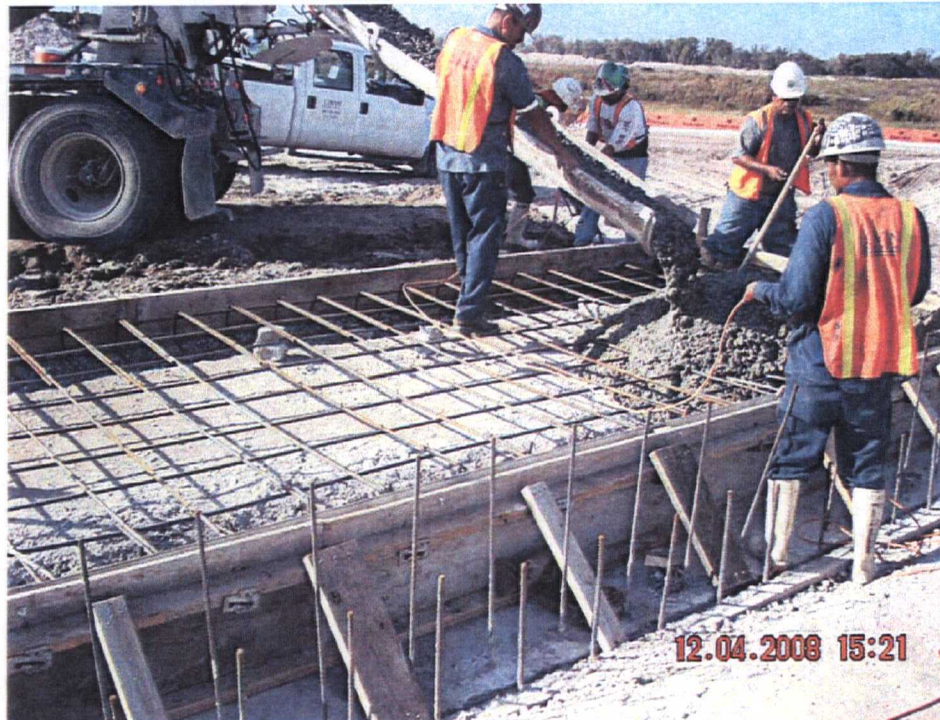
December 4, 2008. Effluent/Leachate Storage Tank Truck Loading Area Trench Drain and truck loading slab – Facing north from the tank site. Pouring the concrete for the truck loading area floor slab.

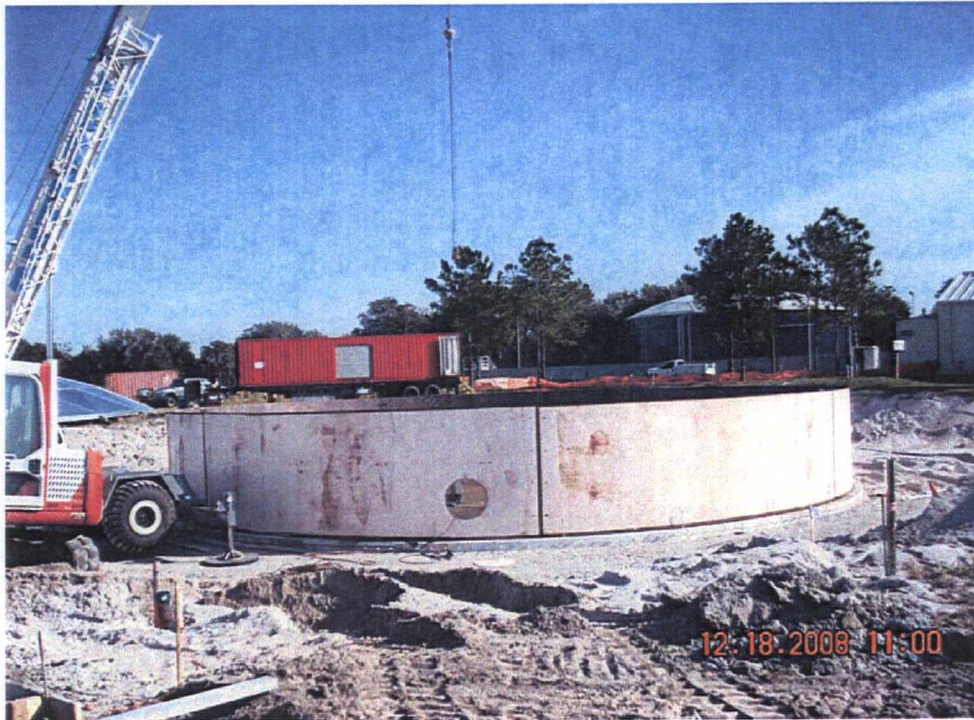
December 18, 2008. Effluent/Leachate Storage Tank - Facing east towards the LTRF. Tampa Tank (tank manufacturer) begins constructing the tank structure on the tank slab.

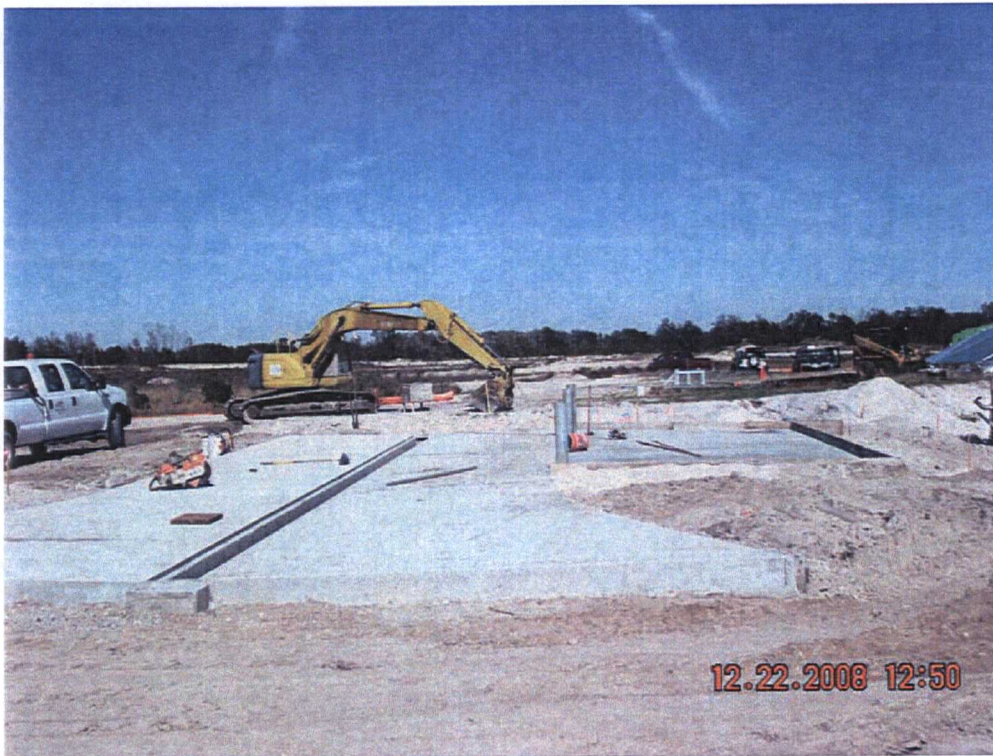
December 18, 2008. Effluent/Leachate Storage Tank - Facing north. Completed truck loading area and booster pump station pads.

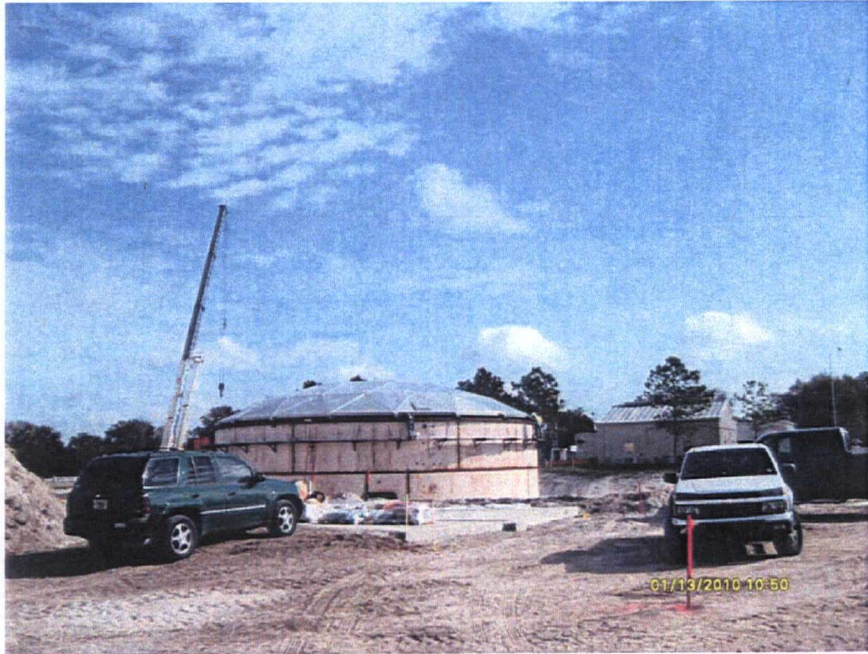
January 13, 2009. Effluent/Leachate Storage Tank – Facing east towards the LTRF. The aluminum dome roof placed on supports and connected to upper tier of storage tank. (Please note the photo indicates 1/13/2010, the photo was taken on 1/13/2009)
