**HILLSBOROUGH COUNTY
SOUTHEAST COUNTY LANDFILL
EFFLUENT/LEACHATE STORAGE TANK
CERTIFICATION OF CONSTRUCTION
COMPLETION**

**ENVIRONMENTAL RESOURCE PERMIT
NO. 29-0270881-003**

**HILLSBOROUGH COUNTY
SOUTHEAST COUNTY LANDFILL
EFFLUENT/LEACHATE STORAGE TANK**

**CERTIFICATION OF CONSTRUCTION
COMPLETION**

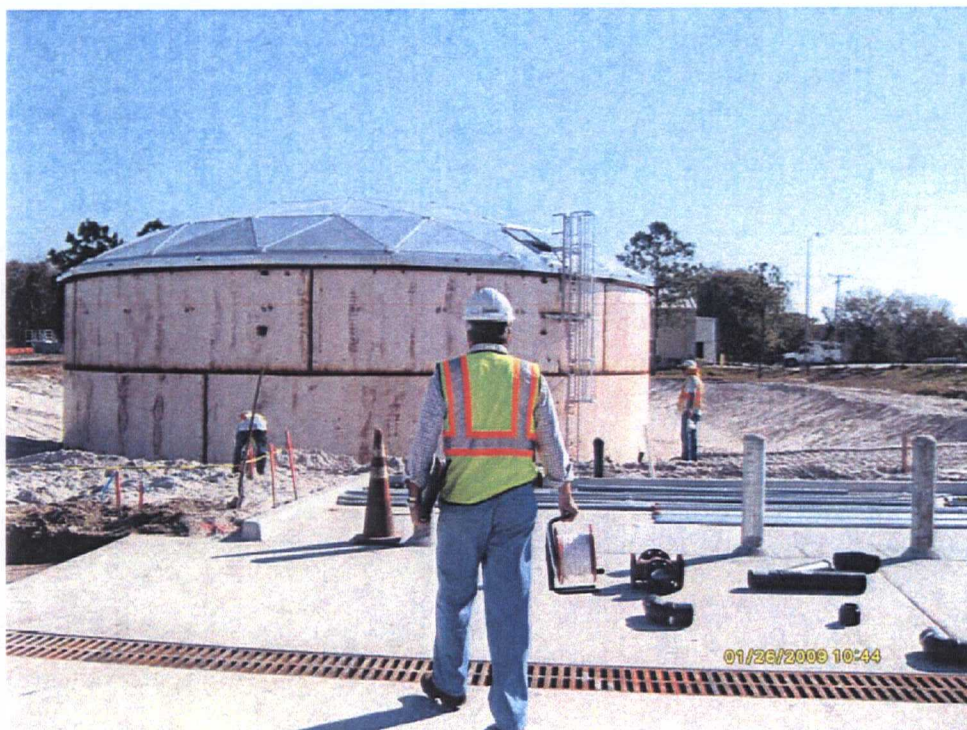
January 26, 2009. Effluent/Leachate Storage Tank - Facing east towards the LTRF. The tank construction has been completed. Contractor and Jones Edmunds are preparing for the hydrostatic test.

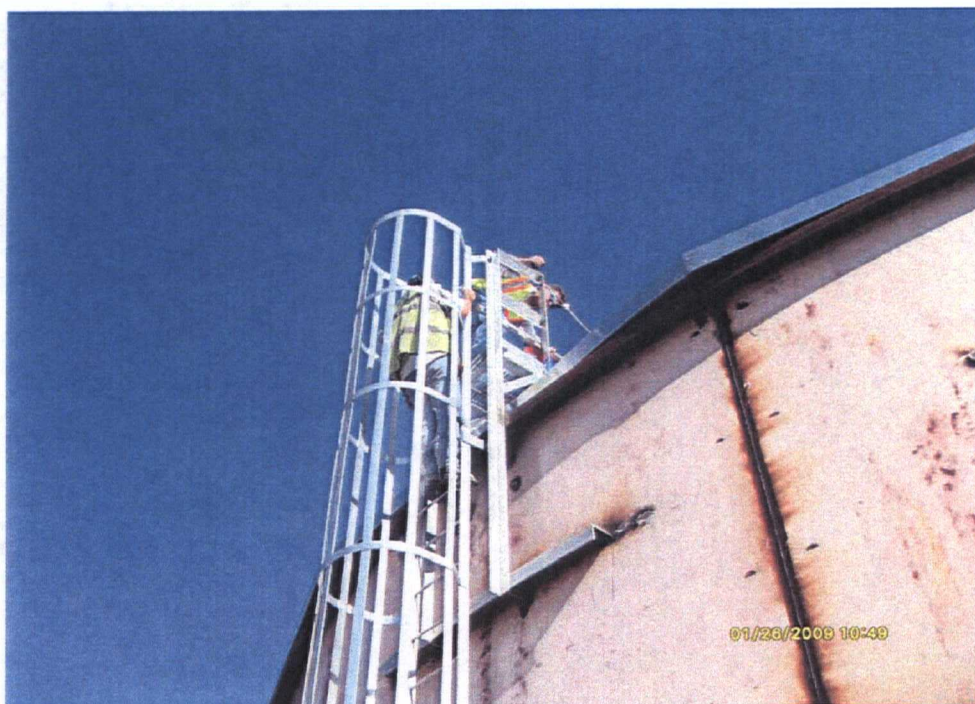
January 26, 2009. Effluent/Leachate Storage Tank. Jones Edmunds representative initiating the hydrostatic test by setting the initial water level.

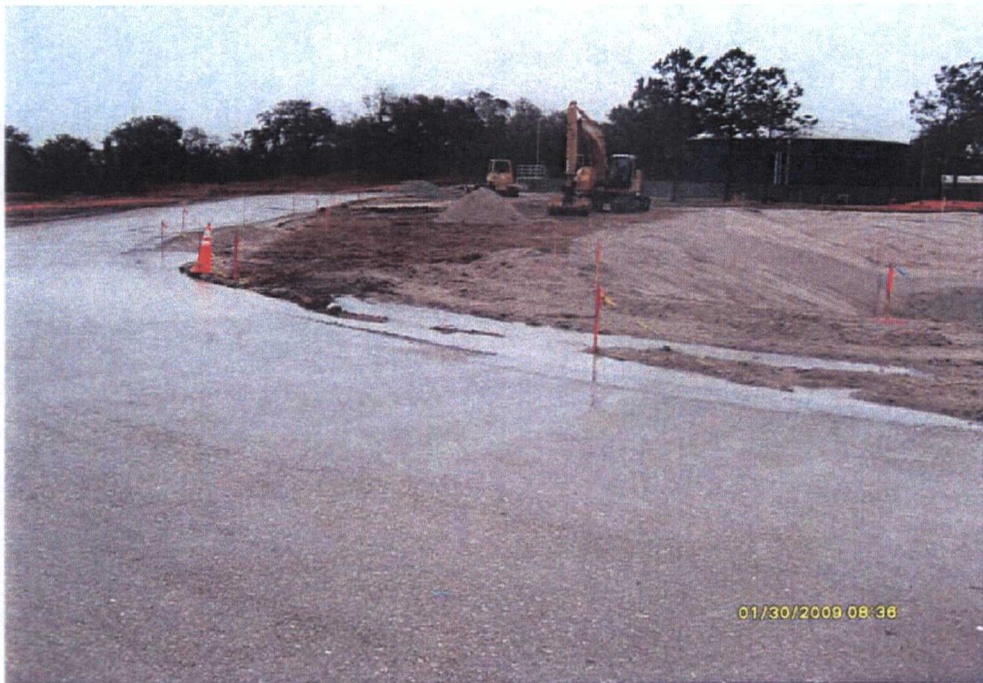
January 30, 2009. Effluent/Leachate Storage Tank Access Road - Facing east towards the LTRF. The crushed concrete base has been installed in a portion of the roadway.

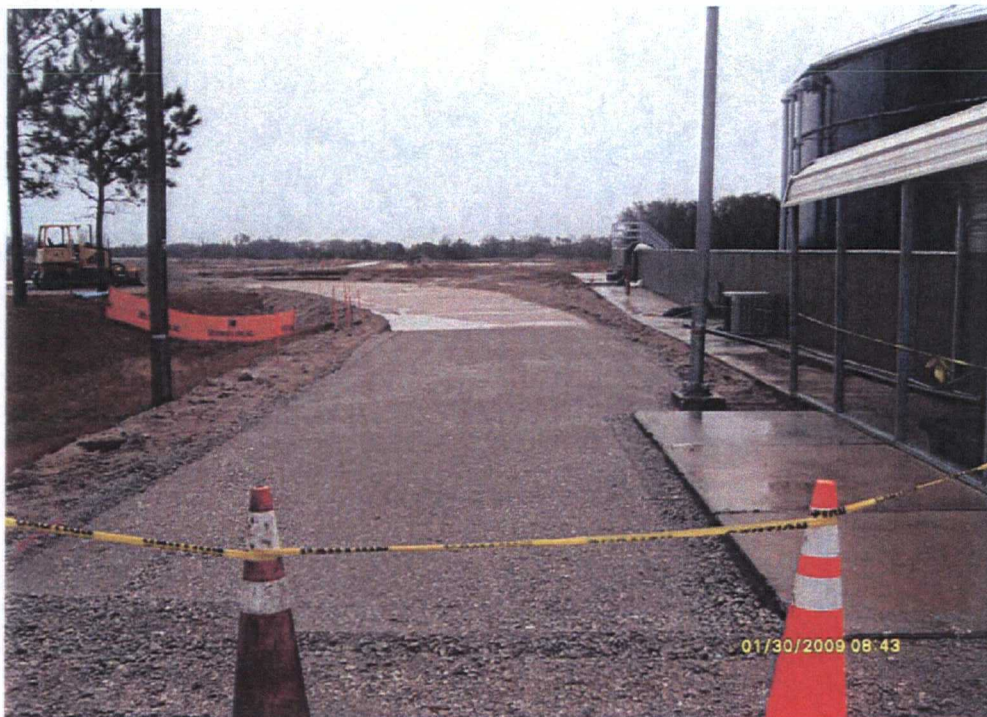
January 30, 2009. Effluent/Leachate Storage Tank Access Road – Facing north from the LTRF. Crushed concrete base installed to the north of the existing truck loading area.

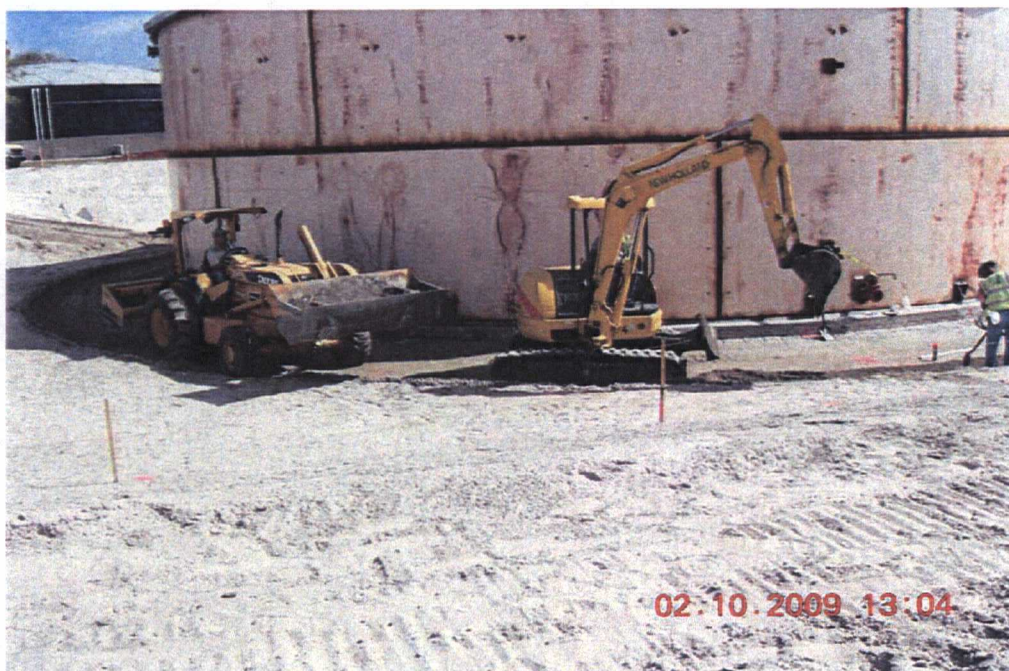
February 10, 2009. Effluent/Leachate Storage Tank – Facing east towards the LTRF. The area around the bottom of the tank is being graded for sidewalk construction around perimeter of the tank.

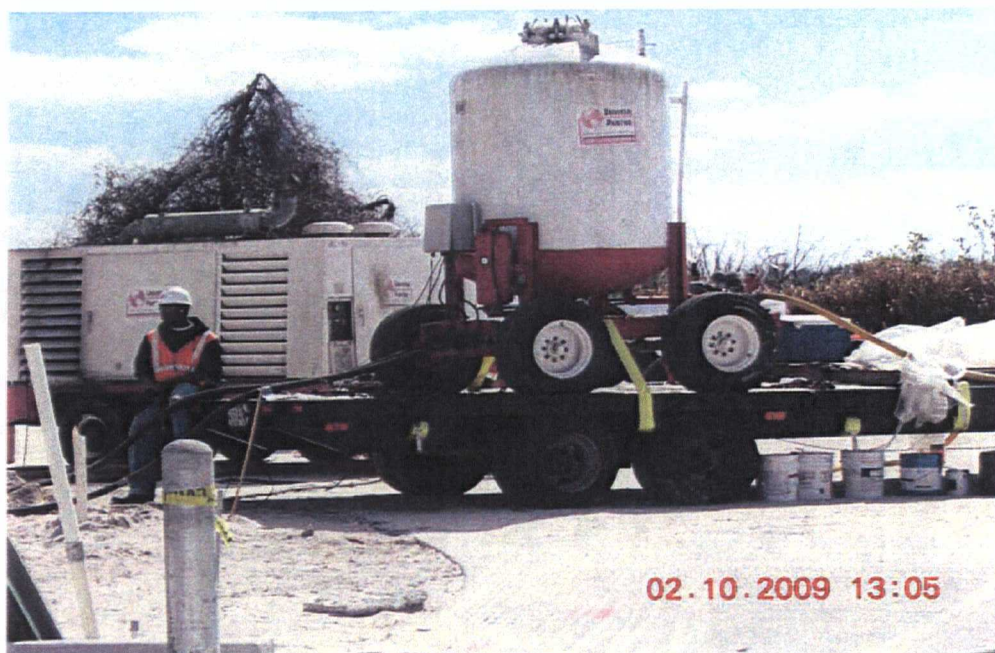
February 10, 2009. Effluent/Leachate Storage Tank – Facing south away from the tank. The painting crew is beginning to sand blast interior of storage tank.

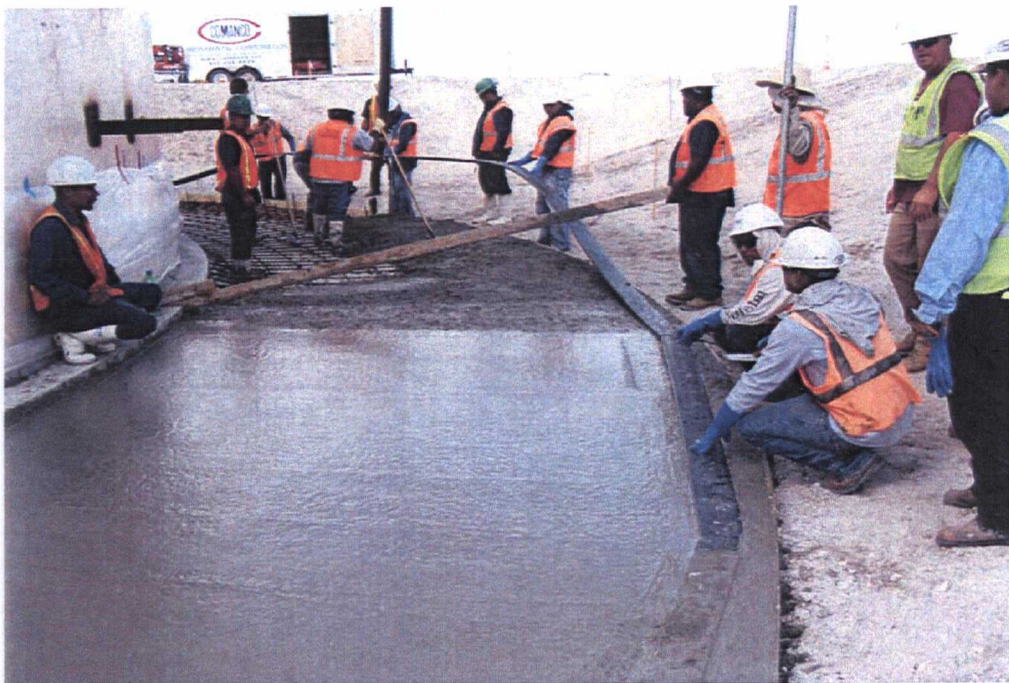
February 25, 2009. Effluent/Leachate Storage Tank Sidewalk - Facing west away from the LTRF. The concrete sidewalk has been poured and the Polylock system is being set in place.

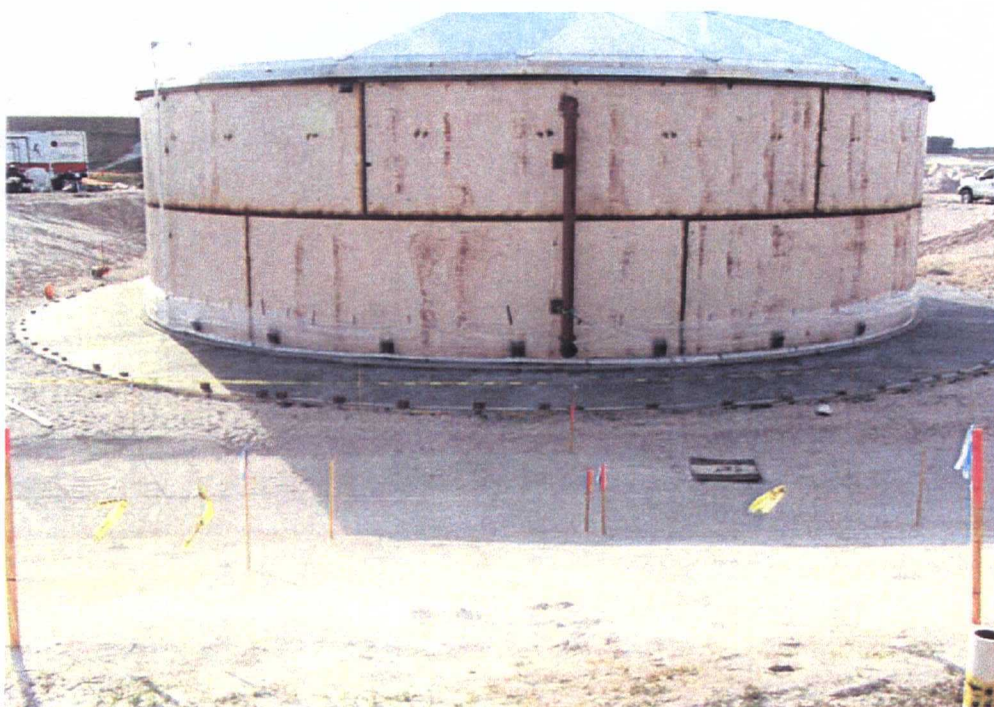
February 25, 2009. Effluent/Leachate Storage Tank Sidewalk. – Facing west away from the LTRF. The sidewalk has been completed and the Polylock installed. Bricks were used on top of the Polylock to maintain its position until the concrete set.

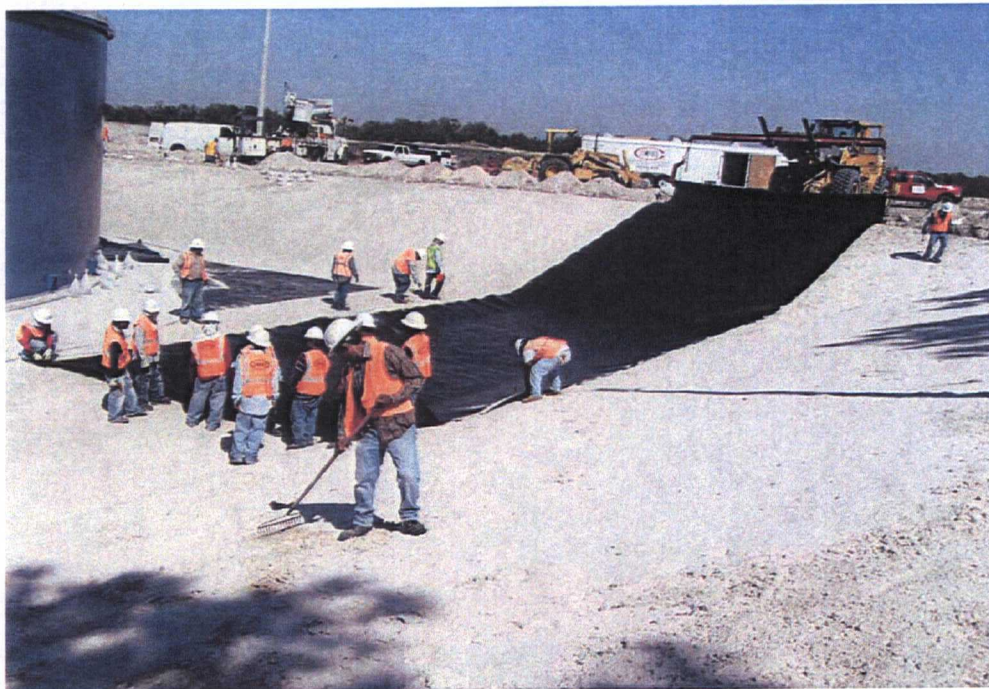
March 10, 2009. Effluent/Leachate Storage Tank Geomembrane Liner. Installation on northeast corner of containment down to the secondary sump area.

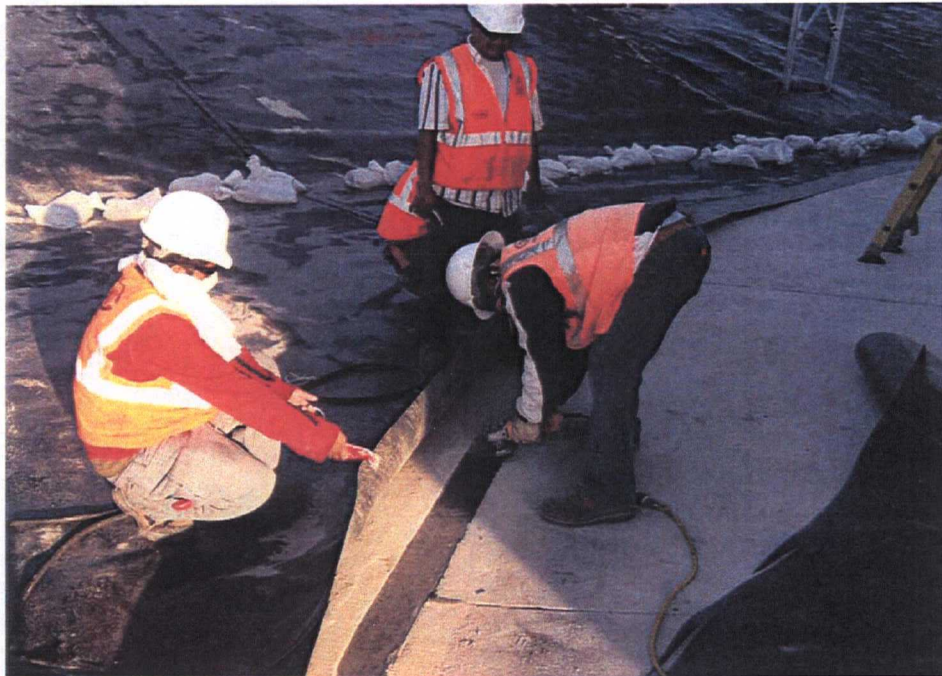
March 11, 2009. Effluent/Leachate Storage Tank Geomembrane Liner. The installation crews prepare the Polylock to weld the geomembrane liner to it.

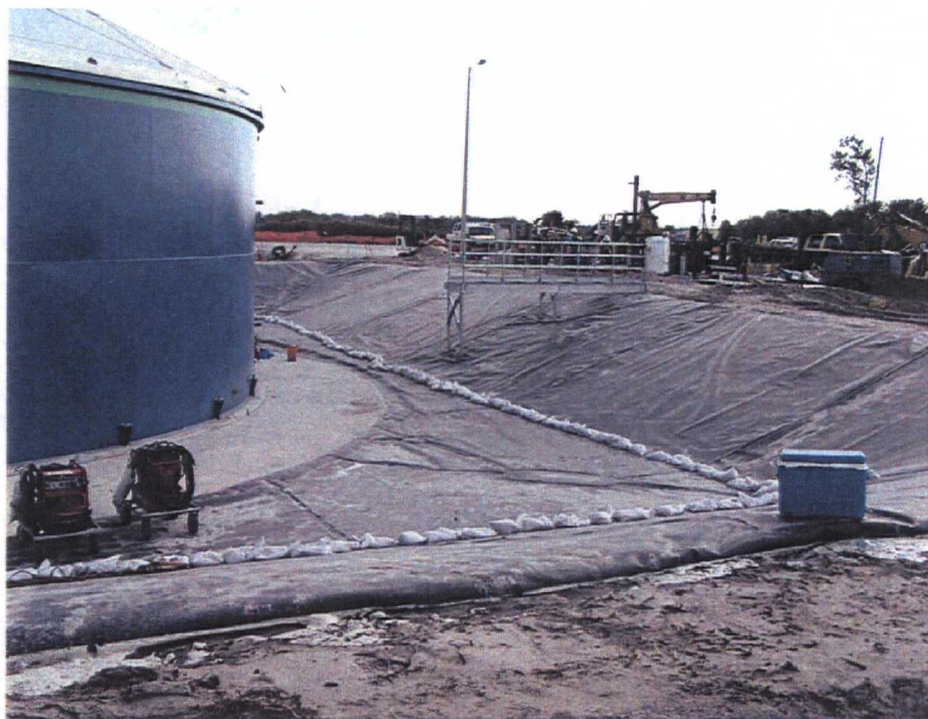
March 11, 2009. Effluent/Leachate Storage Tank – Facing south towards the truck loading area. The geomembrane liner has been installed and the access platform erected.

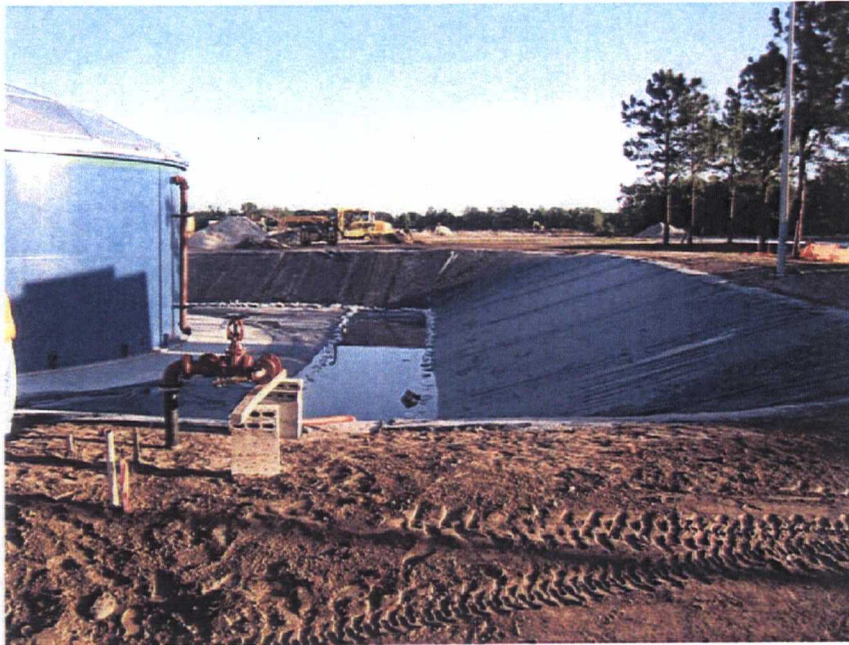
March 24, 2009. Effluent/Leachate Storage Tank. - Facing north across the storage tank area. The piping for the stormwater side slope riser pump is being installed.

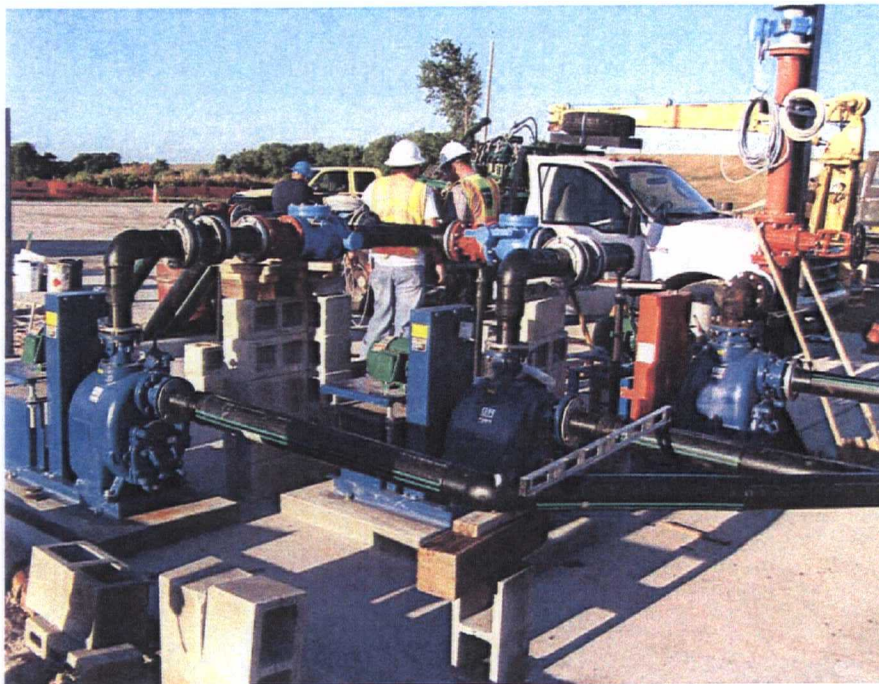
March 24, 2009. Effluent/Leachate Storage Tank. – Facing southwest across the truck loading pad pump station. Piping and fittings being installed and leveled.

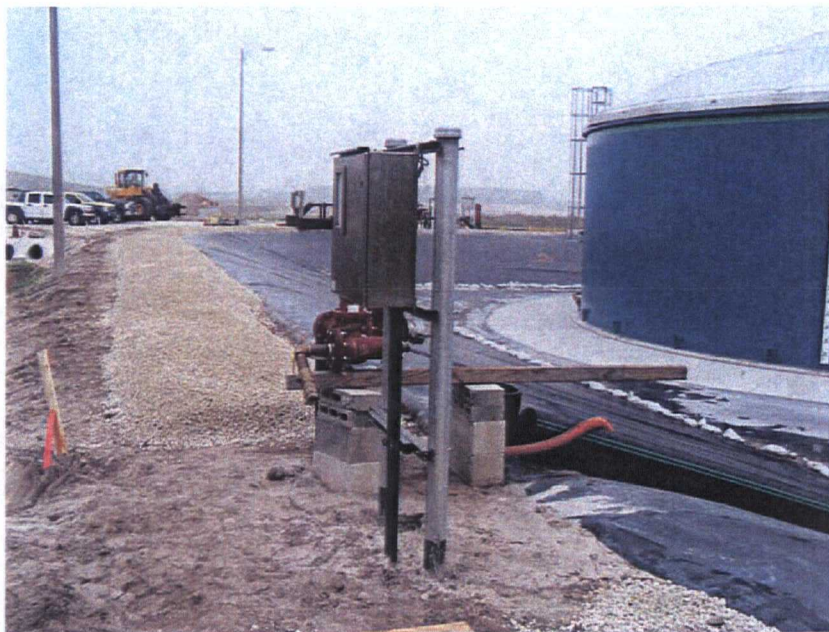
April 2, 2009. Effluent/Leachate Storage Tank. – Facing west. The control panel for the stormwater slide slope riser pump has been installed. Gravel placed around boundary of the containment area for fence installation.

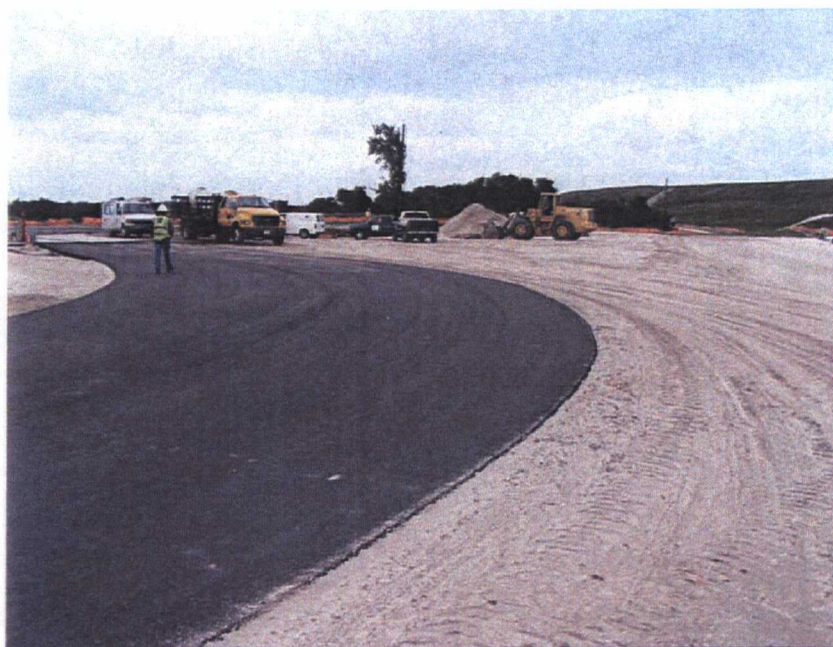
April 7, 2009. Effluent/Leachate Storage Tank. Facing south towards truck loading area. Pavement on truck loading access road completed.

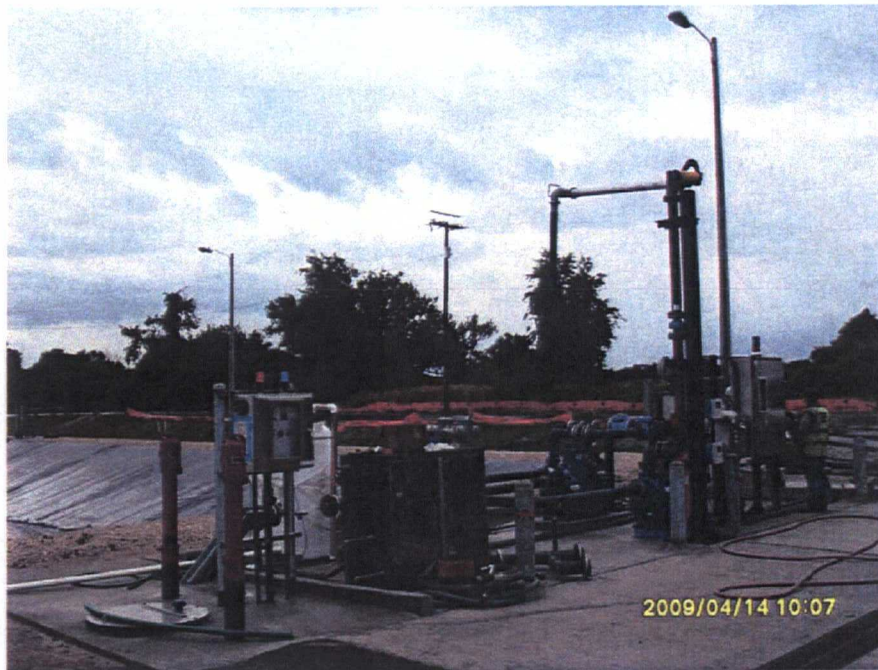
April 14, 2009. Effluent/Leachate Storage Tank. Facing southeast towards pump pad. Piping installed with pipe stands. Control panel mounted. Truck loading arm installed. Waiting pressure testing.

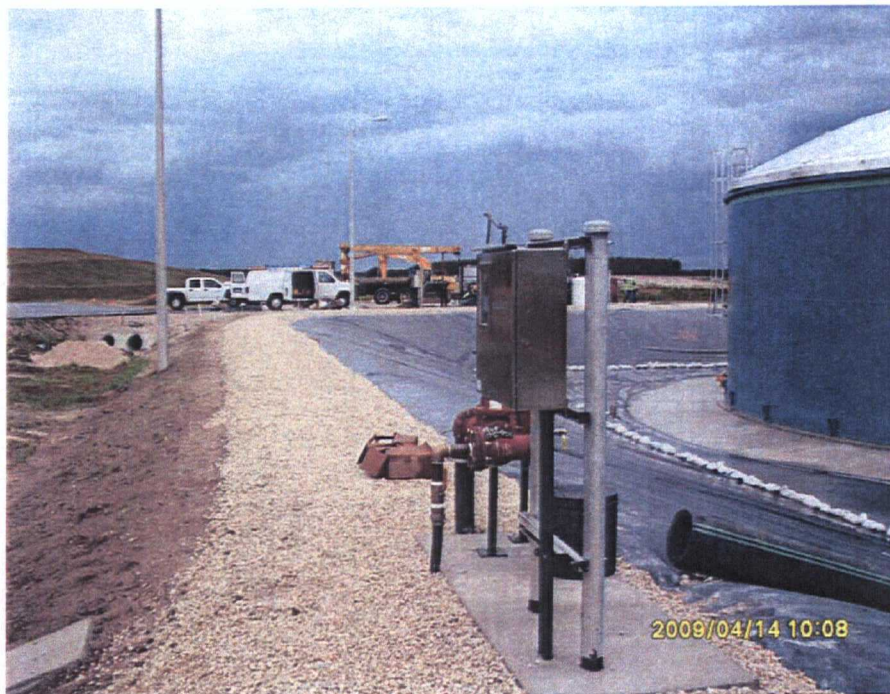
April 14, 2009. Effluent/Leachate Storage Tank – Facing west. Installation of stormwater side slope riser pumps and control panel. Gravel installation complete surrounding tank containment area.

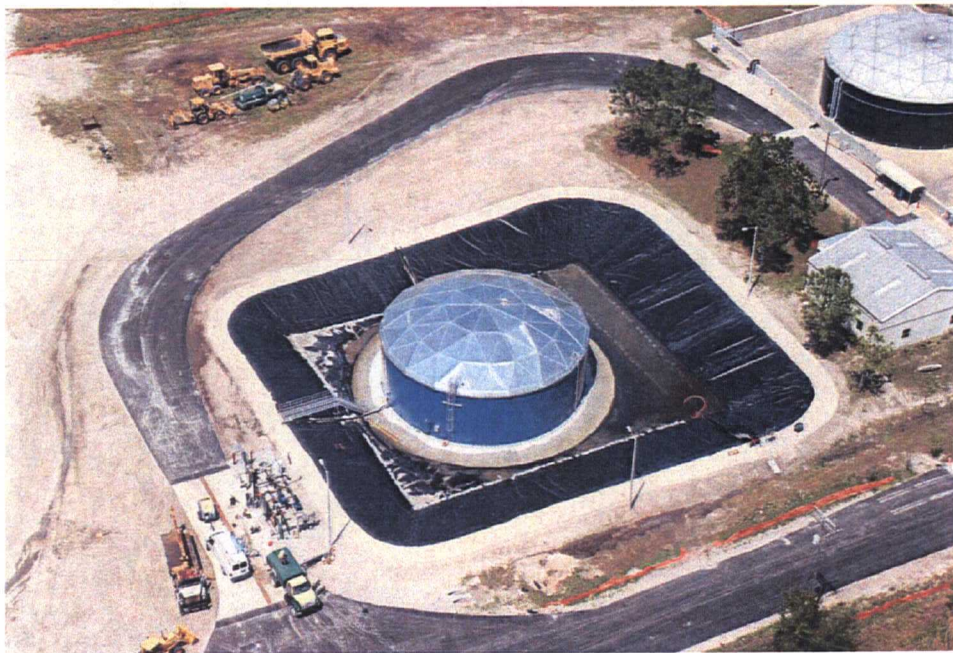
April 15, 2009. Effluent/Leachate Storage Tank. – Aerial view of storage tank, containment area, truck loading station and pad, and access roads.

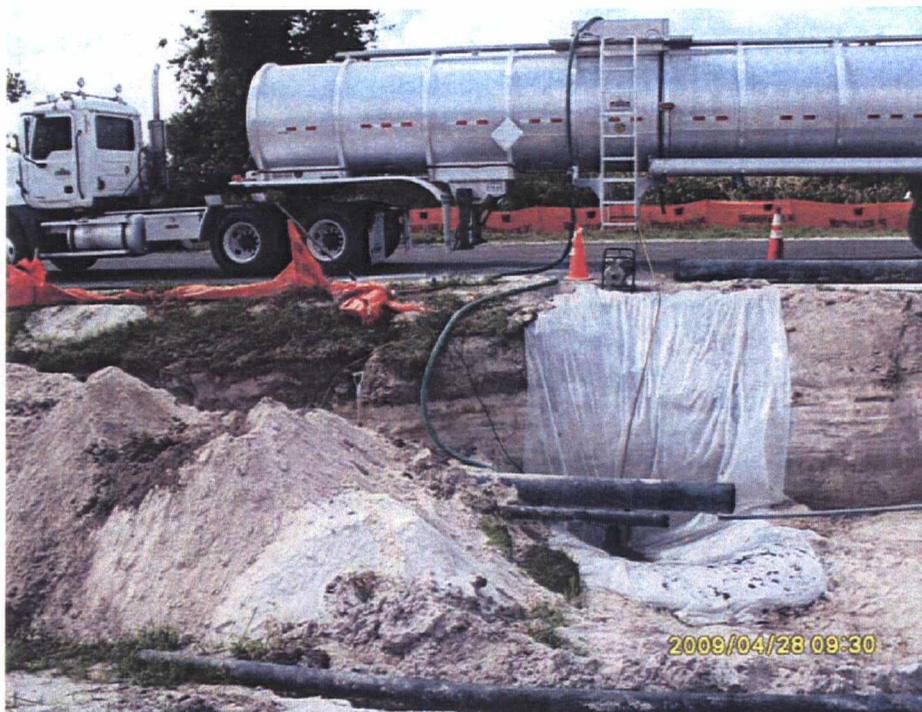
April 28, 2009. Effluent/Leachate Storage Tank. – Existing leachate and effluent force main tie-in south of the storage tank. A sump was constructed and lined with plastic. The force mains were drained the previous day, before cutting the lines, to limit liquid and a pump was placed in the sump to pump to the Hillsborough County leachate tanker for disposal of any liquid that drained from the lines.

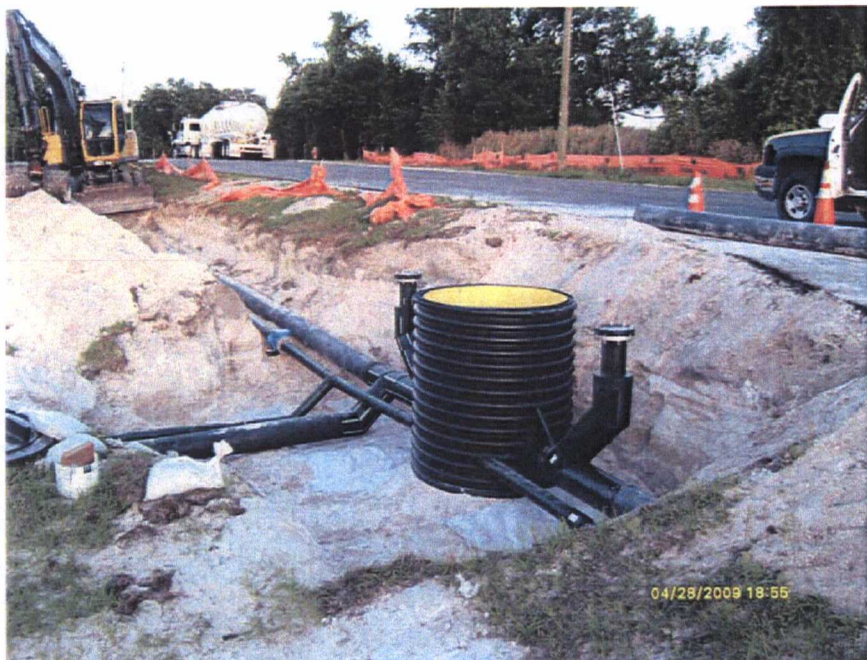
April 28, 2009. Effluent/Leachate Storage Tank. – Completed tie-in to existing leachate and effluent force mains south of the tank. The valve vault for the double-wall leachate force main completed at tie-in. System was re-activated and observed for any leaks before backfill and compaction.

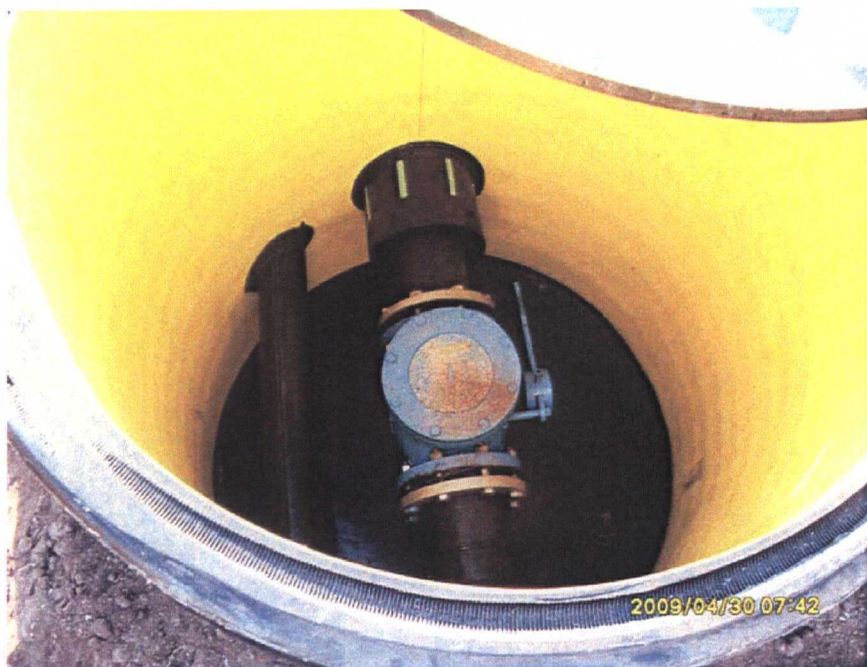
April 30, 2009. Effluent/Leachate Storage Tank. Interior of valve vault at force main tie-in south of storage tank. Check valve installed on double-wall leachate force main to stop leachate flow from effluent/leachate storage tank from going back to the main leachate pump station.

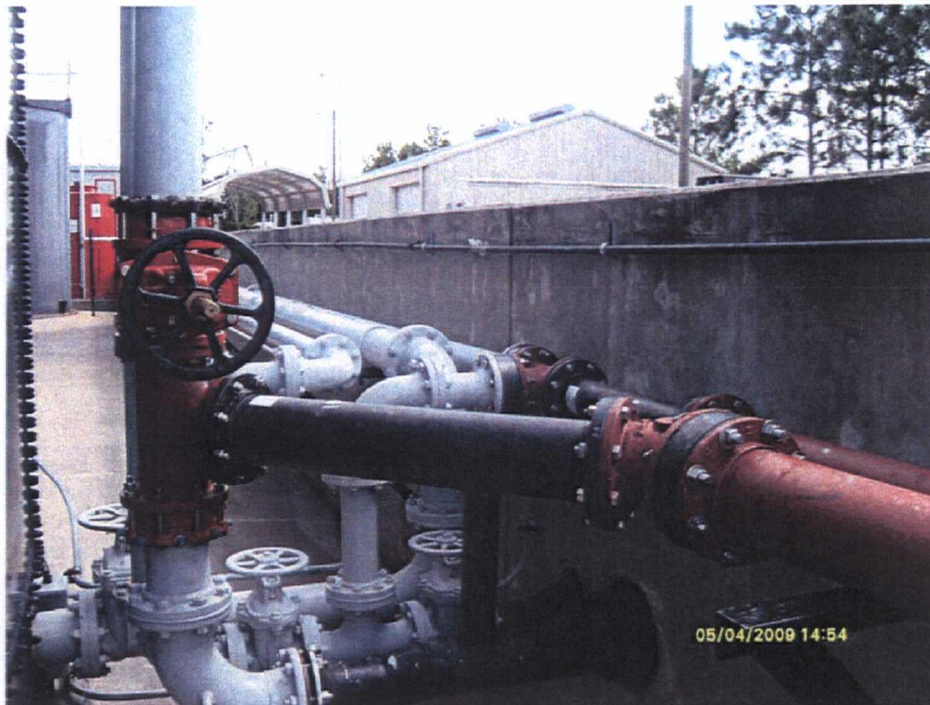
May 4, 2009. Effluent/Leachate Storage Tank – Piping modification at existing leachate storage tank for leachate and effluent lines to the new effluent/leachate storage tank.

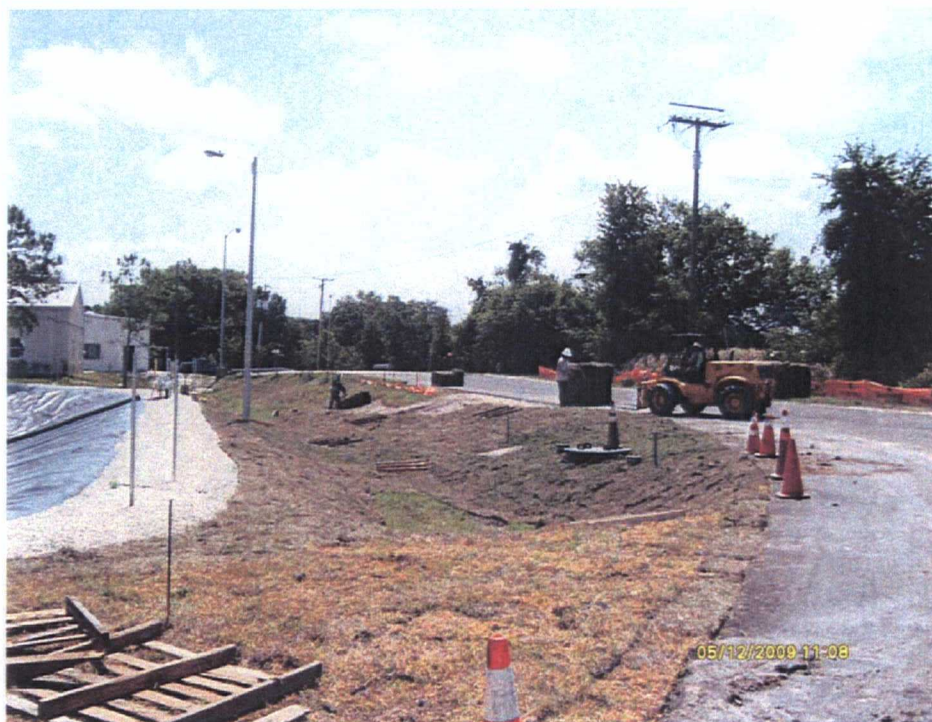
May 12, 2009. Effluent/Leachate Storage Tank. Area south of storage tank completed and sod placement. Begin installation of fencing along perimeter of storage tank area.

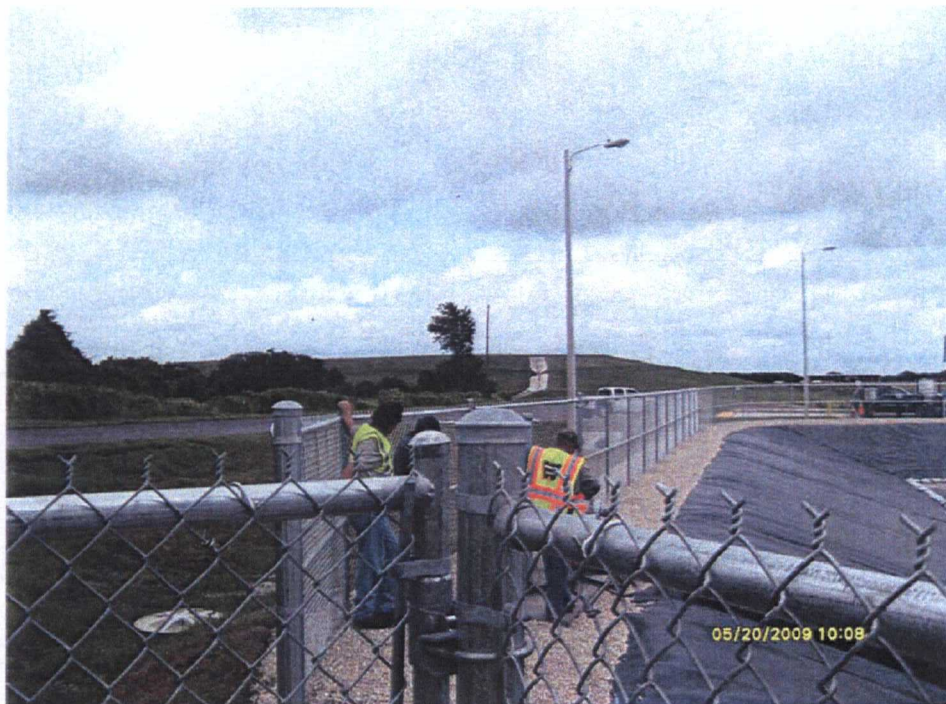
May 20, 2009. Effluent/Leachate Storage Tank. – The fencing around the perimeter of the tank site has been completed.

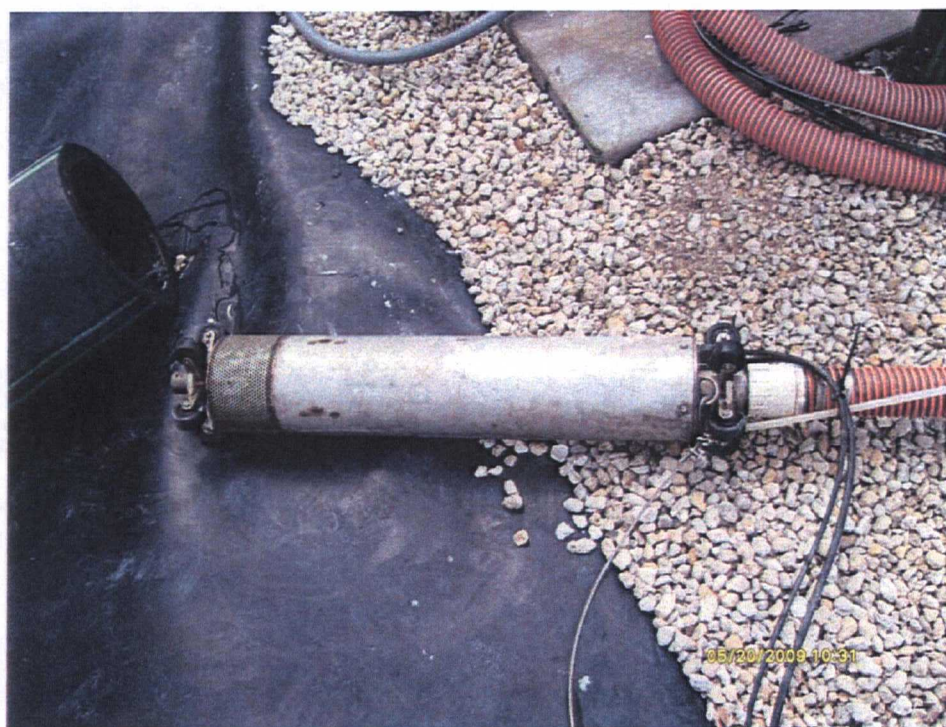
May 20, 2009. Effluent/Leachate Storage Tank Side Slope Riser Pump. – The side slope riser pump was reset within the casing and now operates effectively.

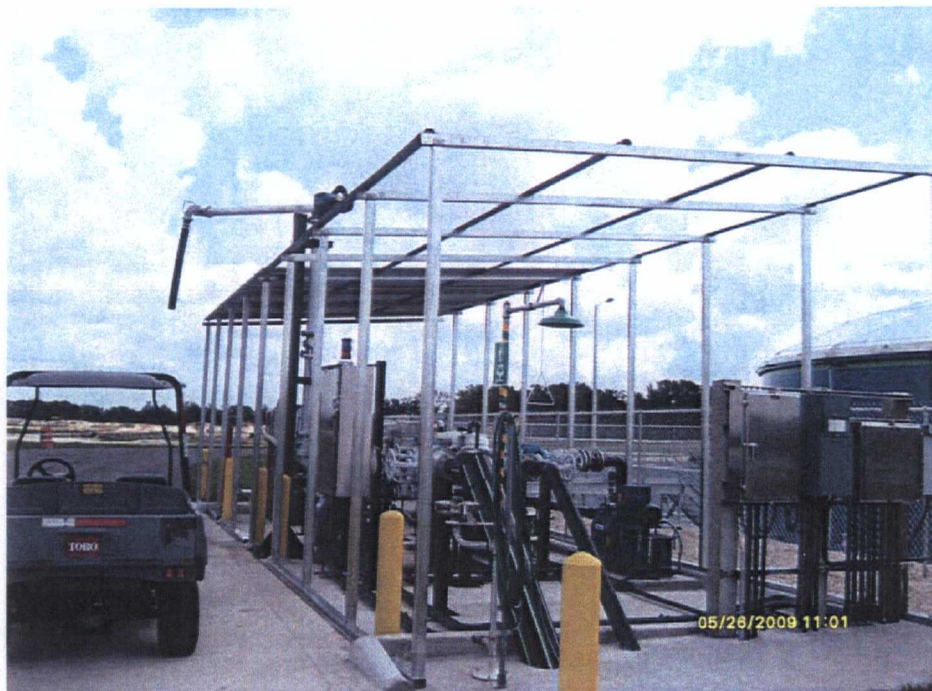
May 26, 2009. Effluent/Leachate Storage Tank Pump Pad. – The canopy roof construction is underway and is approximately 60% complete.

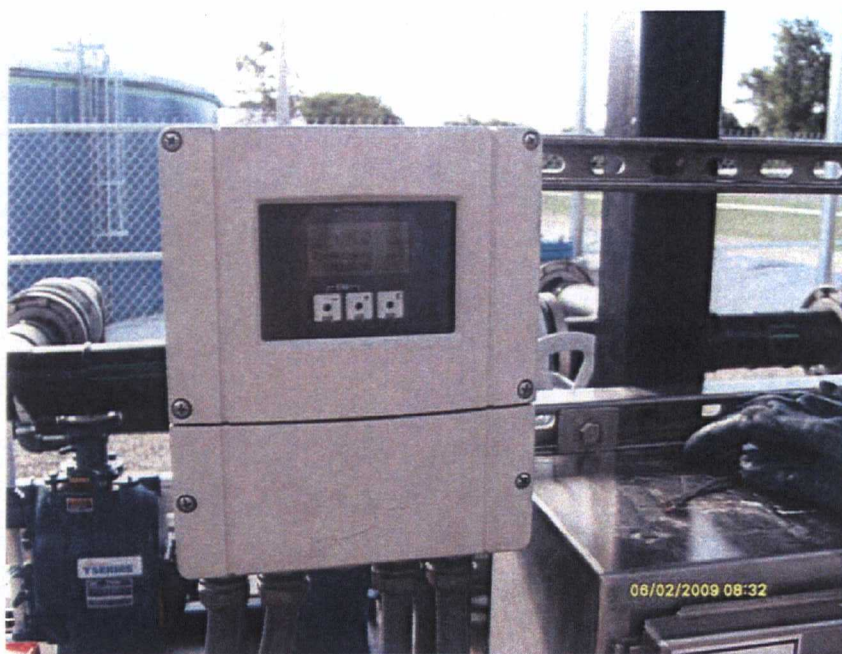
June 2, 2009. Effluent/Leachate Storage Truck Loading Pump Flow Readout.

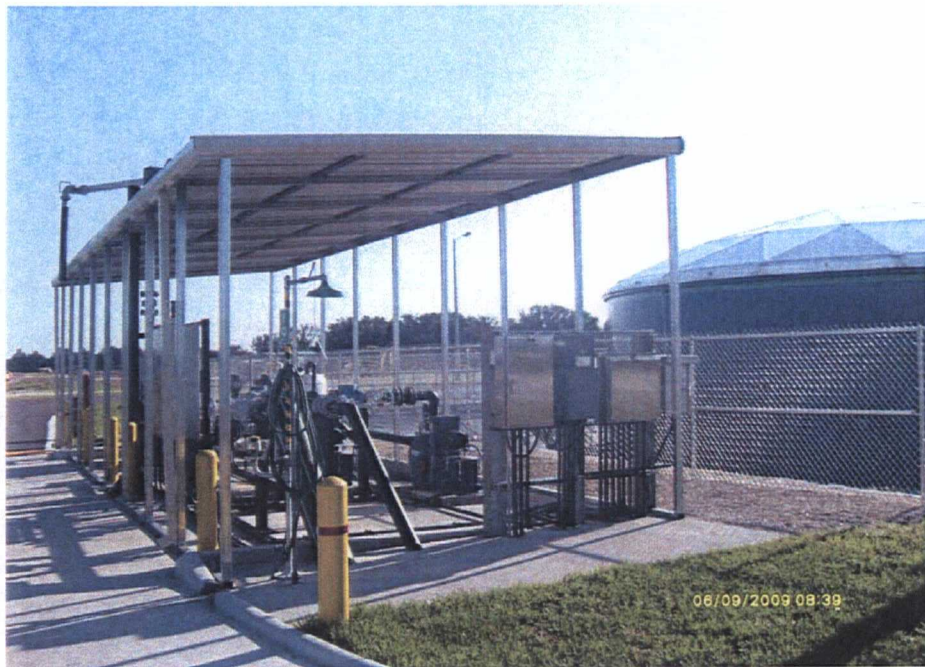
June 9, 2009. Effluent/Leachate Storage Tank Pump Pad. The canopy roof above the pump pad has been completed.

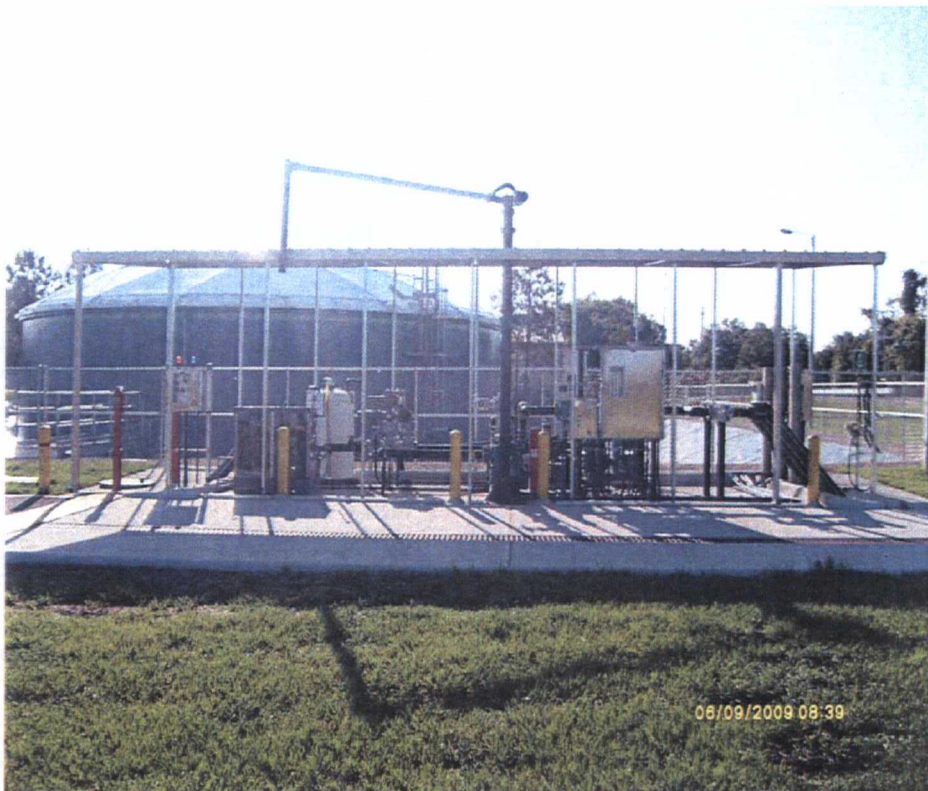
June 9, 2009. Effluent/Leachate Storage Tank Pump Pad – The completed pump pad area; including canopy roof, piping systems and pumps, and truck loading arm.
