**Enterprise Recycling and Disposal Facility  
Cell 6 Construction Completion Certification Report  
FDEP Permits No.: 177982-008-SC/T3 and 177982-007-SO/T3  
WACS No.: 87895**

RE: Enterprise Recycling and Disposal Facility  
Cell 6 Construction Completion Report – Response to RAI No. 2  
Angelo's Aggregate Materials, LTD  
FDEP Permit Nos. 177982-008-SC/T3 and 177982-007-SO/T3  
WACS No.: 87895  
Pasco County, Florida

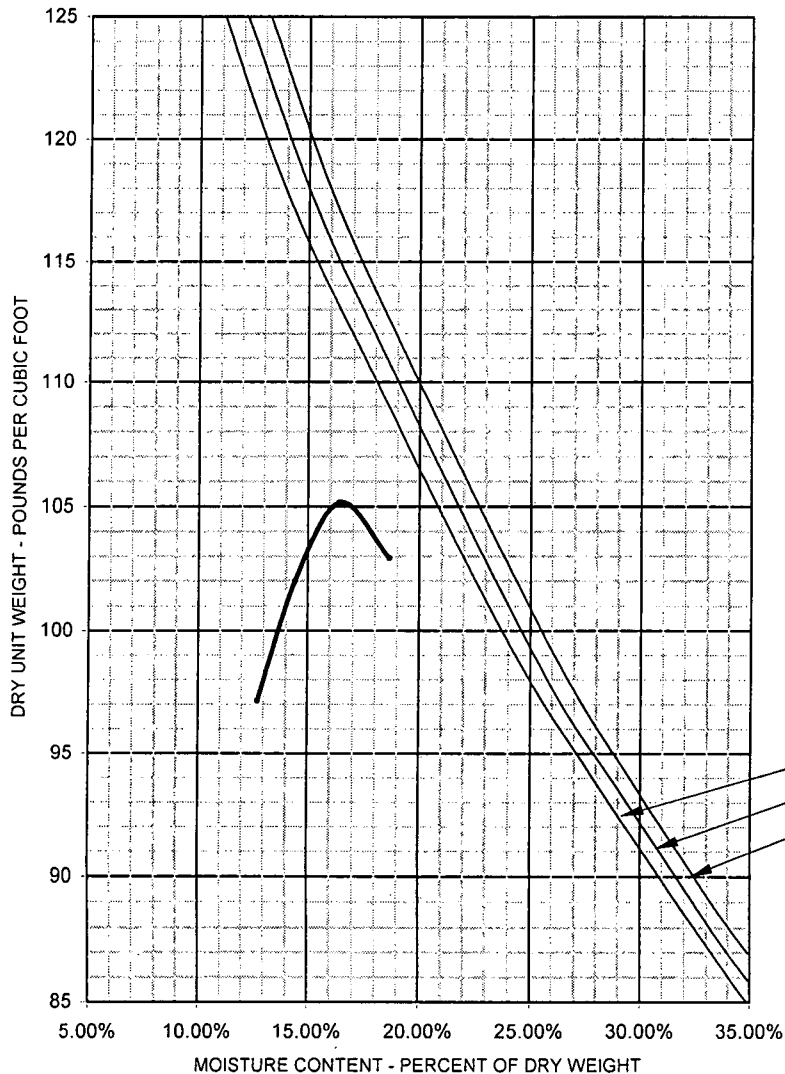
Project No.: 0810.1100040  
Report No.: PR#1  
Report Date: 3/8/2011  
Lab # : 3996  
Test Method : D 698  
Rammer Type: Manual  
Soil Description:  
Tan Clayey Sand

Date Tested :	3/7/2011
Maximum Dry Density(pcf)	105
Optimum Moisture Content (%)	16
Wash 200%	N/A

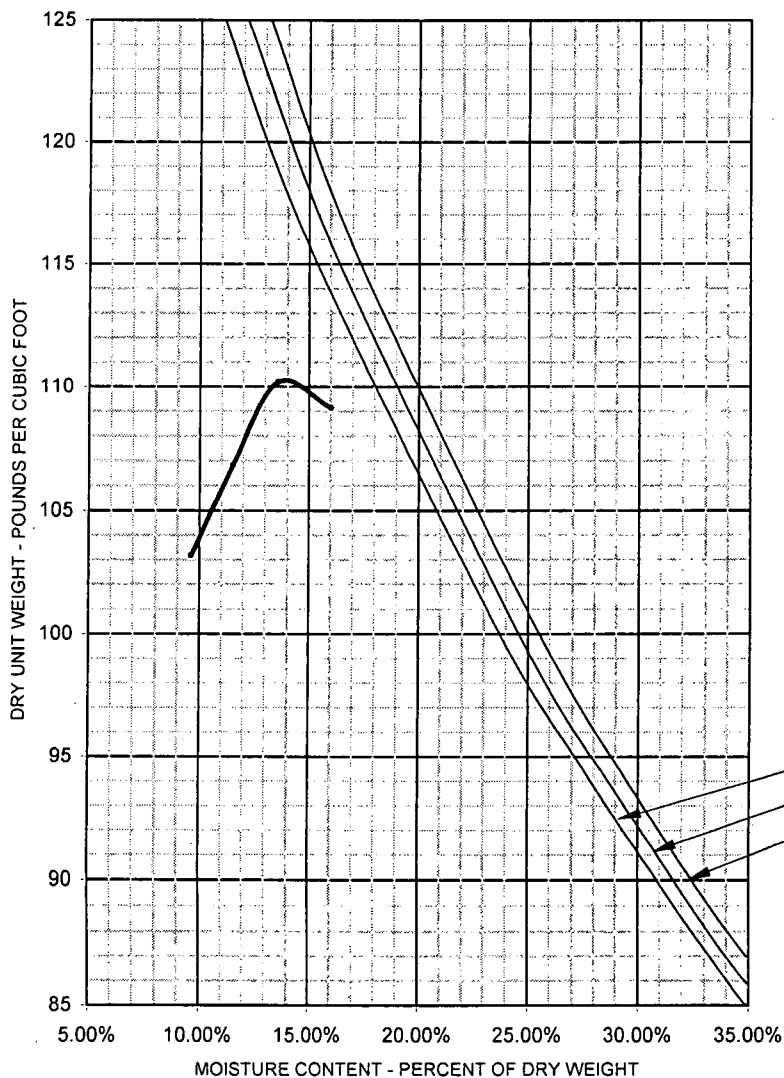
Project No.: 0810.1100040  
Report No.: PR#2  
Report Date: 3/9/2011  
Lab #: 3995  
Test Method : D 698  
Rammer Type: Manual  
Soil Description:  
Brown Clayey Sand

Date Tested :	3/8/2011
Maximum Dry Density(pcf)	110
Optimum Moisture Content (%)	14
Wash 200%	N/A

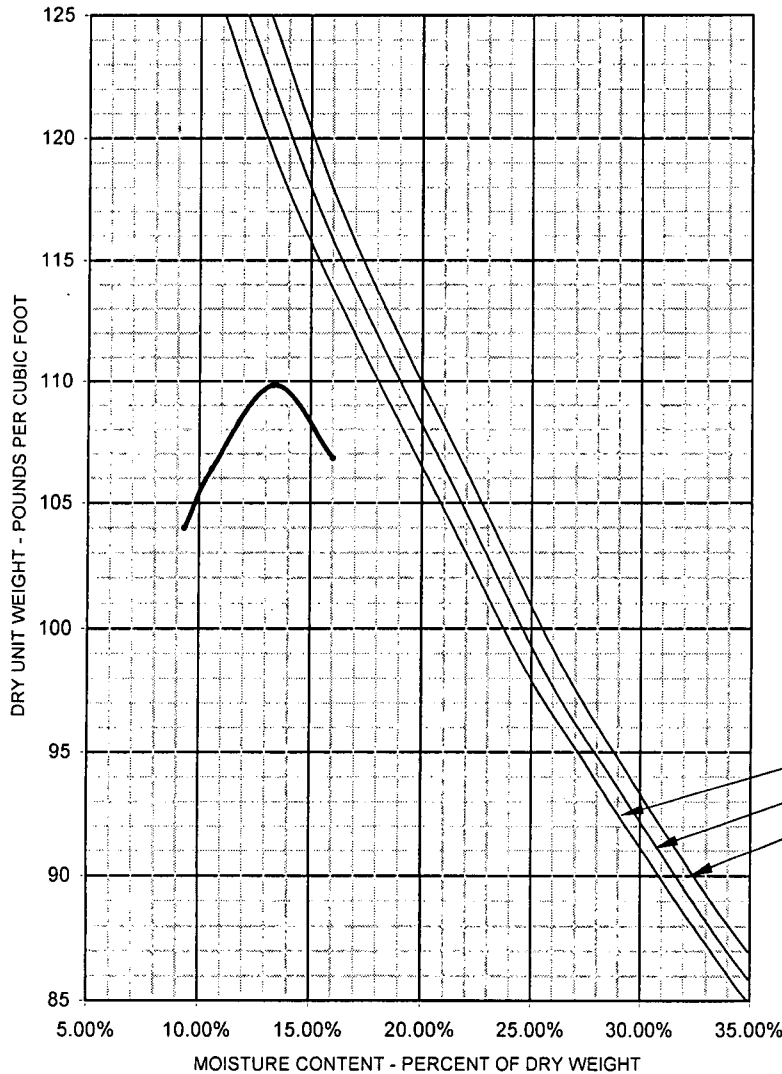
Brown Clayey Sand

Date Tested :	6/20/2011
Maximum Dry Density(pcf)	110
Optimum Moisture Content (%)	13
Wash 200%	N/A

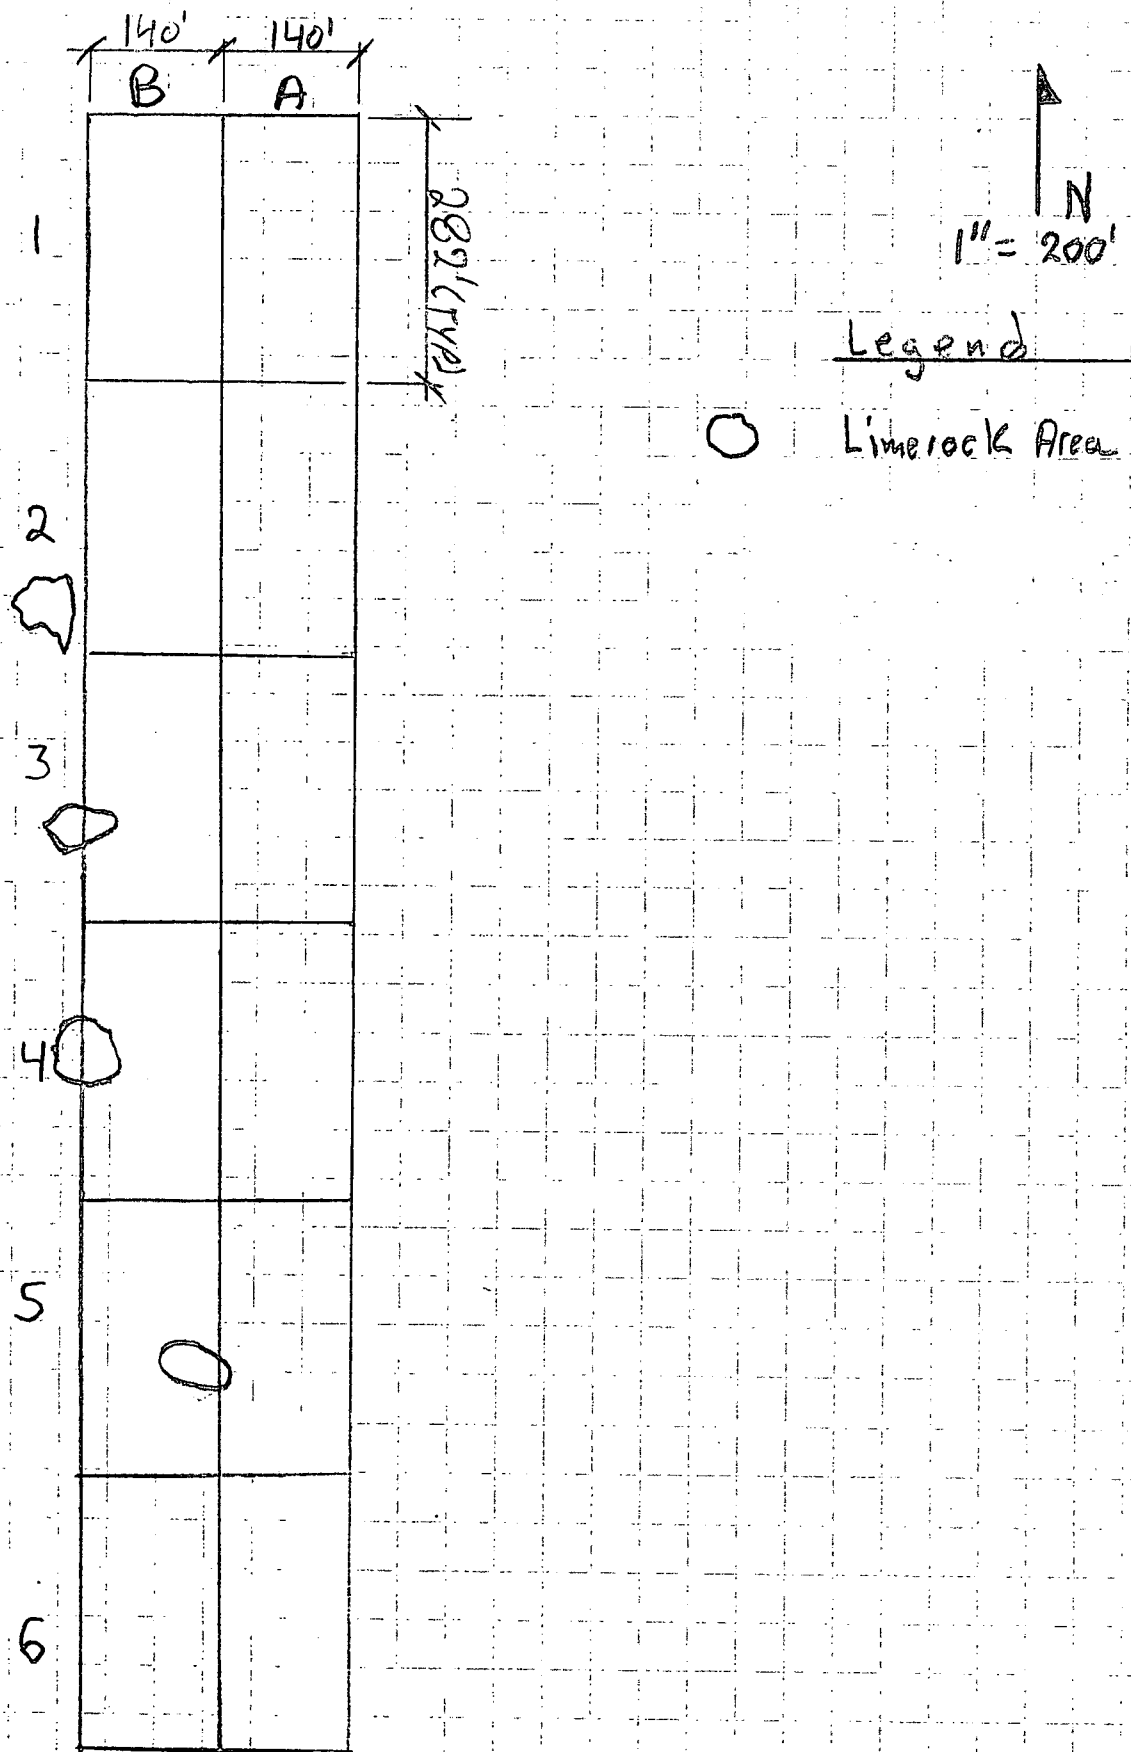
Figure 1

Details and elevations of limerock observed during the construction of Cell 6 are based on the daily field observations performed by John Arnold, P.E. Limerock was observed at locations in testing grids B-5, B-4, B-3, and west of B-2, as shown in Figure 1. The lateral and vertical extents of the limerock are based on relative observations and field measurements made from construction grade stakes installed by the land surveyor, Simmons and Beall, Inc. On a weekly basis 10 to 20 grade control stakes were installed in the work area to facilitate construction and observation activities. Elevations refer to NGVD '29 datum.

Limerock in B-5 was encountered at latitude  $28^{\circ} 19' 49''\text{N}$ , longitude  $82^{\circ} 08' 04''\text{W}$  at an elevation of approximately 100' NGVD. As excavation of the overburden progressed westward, the extent of the limerock was determined to be approximately 65' long by 75' wide. The limerock was firm to hard with a clay mantel. No soft zones or voids within the limerock were observed. The limerock pinnacle/outcrop maximum elevation was 115' NGVD (+/-). The west edge of the limerock pinnacle/outcrop extended to an elevation of 79' NGVD (+/-). All limerock exposed at this location was over-excavated to a depth of 3' as required to construct the 3' thick clay barrier layer.

Limerock in B-3 was encountered at latitude  $28^{\circ} 19' 54''\text{N}$ , longitude  $82^{\circ} 08' 05''\text{W}$  at an elevation of approximately 112' NGVD. As excavation of the overburden progressed westward, the extent of the limerock was determined to be approximately 50' long by 80' wide. The western most extent of the limerock will be determined at a later date with the mining of the area west of Cell 6. The limerock was firm to hard with a clay mantel. No soft zones or voids within the limerock were observed. The limerock pinnacle/outcrop maximum elevation was 115' NGVD (+/-) and minimum elevation of 79' NGVD (+/-). All limerock exposed at this location was over-excavated to a depth of 3' as required to construct the 3' thick clay barrier layer.

Limerock in the area west of B-2 was encountered at latitude  $28^{\circ} 19' 56''\text{N}$ , longitude  $82^{\circ} 08' 06.8''\text{W}$  at an elevation of approximately 90' NGVD. As excavation of the overburden progressed westward, the extent of the limerock was determined to be approximately 100' long by 40' wide. The western most extent of the limerock will be determined at a later date with the mining of the area west of Cell 6. The limerock was firm to hard with a clay mantel. No soft zones or voids within the limerock were observed. The limerock pinnacle/outcrop maximum elevation was 112' NGVD (+/-) and minimum elevation of 88' NGVD (+/-). Limerock exposed at this location was over-excavated to a depth of 3' as required to construct the 3' thick clay barrier layer.

Cell 6 Limerock Observations  
Enterprise Class III Landfill
