**Subject: Cell 1 and Landfill Site Certification Addendum 2
and Responses to Department Certification Comments
Enterprise Recycling & Disposal Facility
Angelo's Aggregate Materials, Ltd.
FDEP Permit Nos. 177982-001-SC, 177982-002-SO
Pasco County, Florida**

CELL No. 1- CROSS-SECTION A-A' - CERTIFICATION
ENTERPRISE RECYCLING AND DISPOSAL FACILITY
DADE CITY, FLORIDA

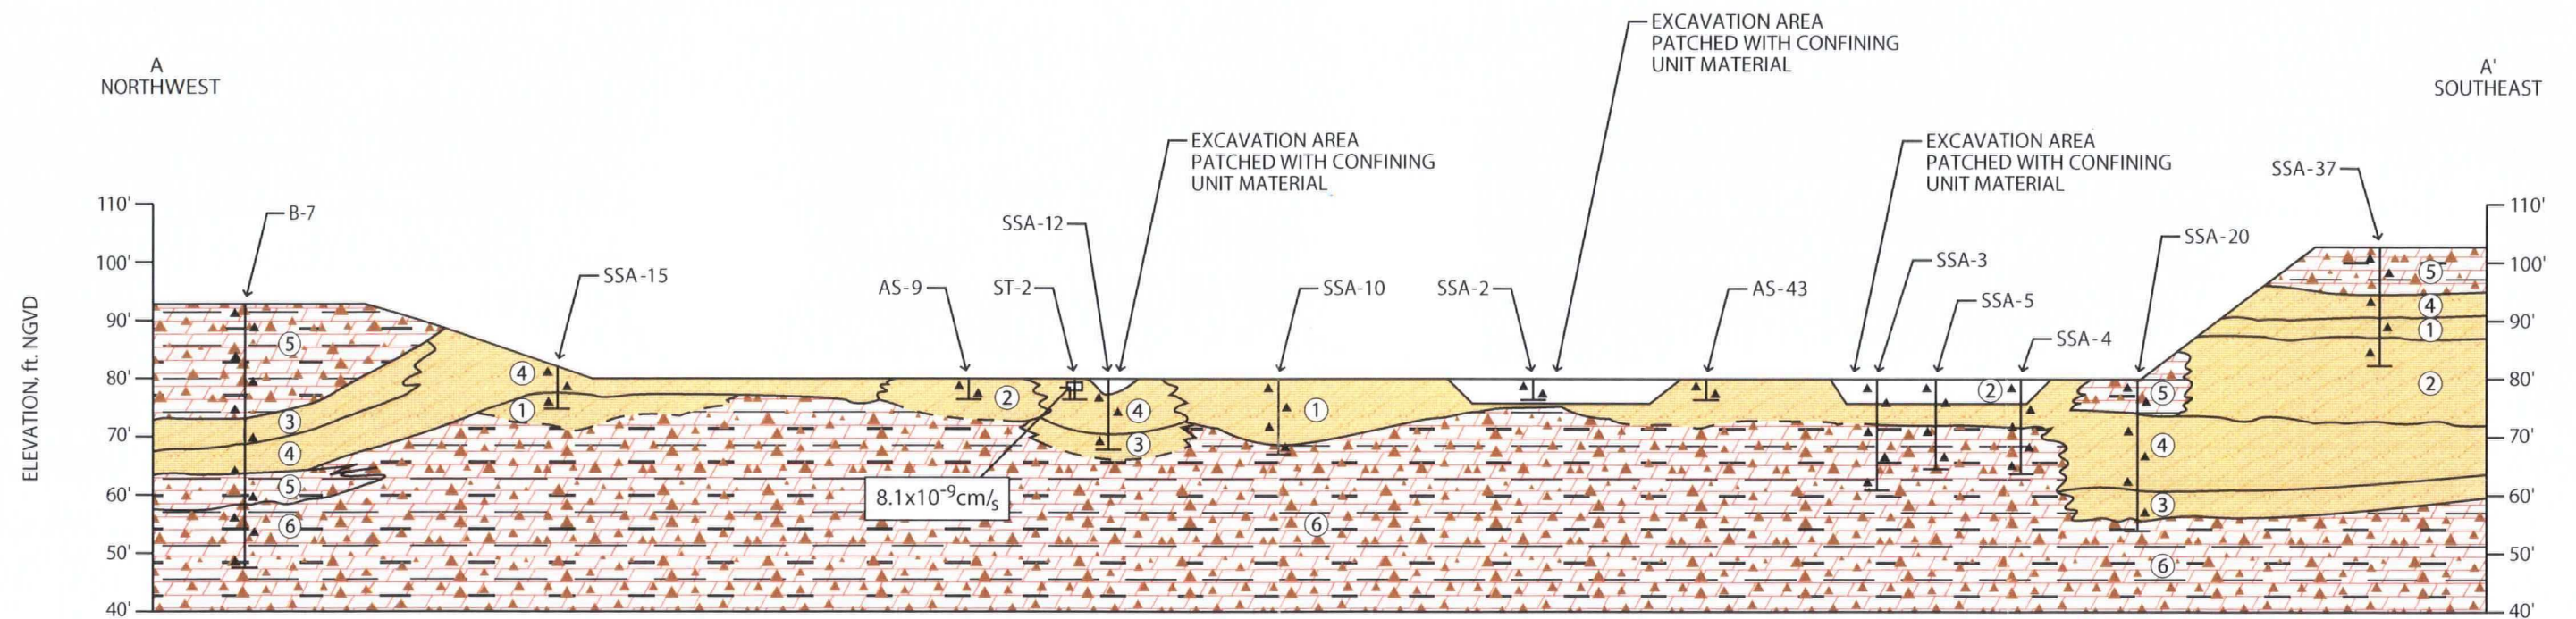
HORIZONTAL SCALE 1" = 60'
VERTICAL SCALE 1" = 30'

Response: It is common in geologic practice to continue cross-sections for a limited depth beyond the extent of borings to represent the likely soil conditions of a site. However, the cross-sections have been revised to include notation (question marks) where appropriate to demonstrate that no deeper borings were completed to confirm the presence of the indicated soil types. The cross-sections do not end at the last included borings since soil types and extents are generally extrapolated in both directions from each boring to the midpoint of the distance to the next. This is done based on knowledge of the site characteristics and available site data. Additional boring locations have been included as discussed during the January 5 meeting, to extend the cross-sections and maximize the areas to be certified. Some AS and SSA borings were added to the cross-sections as deemed necessary by HAI. Each cross-section is shown to depict the geology through a horizontal distance and a vertical elevation. The horizontal distances vary and therefore different scales are required to provide magnification and clarity for ease of evaluation. It was agreed between HAI and the Department through e-mail correspondence that the scales would not be revised. This response is intended to address the entire 1)n) comment, and therefore, each individual component will not have an individual response.

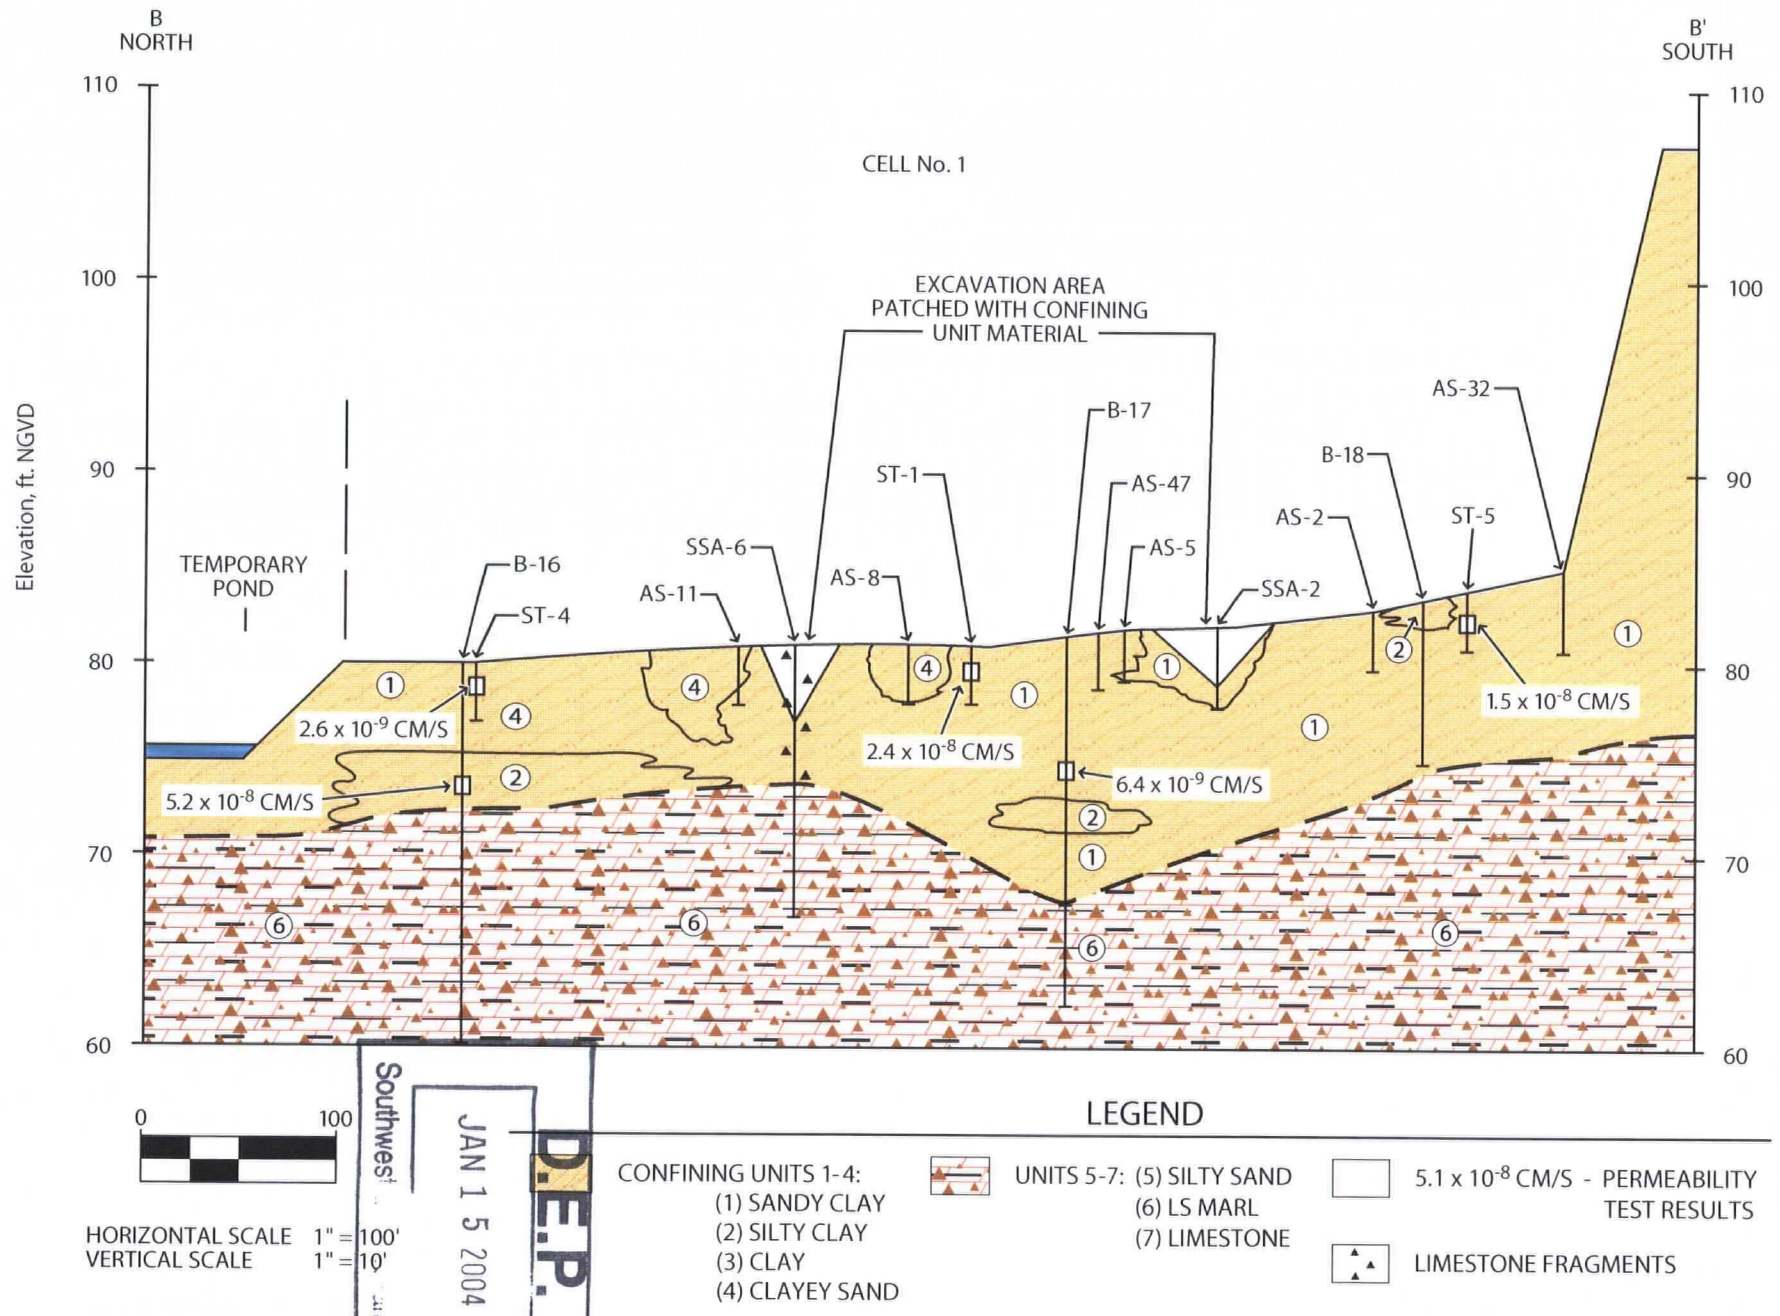
FIGURE 2

**CELL No. 1 - CROSS-SECTION B-B' - CERTIFICATION
ENTERPRISE RECYCLING AND DISPOSAL FACILITY
DADE CITY, FLORIDA**

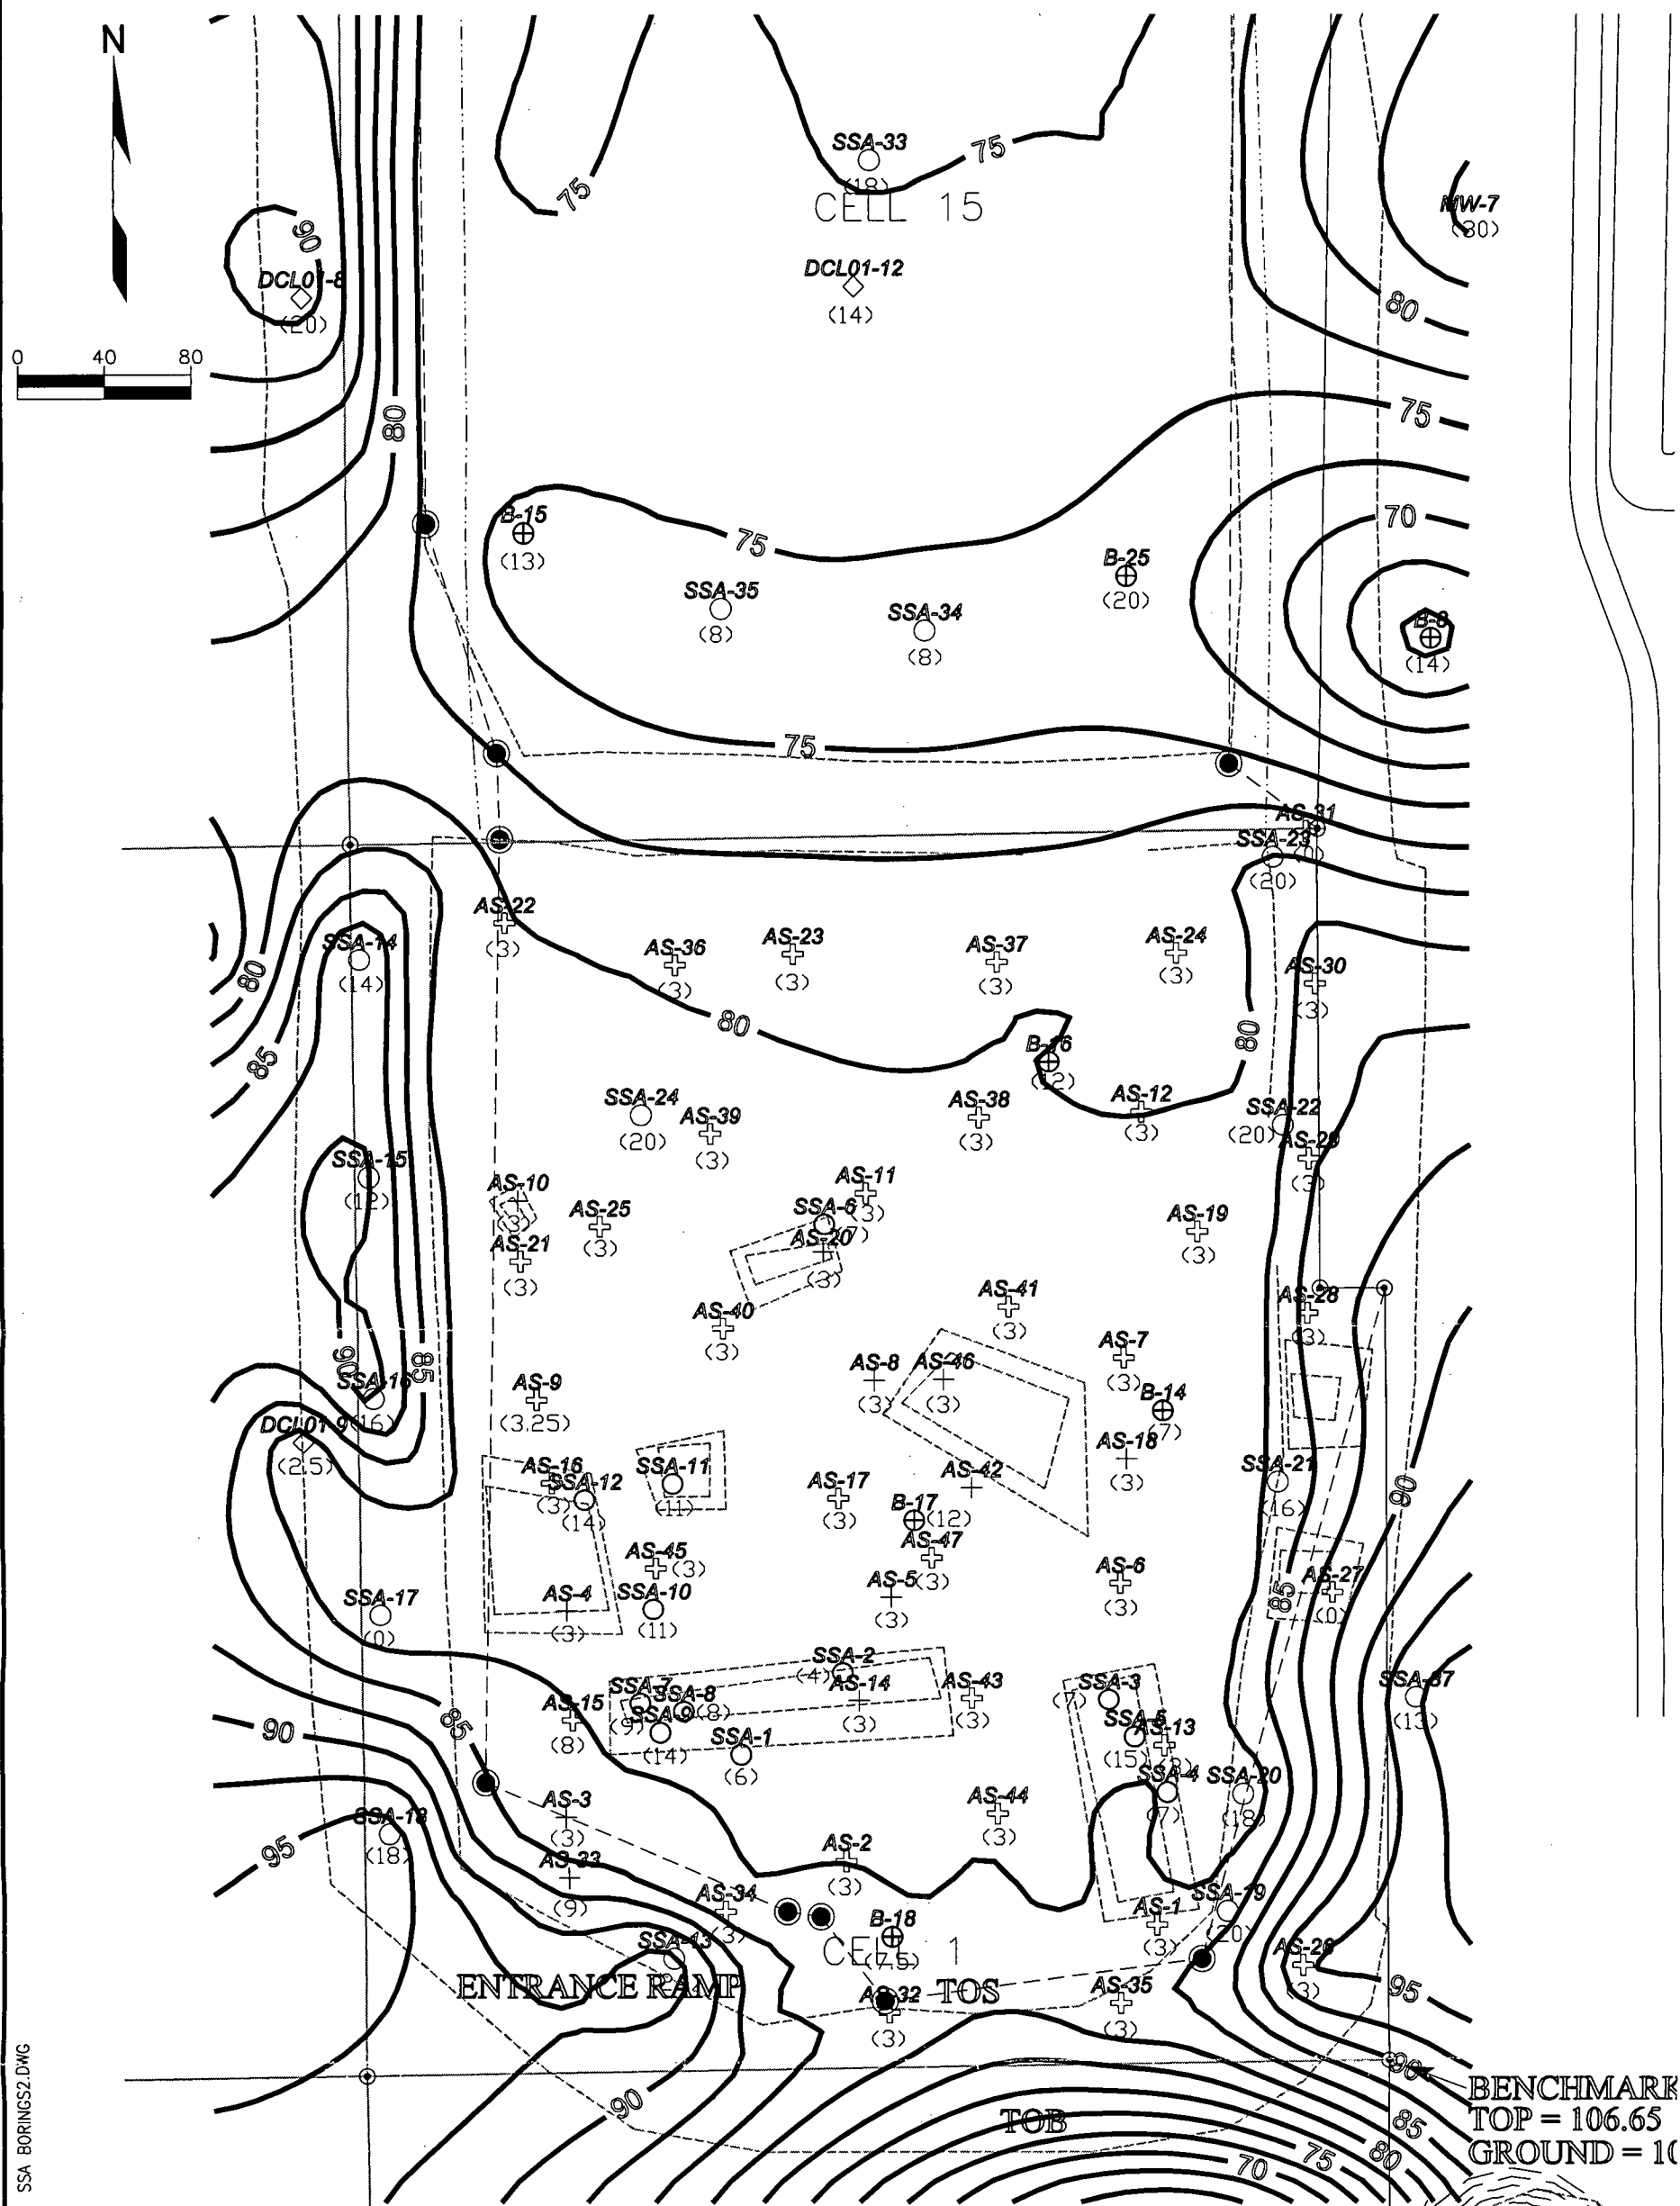
APPENDIX B

*CONTOUR LINES OUTSIDE THE EXTENT OF
CERTIFICATION ARE EXTRAPOLATED.

Response: The purpose of Figure 38 is to show the continuity of confining material throughout Cell 1 and part of Cell 15 in the areas it was proven to exist. We believe that including the requested information creates unnecessary clutter on the map and is not needed since previous submittals provide evidence that these areas were over-excavated and properly patched. The revised Figure 38 is attached in Appendix B.
