RE: 2006 Annual Monitoring of the Phosphatic Clays
Southeast County Landfill, Hillsborough County, Florida
Jones Edmunds Project No. 08449-022-01

**Geotechnical Study Associated with
2006 Annual Monitoring of the Phosphatic Clay
Liner Beneath the Southeast Landfill
in Hillsborough County, Florida**

**Geotechnical Study Associated with
2005 Annual Monitoring of Phosphatic Clay Liner
Beneath the Southeast Landfill
in Hillsborough County**

**Geotechnical Study Associated with
2004 Annual Monitoring of Phosphatic Clay Liner
Beneath the Southeast Landfill
in Hillsborough County**

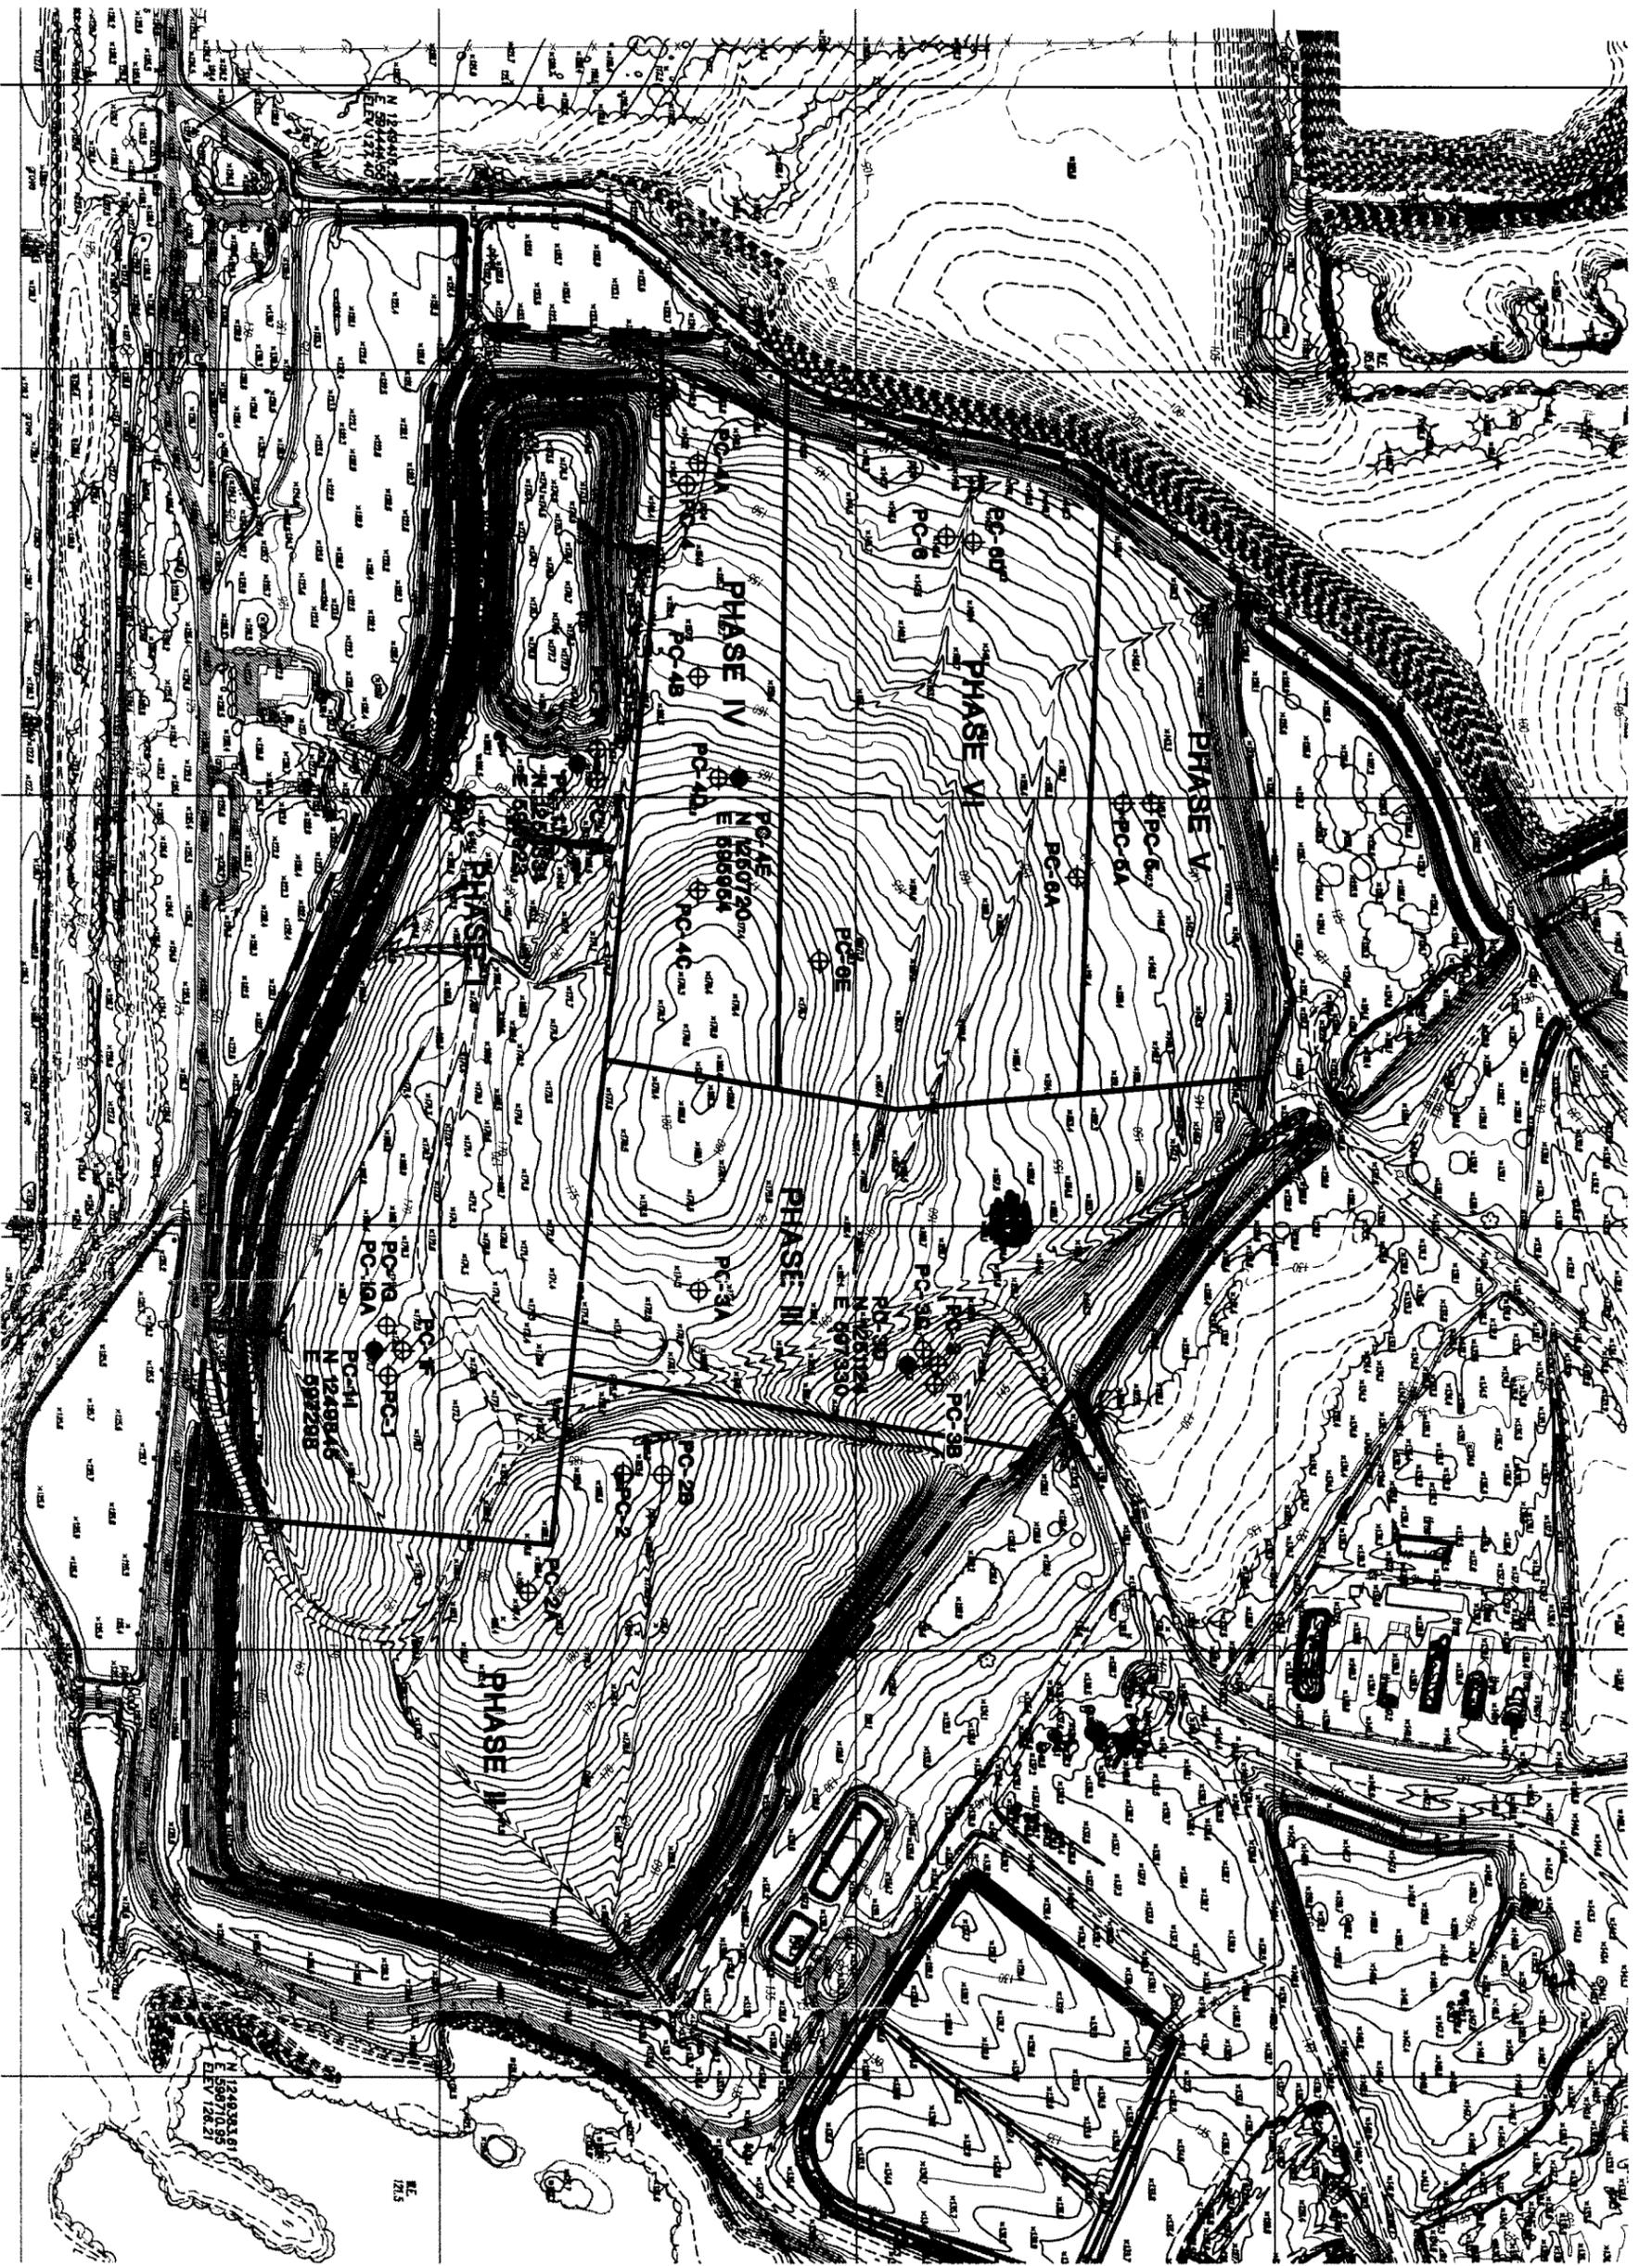
FIGURE: 2

A comprehensive geotechnical study was conducted by Ardaman between 1981 and 1983 to characterize the phosphatic clay deposit and to evaluate the feasibility of constructing a landfill within the waste clay settling area. Results from that study were documented in an Ardaman report titled "Hydrogeological Investigation, Southeast County Landfill, Hillsborough County, Florida", dated February 22, 1983. Based on the data and analyses documented in that report, Ardaman concluded that a landfill could be constructed directly on top of the phosphatic clay. However, to maintain an adequate factor of safety against slope failure, the waste disposal area was divided into different phases, and each phase had to be filled in lifts such that filling above a previous lift would occur only when the underlying phosphatic clay had consolidated under the weight of the previous refuse lift and experienced sufficient increase in shear strength to support any additional load. In areas where the clay thickness was greater than 14 feet, it was recommended that the clay should be pre-loaded prior to placement of the first lift of refuse. A diagram that shows the original thickness of the phosphatic clay within the settling area, as reproduced from the 1983 Ardaman report, is shown in Figure 2. As shown, the phosphatic clay deposit had an original thickness that varied between 4 and 18 feet.

NOTE: REPRODUCED FROM ARDAMAN & ASSOCIATES' 1981-1983 STUDY
