## **LIQUID ASSESSMENT MONITORING MONTHLY PROGRESS REPORT FOR DECEMBER 2017**

### **SOUTHEAST COUNTY LANDFILL LITHIA, FLORIDA**

January 16, 2018  
File No. 09215600.05

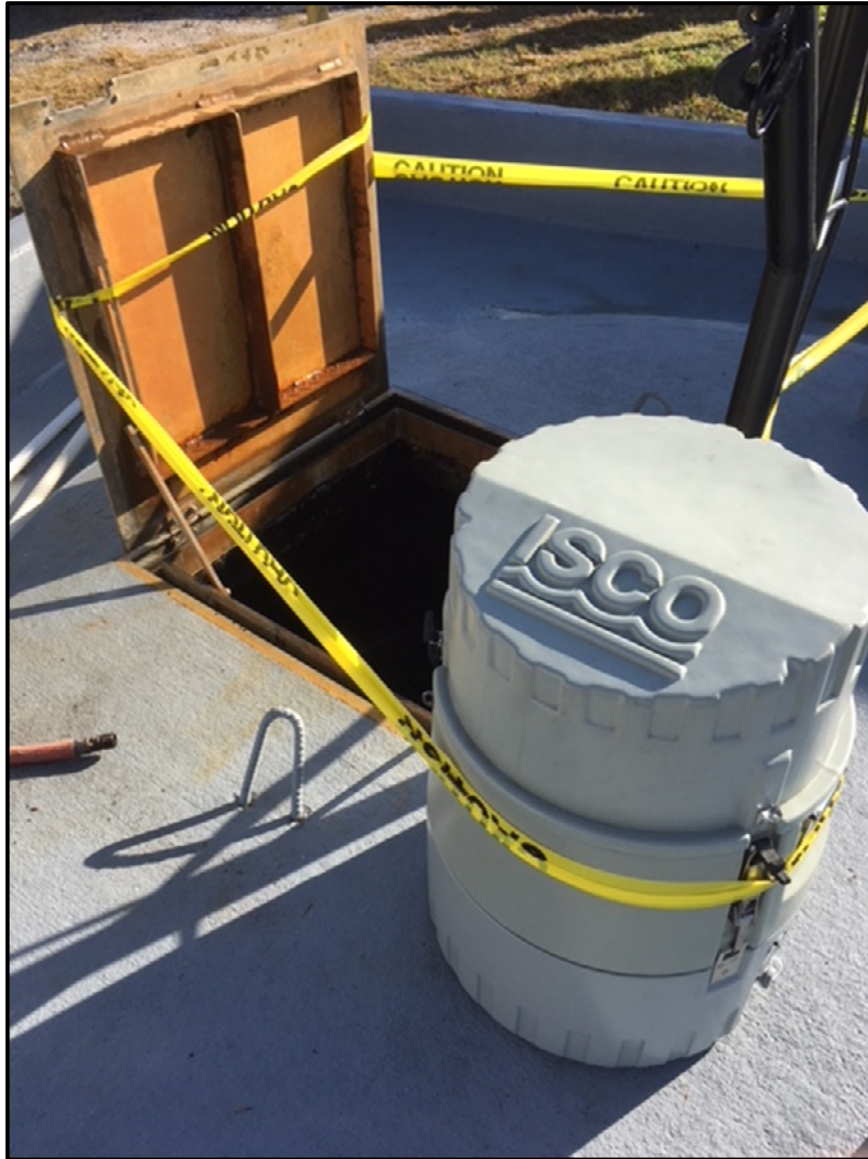
**Photograph 1.** Auto-Sampler Setup on Pump Station A (PS-A)

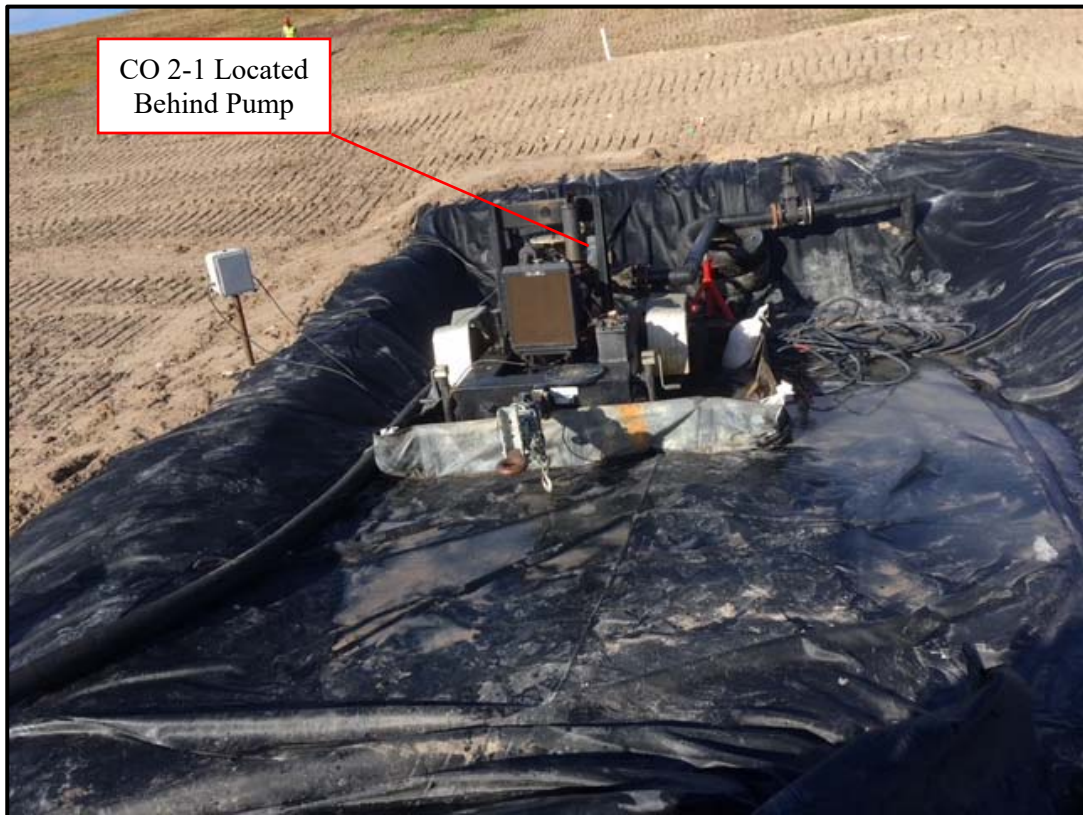
**Photograph 2.** Phase II Header Access Point (CO 2-1)

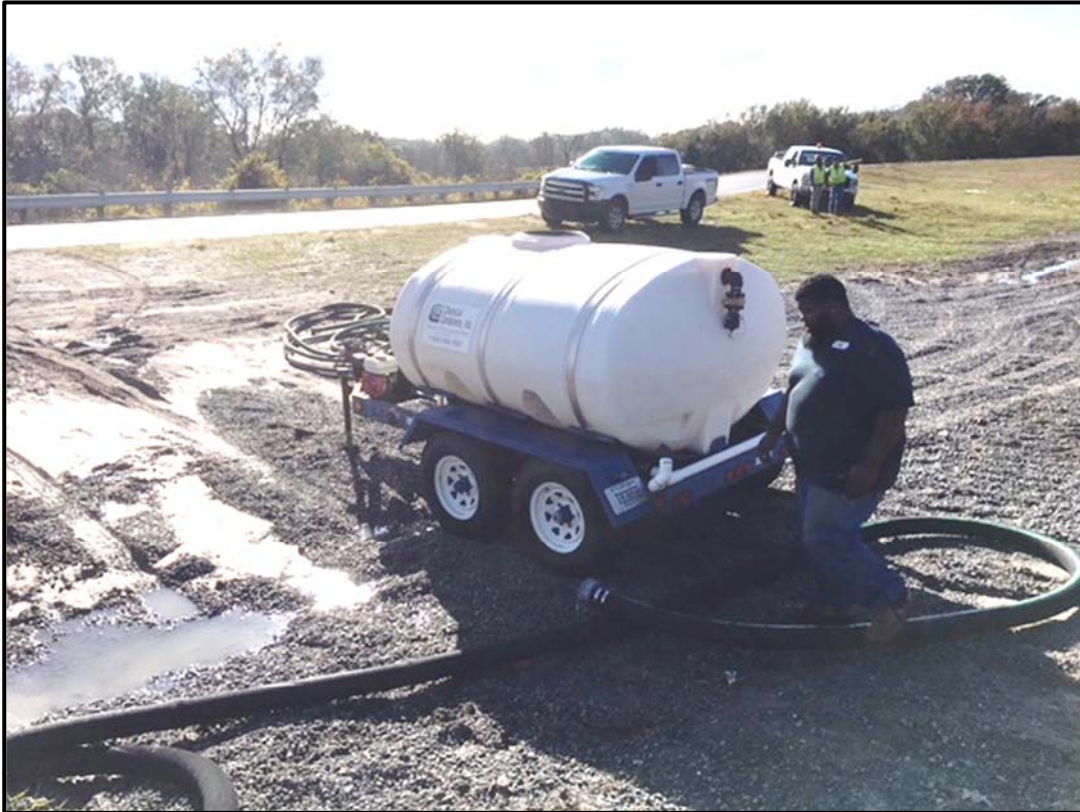
**Photograph 3.** 1,000 Gallon Portable Tank Used to Mix Water and Dye

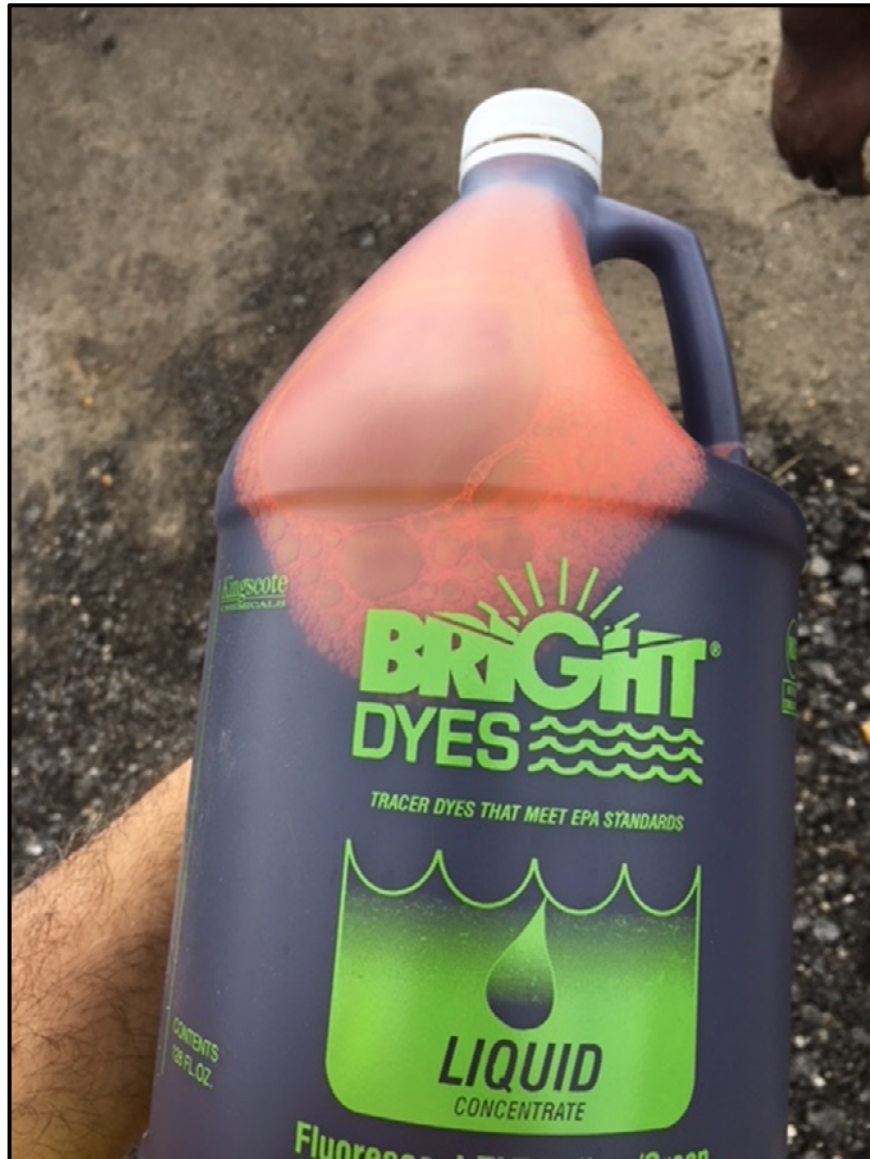
**Photograph 4.** Kingscote Chemicals Bright Dyes Yellow/Green Fluorescent Dye

SWMD personnel added one gallon of the Bright Dyes Yellow/Green fluorescent dye manufactured by Kingscote Chemicals to a portable water tank containing 1,000 gallons of non-potable water (**Photograph 3 and Photograph 4**). At 11:00 a.m., the water and dye mixture (dye mixture) was pumped into the header access point through the PS-2 intake pipe. By using the PS-2 intake pipe to inject the mixture approximately 800 feet into the header pipe from CO 2-1, the SWMD was able to insert the dye directly into the area of concern and bypass the Phase II cut-off trench. From 12:00 p.m. to 12:15 p.m., an additional 1,000 gallons of dye mixture was pumped into the PS-2 intake pipe.

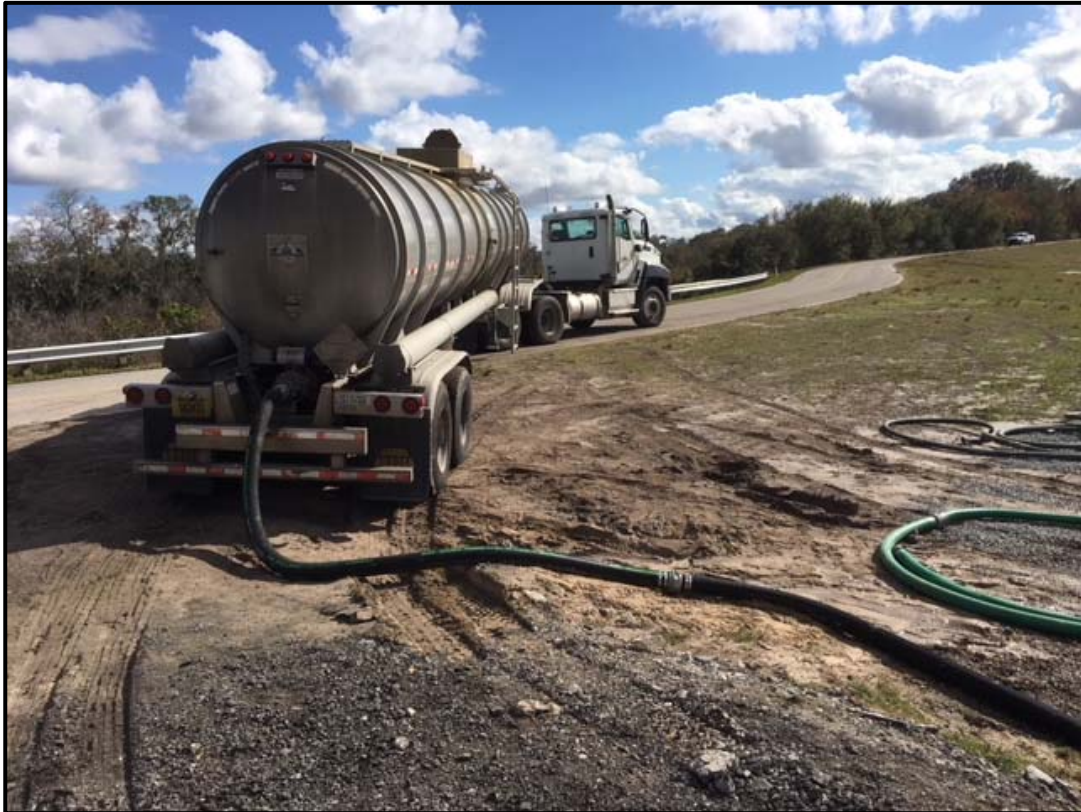
**Photograph 5.** Tank Truck Used to Pump 6,000 Gallons of Water with Tracer Dye “Donut” into the Phase II Header Access Point

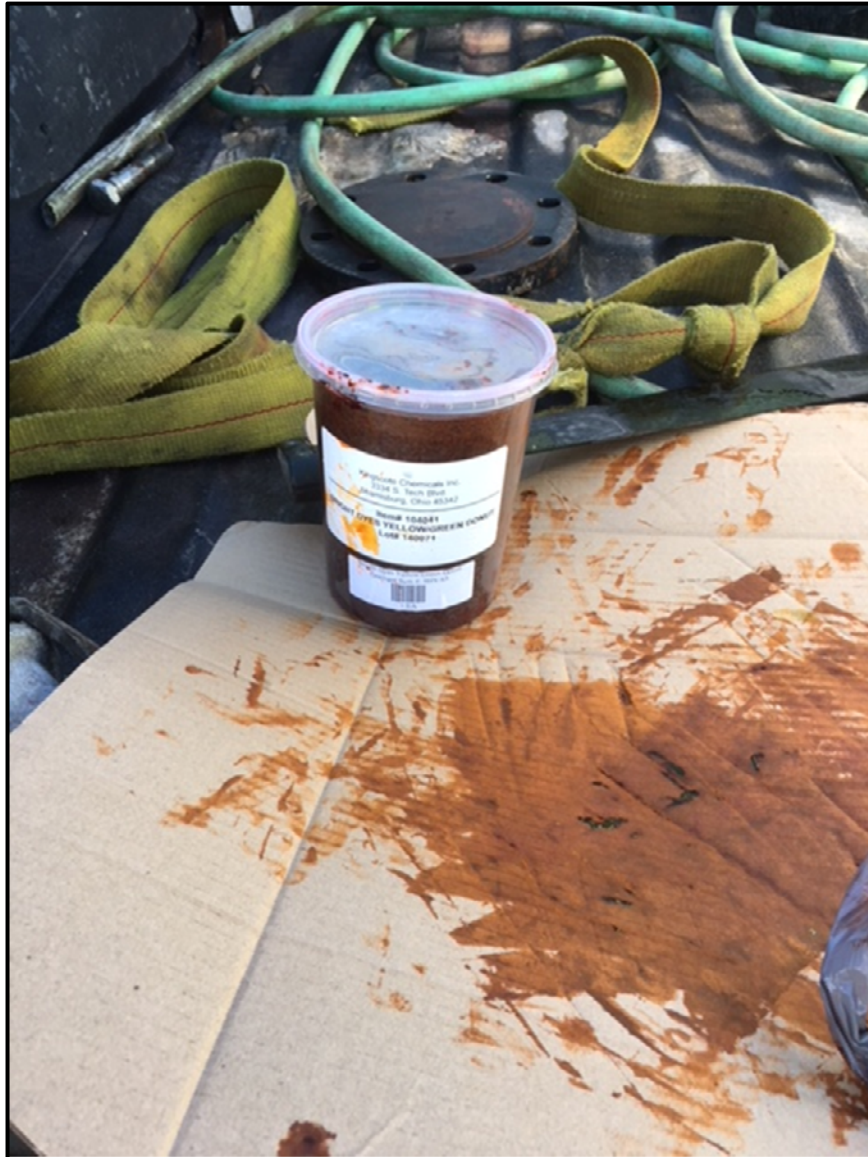
**Photograph 6.** Kingscote Chemicals Bright Dyes Yellow/Green Fluorescent Dye “Donuts”

Additional fluorescent dye was injected at PS-2 in order to increase the amount of dye mixture within the Phase II LCRS. At 2:15 p.m., approximately one-half of a Bright Dyes Yellow/Green Dye “Donut” manufactured by Kingscote Chemicals was added to approximately 6,000 gallons of non-potable water and pumped into the PS-2 intake pipe (**Photograph 5 and Photograph 6**).

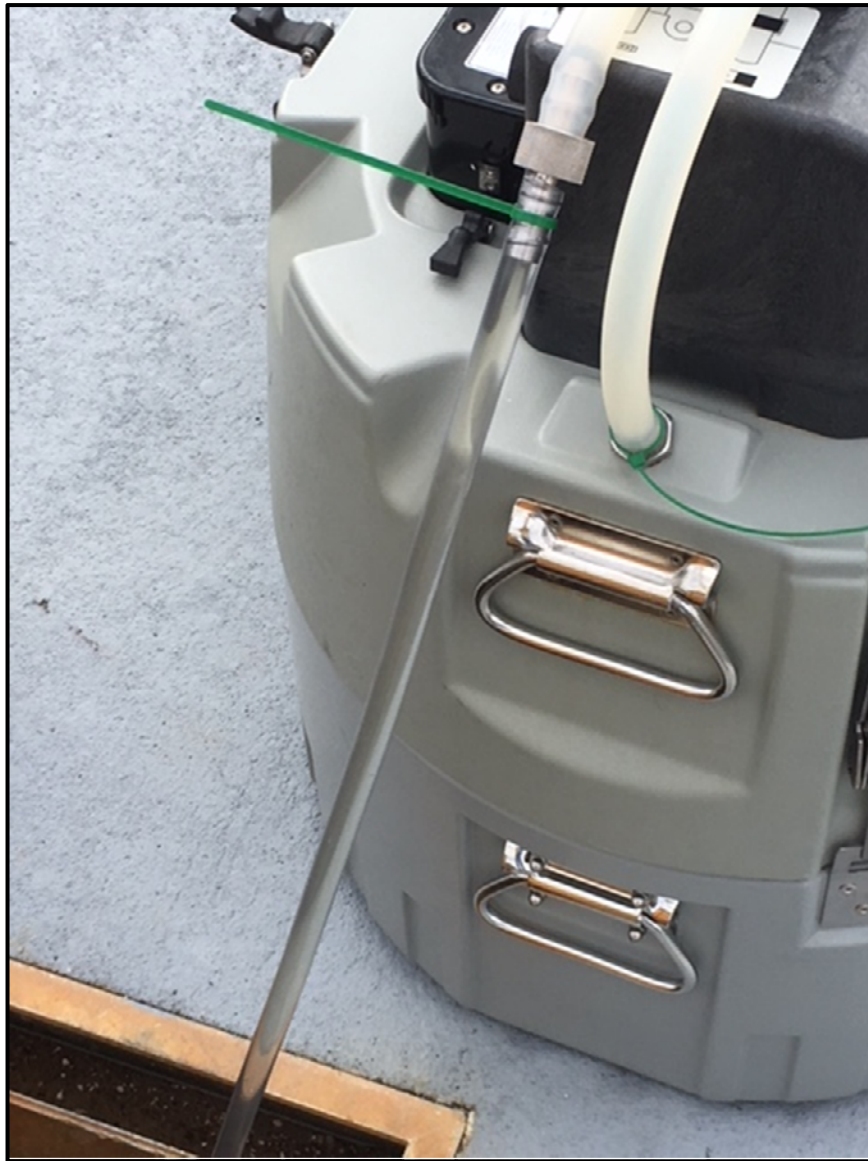
**Photograph 7.** 1:00 p.m. Check on Auto-Sampler at PS-A - No Observable Fluorescent Dye

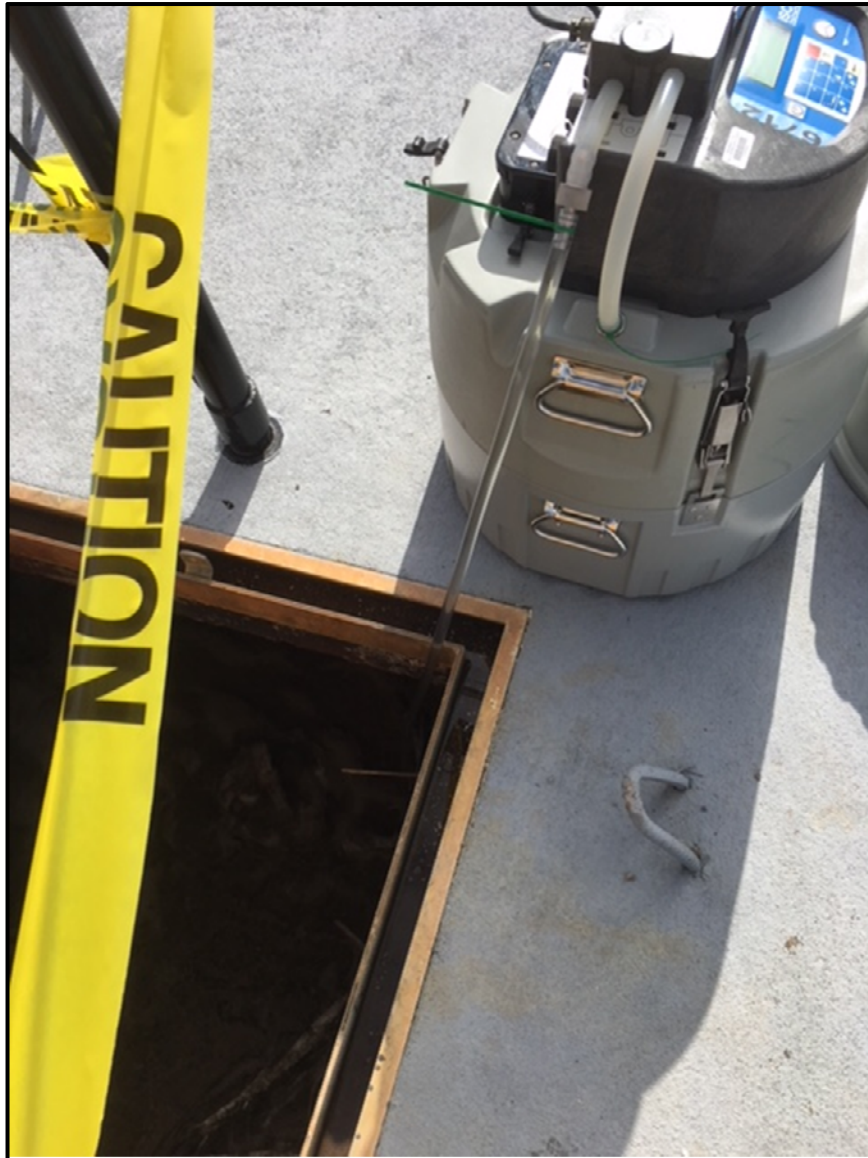
**Photograph 8.** 2:00 p.m. Check on Auto-Sampler at PS-A – No Observable Fluorescent Dye

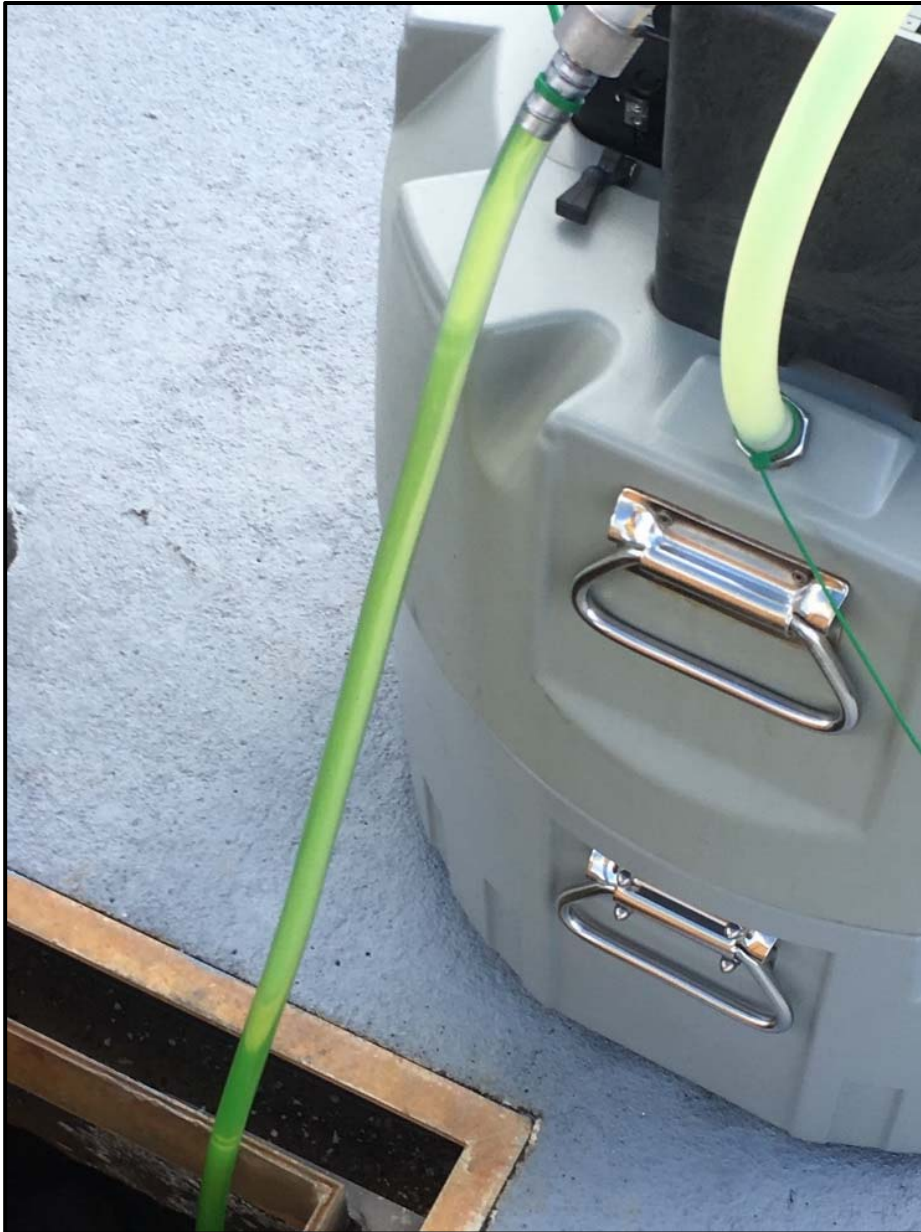
**Photograph 9.** 3:00 p.m. Check on Auto-Sampler at PS-A –Fluorescent Dye Present

Visual observations were made at the sampler every hour following the initial injection of the dye mixture for indications that the dye had reached PS-A. Fluorescent dye was not observed in the first four samples collected (11:00 a.m., 12:00 p.m., 1:00 p.m., or 2:00 p.m.). The dye was visually observed in the sample collected from PS-A at approximately 3:00 p.m., four hours after the initial dye was pumped into the PS-2 intake pipe.

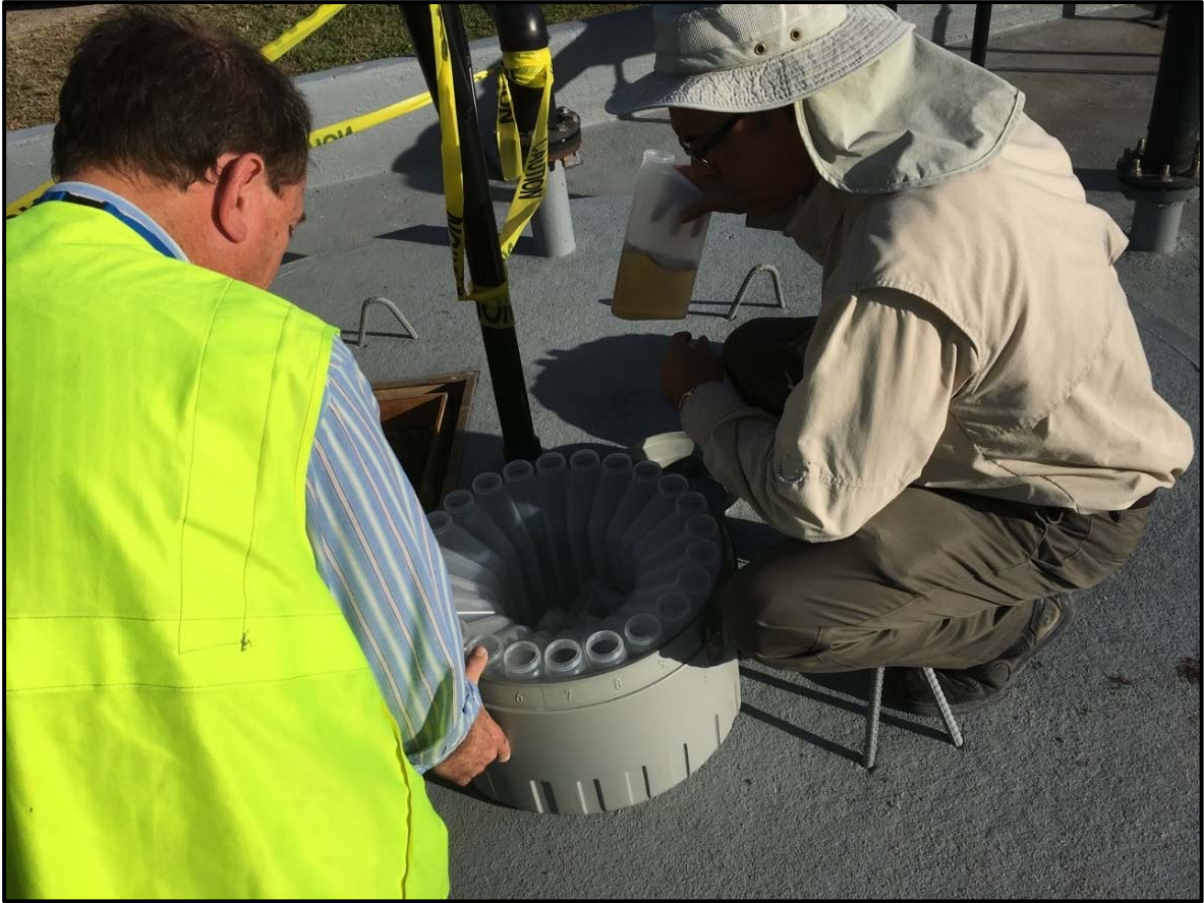
**Photograph 10.** SWMD Collects Sample 1 (1:00 p.m.), 2 (2:00 p.m.), and 3 (3:00 p.m.) from the Auto-Sampler for Laboratory Analysis

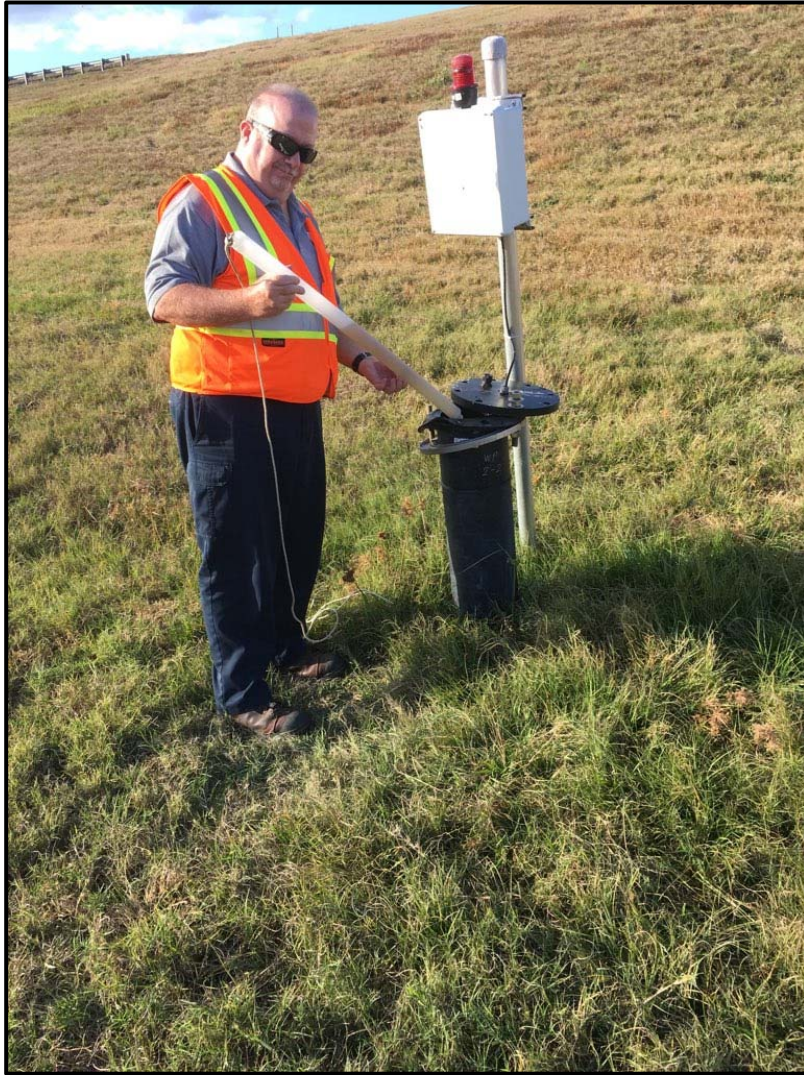
**Photograph 11.** SWMD Collects a Control Sample from MP 2-2 (Sample ID “MD”)

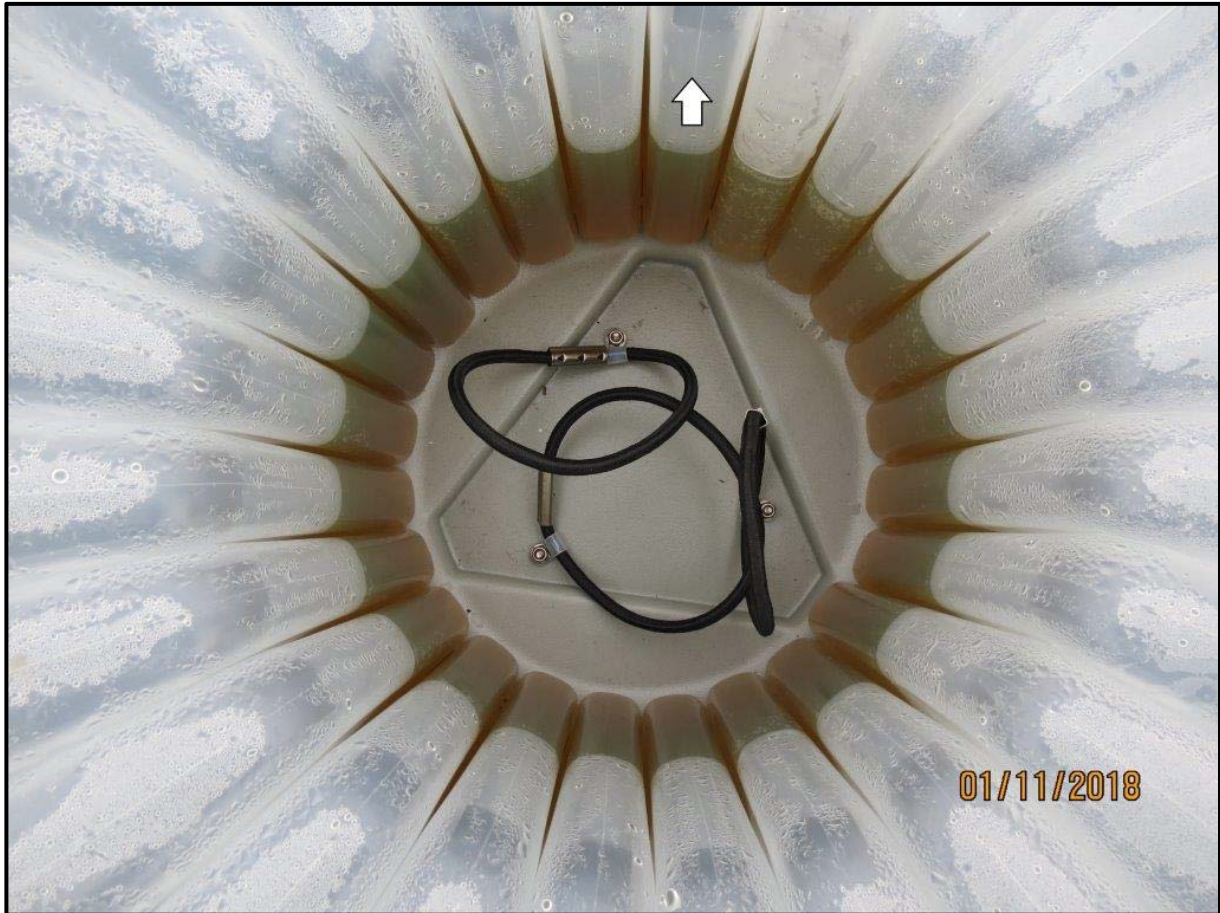
**Photograph 13.** Auto-Sampler Device Samples for 24-48 Hours (01/10/2018 – 01/11/2018). Arrow Indicates the 01/10/2018 11:00 a.m. Sample and Advances Counter-Clockwise at One Sample Per Hour.

The auto-sampler device was allowed to continue operation through 10:00 a.m. on January 11, 2018 for a total of 48 samples. Visual observations were noted and photographs of the samples were taken, but no additional sub-samples were collected for laboratory analysis (**Photograph 12 and Photograph 13**).

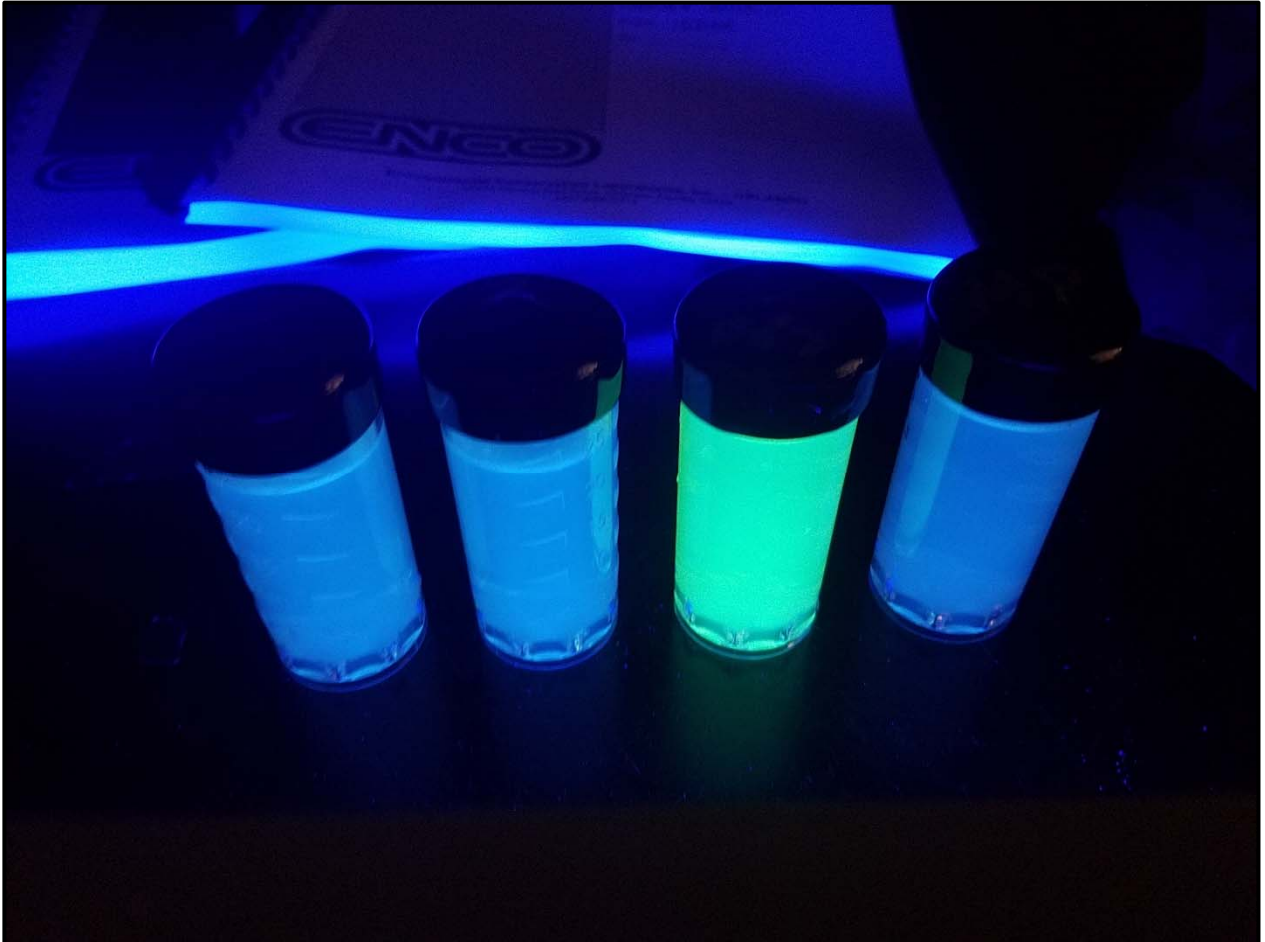
**Photograph 14.** Samples Listed Left to Right – 1 (1:00 p.m.), 2 (2:00 p.m.), 3 (3:00 p.m.), and MD (MP 2-2 Control) as Analyzed

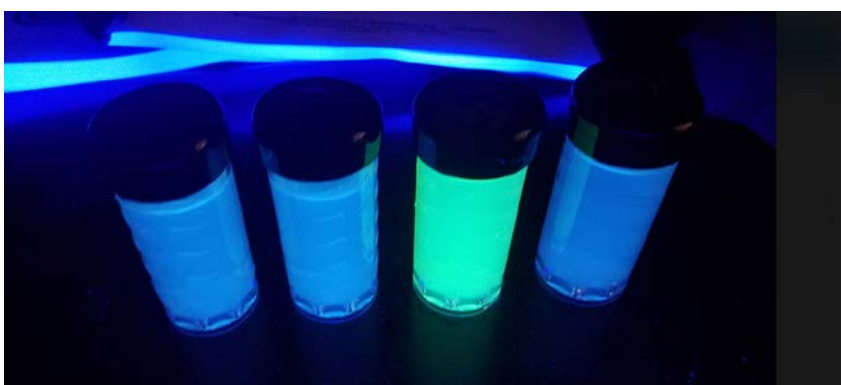
In the image below samples are identified from left to right as "1", "2", "3", "MD". Visual inspection un UV light reveals bright green/yellow luminescence in sample "3" while no luminescence was observed in other samples.
