Re: Warning Letter #WL19-131SW25SWD
Hardee County Regional Landfill
685 Airport Road, Wauchula, FL 33873
WACS ID: 40612
Hardee County

**Florida Department of
Environmental Protection
Inspection Checklist**

Facility Name: HARDEE COUNTY REGIONAL LANDFILL
On-site Inspection Start Date: 12/03/2019
On-site Inspection End Date: 12/03/2019
WACS No.: 40612
Facility Street Address: 685 AIRPORT ROAD
City: WAUCHULA
County Name: HARDEE
Zip: 33873

Routine Operation Inspection for Landfill - Class I

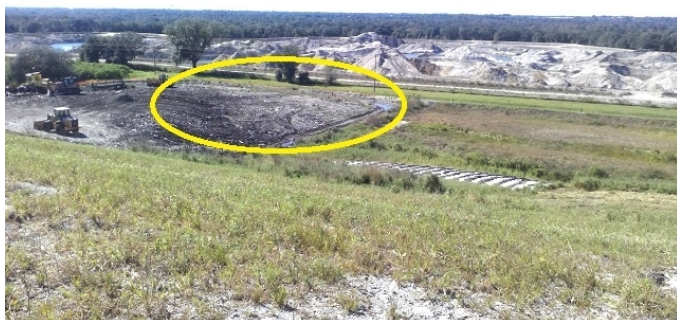
Northwest Corner of Active Area

B) During the inspection, it appeared that waste may have been deposited outside of the permitted cell. The access road into the active area caused the boundary between the lined landfill and the unlined facility to be unclear. Department personnel required that this be amended immediately following the inspection. A facility representative provided photo documentation demonstrating that the boundary between the lined and unlined area of the facility was delineated and that the liner in this area was not compromised.

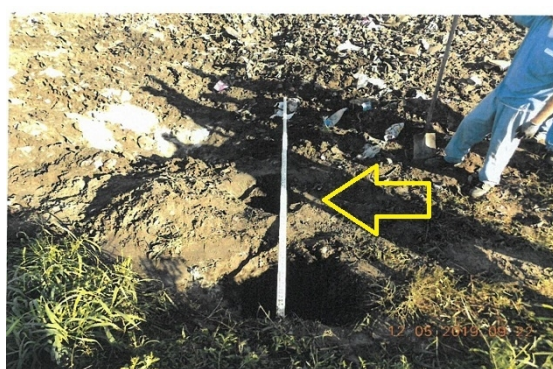
12/13/19 - Liner Boundary & Waste

Phase II Section II - South portion of cell - Liner Location West of ramp - approximately 4' from debris

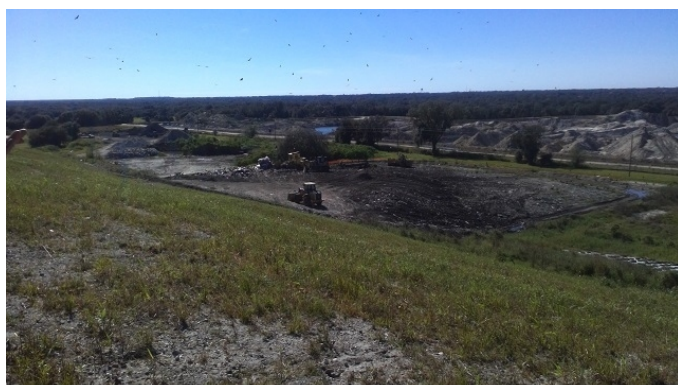
Active Area of Facility

Explanation: Per condition C.8.a. of Permit No. 38414-017-SO-MM and Sections K.7.e. and K.7.f. of the Operations Plan, initial cover shall consist of six inches of compacted soil. The Department observed poor application of initial cover in the southern portion of Phase II Section II. This lack of cover allowed for exposed waste.

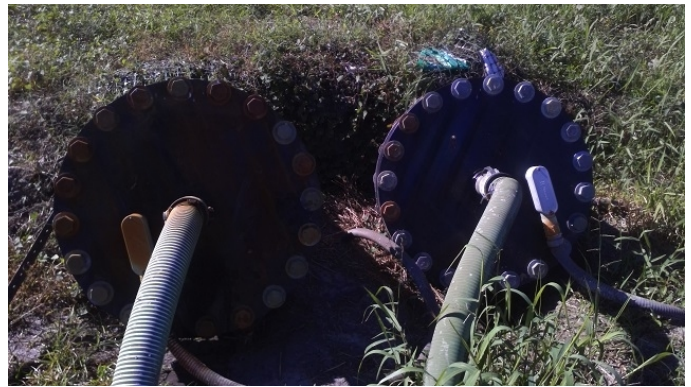
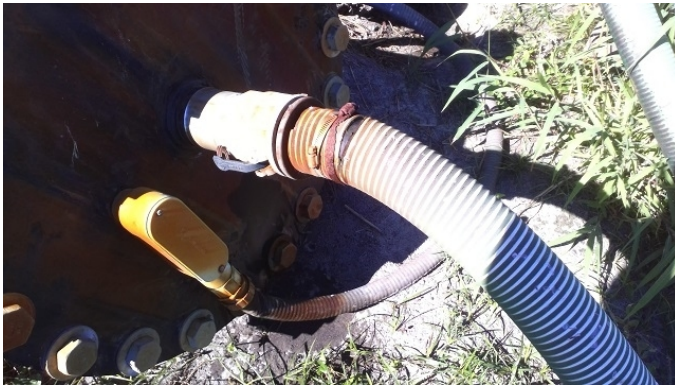
Flex Hose @ Pipes - Poor Cond.

Explanation: A) During the inspection, it was noted that the flex hose and its connections to the Leachate Collection System (LCS) and Leachate Detection System (LDS) riser pipes and the leachate haul-off area were leaking or in poor condition. Department personnel requested documentation demonstrating that these hoses are replaced, the connections are in good condition, and that no leachate is discharging from these flex hoses via email on December 13, 2019. On December 17, 2019, a facility representative provided documentation showing that additional clamps were added to the flex hoses at the riser pipes to prevent further dripping from the hoses.

Corrective Action: A) Please provide photo documentation demonstrating that the flex hose at the leachate tanks is replaced within 30 days of the date listed on the attached Warning Letter. Please continue to ensure that the flex hose and its connections to the LCS and LDS riser pipes are in good condition and do not leak when leachate moves through it.

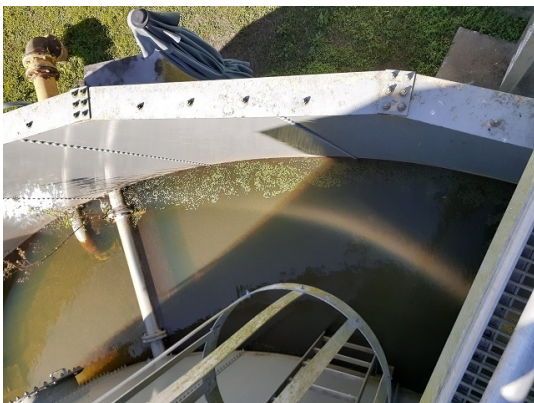
Secondary Tank of Tank #2

B) The secondary leachate tanks were filled with liquid during the inspection. It was unclear if it was leachate or stormwater. Department personnel requested documentation demonstrating that the pumps are functional and that the primary tanks are not leaking via email on December 13, 2019. A facility representative provided documentation on December 17, 2019, indicating that both secondary tanks had approximately 30 inches of stormwater in them. The water level in the primary tank of Tank #1 was decreased to around 2 feet prior to the opening of the access hole into the tank. The stormwater in this tank was removed and utilized for dust control at the facility. A new sump was installed in Tank #1 and the tank was cleaned. Tank #2, upon draining, will be cleaned and the sump pump will be replaced.

B) Within 30 days of the date listed on the attached Warning Letter, please provide documentation demonstrating that the Tank #2 sump pump is functional and that the primary tank is not leaking.

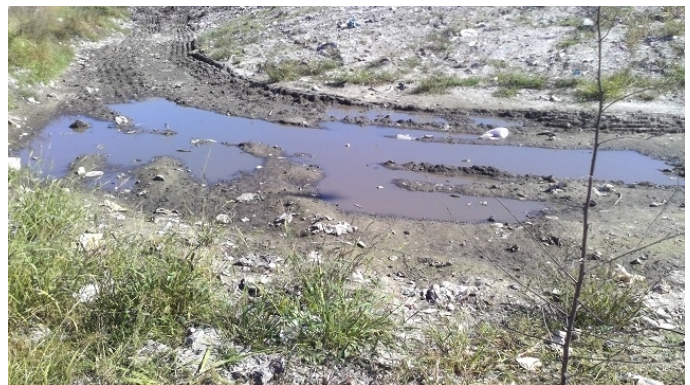
Ponding - NW Corner, Active Area

D) Ponding was observed in the Northwest corner of the southern portion of Phase II Section II. The reason as to why ponding existed in this area was unknown during the inspection, and a facility representative indicated that this area would be excavated to determine the cause. On December 13, 2019, documentation was provided via email by a facility representative explaining that clay soil accumulated in this area via runoff which caused permeability to decrease. Photo documentation demonstrating the ponding to be gone was also provided.

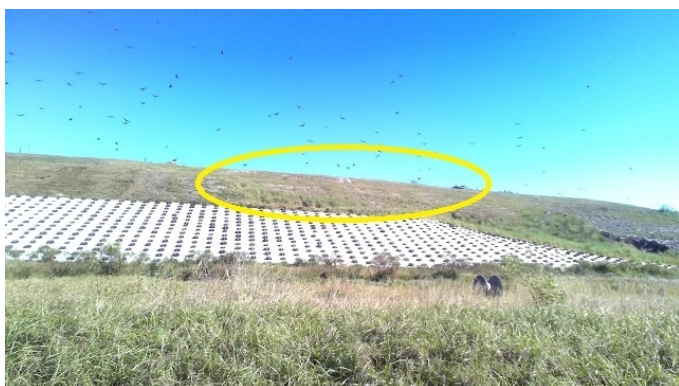
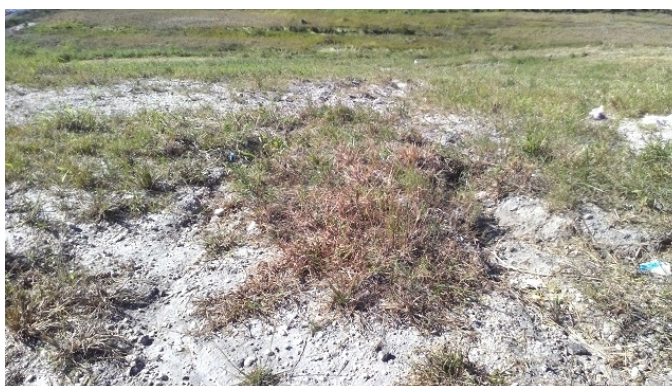
Erosion on Side Slope

Explanation: Erosion was observed on the western side slope of Phase I during this inspection.

Corrective Action: Please evaluate the side slopes of Phase I and repair any eroded areas. Please provide photo documentation showing these repaired areas within 30 days of the date listed on the attached Warning Letter.

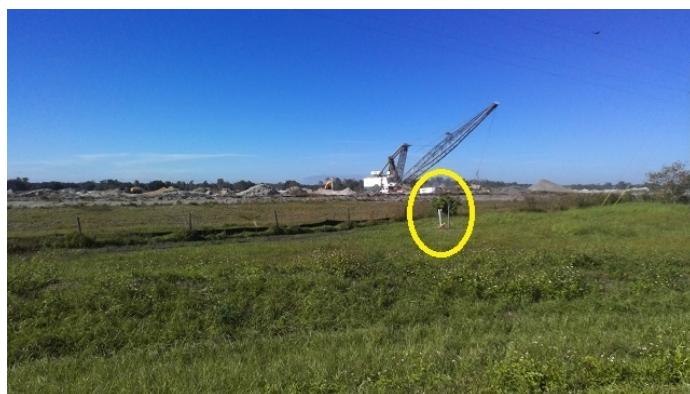
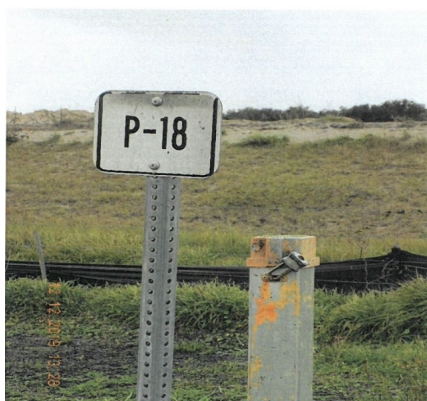
12/03/19 - Piezometer 18

Item 2.37: The entire monitoring well network was not inspected. The casing of Piezometer 18 appeared to be damaged. Upon further review by the facility, it was determined that an incident occurred during which the casing was damaged. Documentation provided to the Department via email on December 13, 2019, shows this piezometer repaired and secured with a lock. Please continue to ensure that the groundwater monitoring wells, piezometers, and gas monitoring wells at this facility are secure and maintained.

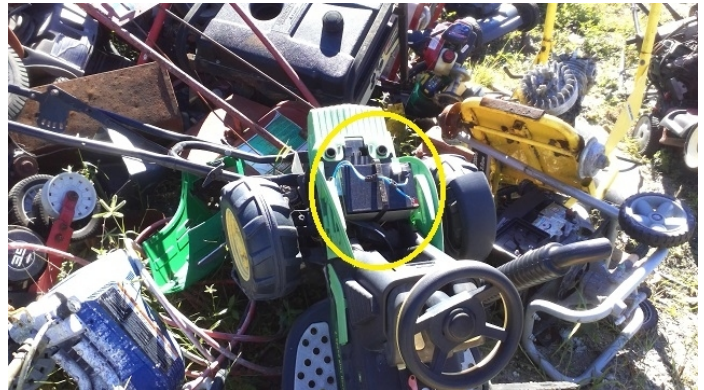
Example/Battery, Scrap Metal Area

A) During the inspection, two batteries were observed in devices in the scrap metal storage area of the facility. Department personnel indicated that these should be removed and placed in the Household Hazardous Waste Collection Center (HHWCC). Department received confirmation of the batteries' removal via email on December 13, 2019.
