December 23, 2019 File No. 09217088.15

Subject: Landfill Gas Monitoring Report, Fourth Quarter 2019

Methane Perimeter Probes and Buildings Sampling

Lena Road Landfill, Manatee County, Florida

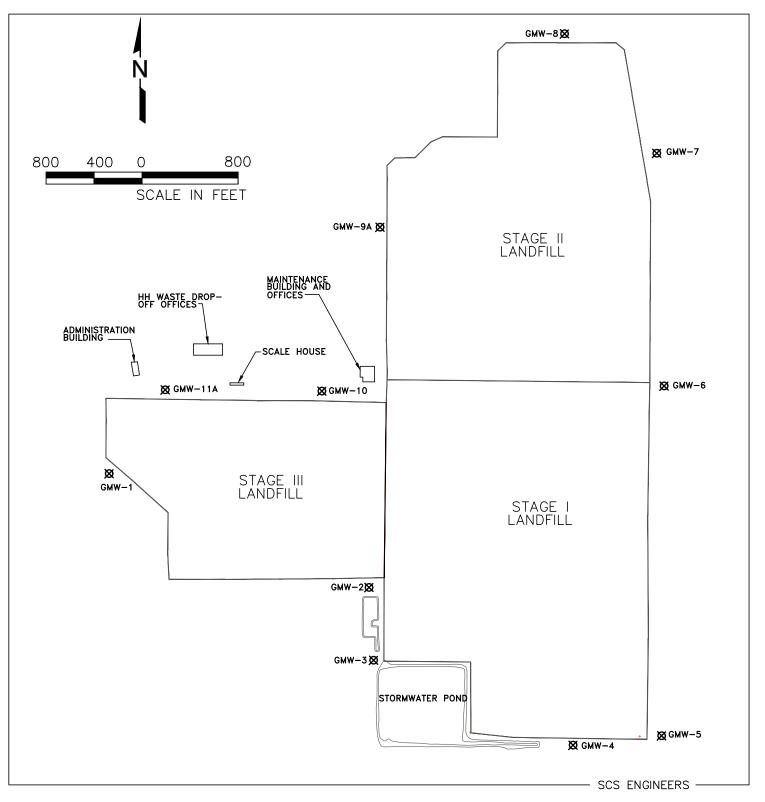
ATTACHMENT 1 GAS PROBE LOCATIONS

Landfill gas probes are designed to monitor whether methane and other gases are migrating underground outside of the landfill area. There are 11 LFG monitoring probes located on site around the boundaries of the Lena Road Landfill. Attachment 1 is a site map showing the LFG monitoring probe locations. This quarterly monitoring was conducted in accordance with Rule 62-701.530(2)(c), F.A.C. per specific condition Part E-4 of the landfill's operations permit #39884-021-S0-01.

Attachment 2 shows the readings obtained from the 11 probes along the property boundary, small amounts of methane were detected in the gas monitoring probes. A site plan showing the probe locations is included in Attachment 1.

No methane was detected in the scale house building, Household Hazardous Waste (HHW) drop-off (Recycling) building/offices, or maintenance building/offices. A small amount of methane was found in the administration building, as shown in Attachment 2. In the buildings, SCS monitored both restrooms, the offices, and common areas. Readings were taken while walking around the buildings and interior rooms in a continuous manner. The location of the buildings monitored can be seen in Attachment 1.

Lena Road Landfill, Manatee County, Florida Attachment 1: Gas Monitoring Probes & Building Locations
