RE: Vista Class III Landfill
SC48-0165969-014
Certification of Construction Completion
Cell 2 Liner System and Leachate Collection System

Vista Landfill, Class III, Cell 2 Construction Certification Report Apopka, Orange County, Florida

FINAL CERTIFICATION REPORT
FOR CONSTRUCTION QUALITY
ASSURANCE SERVICES

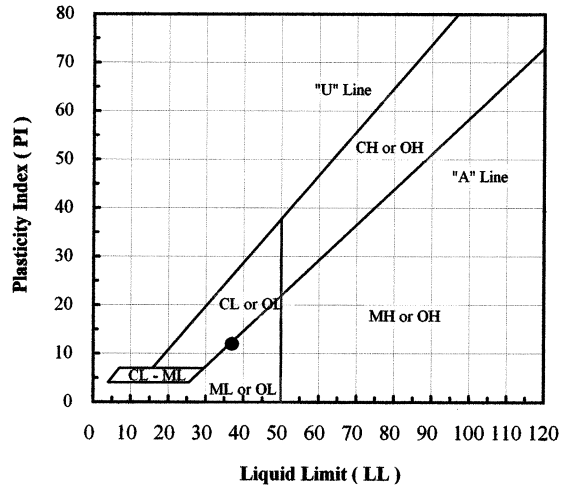
Sieve No.	Size (mm)	% Finer
3"	75	100.0
2"	50	100.0
1.5"	37.5	100.0
1"	25	100.0
3/4"	19	100.0
3/8"	9.5	100.0
#4	4.75	100.0
#10	2.00	99.8
#20	0.850	99.3
#40	0.425	95.9
#60	0.250	86.3
#100	0.150	68.5
#200	0.075	38.6

Gravel (%):	
Sand (%):	61.4
Fines (%):	38.6
Silt (%):	
Clay (%):

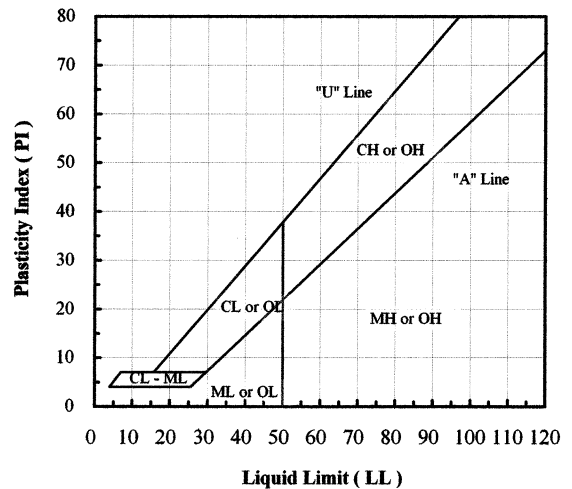
Sieve No.	Size (mm)	% Finer
3"	75	100.0
2"	50	100.0
1.5"	37.5	100.0
1"	25	100.0
3/4"	19	100.0
3/8"	9.5	100.0
#4	4.75	100.0
#10	2.00	100.0
#20	0.850	99.9
#40	0.425	99.4
#60	0.250	98.1
#100	0.150	95.5
#200	0.075	49.3

Client Sample ID.	Lab Sample No.	Moisture Content (%)	Fines Content < No. 200 (%)	Atterberg Limits			Engineering Classification
				LL (-)	PL (-)	PI (-)	
SB-02	J048	30.9	49.3				SC - Clayey sand

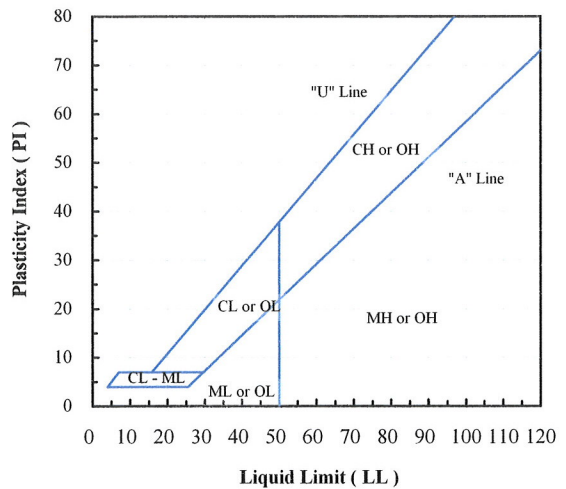
Sieve No.	Size (mm)	% Finer
3"	75	100.0
2"	50	100.0
1.5"	37.5	100.0
1"	25	100.0
3/4"	19	100.0
3/8"	9.5	100.0
#4	4.75	100.0
#10	2.00	100.0
#20	0.850	99.5
#40	0.425	89.1
#60	0.250	49.0
#100	0.150	16.5
#200	0.075	6.3

Client Sample ID.	Lab Sample No.	Moisture Content (%)	Fines Content < No. 200 (%)	Atterberg Limits			Engineering Classification
				LL (-)	PL (-)	PI (-)	
PC-01	K042	2.9	6.3				SP-SM - Poorly graded sand with silt

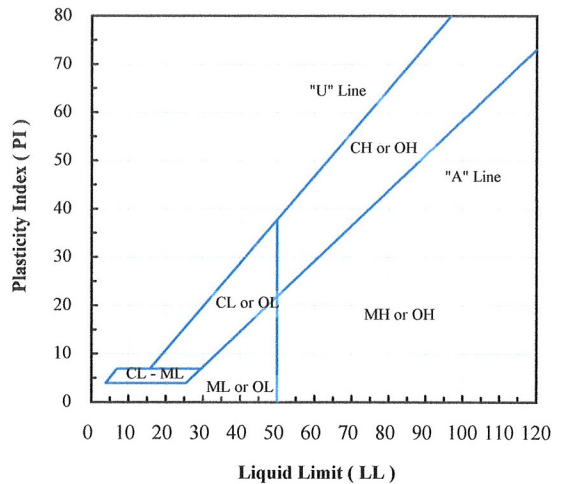
Sieve No.	Size (mm)	% Finer
3"	75	100.0
2"	50	100.0
1.5"	37.5	100.0
1"	25	100.0
3/4"	19	100.0
3/8"	9.5	100.0
#4	4.75	100.0
#10	2.00	100.0
#20	0.850	99.8
#40	0.425	96.3
#60	0.250	57.3
#100	0.150	11.1
#200	0.075	7.1

Client Sample ID.	Lab Sample No.	Moisture Content (%)	Fines Content < No. 200 (%)	Atterberg Limits			Engineering Classification
				LL (-)	PL (-)	PI (-)	
PC-08	L029	6.9	7.1				SP-SM - Poorly graded sand with silt

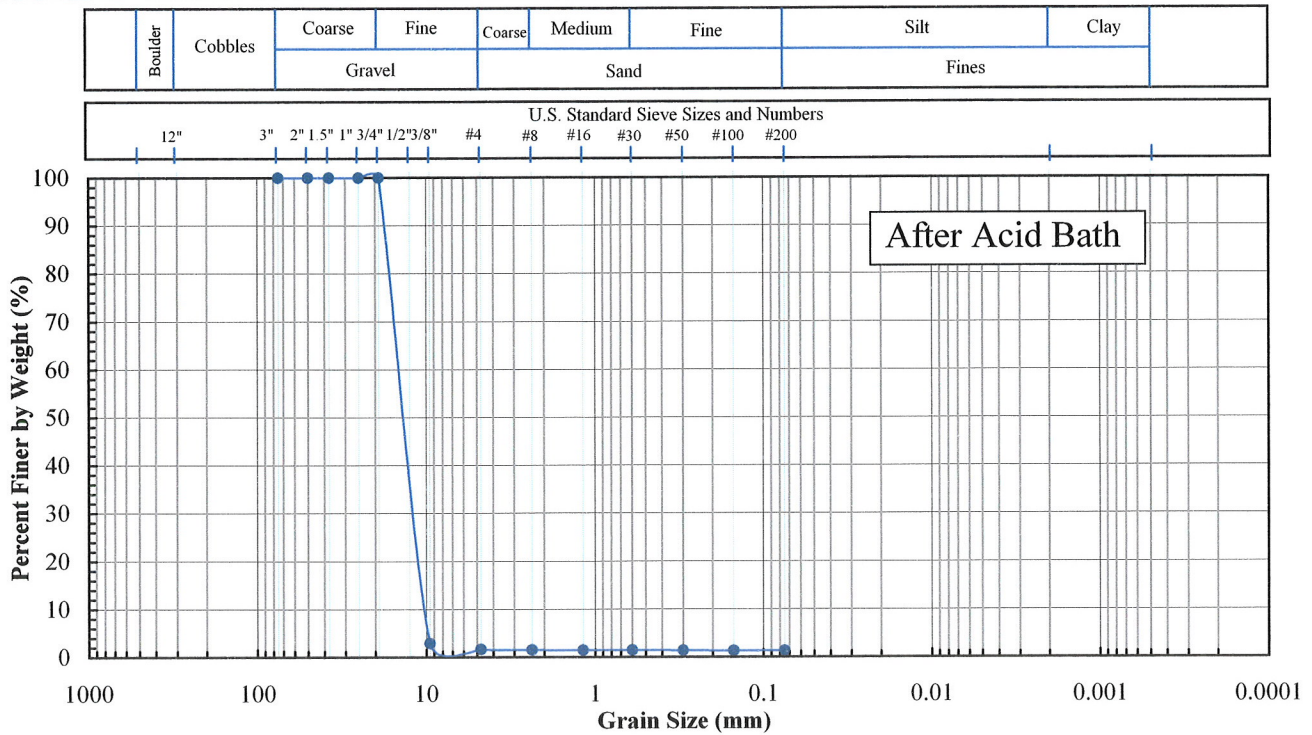
Sieve No.	Size (mm)	% Finer
3"	75.0	100.0
2"	50.0	100.0
1.5"	37.5	100.0
1"	25.0	100.0
3/4"	19.0	100.0
3/8"	9.50	2.9
#4	4.75	1.7
#8	2.00	1.5
#16	0.850	1.5
#30	0.425	1.4
#50	0.250	1.4
#100	0.150	1.4
#200	0.075	1.4

Client Sample ID.	Lab Sample No.	Moisture Content (%)	Fines Content < No. 200 (%)	Atterberg Limits			Total Insoluble Residue (%)
				LL (-)	PL (-)	PI (-)	
DA-01 (Trench)	K033		1.4				98.6

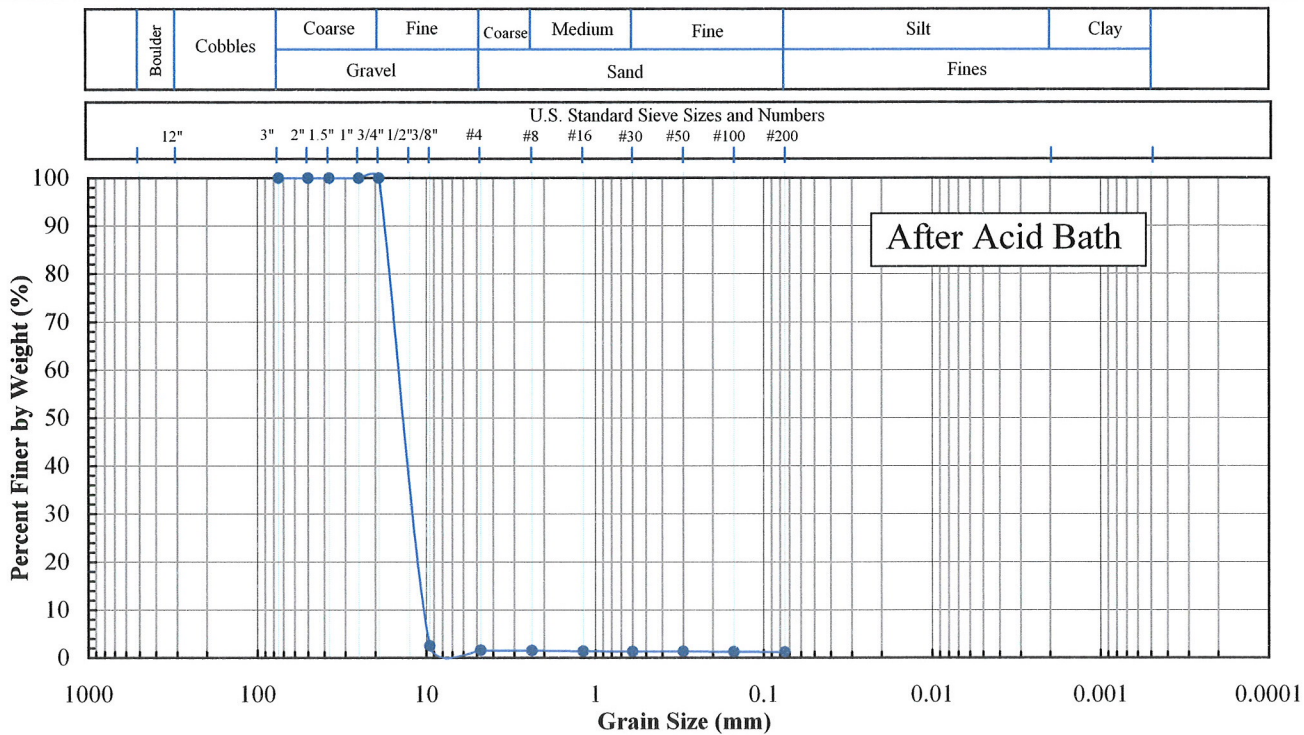
Sieve No.	Size (mm)	% Finer
3"	75.0	100.0
2"	50.0	100.0
1.5"	37.5	100.0
1"	25.0	100.0
3/4"	19.0	100.0
3/8"	9.50	2.5
#4	4.75	1.6
#8	2.00	1.5
#16	0.850	1.4
#30	0.425	1.4
#50	0.250	1.3
#100	0.150	1.3
#200	0.075	1.2

Client Sample ID.	Lab Sample No.	Moisture Content (%)	Fines Content < No. 200 (%)	Atterberg Limits			Total Insoluble Residue (%)
				LL (-)	PL (-)	PI (-)	
DA-03 (Sump)	K038		1.2				98.8
