**Re: Phase I Hot Spot Issue
Status and Proposed Response Plan
Central County Solid Waste Disposal Facility
Sarasota County, Florida**

Submitted on behalf of Sarasota County Solid Waste, the purpose of this letter is to summarize the status of observed excessive temperature (Hot Spot) in the landfilled waste mass within the southwest portion of the south side slope of Phase I, approximately 35 feet southwest of Gas Well (GW) – 26, Central County Solid Waste Disposal Complex (CCSWDC), Sarasota County, Florida. Provided below is a summary of events since the first observation of the Hot Spot, actions taken to assess the temperature and lateral extent of the Hot Spot, a plan to accelerate the cooling of the Hot Spot, and a summary of potential repairs to the landfill gas (LFG) piping within the subject area.

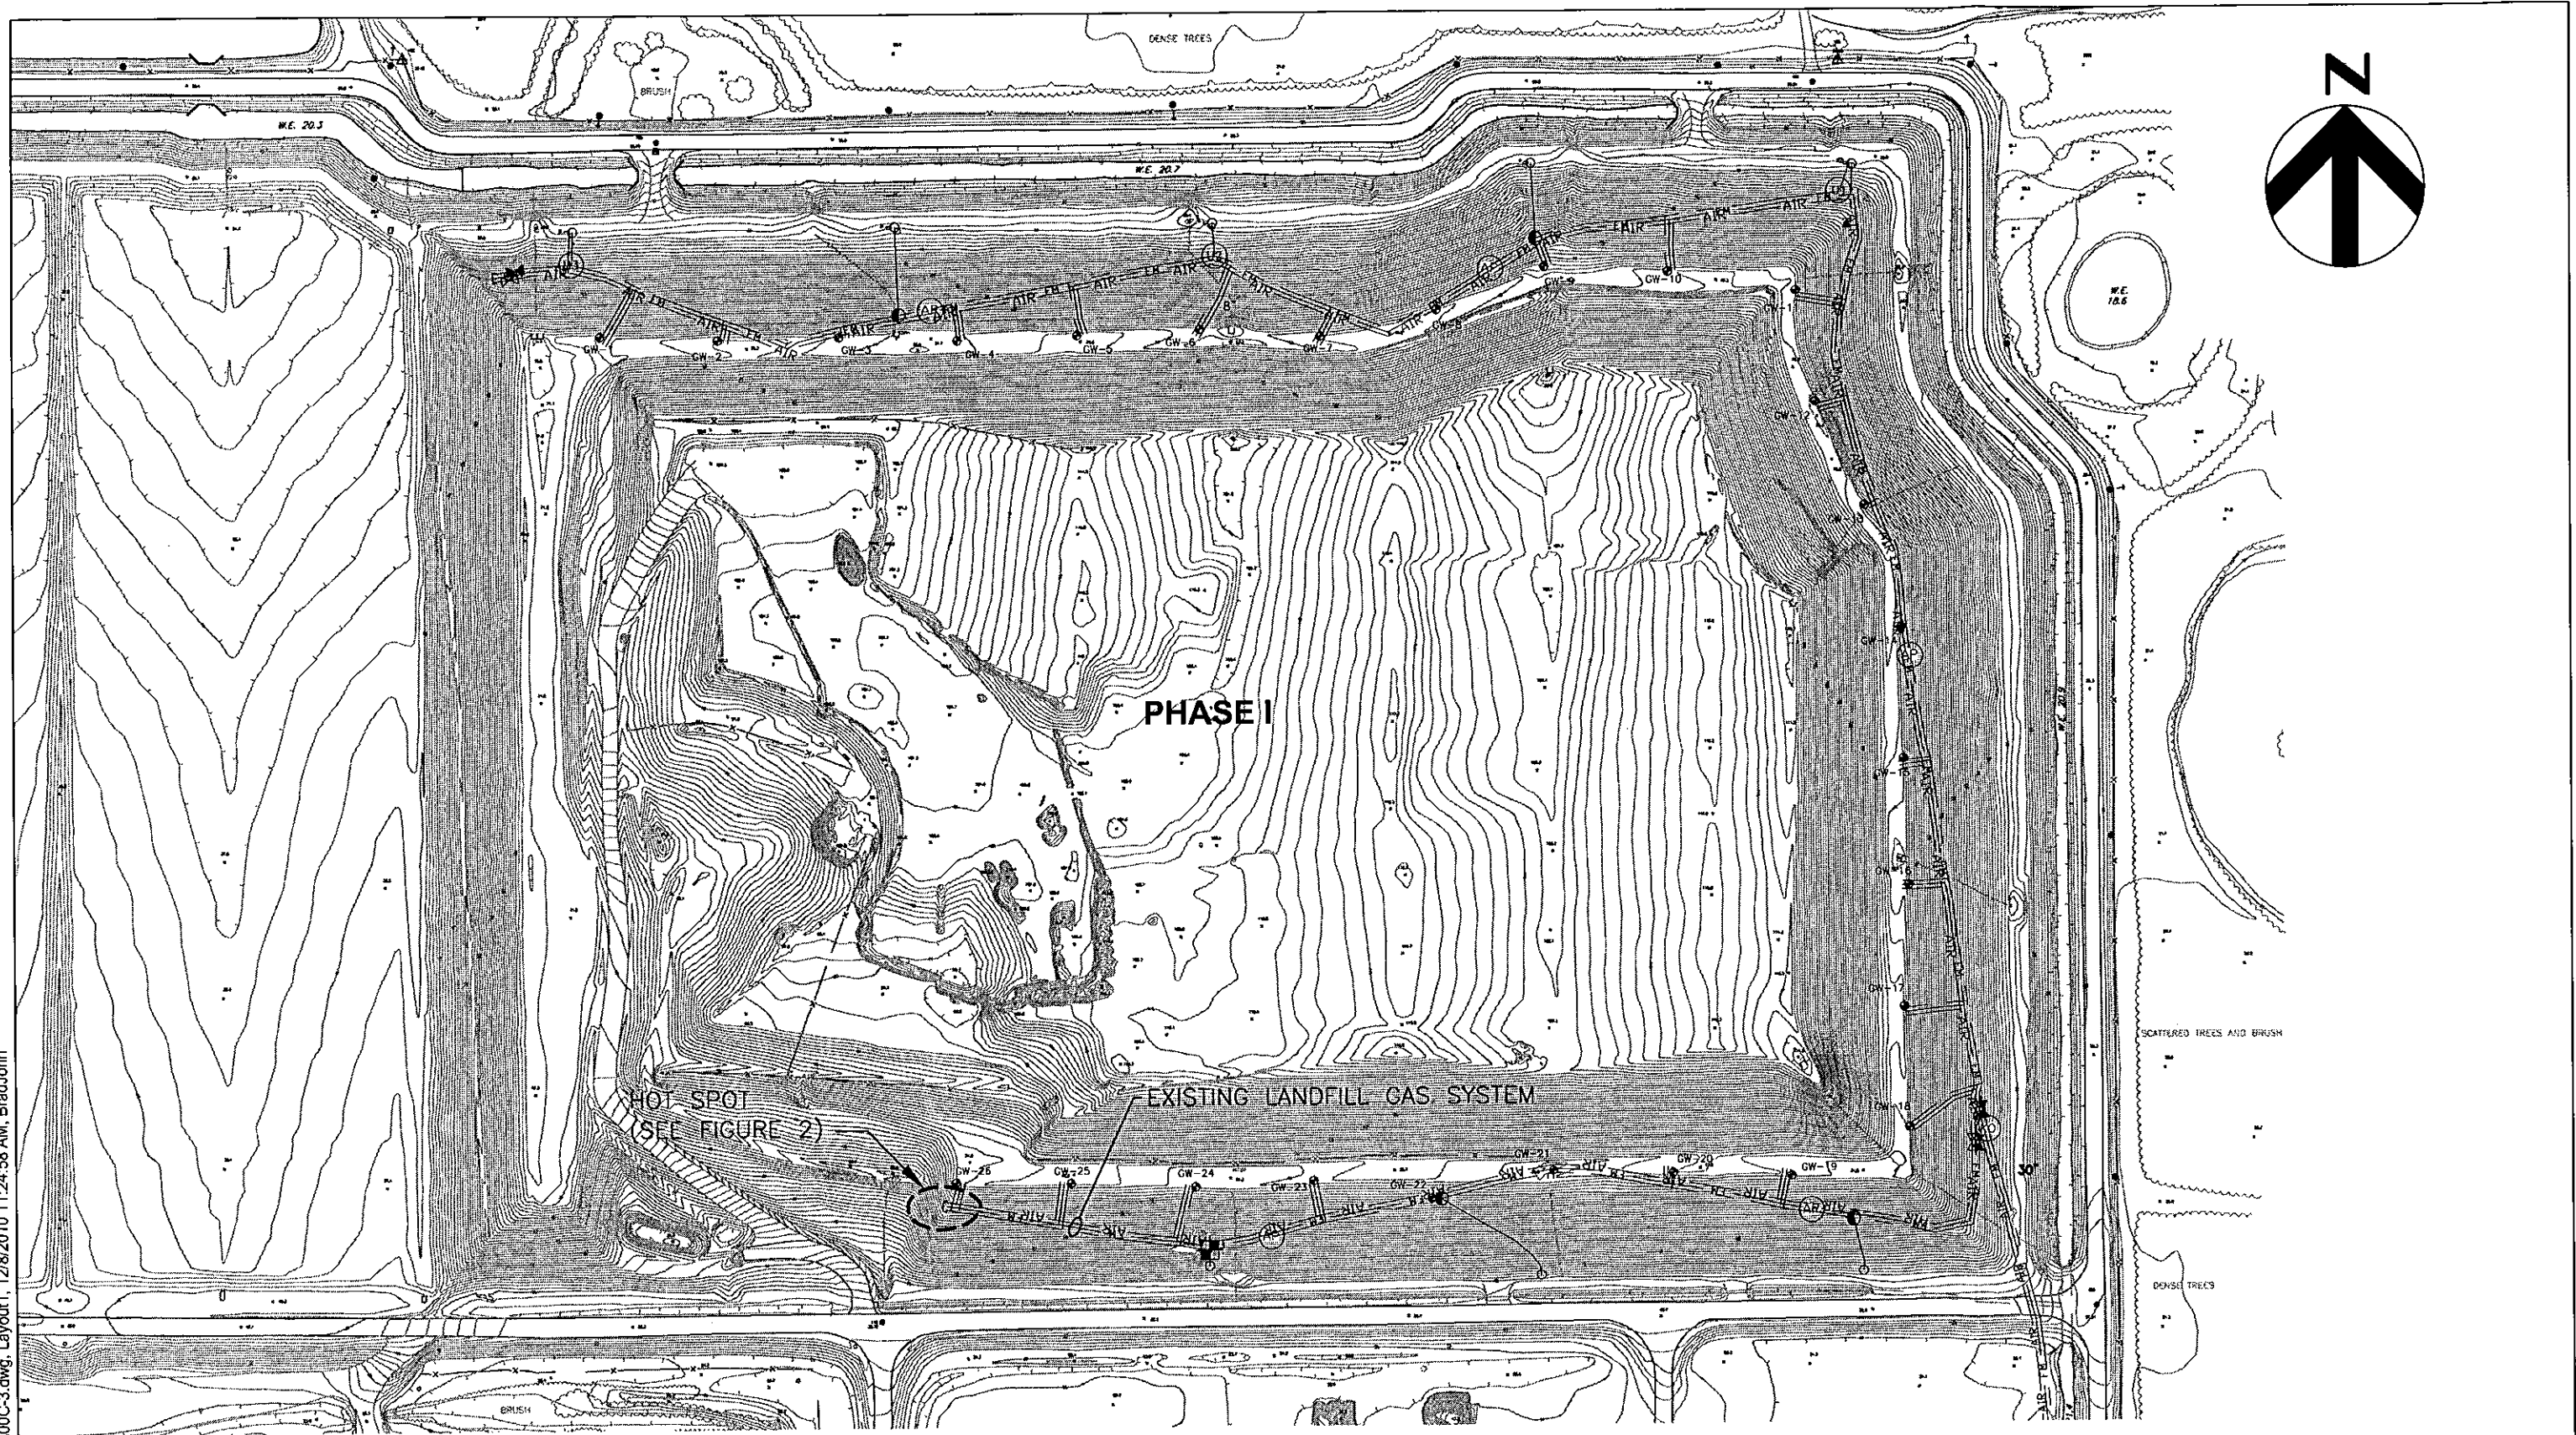
SCALE	1"=200'
FILENAME	00C-03.DWG
FIGURE	1

PROJECT TITLE	TEMPERATURE MONITORING PROBES
SHEET TITLE	SARASOTA COUNTY CENTRAL COUNTY SOLID WASTE DISPOSAL COMPLEX

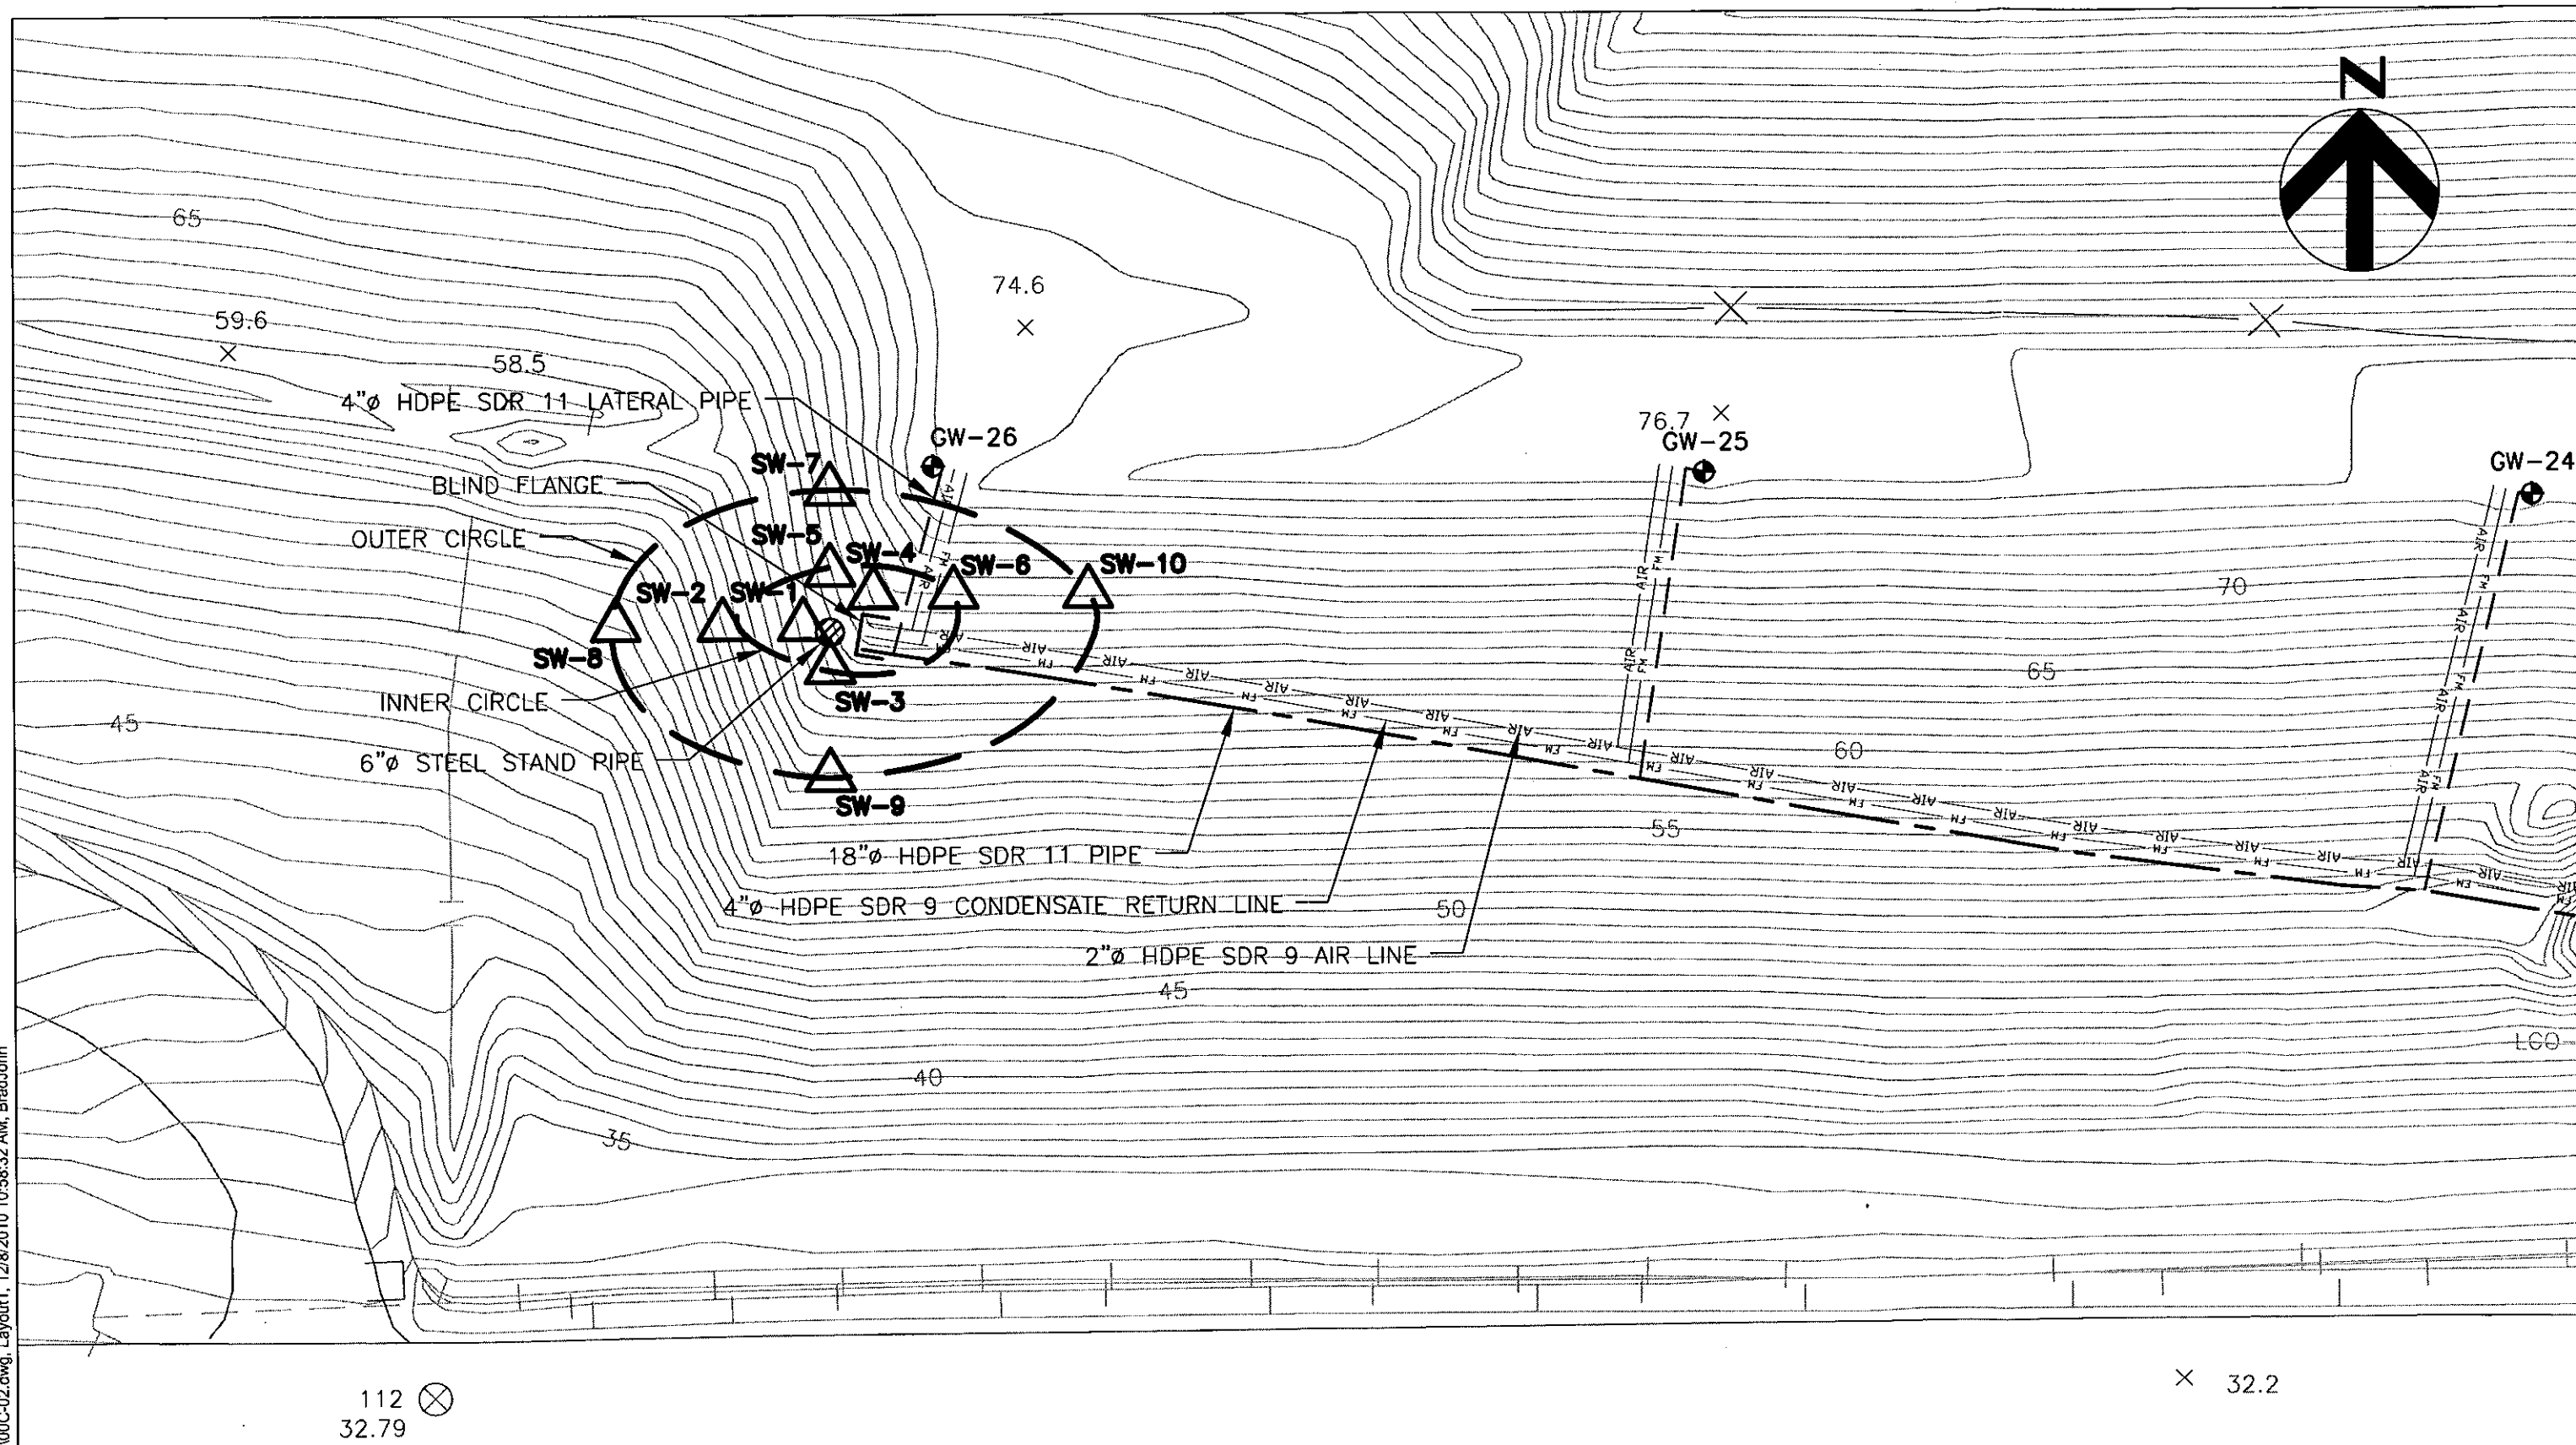
SCALE	1"=30'
FILENAME	00C-02.DWG
FIGURE	2

Based on the above observations, County and HDR staff developed a plan to assess the temperature and lateral extent of the Hot Spot. On November 23, 2010, a geoprobe was used to install ten, 2-inch diameter steel pipes into the waste mass for use in assessing the temperature and lateral extent of the Hot Spot. As shown on Figure 1 and attached photographs, the pipes were installed using an inner ring and outer ring approach. The inner ring probes (probes SW-1 through SW-6) were installed within 10 feet of the stand pipe. The outer ring probes (probes SW-7 through SW-10) were installed within approximately 25 feet of the stand pipe. Thermocouple wires were installed in each of the temperature probes and GW-26. An electronic thermometer was provided to connect to each thermocouple wire for observing the temperature in each of the installed temperature probes and GW-26.

As shown on the attached table, the temperature in the inner circle probes (probes SW-1 through SW-6) on December 7, 2010, ranged from 160 to 204 degrees F. The temperature within the outer circle probes (probes SW-7 through SW-10) on December 7, 2010, ranged from 98 to 132 degree F. The temperature in GW-26 on this same date was 135 degrees F. Based on the temperature data recorded thus far, it appears that the Hot Spot (temperature greater than 150 degrees F) is limited to the inner circle probes, SW-1 through SW-6, which is slowly cooling, and is not laterally expanding.

PROJECT TITLE	TEMPERATURE MONITORING PROBES
SHEET TITLE	SARASOTA COUNTY CENTRAL COUNTY SOLID WASTE DISPOSAL COMPLEX
