## **WARNING LETTER**

## HAZARDOUS WASTE INSPECTION REPORT

**FACILITY NAME:** International Paper, Inc. **DEP/EPA ID #:** FLD 008 166 639

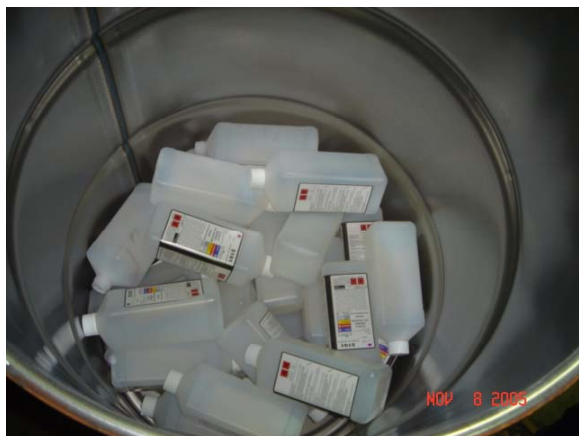
picture A

There are three process lines in the converting area on which Xerox paper is cut to size, printed with a code and packaged in pre-printed paper. James Eiland, Benco Operator, demonstrated that printing is accomplished by “mod” printers using disposable cartridges which contain MEK. The cartridges are removed from the printers when empty and replaced. Cartridges (usually empty) are placed in a Satellite Accumulation Area (SAA) drum, see picture A. The SAA drum was labeled “Hazardous Waste” and covered, see picture B. Solvent containing MEK used for cleaning purposes is caught in a container attached to a funnel, see picture C. When the container is full it is placed in the SAA drum along with the empty cartridges.

- d) If cartridges are "empty" per 40 CFR 261.7 when discarded, the cartridges and any residue remaining in the cartridge is not subject to regulations under parts 261-265, or part 268, 270 or 124 of Chapter 40 CFR or to the notification requirements of section 3010 of RCRA. Therefore, they may be handled as non-hazardous waste.

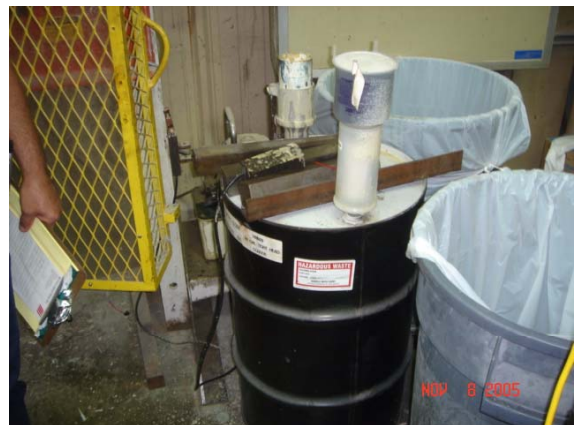
picture D

There was one SAA in the Converting Area Maintenance Shop for collecting residue from punctured cans, see picture D. The punctured cans are collected in a dedicated trashcan and handled as scrap metal. Rags used in this area are disposed of with the regular trash. A review of manifests subsequently submitted by IP for aerosol cans observed in this area suggests that none contain any constituents listed for any reason other than ignitability (F003).

- (2) Training should include management of spent aerosol cans. Employees should be familiar with the proper way to manage un-punctured and punctured cans. The puncturing of aerosol cans is considered hazardous waste treatment requiring a hazardous waste permit unless the punctured cans are managed as scrap metal which causes the puncturing operation to be exempt from RCRA regulation.

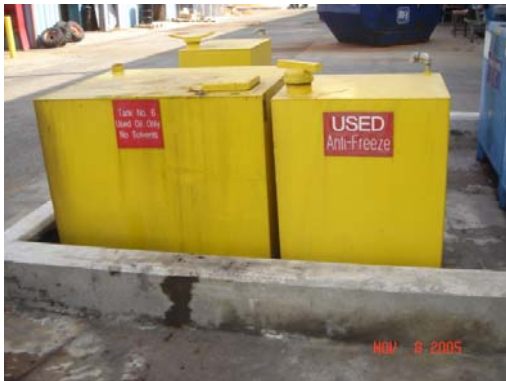
picture E

Used oil, used antifreeze and waste gas generated in the vehicle maintenance area are collected in separate tanks located within secondary containment just outside the shop area, see pictures E and F. The tanks were appropriately labeled and in good condition. Gasoline collected in the tank labeled "Waste Gas and Water Mixture" is picked up to be used as a fuel and is therefore exempt from the definition of "solid waste" and not regulated under RCRA. The secondary containment was compromised by an open valve which Mr. Dail closed upon discovery, see picture G. Used Oil Filters are crushed and placed in a drum labeled "Drained Used Oil Filters, see picture H." Aerosol cans are punctured in this area and residue is collected in a closed container labeled "Hazardous Waste". Punctured and un-punctured aerosol cans and fuel filters were found mixed in with the regular trash, see picture I and J.

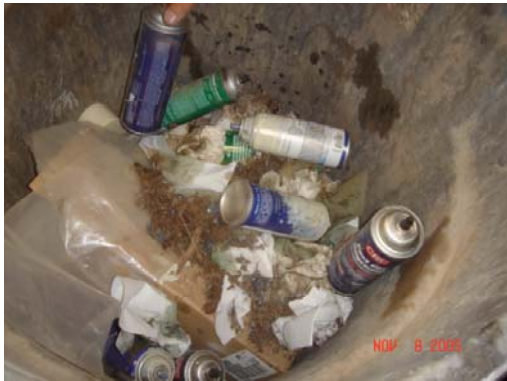
picture I

Waste fuel filters were found in the regular trash. Fuel filters generally are characteristically hazardous (D001/D039) when disposed of. Fluorescent tubes were found abandoned and broken in the wood yard area and generally are characteristically hazardous (D008). The dip tank solution located behind the machine shop will be characteristic hazardous waste (D002) when spent and no determination has been made on whether heavy metals or other contaminants may become entrained as a result of its use. The hose connected to the bottom of the tank appeared to be there for the purpose of draining the dip tank onto the road and no other explanation was offered.

- (1) Training should include management of used fuel filters. Used fuel filters may be managed with used oil filters if accepted by your hauler and destination facility. The containers should be labeled "Used Oil and Fuel Filters" and managed per used oil filter requirements. If the filters are disposed of with the regular trash, they are solid waste and most likely hazardous waste.

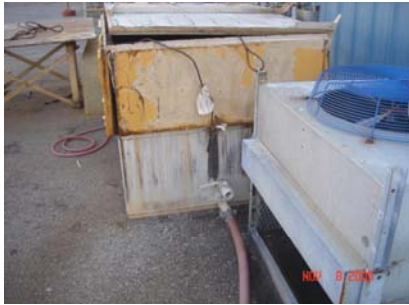
There is a System One parts washer and agitating parts washer in this area. Both units use non-hazardous solvent and are serviced monthly by Safety Kleen. Aerosol cans generated in this area are taken to the vehicle maintenance shop to be punctured and rags are disposed of with the regular trash. There was a covered dip tank located just outside the machine shop. A hose was attached to the bottom of the tank and extended out to the end of the building, see picture K - N. The inspectors asked about the use of the hose and how the dip tank solution is normally disposed of when spent. Mr. Dail said that he did not know why the hose had been attached and that it should not be there. He called someone to have the hose removed. He also said that the spent dip tank solution is normally recovered for its caustic value by pumping it into the sodium hydroxide solution (white liquor) used to break down wood chips in the pulping process. There were several rusty drums in the same area. We asked Ken Borne, machinist, what the drums contained. He said that they contained detergent that is diluted and used in the dip tank. There were no waste drums in this area. On 11/14/05 Nicole McDonald and Melissa Woehle tested the pH of the dip tank solution using wide and short range pH paper with the following results:

- c) IP should perform a hazardous waste determination for the caustic dip tank solution when spent per 40 CFR 262.11. If the waste is excluded or exempted under 261.2-6, then a one-time notice describing such generation, subsequent exclusion or exemption and the disposition of the waste should be placed in IP's on-site files, as required in 268.7(a)(7).

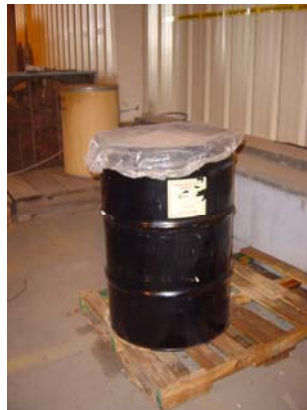
picture P

In the less than 180-day hazardous waste accumulation area, there was one 55-gallon drum labeled Hazardous Waste / solid paint waste F003/D001 dated 11/3/05. The drum was in good physical condition and closed. There were three drums labeled Non-Hazardous / fuel oil dirt from dikes and “oily material tested for halogens & flashpoint.” There were several over-pack drums, spill control kits and absorbents staged in this area for use by IP’s Emergency Response Team (ERT). See pictures O – Q.

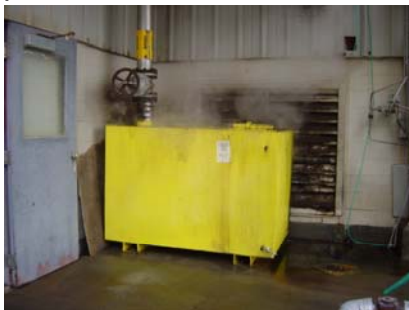
picture R

Ten used oil accumulation areas located throughout the mill were visually inspected including the bleach plant, wood yard, digester area, paper machine area, power boiler area, and the recovery boiler area. All used oil containers were in good condition, closed and labeled; however, they were not located within secondary containment, see pictures R - V.

- e) IP should ensure that all used oil at the facility is stored in accordance with 40 CFR 279.22 and 62-710 FAC, including secondary containment and labeling.

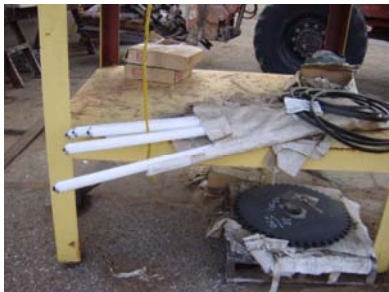
picture W

There is a maintenance shop located in the wood yard area. Aerosol cans are punctured in this area and used oil and universal waste is generated. A weathered box of improperly stored fluorescent tubes was observed, see picture W. Two of the tubes were broken.

- (3) Training should include management of universal waste from generation through to proper containment and labeling. Each container of universal waste lamps should be labeled as specified in 40 CFR 273.14.

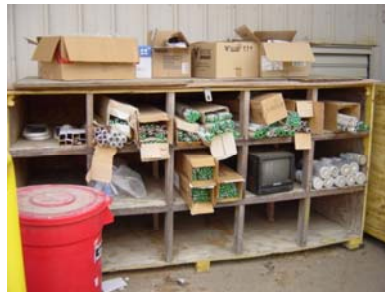
picture X

Waste fluorescent tubes, batteries and ballast are collected throughout the mill and aggregated for management in the universal waste storage area. The battery container was properly labeled "Used Batteries" and closed; however, the lamp containers were not labeled or closed.

The boxes containing used lamps were not labeled or closed.
