## HAZARDOUS WASTE INSPECTION REPORT

**FACILITY NAME:** Safety-Kleen Systems, Inc. **DEP/EPA ID #:** FLD 982 133 159

**STREET ADDRESS:** 4426 Entrepot Boulevard, Tallahassee, Florida 32310

**COUNTY:** Leon **PHONE:** (850) 576-9764 **DATE:** April 4, 2006 **TIME:** 1:00 P.M.

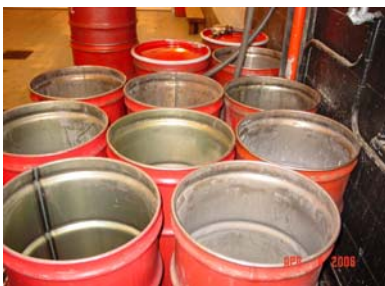
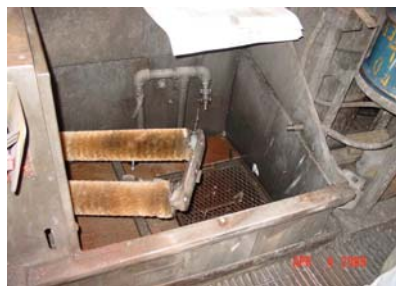
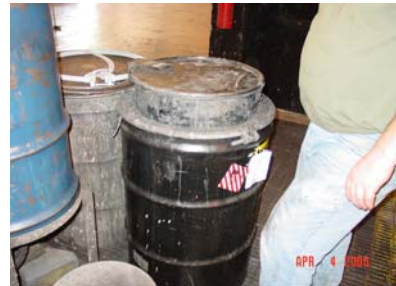
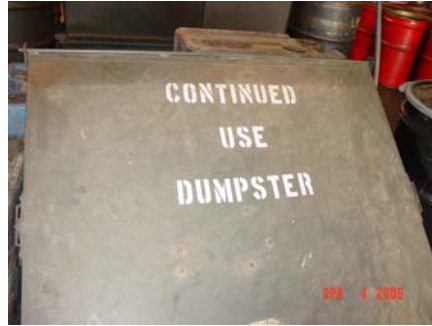
**Return/Fill Shelter**

The area was inspected mid-afternoon when no loading/unloading activity was underway. The loading and unloading area was well maintained, located with easy access to the emergency and safety equipment installed in this area. In this area were eight 30-gallon empty drums that were waiting to be filled with solvent.

The shelter area held no containers of hazardous waste with the exception of the satellite accumulation 55-gallon drum for hazardous waste solids/sludge from the dumpster/drum washing unit. Sludge from the drum washing unit is removed every shift. This drum was labeled, in good physical condition and closed.

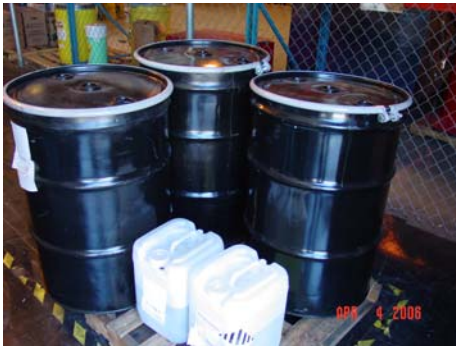
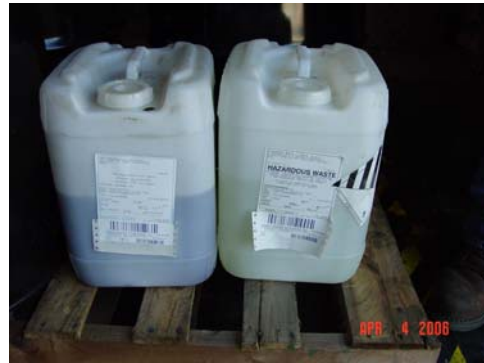
### **10-day Transfer Station**

This area contained two 5-gallon drums of imaging waste and three 55-gallon drums of universal waste awaiting follow-on transport to final TSD Facilities or destinations. The oldest date noted on any container was April 3, 2006, which matched the wallboard for this area noting the oldest date container as April 3, 2006. All containers were in good physical condition, closed, and labeled. The daily inspection record for the 10-day Transfer Station was reviewed and appropriate documentation was available during the inspection. Adequate aisle space was available to inspect each container.

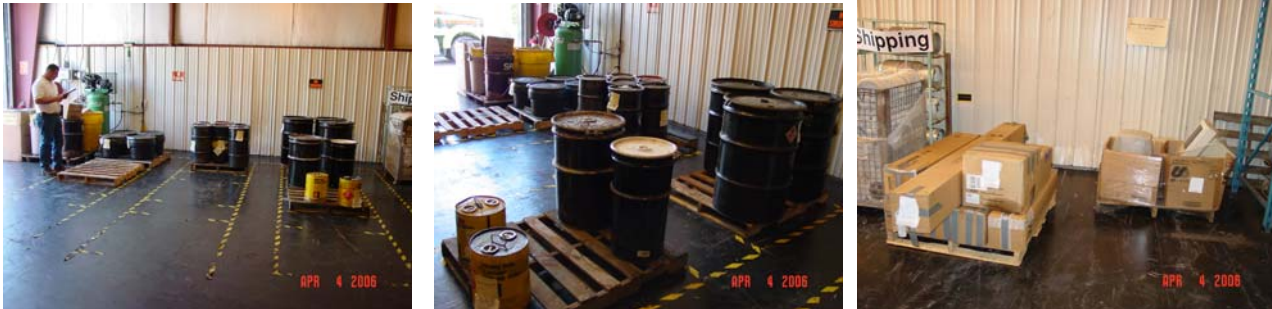
### **TSD Storage Area**

The TSD Storage Area was well organized and aisle space maintained to allow inspection of each container. All containers were in good physical condition, closed, and labeled. Two random containers were selected (Container #'s 06030402037 & 060120004074) and a computer and hardcopy records check conducted to verify its origin, transport history and storage inventory. No

discrepancies were noted. The containers Identified above when referenced against manifest revealed that these containers were identified on manifest #'s 10117 & 11740 respectively. A visual inventory of drums versus computer record inventory for the TSD Storage Area was conducted by Mr. Hinsey and the Department Inspectors with no discrepancies identified. Also located in this area was Universal Waste that was being managed properly with no discrepancies identified.

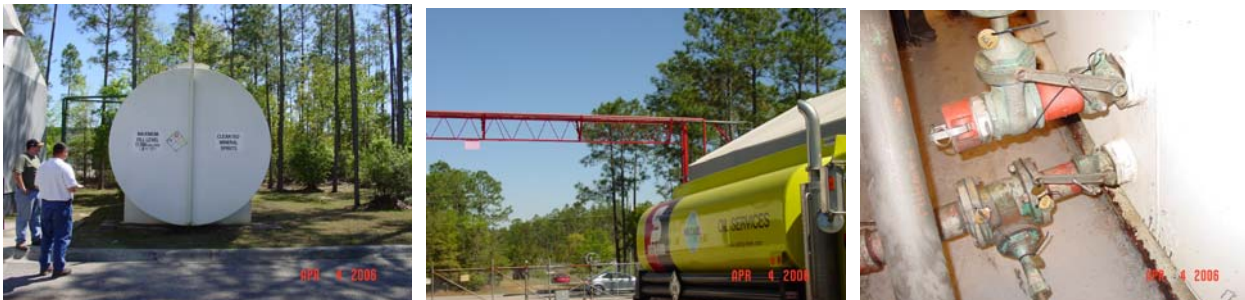
### Tank Storage Area

The area was well maintained with no evidence of tank leakage noted. The load/unload pipe manifold area showed no evidence of leakage or spillage from the piping and equipage in this area. The accumulation drum located in this area was closed, labeled and in good condition.

The facility's 40 CFR 264 Subpart BB compliance procedures for the waste mineral spirits solvent management system were in place and being implemented during this inspection. The waste mineral spirits solvent management system equipage (piping, valves, flanges, pumps, etc) was color coated to distinguish it readily from the other equipage in the facility. Red piping is for dirty solvent, orange piping represents Safety Kleen's 105° solvent and green piping represents 150° solvent. This coloring scheme allows the daily inspector of the system to track the equipage and inspect for liquid leaks. The tank system consists of two 15,000-gallon tanks and one 11,400-gallon tank. All tanks are double-walled. Brass numbering tags are used to identify valves and flanges associated with the tank system. The daily inspection logs were reviewed for the previous year with no discrepancies noted.

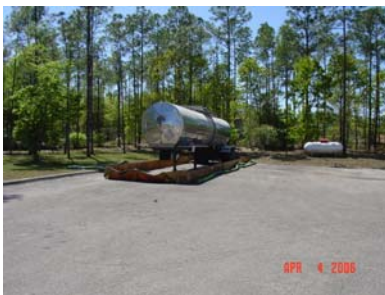
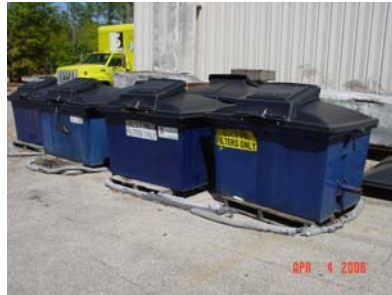
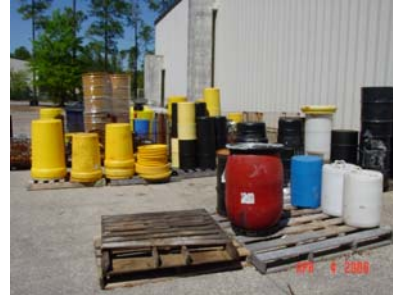
**External Area**

The outside storage/laydown area, driveways, vehicle parking lot, solid waste dumpsters and the perimeter fence/lawn areas were inspected with no discrepancies noted. All other security and safety equipment was installed in accordance with the permit and operational. A tanker trailer had been parked within a temporary secondary containment at the southwest corner of the rear asphalt parking area. This tanker will be used for on-site consolidation of wastes collected daily in the vacuum truck and then transfer and stored on-site in the tank trailer until a full 5,000-gallon load makes it necessary for transport to the follow-on processor. Also in this area were seven "Used Oil Filter" dumpsters that were properly labeled and closed. Mr. Hinsey indicated that all collected used oil filters are sent to a processing facility called Oil Filter Recyclers located in Illinois. There were also several empty containers that Safety Kleen utilizes during its daily operations located outside the facility.
