## HAZARDOUS WASTE INSPECTION REPORT

**FACILITY NAME:** Safety-Kleen Systems, Inc. **DEP/EPA ID #:** FLD 982 133 159

**STREET ADDRESS:** 4426 Entrepot Boulevard, Tallahassee, Florida 32310

**COUNTY:** Leon **PHONE:** (850) 576-9764 **DATE:** April 23, 2008 **TIME:** 12:45 P.M.

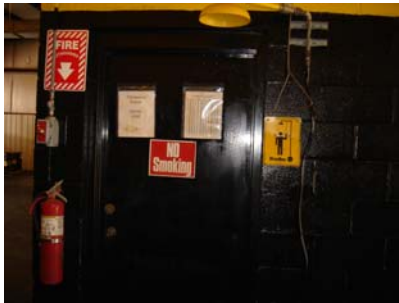
Safety Equipment

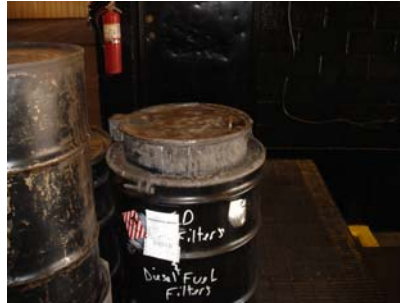
The shelter area held no containers of hazardous waste with the exception of the satellite accumulation 55-gallon drum for hazardous waste solids/sludge from the

dumpster/drum washing unit. Sludge from the drum washing unit is removed every shift. This drum was labeled, in good physical condition and closed.

SAA drum -Return/Fill Area

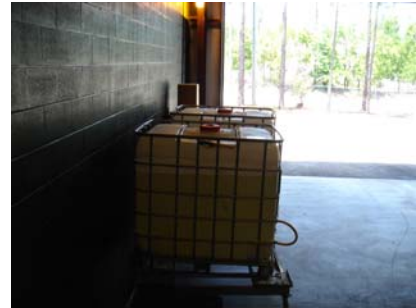
Aqueous Parts-washing

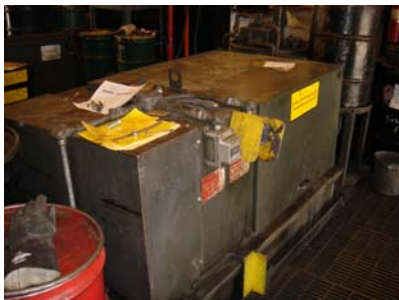
HW drain dumpster

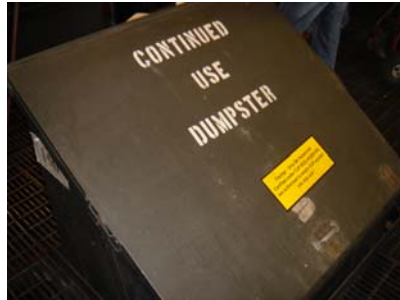
CUP drain dumpster

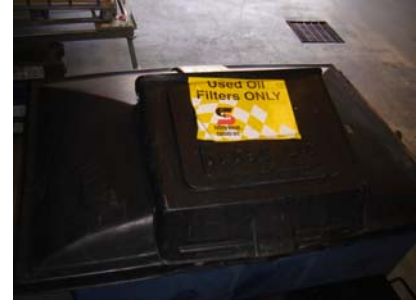
UOF Accumulation

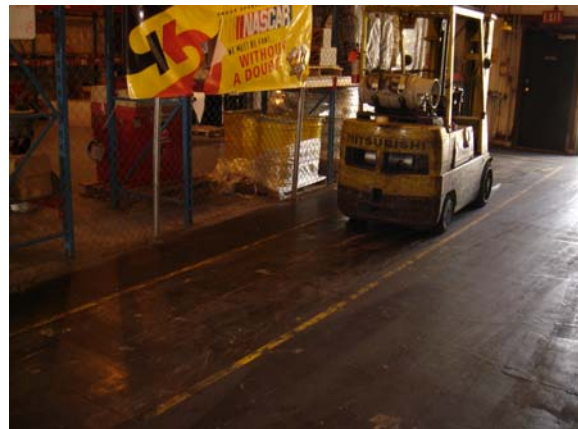
This area contained no containers as the weekly S-K transport vehicle was loaded and departed with all containers in this area just prior to this inspection. This area was well kept with no discrepancies noted. The daily inspection record for the 10-Day Transfer Station was reviewed and appropriate documentation was available during the inspection. Adequate aisle space is available to inspect each container.

10-Day Transfer Station

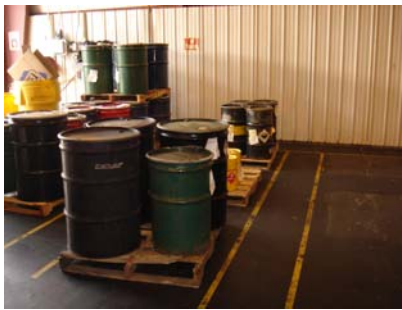
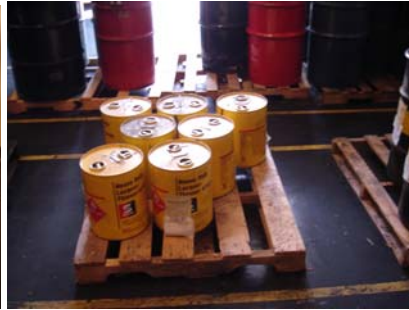
The TSD Storage Area was well organized and aisle space maintained to allow inspection of each container. All containers were in good physical condition, closed, dated and labeled. Two random containers were selected (Container #'s 16766 and 6512) and a computer and hardcopy records check was conducted to verify its origin, transport history and storage inventory. No discrepancies were noted. A visual inventory of drums versus computer record inventory for the TSD Storage Area was

TSD Storage Area

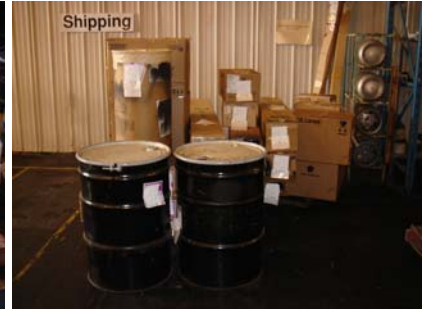
conducted with no discrepancies noted. Also located in this immediate area was Universal Waste that was being managed properly with no discrepancies identified.

Universal Waste Storage

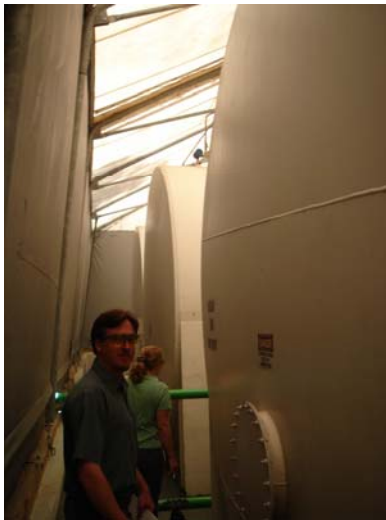
All tanks appeared to be in good condition and well maintained with no visual evidence of any tank leakage noted. The load/unload pipe manifold area showed no evidence of leakage or spillage from the piping and equipage in this area.

East end of Tank Farm

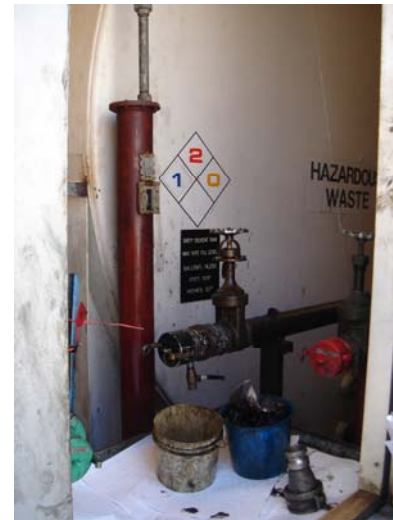
Tank Load/Unload valves

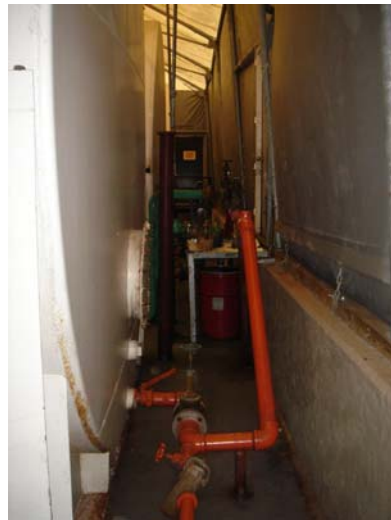
West end of tank Farm

The tank farm consists of two 15,000-gallon tanks and one 11,400-gallon tank. All tanks are double-walled. The waste mineral spirits solvent management system equipage (piping, valves, flanges, pumps, etc) was color coated to distinguish it readily from the other equipage in the facility. Red piping is for dirty solvent, orange piping represents Safety Kleen's 105° solvent (waste solvent) and green piping represents 150° solvent. This coloring scheme allows the daily inspector of the system to track the equipage and inspect for liquid leaks. Brass numbering tags are used to identify valves and flanges associated with the waste solvent tank system.

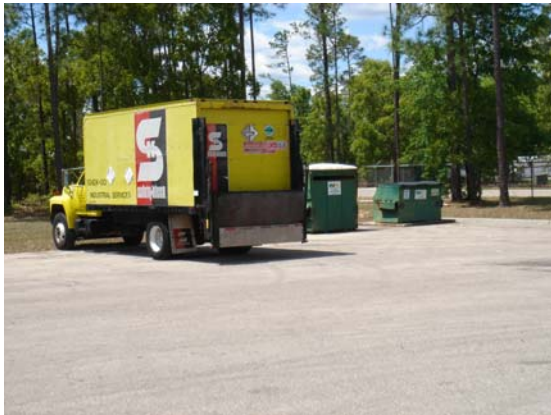
Empty dumpsters

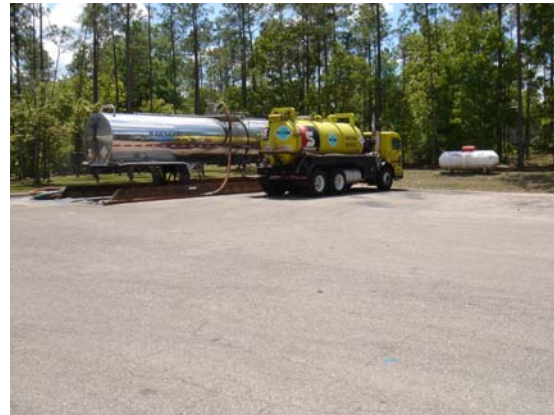
The outside storage/laydown area, driveways, vehicle parking lot, solid waste dumpsters and the perimeter fence/lawn areas were inspected with one discrepancy noted. Signs which should be attached to the perimeter fencing per permit requirements were missing from areas on the west side and east side of the perimeter. All other security and safety equipment was installed in accordance with the permit. Both the regular solid waste dumpster and cardboard recycling dumpster were empty at the time of this inspection. A tanker trailer had been parked within a temporary secondary containment at the southwest corner of the rear asphalt parking area. This tanker will be used for on-site consolidation of wastes collected daily in the vacuum truck and then transfer and stored on-site in the tank trailer until a full 5,000-gallon load makes it necessary for transport to the follow-on processing.

5,000-gallon tank trailer

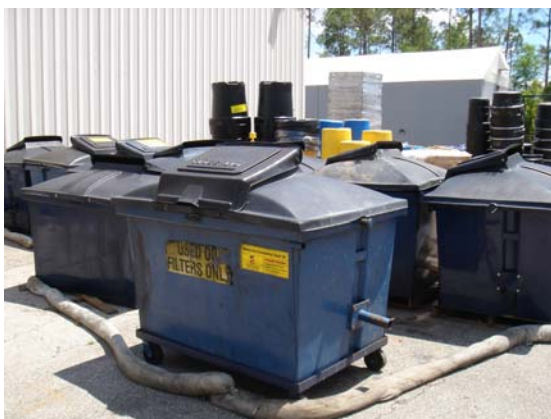
At the rear of the build were numerous “Used Oil Filter” dumpsters, only three dumpsters (properly labeled and closed) contained filters and were surrounded by spill containment “pigs”. Mr. Hinsey indicated that all collected UO filters are sent to a processing facility called Oil Filter Recyclers. There were also several other empty containers that Safety Kleen utilizes during its daily operations located in this area.

“Used Oil Filter” dumpsters

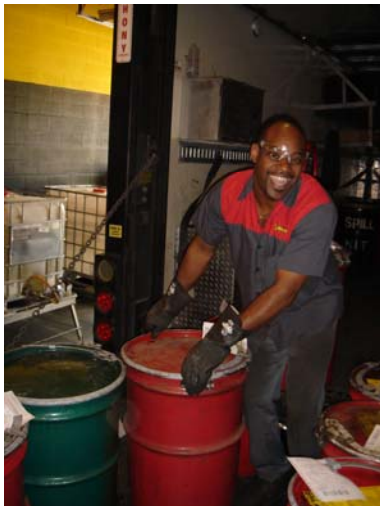
Two returning route trucks were inspected upon their arrival at the facilities loading/unloading area. A review of each driver's shipping records and actual contents of their trucks was conducted for verification of DOT transport regulations. Nicole McDonald performed an inventory of the waste on the first truck with driver Duane Elkins. Mr. Elkins pulled the manifest and shipping documents for all waste on the load to begin inventory. Upon first count of the drums, there was one paint waste, eight HW, five CUP, one Used Oil drum. When Mr. Elkins began matching up paperwork to drums, he informed me that some were mislabeled. He explained that he did not have the correct labels and labeled three drums (two 30-gallon drums and one 16-gallon drum) with the company "Man Trans" as "CUP solvent". These drums were from three different businesses (Honest Engines, Rahall Chevrolet, and NF Performance). Only one drum from Rahall Chevrolet (30 gal) was CUP solvent, the other two drums should have been labeled as a hazardous waste. One 30-gallon drum from Tallahassee Powersport was on this truck but the paperwork was in with the prior day's, March 22, 2008, shipping papers. Mr. Elkins explained that the waste was picked up on March 22, 2008 and was still on the truck because he had to return to the facility on March 23, 2008. Another truck was inspected with driver William Edmund. All drums on Mr. Edmunds truck were labeled appropriately and paperwork was in order and correct for each drum.

David off loading drums

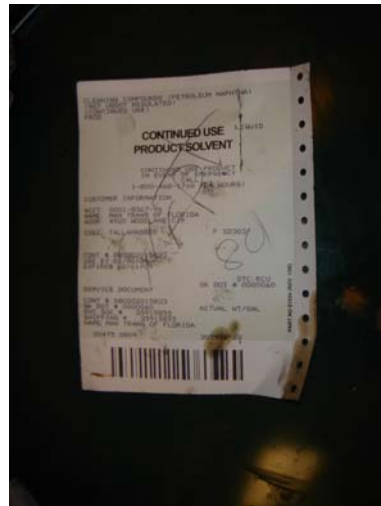
Incorrect labels

- 1) One 30-gallon drum of hazardous waste solvent did not have the appropriated shipping papers with the driver while the drum was being transported over the road.
- 2) Three (two 30-gallon & one 16-gallon) drums were not labeled with the correct generator name or contents.

- a) S-K needs to ensure that drums are labeled with appropriate contents during transport to ensure that solvents are emptied into the appropriate bins.
- b) S-K needs to ensure that all waste containers on a truck are accompanied with the appropriate shipping papers for each drum.
- c) S-K needs to ensure that "non-accessible equipage points are inspected annually per the permit.
- d) S-K needs to ensure that signage is placed along the perimeter of the facilities fencing in accordance with Specific Condition 12 in Part 1 of the permit.
