Volusia County – HW
A.R. Paquette Co, Inc. - FLD982105884
Inspection Summary

HAZARDOUS WASTE INSPECTION REPORT

FACILITY NAME A. R. Paquette & Co., Inc. EPA ID # FLD982105884

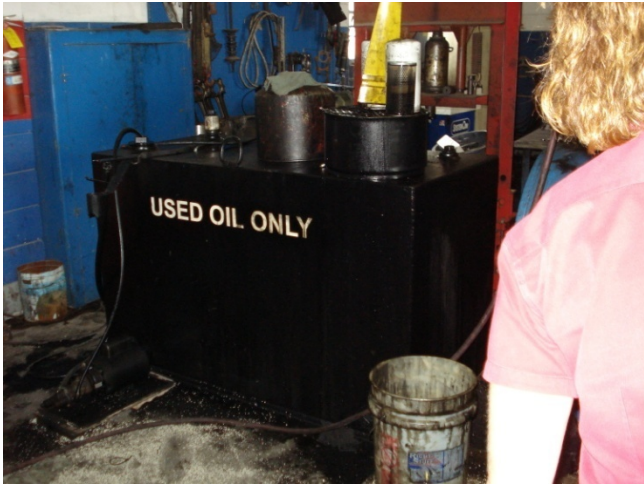
The facility conducts routine maintenance on their vehicles. Used oil is stored in a 200-gallon tank (Figure 1), labeled "used oil." All associated used oil storage containers were labeled properly (Figure 2). Waste antifreeze is stored in a 55-gallon drum (Figure 4) and reused in the trucks. Used oil filters are stored in two 55-gallon drums, labeled "used oil filters." Employees maintain a SystemOne parts washer. A high flash mineral spirit is used in the parts washer. Sludge from the parts washer is disposed of with used oil. Unifirst launders the shop towels.

Figure 1: Used oil tank

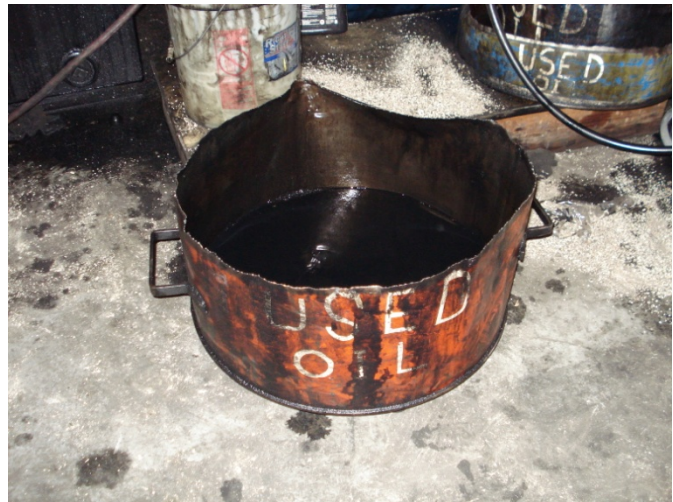
Figure 2: Used oil catch pan

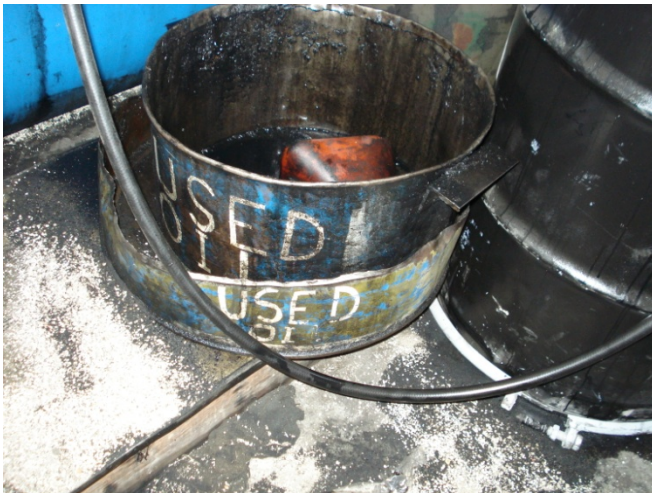
Although the oil tank is located inside, used oil releases should be immediately responded to and cleaned up (Figure 3). The facility only has one mechanic; therefore, used oil releases should be kept to a minimum.

Figure 3: Used oil releases

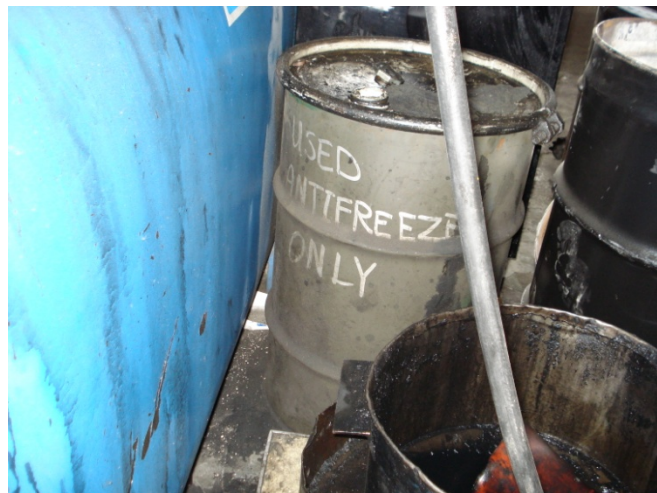
Figure 4: Used antifreeze drum

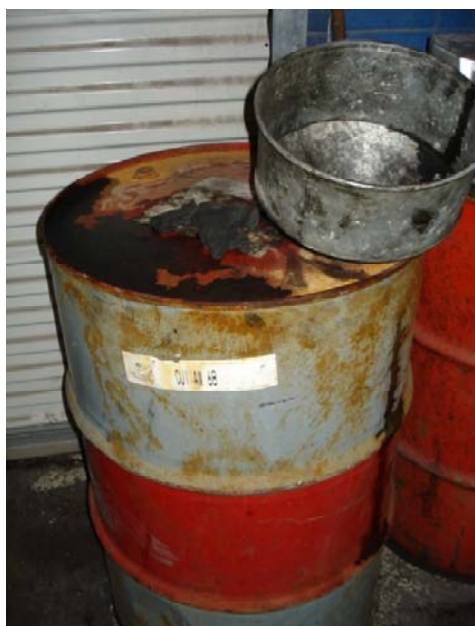
Figure 5: Empty drum

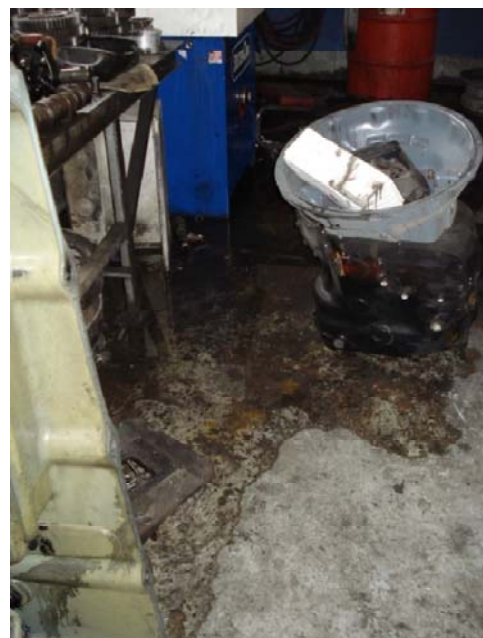
The facility had a leak in the roof located near the used oil storage and parts washer (Figure 6). In order to avoid contaminated water, the Department recommends repairing the roof.

Figure 6: Water intrusion from leaking roof
