Florida Department of
Environmental Protection
Hazardous Waste Inspection Report

Facility Name: Safety - Kleen Systems Inc

On-Site Inspection Start Date: 02/26/2009

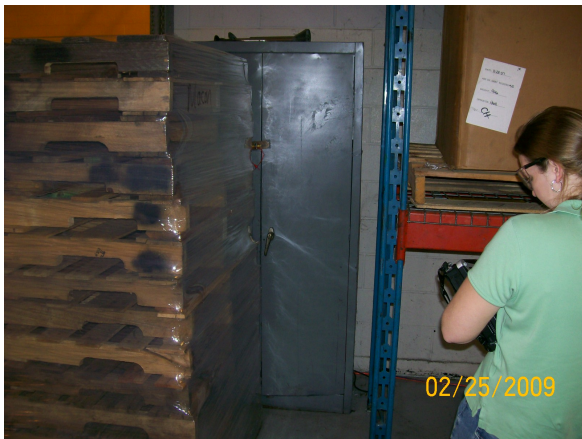
This area contained 8 containers of hazardous waste, all were labeled and dated within the 10 day time period. This area was well kept with no discrepancies noted. The daily inspection record for the 10-Day Transfer Station was reviewed and appropriate documentation was available during the inspection. At the time of inspection waste was being moved to a transport truck and emergency equipment was temporarily blocked. Emergency equipment should be accessible at ALL times during facility operations.

Blocked Emergency Equipment
