Florida Department of  
Environmental Protection  
Hazardous Waste Inspection Report

**Facility Name:** 419 Metal & Auto Recycling Center Inc  
**On-Site Inspection Start Date:** 03/03/2009      **On-Site Inspection End Date:** 03/03/2009  
**ME ID#:** 18948      **EPA ID#:** FLR000026625  
**Facility Street Address:** 600 Old Sanford Oviedo Rd, Winter Spgs, Florida 32708-2646  
**Contact Mailing Address:** 600 Old Sanford Oviedo Rd, Winter Springs, Florida 32708-2646  
**County Name:** Seminole      **Contact Phone:**

Complaint Inspection for CESQG (<100 kg/month) facility

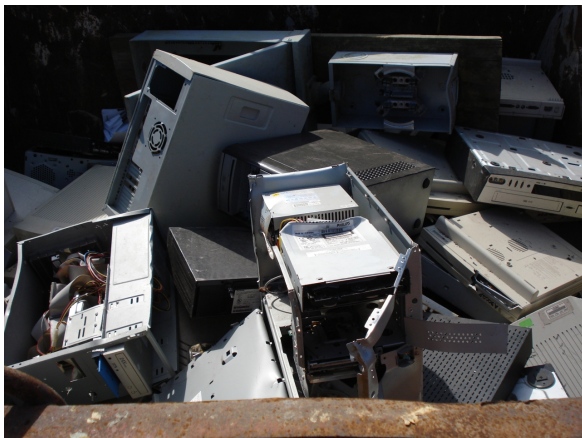
419 had a roll off dumpster for electronics next to the office (Figure 1). According to Mr. Phillips, they will remove chips from the circuit boards in order to reclaim the precious metals, which will be sold to an electronics recycler. The remaining parts will be shredded. The facility has been

Figure 1 - Waste electronics

accepting electronic waste for approximately four months but has not started removing chips. The facility must contact the FDEP Recycling Program in Tallahassee at (850)245-8706 for requirements of the electronics recycling program.

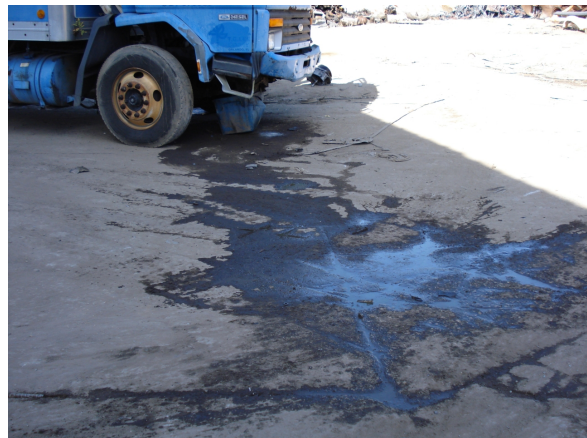
The auto dismantling area showed several locations where automotive fluids had been released to the ground and the housekeeping in the area was very poor (Figures 4 to 7). There was a truck near the entrance to the area with a puddle of antifreeze next to and running from the truck (Figure 2). Two vehicles were situated on racks over open top totes (~200 gallon) (Figures 8 and 9). The totes were supposed to capture any automotive fluids being drained from the vehicles but there were significant areas of spillage around the totes. The totes were labeled with the words "Used Oil" but were OPEN AND NOT LOCATED INSIDE SECONDARY CONTAINMENT [62-710.401(6), Florida Administrative Code (F.A.C.)]. Each was ~1/3 full. There was also a 5-gallon pail situated underneath one of the vehicles in an attempt to capture gasoline (Figure 12). Even though the totes were situated underneath the roof of the structure they WERE NOT BEING MANAGED IN A MANNER THAT WOULD KEEP THEM FROM BEING IMPACTED BY RAIN DURING A STORM EVENT. There were also several full drums of petroleum contaminated soil (Figure 14). There was a 5-gallon pail of used oil that was OPEN AND NOT LABELED "USED OIL" [62-710.401(6), F.A.C.] (Figure 29).

Figure 2 - Antifreeze release

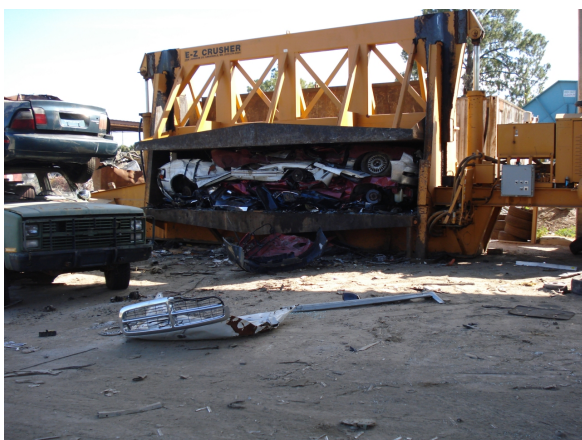
Autos are processed on the North side of the facility. Cars are purchased from individuals and at auction. 419 has an auto crusher on site (Figure 3).

Figure 3 - Auto crusher

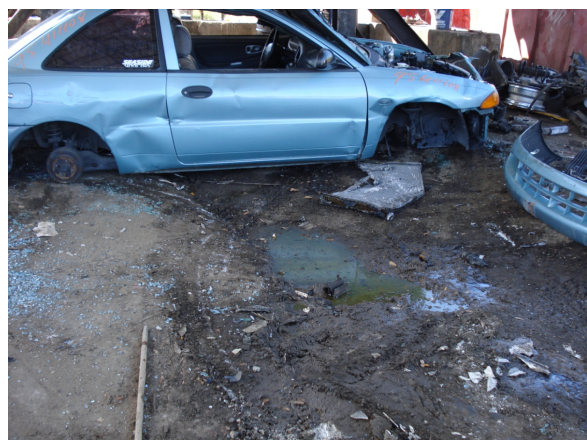
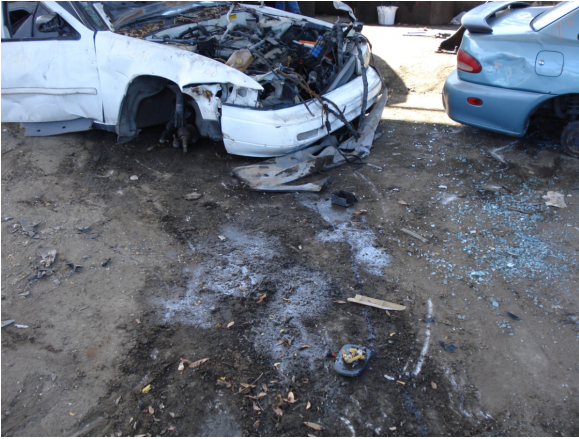
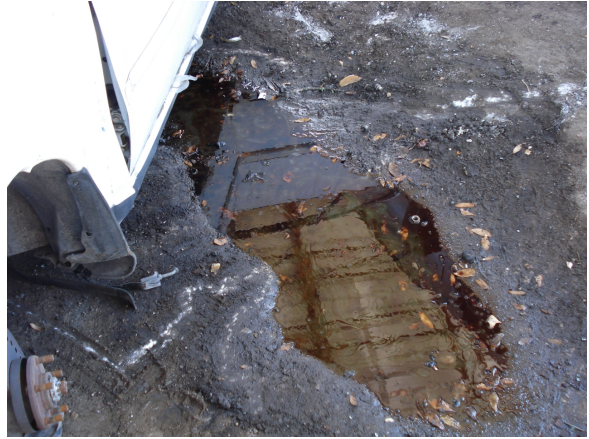
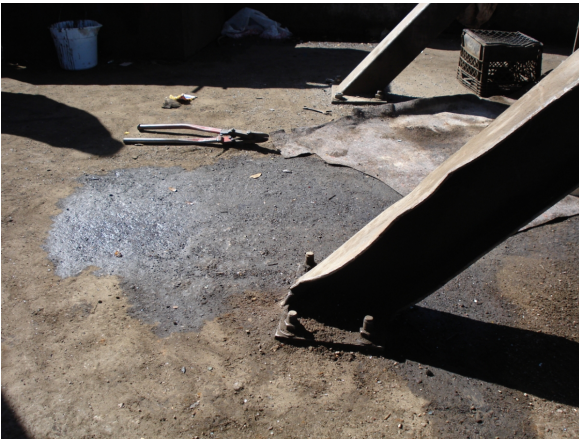
According to Mr. Phillips, his employees clean the dismantling area every day before they go home at 6:00 p.m. and all used oil is pumped into the used oil storage tank. The amount of releases noted as well as the volume of used oil located in the totes did not support the claim that the area is cleaned daily. Mr. Phillips was told that he needs to work on housekeeping in the area and would have to clean up the areas of petroleum releases. He was further instructed that the used oil tote would need to be kept closed.

Figure 4 - Auto fluids release

Figure 5 - Auto fluids release

Figure 6 - Auto fluids release

Figure 7 - Auto fluids release

Type: Violation  
 Rule: 279.22(d)  
 Explanation: 419 failed to clean up numerous used oil releases at the vehicle processing area.  
 Corrective Action: 419 must conduct a site screening as outlined in the attachment titled Site Screening Plan. Provide documentation of facility operational changes addressing minimization of releases and immediate response to releases to the Department within 30 days of your receipt of this Warning Letter.

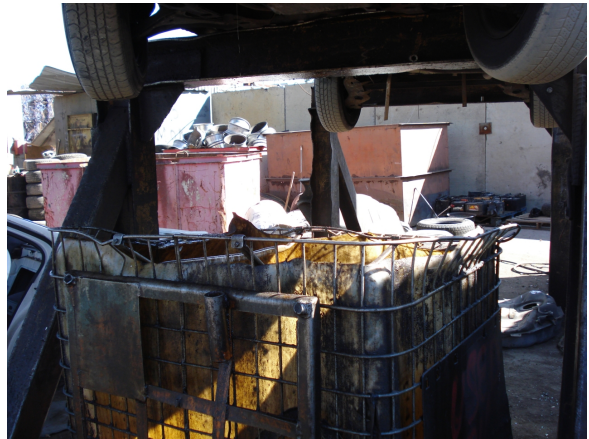
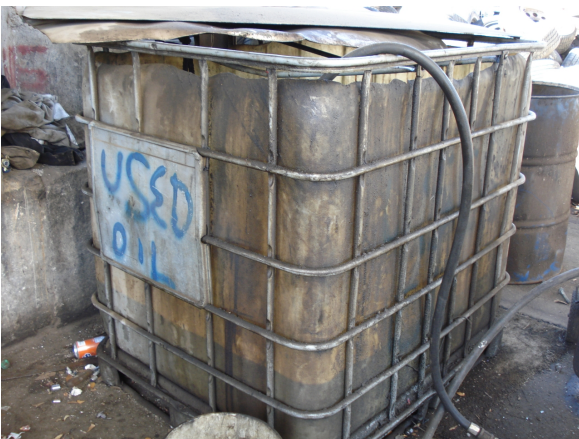
Figure 8 - Used oil tote

Figure 9 - Used oil tote

Type: Violation  
 Rule: 62-710.401(6)  
 Explanation: 419 failed to keep closed and provide secondary containment for totes storing used oil and keep closed and label "Used Oil" a 5-gallon pail storing used oil. In addition, the secondary containment for the used oil tanks was not sufficient. The secondary containment must be constructed to contain any leaks from the used oil tanks.  
 Corrective Action: Provide documentation of closed and labeled containers and secondary containment for containers and tanks storing used oil to the Department within 30 days of your receipt of this Warning Letter.

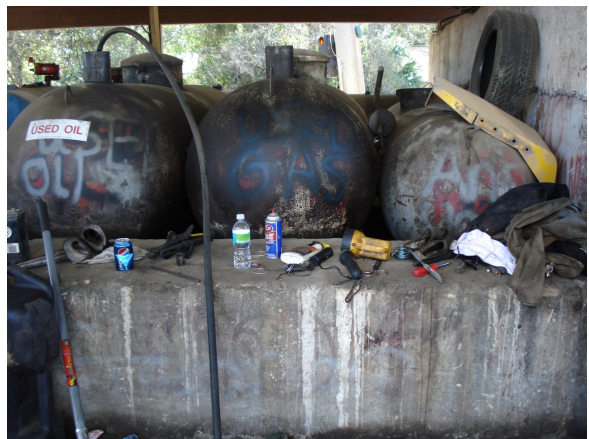
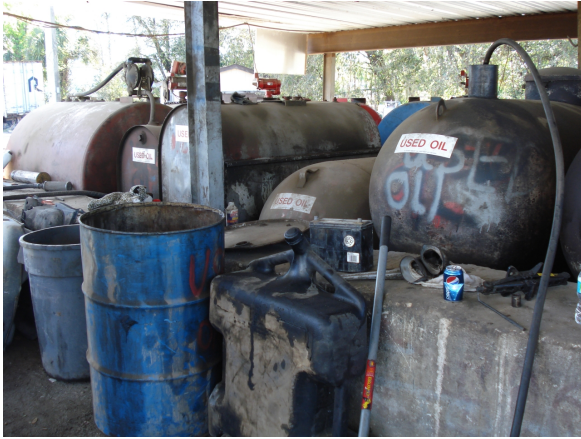
Next to the dismantling area was a structure for waste and product tanks. The structure consisted of a concrete block secondary containment and a "pole barn" type roof. Inside the containment were four tanks for used oil, one tank for used antifreeze, and one tank for waste fuels (Figures 10 and 11). THE SECONDARY CONTAINMENT WAS CONSTRUCTED OF CONCRETE BLOCKS THAT WAS NOT SEALED AT THE JOINTS [62-710.401(6), F.A.C.].

Figure 10 - Storage tanks

Figure 11 - Storage tanks

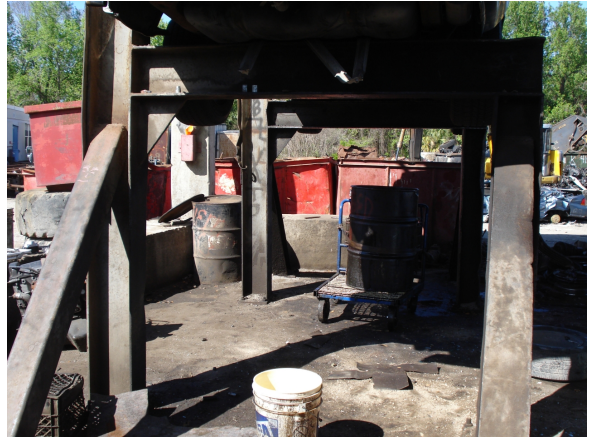
Figure 12 - Pail for waste gas

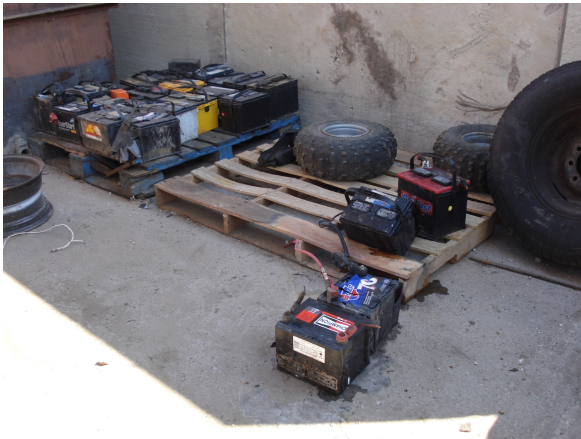
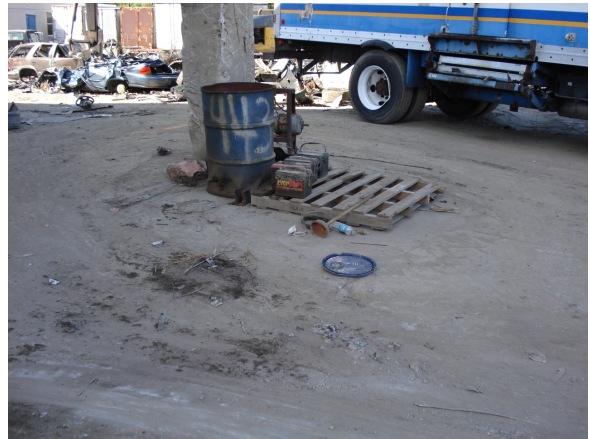
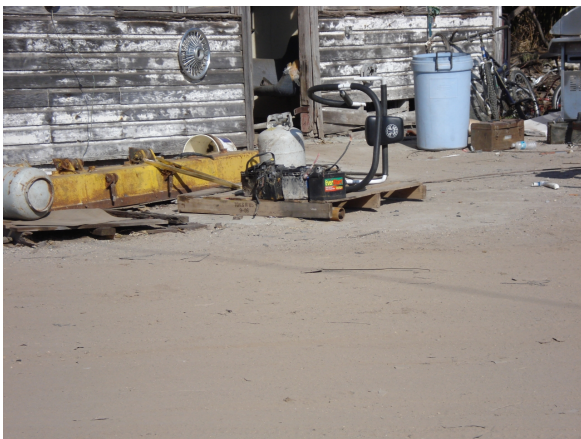
Also located on the North side of the facility was an area for collecting and bailing aluminum and a trailer for waste batteries. Waste batteries are stored outside during the day throughout the facility and brought to the storage trailer every night (Figures 13, 20, and 21). Batteries that do not have a resale value are palletized and shrink wrapped and sent to US Lead for recycling (Figure 22). Outside in a storage area were three pallets of waste batteries that were shrink wrapped and covered with a piece of cardboard and three open 55-gallon drums of waste batteries (Figures 23 and 24).

Figure 13 - Used batteries

Figure 20 - Used batteries

Figure 21 - Used batteries

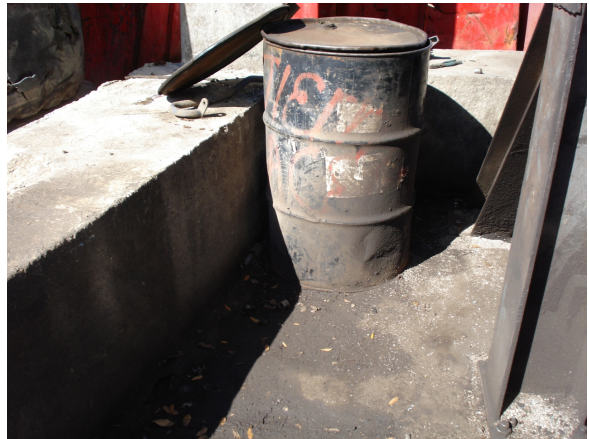
Figure 14-Petroleum impacted soil

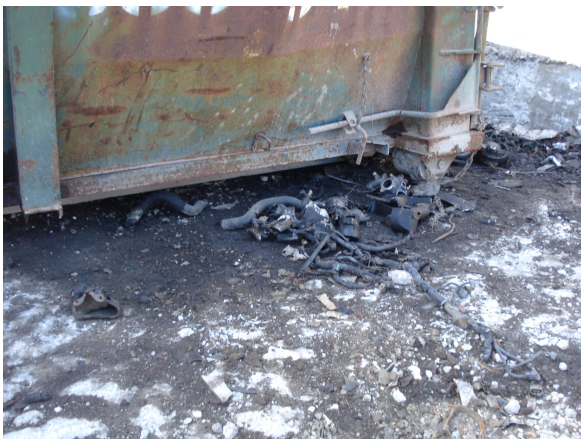
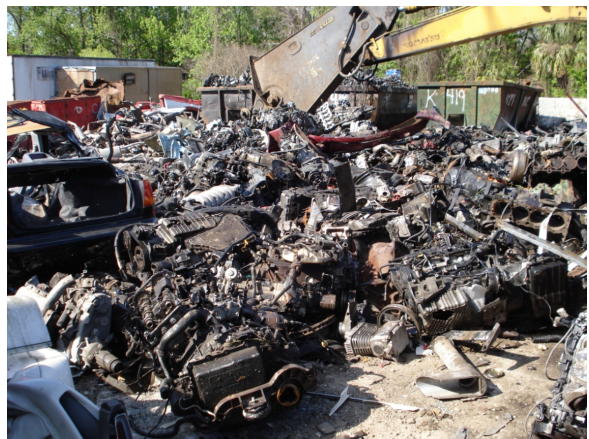
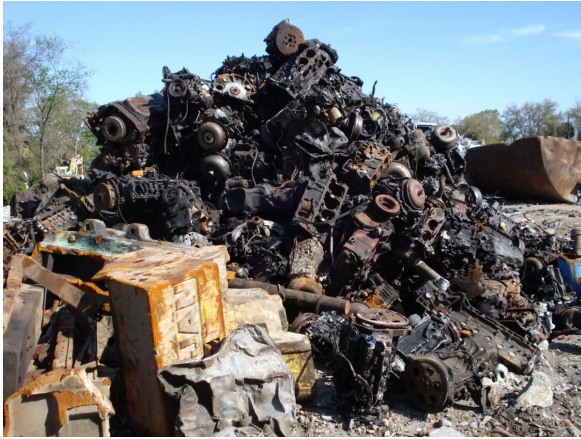
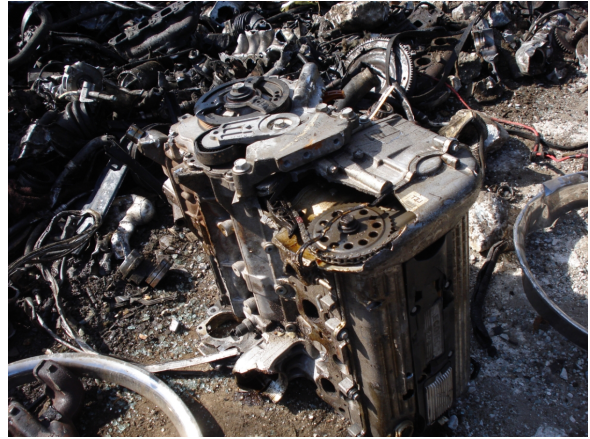
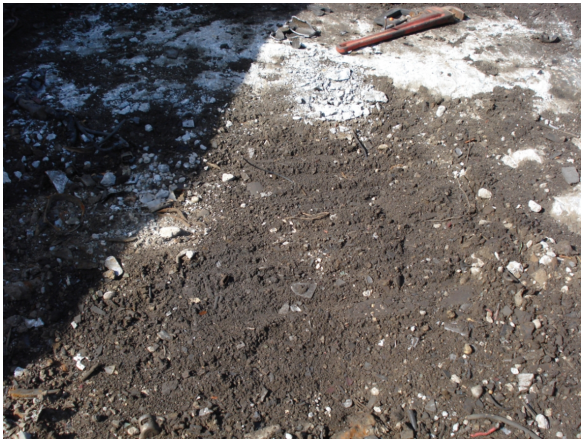
CORE PARTS ARE STORED DIRECTLY ON GROUND SURFACES AND PETROLEUM RELEASES WERE NOTED IN THE AREA [40 CFR 279.22(d)] (Figures 15 to 19). Mr. Phillips was instructed that core parts and any fluid containing parts had to be stored under cover and on an impermeable surface as part of the facility's Stormwater Pollution Prevention Plan (SWPPP).

Figure 15 - Petroleum release

Figure 16-Engine cores on ground

Figure 17-Engine cores on ground

Figure 18-Engine core on ground

Figure 19 - Petroleum release

Type: Violation  
 Rule: 403.161(1)(b)  
 Explanation: 419 failed to comply with the MSGP issued to its facility.  
 Corrective Action: 419 must comply with all requirements of the MSGP issued to its facility. Provide documentation of core parts and fluid containing parts being stored under cover and on an impermeable surface, updated site map to include the 4 acres across the street, current Quarterly Visual Stormwater Inspection, current Quarterly Facility Inspection, documentation of annual training, annual comprehensive permit review, and DMR for years 2 and 4 to the Department within 30 days of your receipt of this Warning Letter.

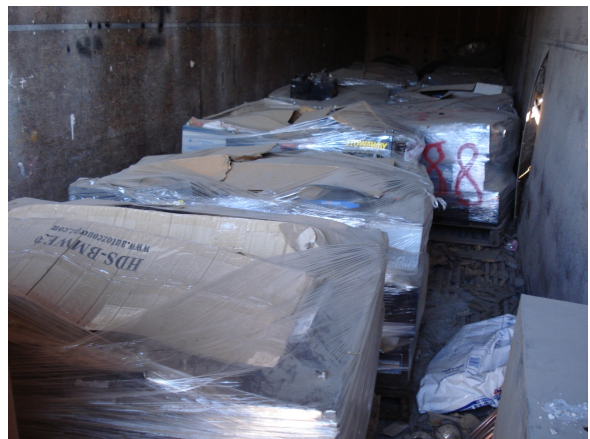
Figure 22-Pallets used batteries

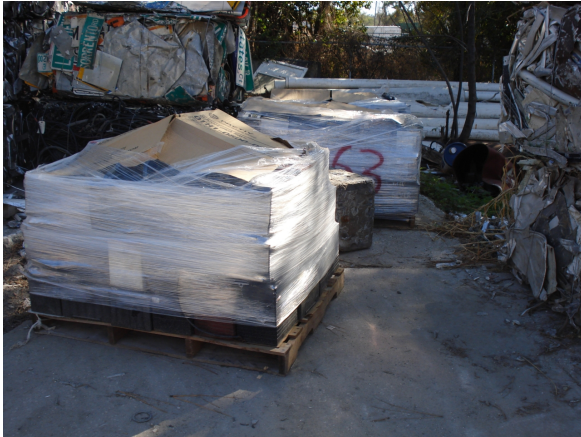
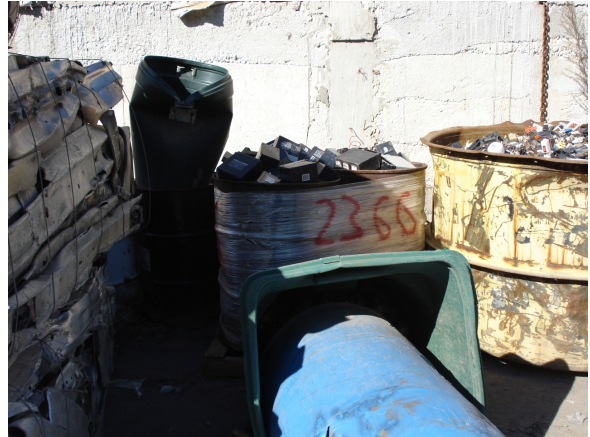
Figure 23-Pallets used batteries

Figure 24 - Drums used batteries

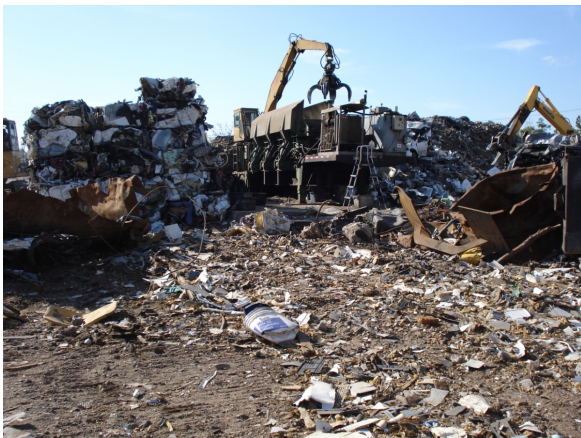
The property across the street is used mainly for processing non-ferrous metals (tin primarily) and for storage. Materials are bailed and loaded onto rail cars that run along the property boundary (Figure 25). Three additional roll offs containing electronics were waiting to be processed (Figure 26). There was a roll off located next to the rail line destined for GEL Recycling that contained

Figure 25-Scrap metal bailer

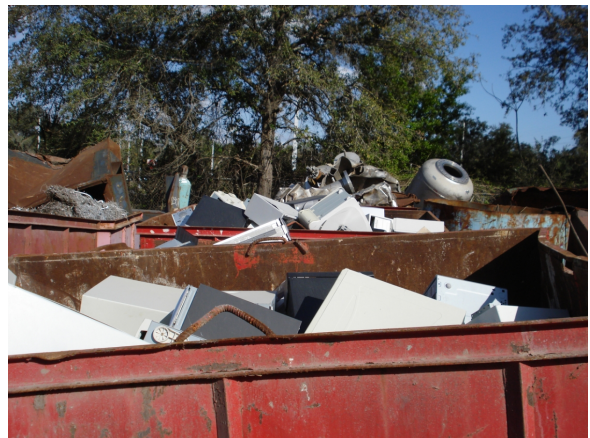
Figure 26 - Waste electronics

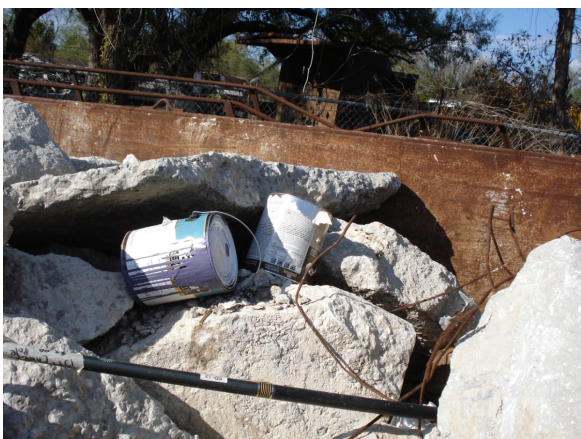
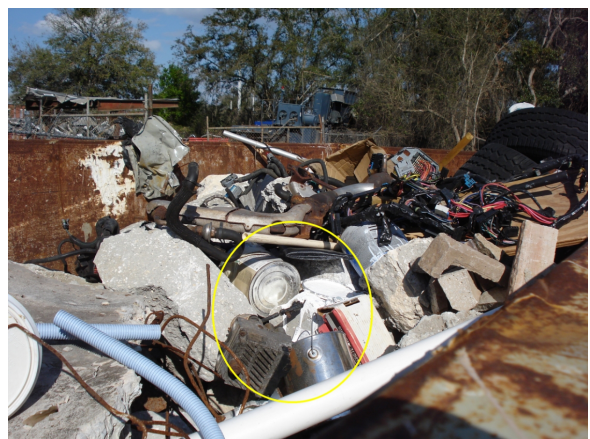
concrete blocks. Several cans of paint were noted in the roll off and Mr. Phillips was instructed to have someone remove the paint (Figures 27 and 28).

Figure 27 - Waste paint cans

Figure 28 - Waste paint cans

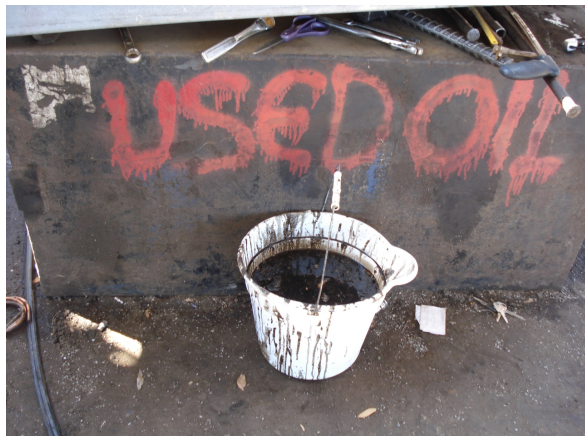
Figure 29 - Used oil container
