Florida Department of Environmental Protection

Brevard County
AERC Recycling Solutions - FLD984262782
Compliance Evaluation Inspection

Florida Department of
Environmental Protection
Hazardous Waste Inspection Report

On-Site Inspection Start Date: 12/16/2009 **On-Site Inspection End Date:** 12/16/2009

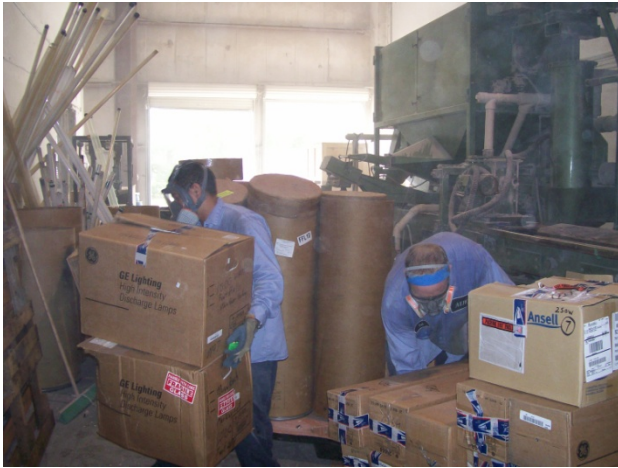
Figure 1: LSS – 1 in operation

LSS-1 was operating at the time of the inspection (Figures 1-2). Lamps coated in a plastic shatter shield are sorted and stored separately from regular lamps because of the plastic. The shatter shield is manually removed from the lamps prior to crushing.

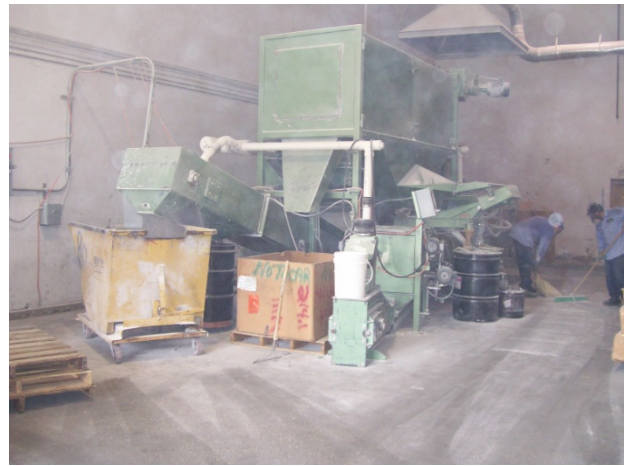
Figure 2: Production area

HID lamps contain liquid mercury; therefore, the lamps cannot be processed at this facility and must be shipped to the Pennsylvania facility. HID lamps are sorted, mercury ampoules removed, and stored separately from regular lamps until transported. At the time of the inspection, there was one 55-gallon drum of mercury ampoules, which was labeled and dated properly.

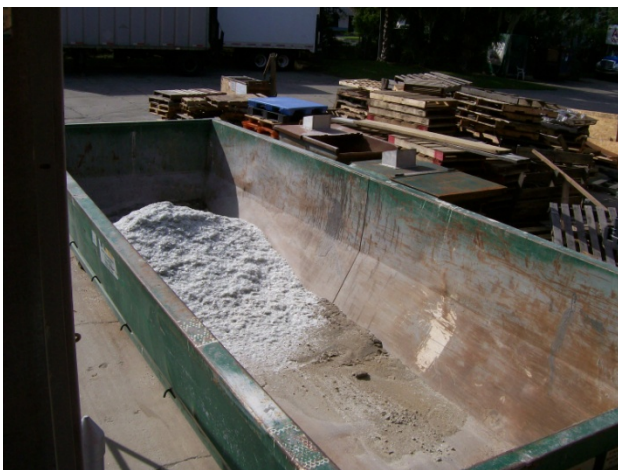
Figure 3: Roll off outside Loading Dock

Outside next to the loading dock is the area for the roll off containers used to store glass from the mercury lamp processing operation. At the time of the inspection, waste was being placed in the roll offs (Figure 3).

This area also contained the air filtering unit for the LSS-1. Three sets of air filters are used, pre-filters, HEPA-filters, and carbon filters. The filters are monitored on a regular basis and when the levels of Mercury reach a certain level, the filters are changed. The Pre-Filters have been tested and determined to be non-hazardous. The HEPA-filters and carbon filters are disposed of as hazardous waste.

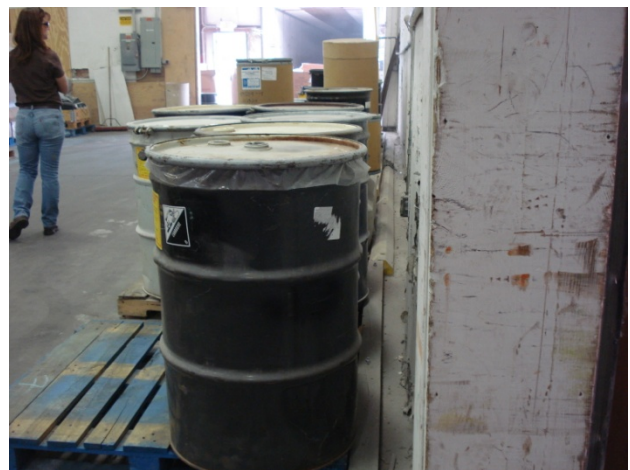
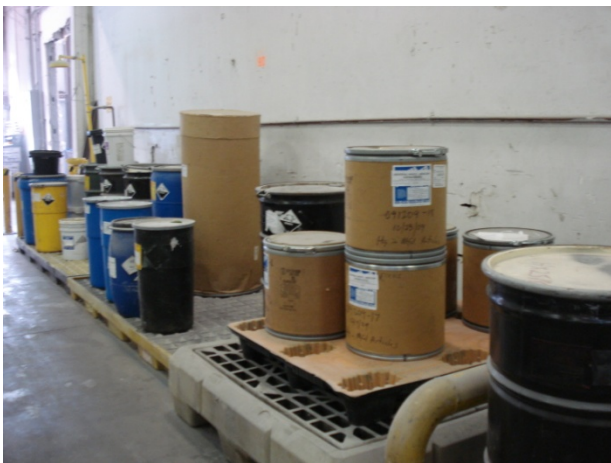
This area is for containers of mercury containing devices (ie. glassware, elemental mercury, soil, amalgam, etc) that only have the D009 waste code (Figures 4-5). These wastes are consolidated and sent to the Pennsylvania facility for final disposal. Inspectors noted that dates were not consistently placed on drums when they entered the facility. Ms. DePaola explained that if a container was picked up by AERC, an AERC label was placed on the container, along with the date it entered the facility. If a container was shipped directly to AERC by another transporter, the date from facility is used and the container does not receive a date when the container enters AERC. Inspectors suggested the date when any container enters the facility be placed on the container to prevent any confusion.

Figure 4: 90-day storage area

Figure 5: 90-day area

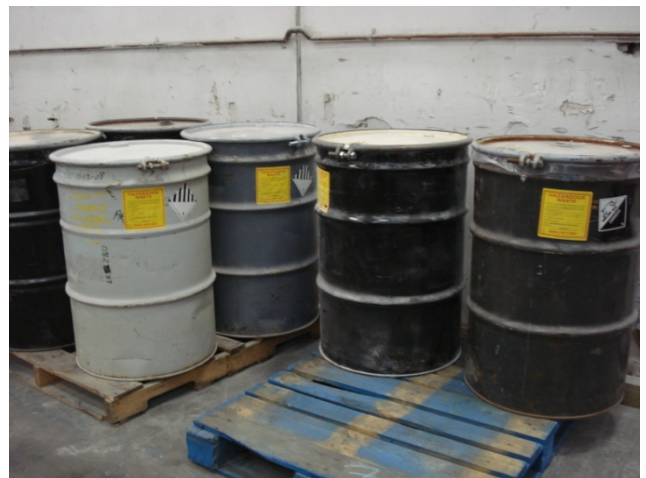
Figure 6: 10-day Transfer drums

The 10-day transfer area contains wastes received with the D009 code plus additional waste codes (Figure 6). These wastes are transferred to the Pennsylvania facility within 10-days of receipt.
