Florida Department of
Environmental Protection
Hazardous Waste Inspection Report

Facility Name: Safety - Kleen Systems Inc
On-Site Inspection Start Date: 06/07/2010 **On-Site Inspection End Date:** 06/07/2010
ME ID#: 20821 **EPA ID#:** FLD982133159
Facility Street Address: 4426 Entrepot Blvd, Tallahassee, Florida 32310-8740
Contact Mailing Address: 3003 W Breezewood Lane, Neenah, Wisconsin 54957-0368
County Name: Leon **Contact Phone:** (800) 558-5011

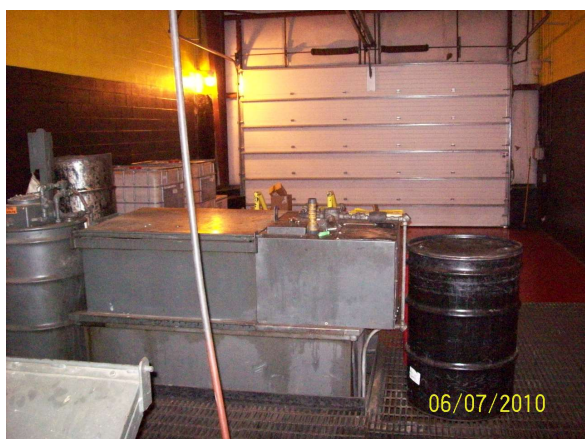
A. Return/Fill Dumpster

The area was inspected early-morning when no loading/unloading activity was underway. The loading/unloading area was well maintained and located with easy access to emergency and safety equipment installed in this area. Both the hazardous waste drain dumpster and Continued Use Program (CUP) drain dumpster lids were closed. One satellite accumulation area contained a 55-gallon drum for hazardous waste solids/sludge from the dumpster/drum washing unit and CUP drain dumpster. This drum was labeled, in good physical condition and closed. Sludge from the drum washing unit is removed at the end of every day. Several empty drums were being stored in this area for later use.

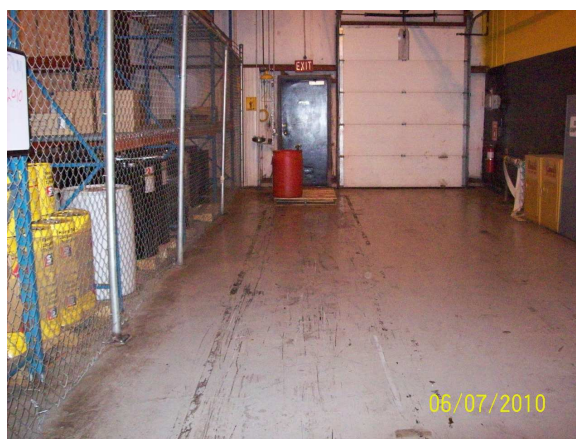
B. Transfer Area

One container of hazardous waste was located in this area. It was labeled, dated and within the 10 day time period. Records were pulled for this drum (I.D. 2489813) with no deficiencies noted. This area was well kept and organized. The stripping on the floor to indicated the physical location of the transfer area was highly worn or missing. Emergency equipment has been inspected and is easily accessible.

S-K needs to ensure that the stripping for the physical location of the Transfer Area is present and in good condition.

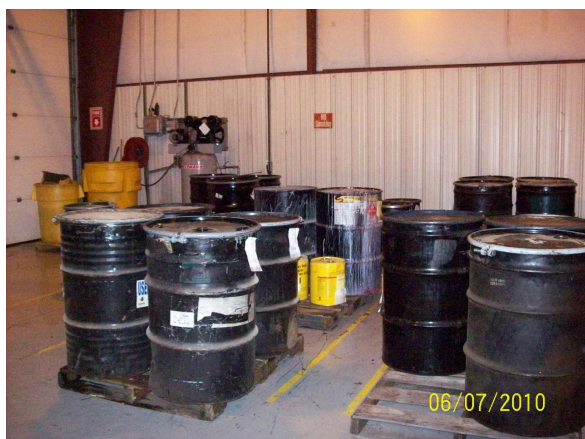
C. Storage Area

The TSD Storage Area was well organized and appropriate aisle space is maintained. A total of 28 drums/containers were in this location. Two containers with manifest number (2409896) paperwork was pulled to review, with no deficiencies noted. All containers were in good physical condition, closed, dated and labeled. Located in this area is the Universal Waste storage area. Seven boxes of waste universal fluorescent lamps and one 5-gallon bucket of waste universal batteries were labeled, dated and closed.

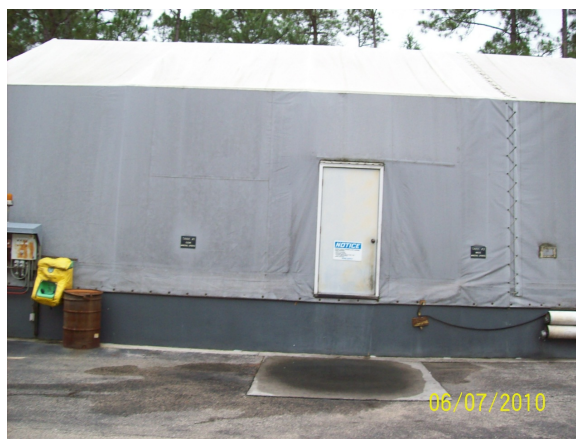
D. Tank Storage

The covered and enclosed tank storage area contains a used oil, 105° solvent and permitted hazardous waste storage tank. Outside this area are a 150° solvent tank and a used antifreeze tanks. All tanks and the load/unload pipe manifold area appeared to be in good condition and well maintained with no visible evidence of any tank leakage. The waste mineral spirits solvent management system equipage (piping, valves, flanges, pumps, etc) was color coated to distinguish it readily from the other equipage in the facility. Red piping is for dirty hazardous waste solvent, orange for 105° solvent and green piping represents 150° solvent. This coloring scheme along with the valve tagging system, allows the daily inspector of the system to track the equipage and inspect for liquid leaks.
