Enclosure: Inspection Report

Florida Department of  
Environmental Protection  
Hazardous Waste Inspection Report

**Facility Name:** Safety - Kleen Systems Inc

**On-Site Inspection Start Date:** 02/23/2011

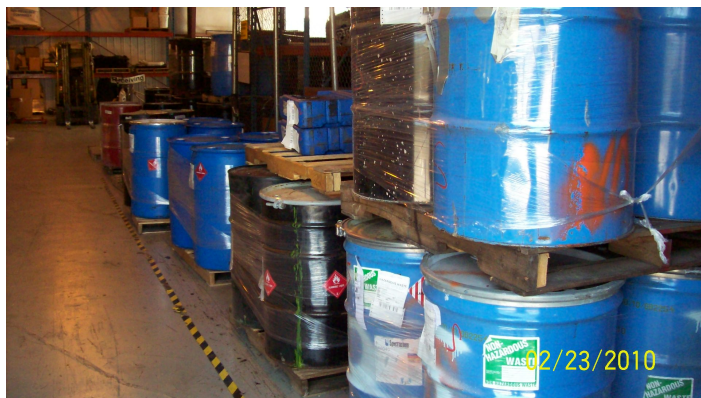
Transfer Area

Explanation: Portions of the floor markings for the transfer area were missing. At the time of inspection no hazardous waste was stored outside the permitted transfer area.

Corrective Action: Within S-K's Permit, Part II Subpart B.1 #7 states "The accumulation areas containing transfer facility waste shall be clearly marked with signage and floor markings." Post inspection the floor was remarked with yellow paint.
