**SUBJECT: Department of Environmental Protection v. Water Recovery, LLC**  
**OGC File No. 20-1675**  
**EPA/DEP ID: FLR 000 069 062**

**RE: Warning Letter No. WL20-242 (Significant Non-Complier)**  
**EPA/DEP ID: FLR 000 069 062**  
**Duval County – Hazardous Waste**

Florida Department of  
Environmental Protection

Hazardous Waste Inspection Report

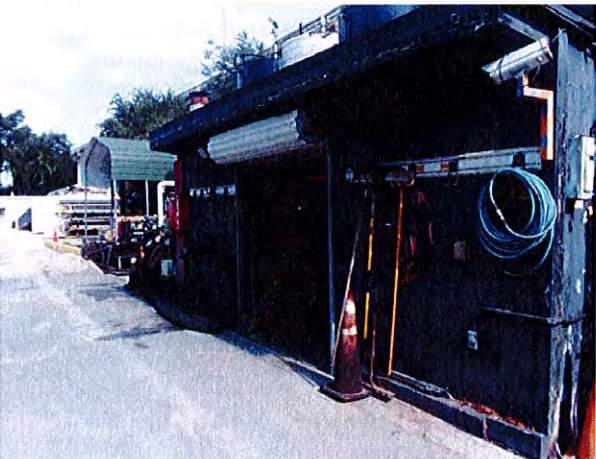
Photo 5

The Tool Room is a small building located adjacent to the Used Oil Processing Area, described below, where materials are stored and where staff may perform small repairs and general maintenance (Photo 5). Facility staff perform small painting operations out of this building. The facility typically contracts out tank painting and other larger jobs. There was no hazardous waste, used oil or used oil filters accumulating in this area at the time of inspection. The facility is reminded that some of the coatings stored in the Maintenance Shed may generate a hazardous waste when disposed of and that a hazardous waste determination should be conducted prior to disposal of any non-empty containers or rags or brushes contaminated with coatings.

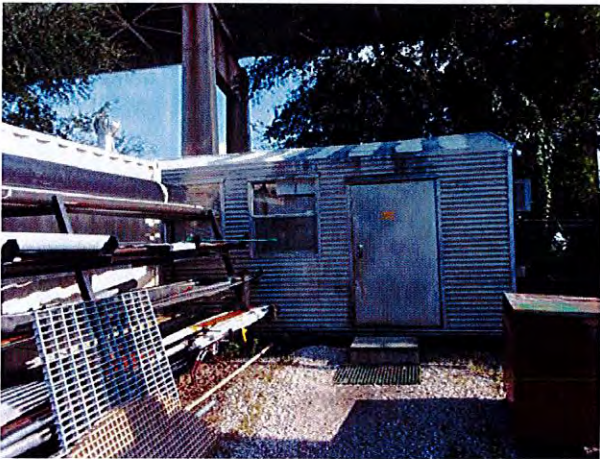
Photo 9

The Maintenance Shed, located west of the Used Oil Processing Area, is a small trailer where tools and miscellaneous equipment are stored (Photo 9). This area does not accumulate or generate any hazardous waste. The sink inside the trailer drains to the secondary containment for the Used Oil/PCW Processing Area,

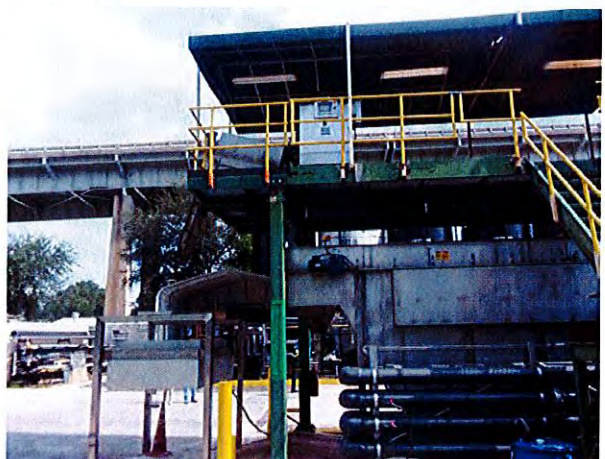
Photo 12

The Wastewater Processing Area is a tank farm of eleven green-painted cone-bottom batch tanks and a plate-and-frame filter press (Photo 12). The main green tank farm is numbered 1-W to 9-W, and is aligned in consecutive order tank pairs, 1-W/2-W, 3-W/4-W, 5-W/6-W, 7-W/8-W, with 9-W closest to the main office. The discharge and equalization tanks are adjacent to the plate-and-frame filter press. The estimated capacities for the tanks are as follows: 1-W to 9-W, 7,000 gallons each; discharge and equalization (EQ) tanks, 50,000 gallons each. The green tank system is a unilaterally interconnected loop.

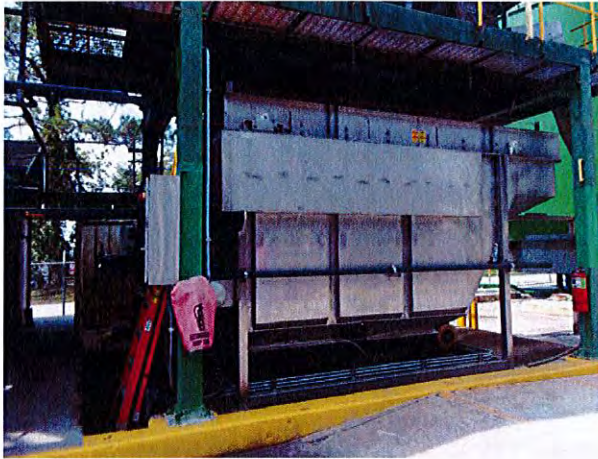
Photo 13

Wastewater requiring further treatment with oil/water separation and/or Dissolved Air Flotation (DAF) is directed into the EQ Tank. Wastewater in the EQ tank is air mixed and gravity fed into the DAF unit (Photo 13) and/or the oil/water separator for additional treatment, prior to direction into the Discharge Tank. The DAF unit has been replaced since the previous inspection. The DAF adjusts pH and performs continuous chemical precipitation and solids removal. The oil/water separator skims off any oil which is accumulated in Tank 11P and then piped to the black side tank 2-P for heat and chemical treatment. Water in the final Discharge Tank may be redirected into the EQ Tank for further treatment as needed or discharged to the POTW. There are two city sewer compliance sampling points. Sampling point SP001 is located outside the main security fence at the corner of East Bryan Street and Albert Street (Photo 14) and sampling point SP002 is located in a small building adjacent to the north side of the used oil processing black tank farm (Photo 15).

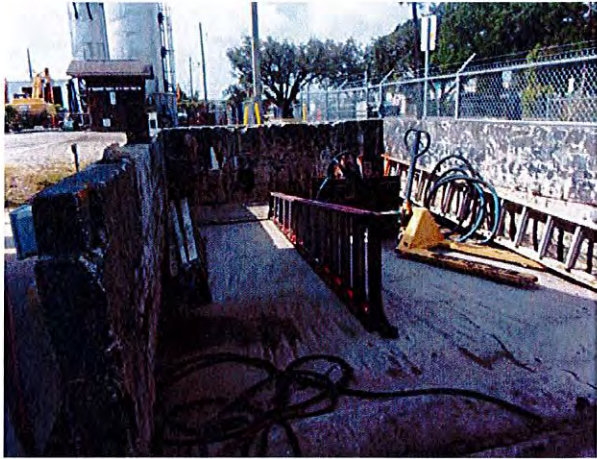
Photo 16

A Truck Clean-out Holding Pit was formally located across East Bryan Street (Photo 16). In the past, customers

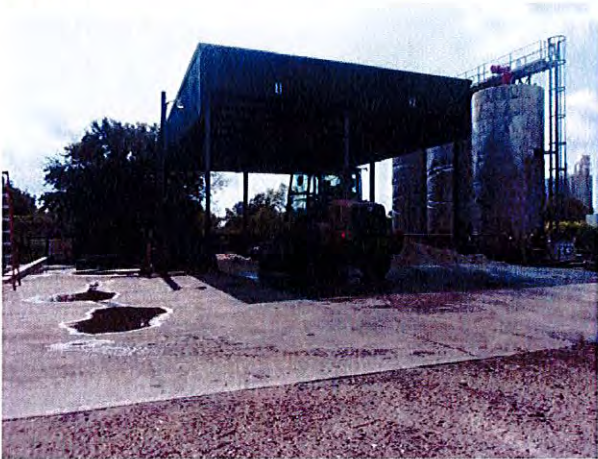
Photo 17

A large, two-pit Solid Waste Solidification Area is also located across Bryan Street (Photo 17). The pits are used to solidify other facility's non-hazardous waste streams. In addition, WR process wastes, including the wastewater filter cake and formally generated truck clean-out solids, are also added to the pits. This solidification media consists primarily of tobacco, peanut shells, paper dust, ceiling tile dust and other non-hazardous solids or sludge. A small bucket loader is used to mix up the solid, non-hazardous waste before being sent off-site for disposal to Chesser Island Landfill. Approximately 20 tons of waste is transported approximately daily.

The facility uses generator knowledge and/or analytical data (depending on the waste stream) provided by the customer in their waste profile to verify that a waste stream accepted for solidification is non-hazardous. Routine waste streams would only be required to be re-analyzed after the initial shipment if there were changes to the waste profile. The facility also currently analyzes the Solid Waste Solidification Area sludge quarterly for TCLP metal, semi-volatile and volatile constituents. Records of the results of the quarterly TCLP analysis were reviewed since the previous inspection. Samples collected on September 28, 2018, November 6, 2018, September 13, 2019, March 10, 2020, and August 13, 2020 indicated the waste was non-hazardous. The method detection limits were above the regulatory limits for 2,4-dinitrotoluene, hexachlorobenzene and hexachlorobutadiene for the samples collected on February 13, 2019, June 27, 2019, and December 2, 2019. Therefore, a complete hazardous waste determination was not conducted [40 CFR 262.11]. The results obtained on June 17, 2020 for the sample collected on June 4, 2020, indicated that there was 0.39 mg/L of 2,4-dinitrotoluene present in the sample. Because the waste contained 2,4-dinitrotoluene in a concentration greater than the regulatory limit of 0.13 mg/L, the waste was a D030 hazardous waste. Records indicate 26.48 tons of this waste stream were shipped on a non-hazardous manifest and improperly disposed of as non-hazardous waste in Chesser Island Landfill on June 5, 2020, [40 CFR 262.20(a)(1)]. The facility did not perform an accurate hazardous waste determination on this waste stream [40 CFR 262.11] and did not determine if the waste had to be treated prior to land disposal [40 CFR 268.7(a)(1)]. The Lab Supervisor stated during a phone call following the inspection that the exceedance was missed.

3. Solid Waste Solidification Area - Solidification pit solids.  
 Corrective Action: Item 1: In order to return to compliance, the facility should perform and fully document a hazardous waste determination on the ICP-OES wastewater by having the waste stream analyzed by a certified laboratory for the following:

Items 2-3: In order to return to compliance, the facility should submit proposed written operating procedures within 30 days of receipt of this report to DEP for approval, indicating how the facility will ensure that a full and accurate hazardous waste determination will be completed on all solid waste streams prior to disposal. The facility should immediately implement its operating procedures upon receipt of DEP's approval.

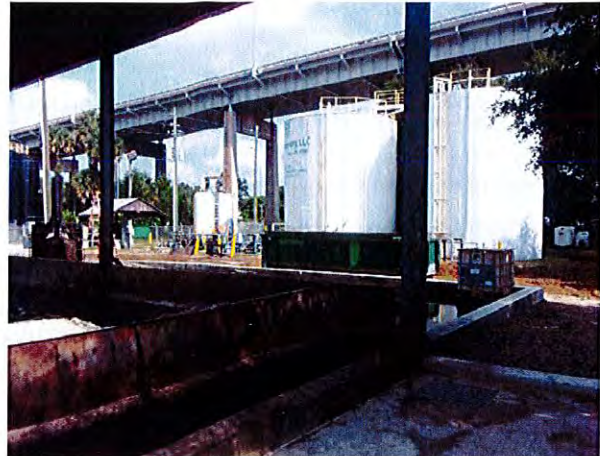
Photo 20

There are two landfill leachate wastewater tanks (Photo 20) located adjacent to the former Truck Clean-out Holding Pit. The tanks receive tanker trucks of leachate from Nassau County Landfill, Otis Road Landfill or Lake County Landfill. Recovered leachate wastewater is stored in tanks and then discharged under the facility's JEA Industrial User Discharge Permit, typically without treatment. If treatment is required due to nitrogen levels, aeration of the wastewater is performed until acceptable nitrogen levels are achieved.
